Report Title: Geotechnical Report <b>146 Whale Beach Road, Whale Beach</b>
Report Date: <b>12/12/24</b>
Author: <b>BEN WHITE</b>
Author's Company/Organisation: <b>WHITE GEOTECHNICAL GROUP PTY LTD</b>

## **GEOTECHNICAL INVESTIGATION:**

### **Alterations and Additions at 146 Whale Beach Road, Whale Beach**

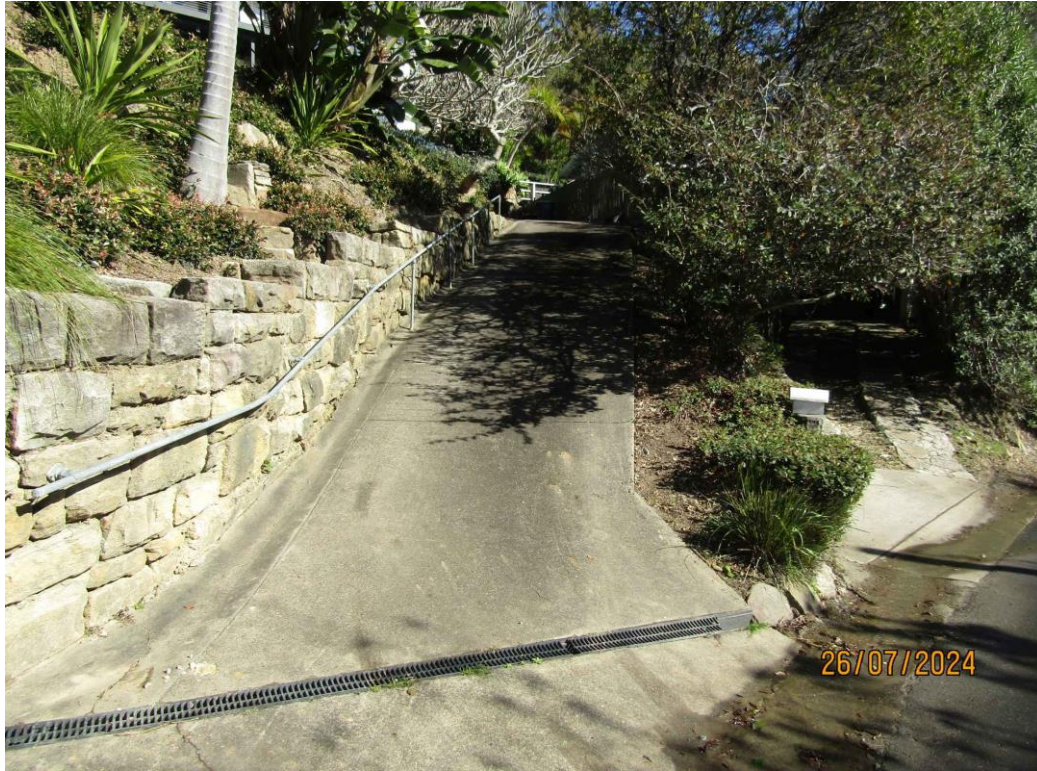
Photo 1

- 2.1** The site was inspected on the 26<sup>th</sup> July, 2024 and several times previously.
- 2.2** This residential property is on the high side of the road and has an NE aspect. It is positioned on the moderate to steeply graded upper middle reaches of a hillslope. From the road, the natural slope rises at an average angle of ~18° to the upper boundary where sandstone beds outcrop and form a small rock face. The slope above and below the property continues at similar angles.
- 2.3** At the road frontage, a concrete driveway runs up the slope to a paved parking area downhill of the house (Photos 1 & 2). A stable sandstone block retaining wall up

to ~1.7m high supports a cut for the driveway and the toe of a fill batter for a garden area above (Photo 1). The fill for the driveway and garden area above are battered at stable angles where they are not supported by retaining walls (Photos 2 & 3). The cut for the parking area is supported by a sandstone block retaining wall that reaches a maximum height of ~3.0m that will be demolished as part of the proposed works (Photo 4). A detached sandstone joint block outcrops above the parking area (Photo 5). The joint block will be removed as part of the proposed works. The single storey brick house is in good condition for its age (Photo 6). A cut to a maximum height of ~1.5m has been made into the slope to provide a level platform for the uphill side of the house (Photo 7). The area above the wall is sparsely-vegetated and rises to a Medium Strength Sandstone bed that outcrops along the upper boundary of the subject property (Photo 8). No signs of slope instability were observed on the property that could have occurred since the property was developed. The adjoining neighbouring properties were observed to be in good order as seen from the street and subject property.

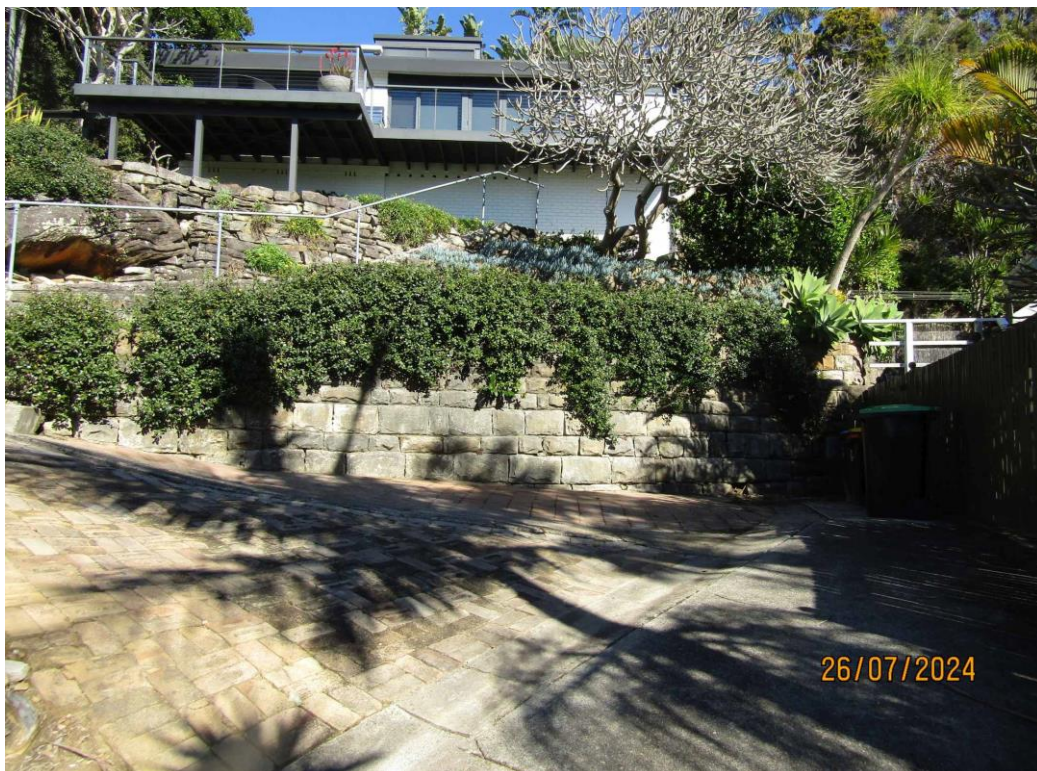
Photo 4

Due to the depth of the excavation and its proximity to the surrounding structures and property boundaries, all sides of the excavation will require ground support prior to the commencement of the excavation and prior to the demolition of the existing sandstone block retaining wall (Photo 4).

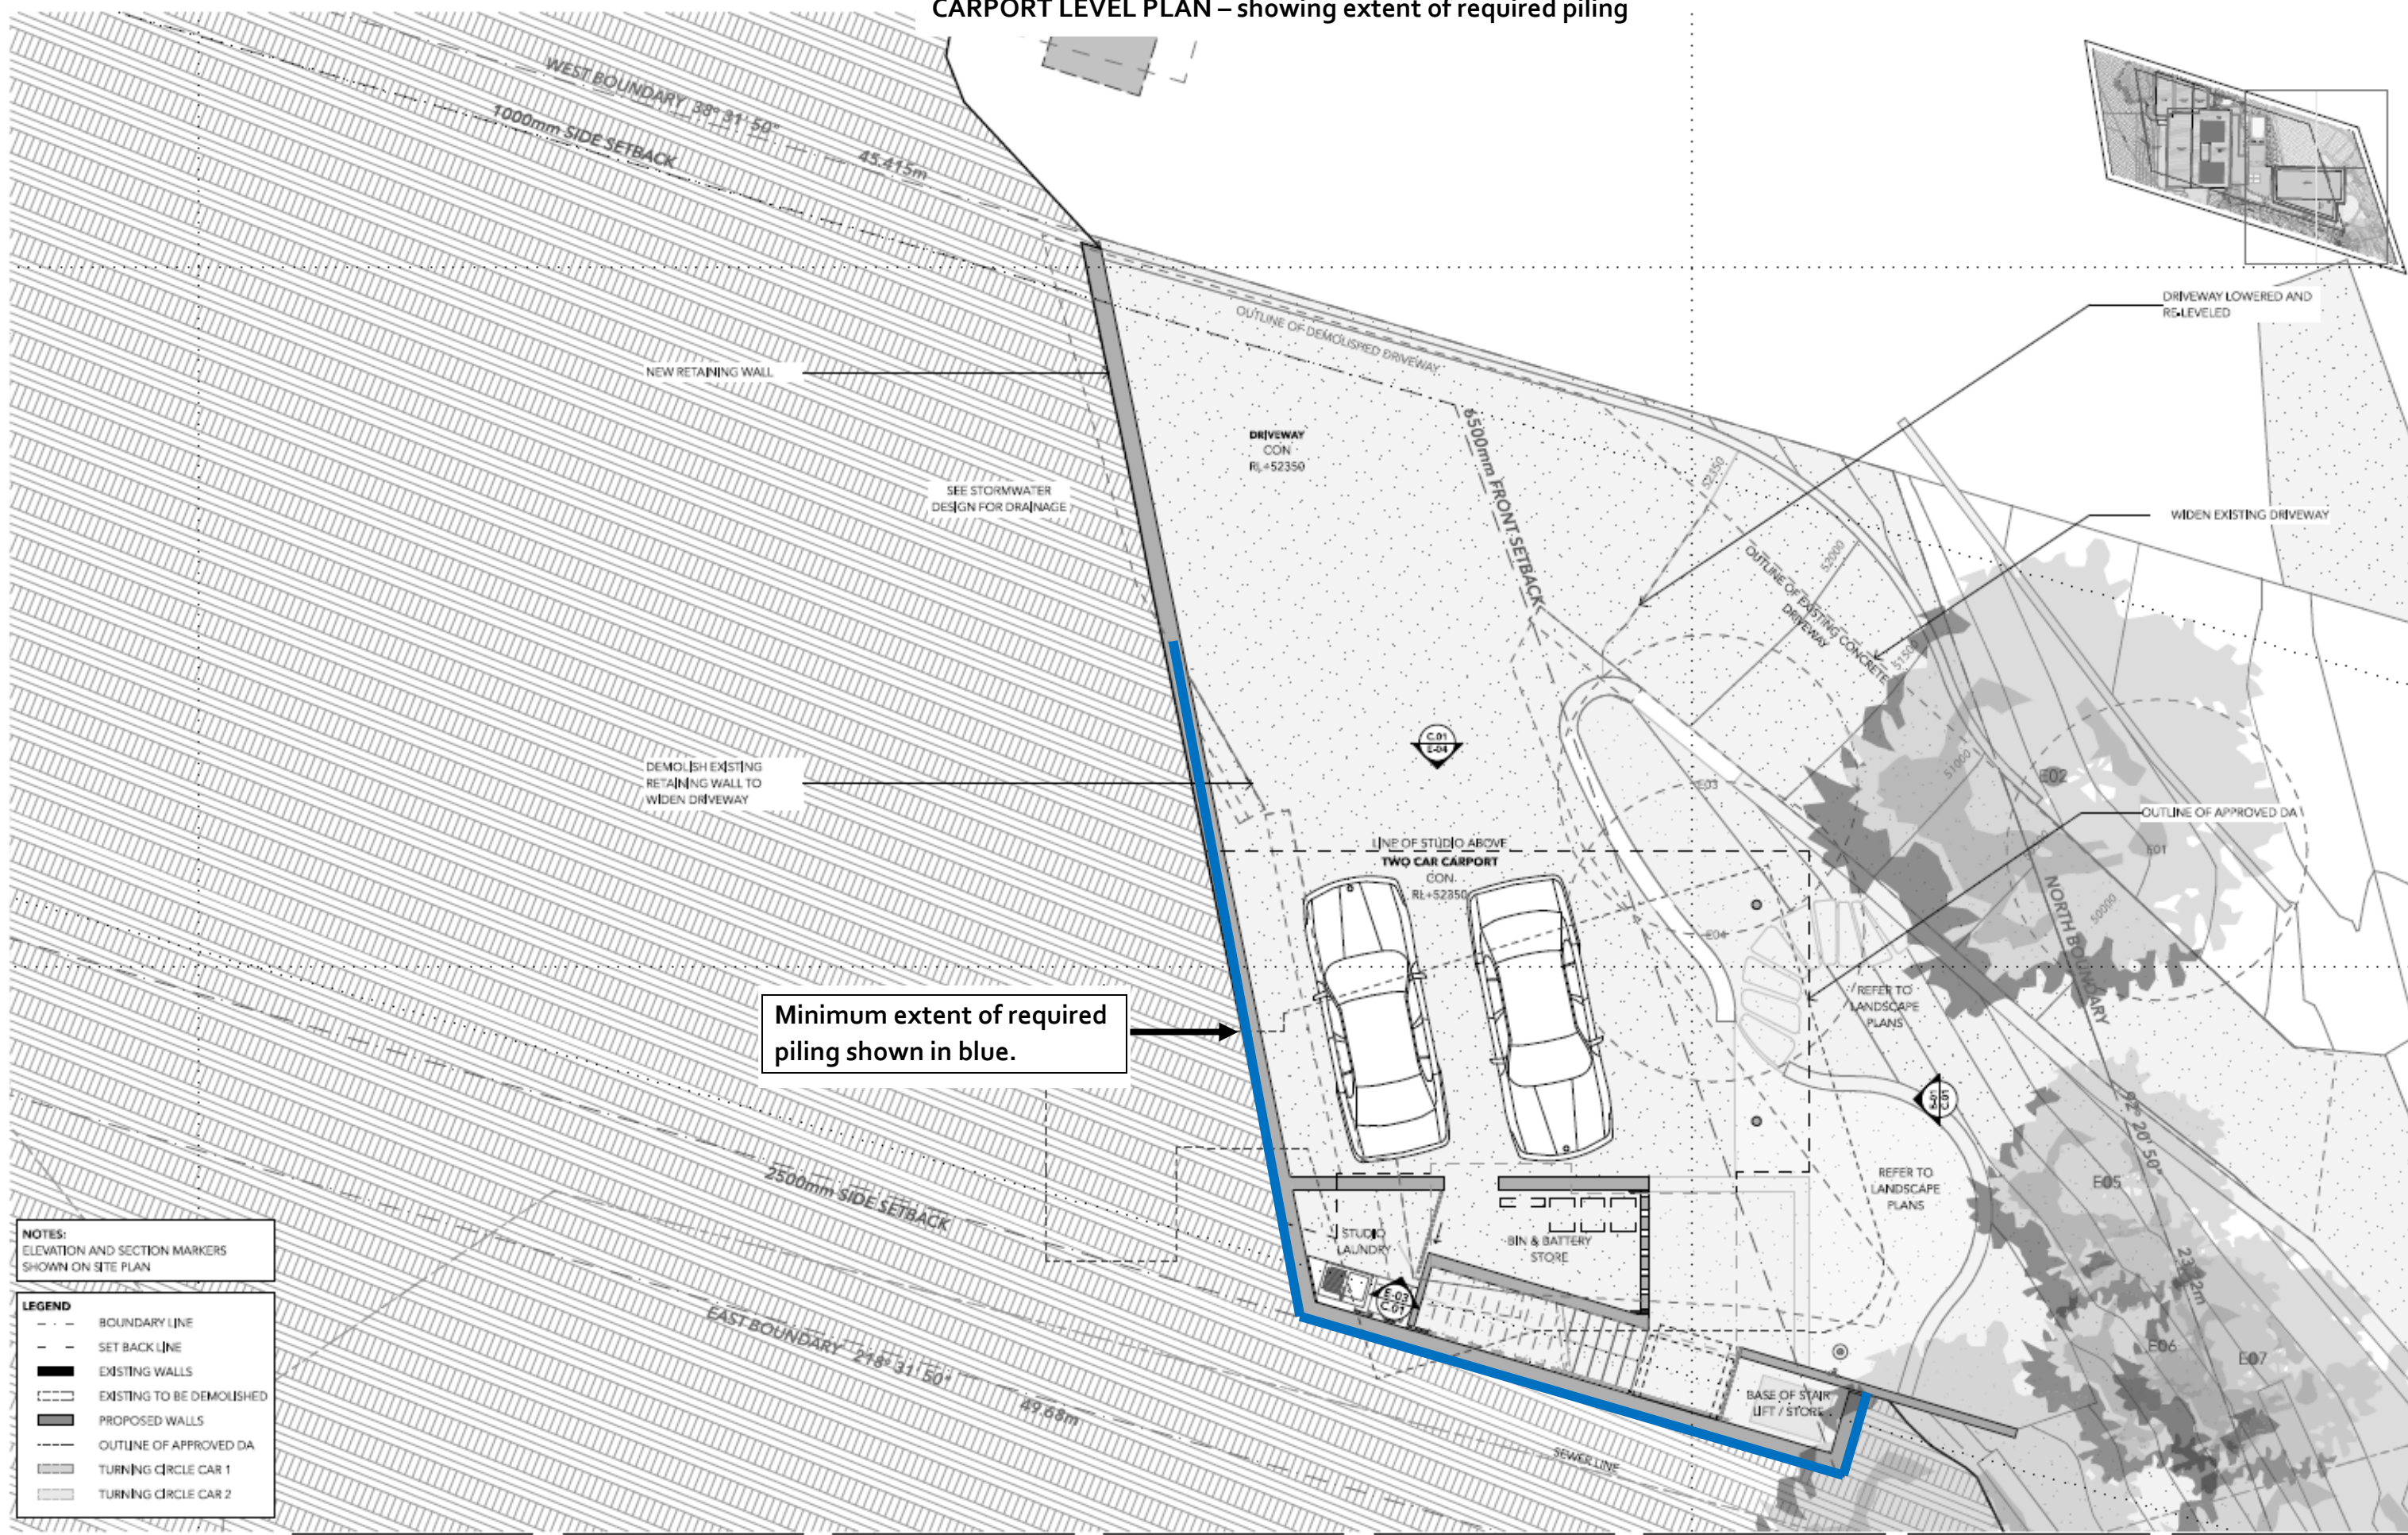
DRAWING  
**CARPORT LEVEL**  
DRAWING NUMBER  
**B.02**  
ISSUE  
**A**

Minimum extent of required piling shown in blue.

A spaced pile retaining wall is one of the suitable methods of support. See the Carport Level and Studio Level plans attached for the minimum extent of the required piling shown in blue. Pier spacing is typically ~2.0m but can vary between 1.6 to 2.4m depending on the design. As the excavation is lowered in 1.5m lifts, infill sprayed concrete panels or similar are added between the piers to form the wall. Drainage is to be installed behind the panels. To drill the pier holes for the walls, a pilling rig that can excavate through Medium to High Strength Rock will be required. The piers can be temporarily supported by embedment below the base of

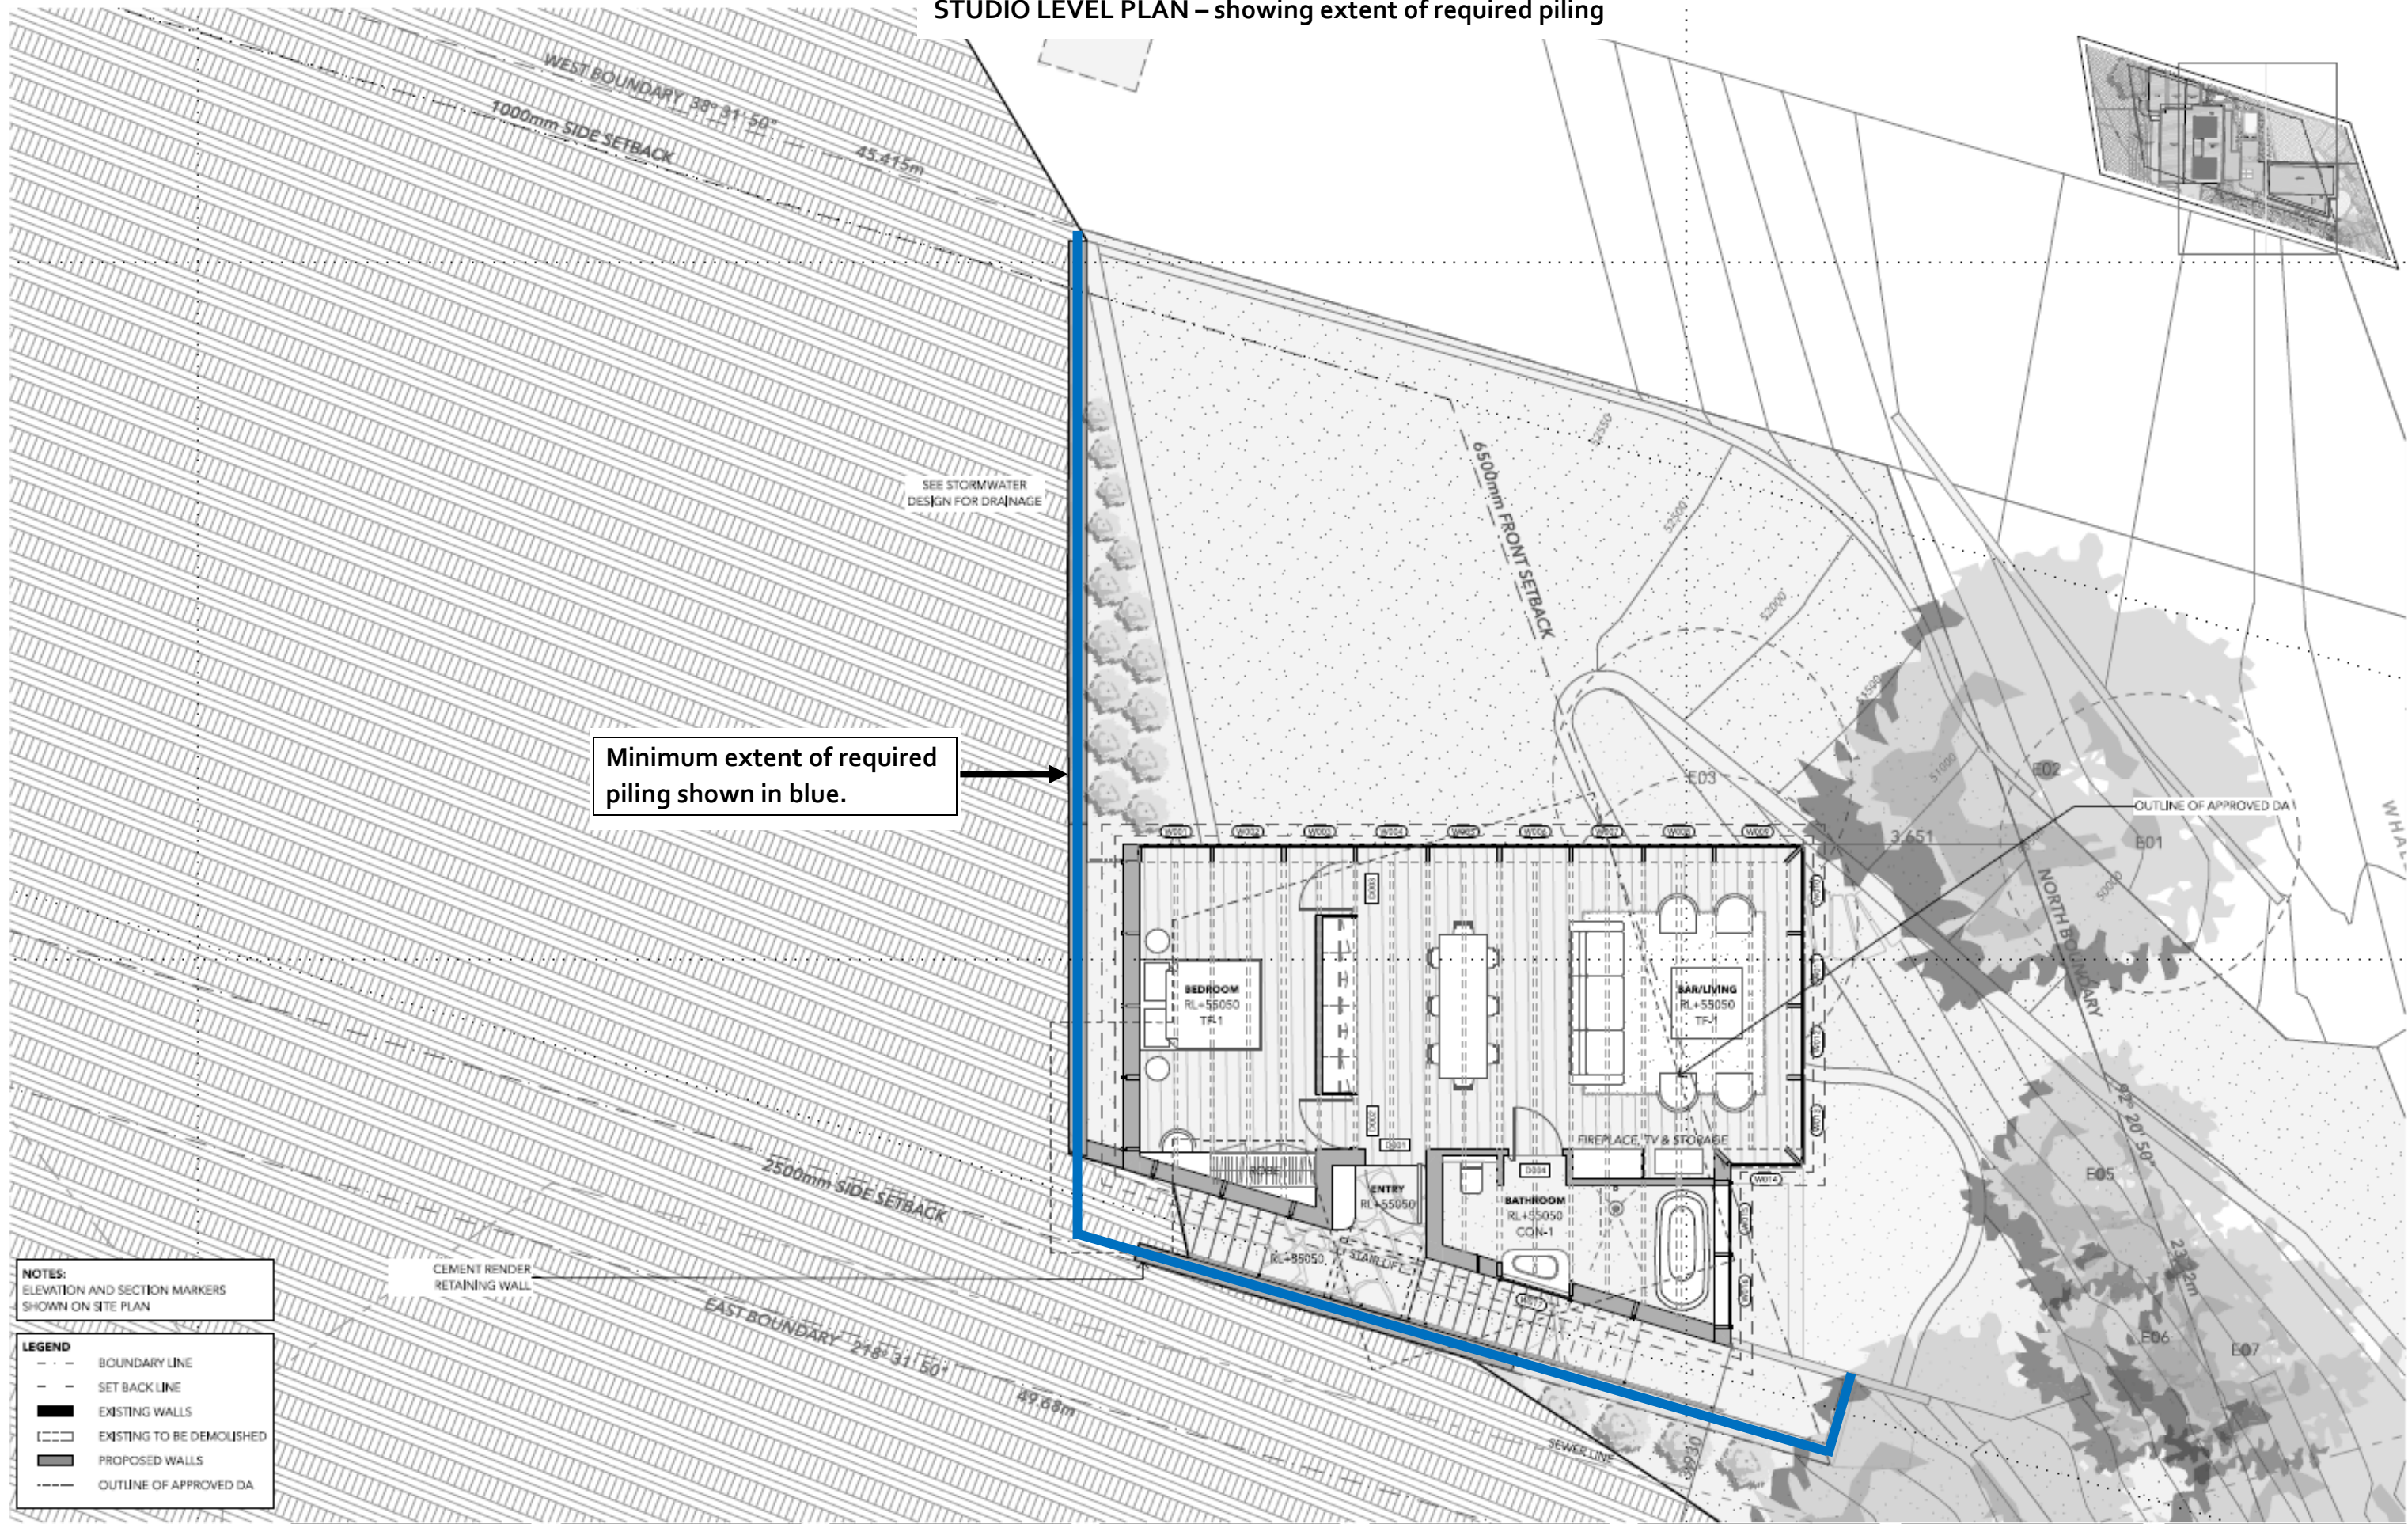
DRAWING  
**STUDIO LEVEL**  
DRAWING NUMBER  
**B.03**  
ISSUE  
**A**

Minimum extent of required piling shown in blue.

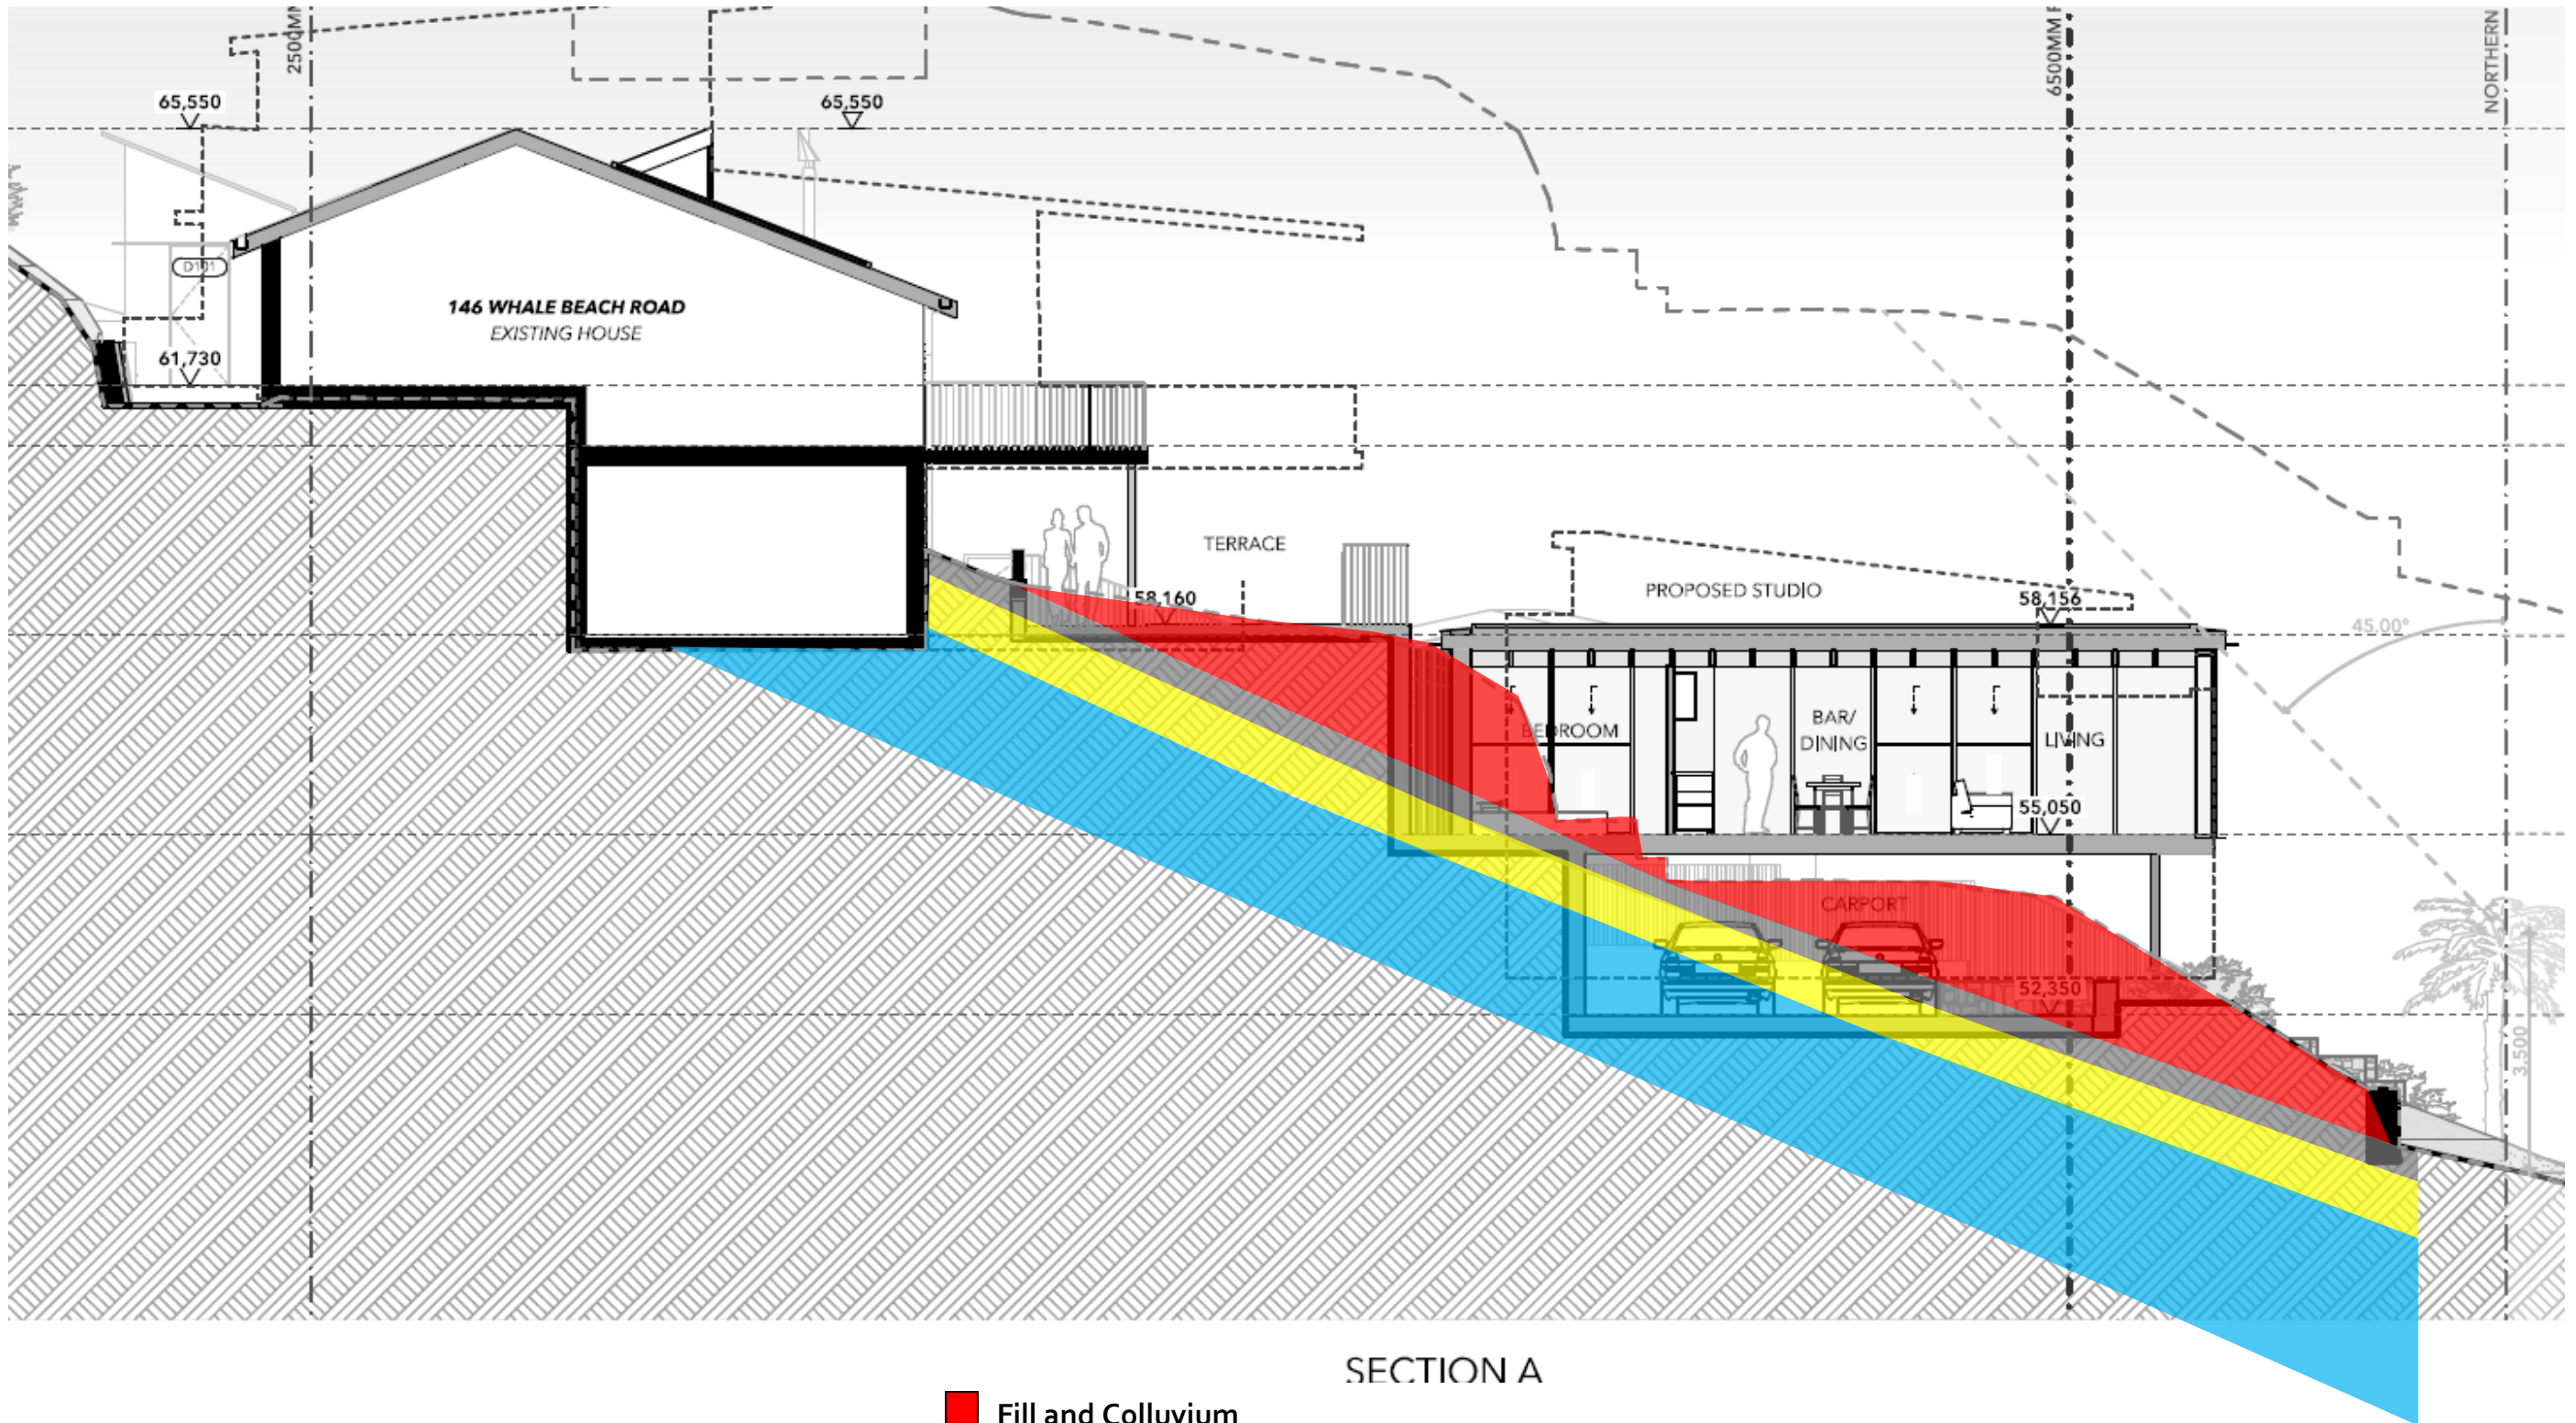
SECTION A

In the test locations, shallow sandy soil overlies a Firm to Stiff Clay that extends to depths of ~2.0m. This is underlain by Extremely Low to Low Strength Shale and Laminite with occasional clay zones. The rock quality generally improves beyond 4.0m with Low to Medium Strength Laminite encountered in most holes. Fine grained Very Low to High Strength Sandstone was present beyond 5.0m. The profile in BH 4 varied from the others and appeared to consist of a dislodged sandstone joint block from the rock face above through the first 3.0m. The DCP tests that encountered refusal at shallow depths likely refused on buried sandstone boulders as an unusually high number of sandstone boulders lay embedded and exposed on the slope. See Type Section attached for a diagrammatical representation of the expected ground materials.

- Fill and Colluvium
- Topsoil
- Clay – Firm to Stiff
- Narrabeen Group Rocks – Extremely Low to Low Strength Shale, Very Low to Medium Strength Sandstone at depths greater than ~4.0m.
