54 Bardo Road, Newport

Geotechnical Comments for Section 4.55.

GEOTECHNICAL INVESTIGATION:

New Seniors Housing Complex at 54 Bardo Road, Newport

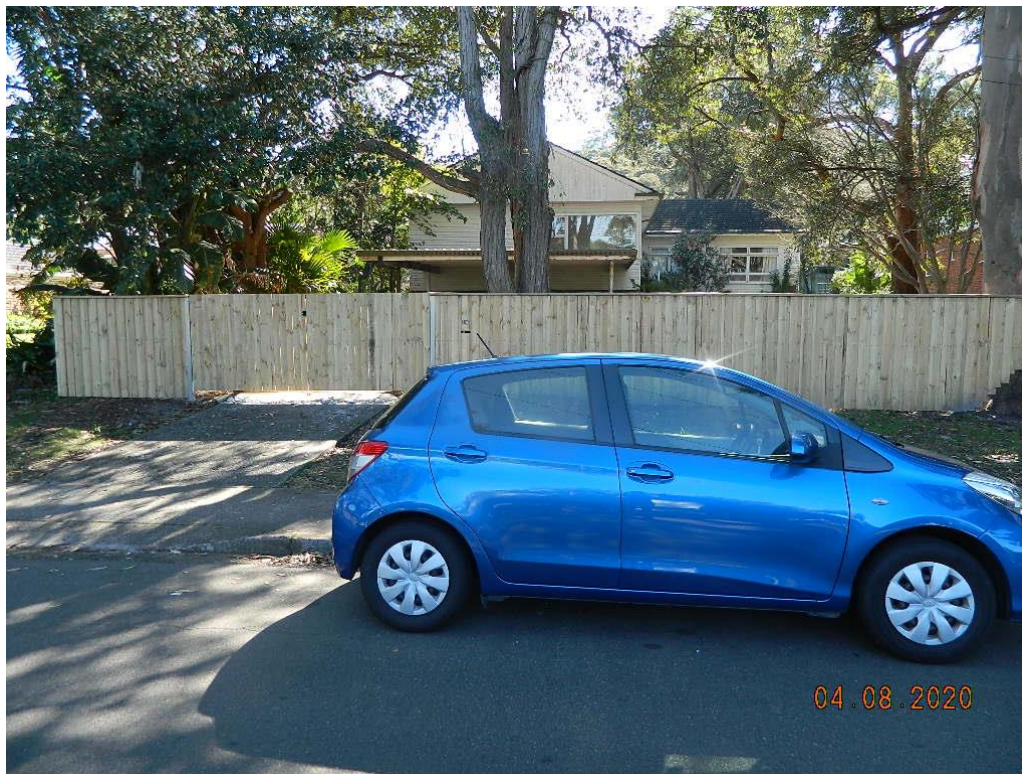
Photo 1

- 2.3** At the road frontage, a concrete driveway runs to a carport on the downhill side of the house (Photos 1 & 2). A gently sloping lawn is located E of the driveway, carport and house (Photo 3). The one storey brick and timber clad house is supported by brick walls and brick piers (Photo 3). The supporting walls and piers stand vertical and show no significant signs of movement (Photo 4). A gently sloping lawn extends from the uphill side of the house to the uphill property boundary (Photo 5). A fibro shed is located near the NW corner of the property. The house and shed will be demolished and the site will be cleared as part of the proposed works. The adjoining

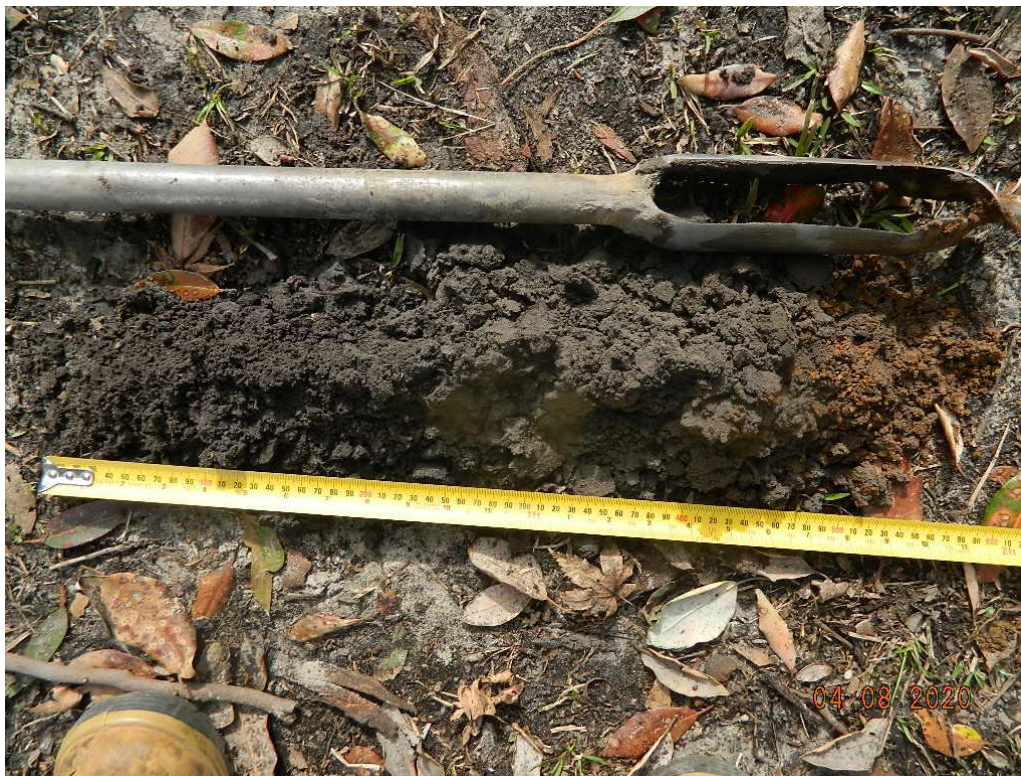
AUGER HOLE 1 (~RL14.8) – AH1 (Photo 6)

Depth (m)	Material Encountered
0.0 to 0.5	SILTY SAND , dark brown, damp, fine to medium grained with fine trace organic matter.
0.5 to 0.6	HARDPAN (Laterite) . light brown/orange, damp.

Refusal @ 0.6m in hardpan (laterite). No watertable encountered.

Photo 6: AH1 – Downhole is from left to right.

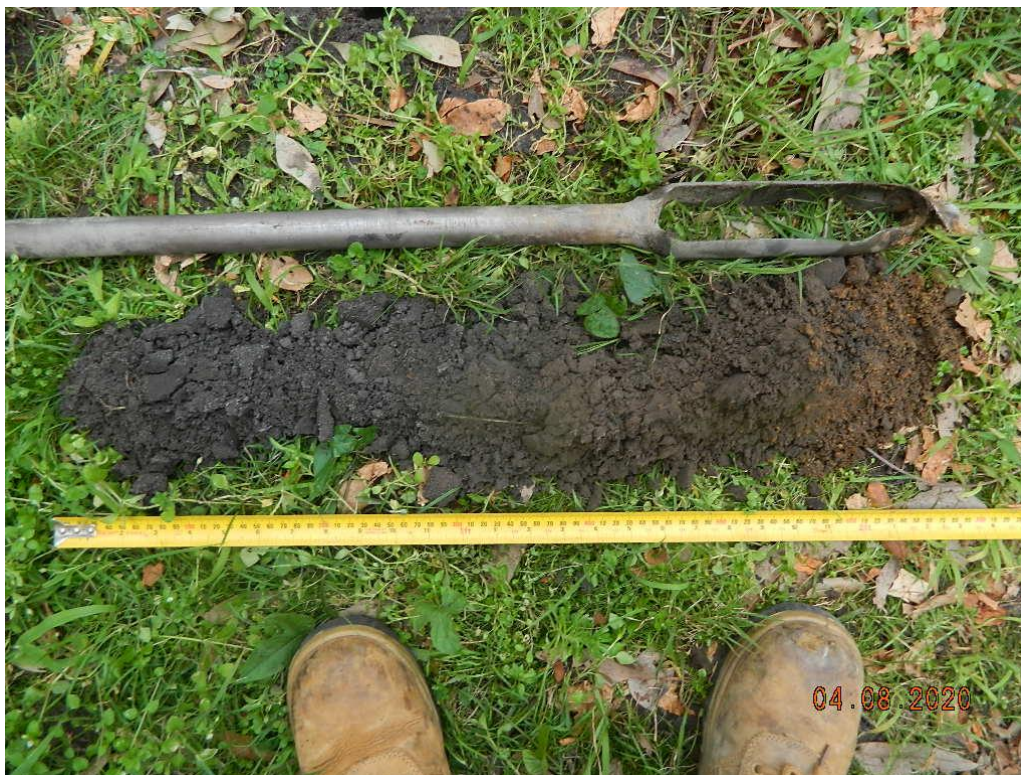
AUGER HOLE 2 (~RL17.7) – AH2 (Photo 7)

Depth (m)	Material Encountered
0.0 to 0.5	SILTY SAND , dark grey/brown, loose to medium dense, moist, fine to medium grained.
0.5 to 0.7	HARDPAN (Laterite) , light brown/orange, moist.

Refusal @ 0.7m in hardpan (laterite). No watertable encountered.

Photo 7: AH2 – Downhole is from left to right.

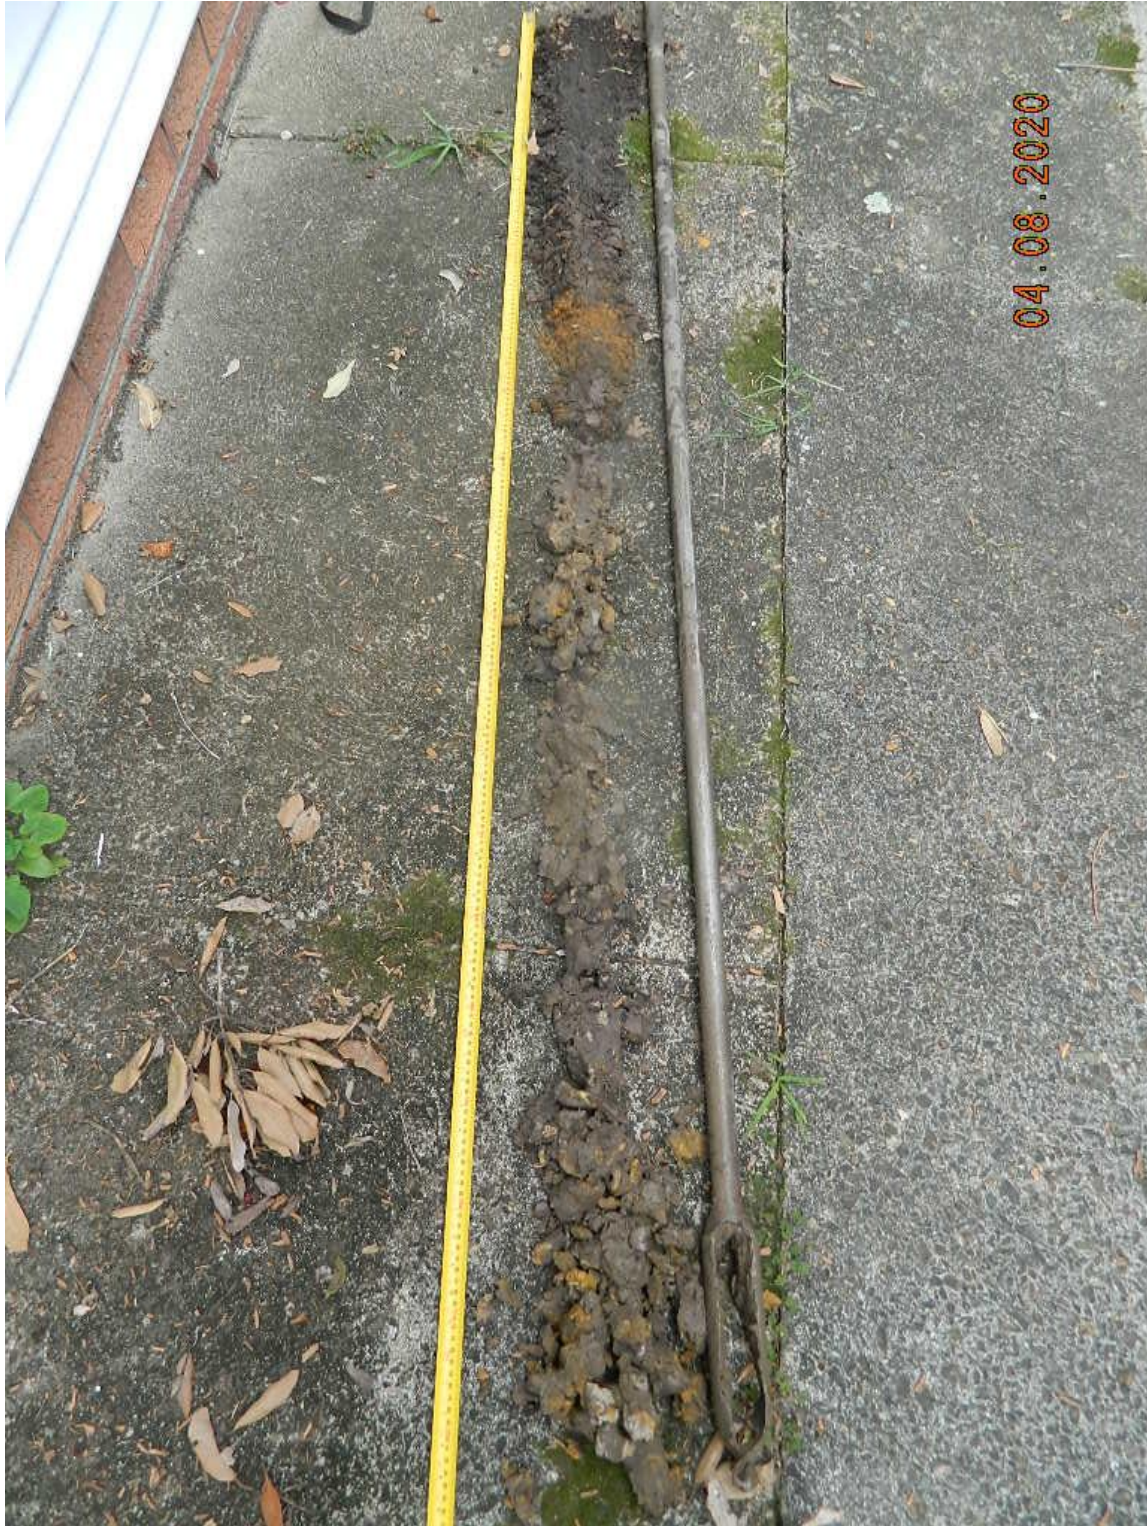
AUGER HOLE 3 (~RL16.5) – AH3 (Photo 8)

Depth (m)	Material Encountered
0.0 to 0.7	SILTY SAND , dark brown/grey, loose to medium dense, moist, fine to medium grained with fine trace organic matter.
0.7 to 0.8	HARDPAN (Laterite) , light brown/orange, moist.
0.8 to 1.1	SILTY SAND , dark brown, damp to wet, medium grained.
1.1 to 1.2	SAND , light grey/orange, wet, medium grained.
1.2 to 2.2	SANDY CLAY , orange, grey and dark brown, soft to very stiff, wet.

End of hole @ 2.2m in very stiff sandy clay. No watertable encountered.

Photo 8: AH3 – Downhole is from top to bottom.

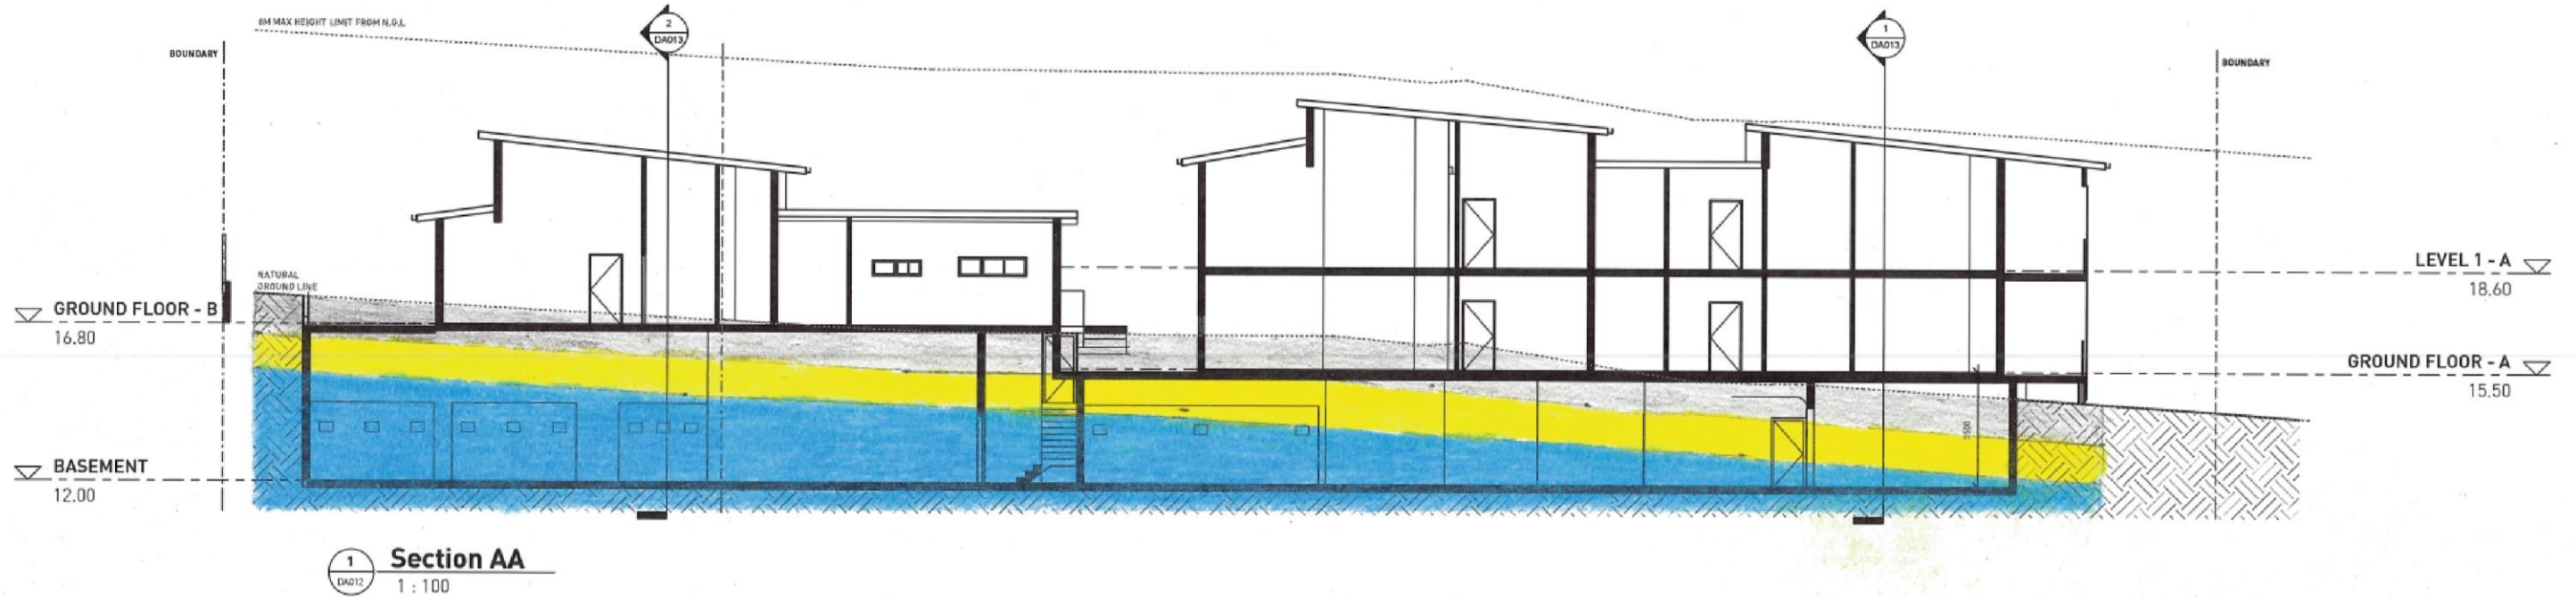
TYPE SECTION – Diagrammatical Interpretation of expected Ground Materials

The slope materials are colluvial at the near surface and residual at depth. In the test locations, the ground materials consist of silty sand, hardpan (laterite) and sand over clays. It is interpreted that DCP1 to DCP3, DCP6 and DCP10 hit refusal on the laterite band. The clays merge into the weathered zone of the underlying rocks at depths of between 1.8m to 2.4m below the current surface. The weathered zone of the underlying rock is interpreted as Extremely Low Strength Shale. It is to be noted that this material is a soft rock and can appear as a mottled stiff clay when it is cut up by excavation equipment. See Type Section attached for a diagrammatical representation of the expected ground materials.

- Silty Sand
- Sandy Clay
- Narrabeen Group Rocks – Extremely Low Strength Shale - after being cut up by excavation equipment can resemble a stiff to hard clay.
