Tree Impact Assessment Report

7 Coolena Road

Elanora Heights, NSW 2101

4-05-2016

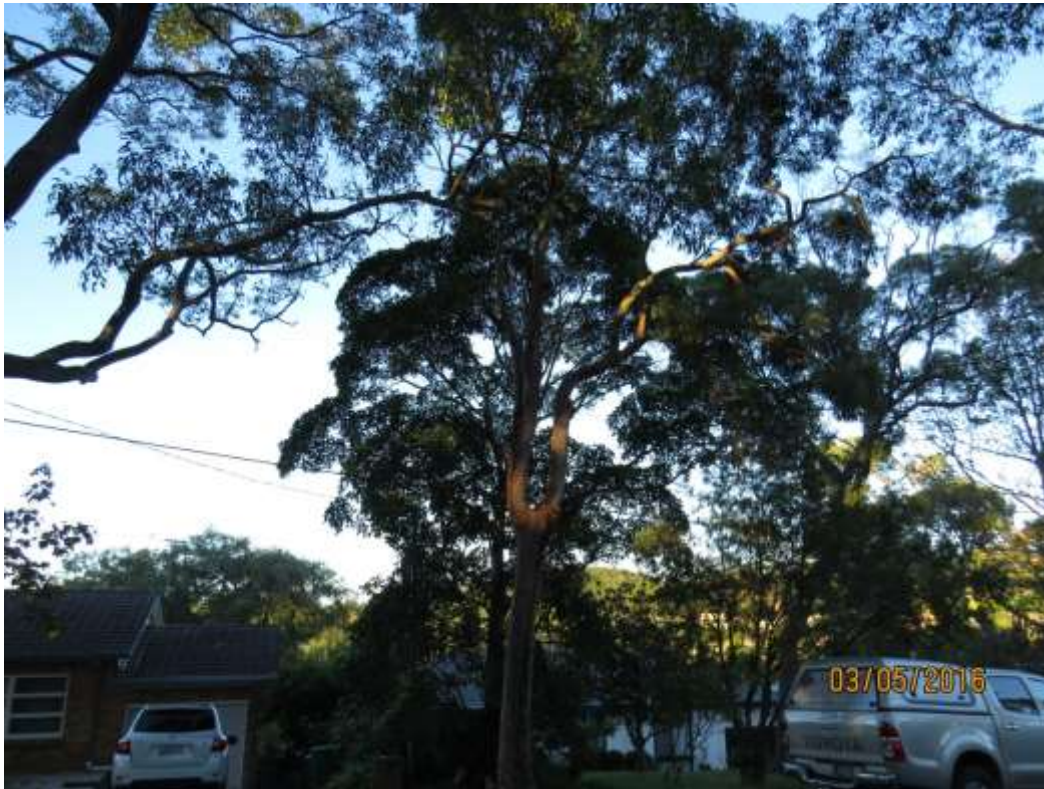
Photo 1 Trees 2 and 1

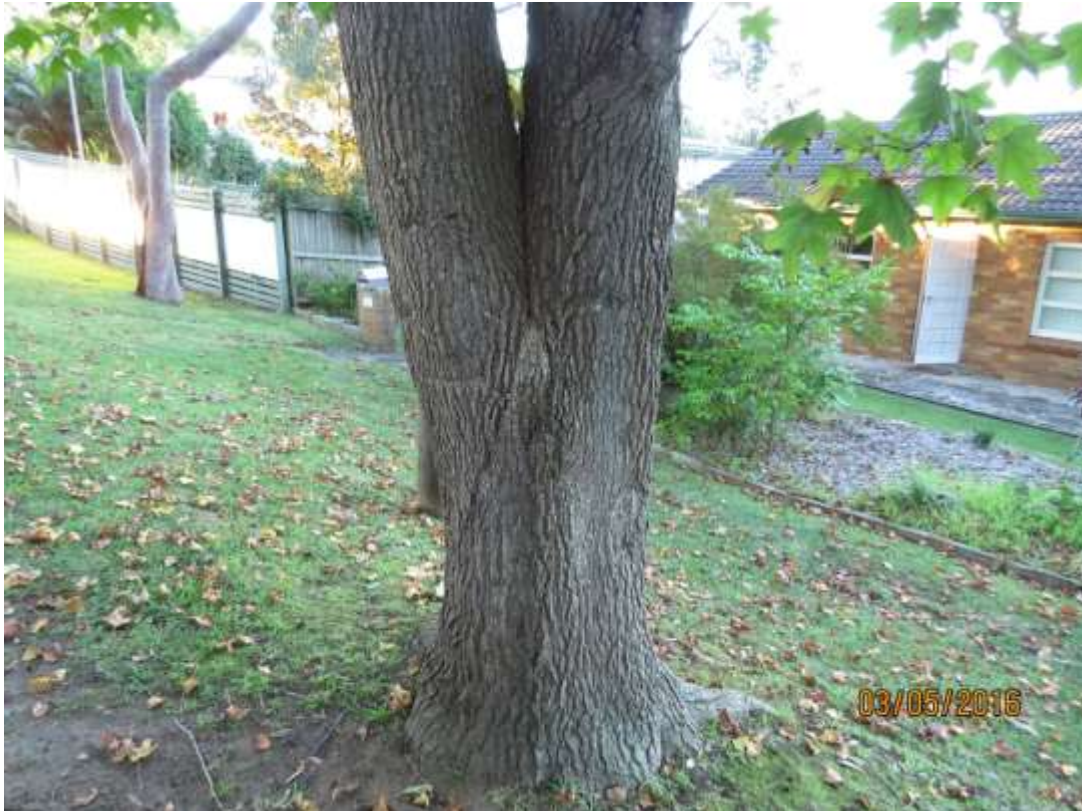
Photo 2 Trees 3 Junction

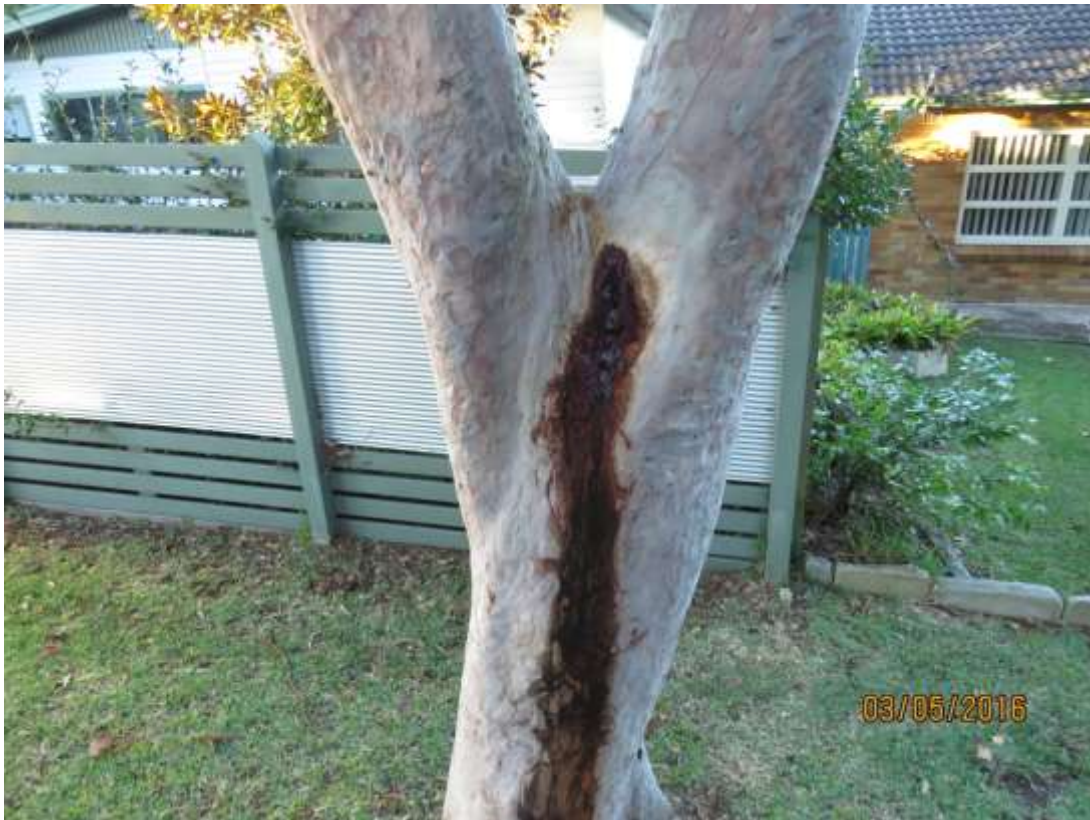
Photo 3 Trees 4 Junction with sap ooze

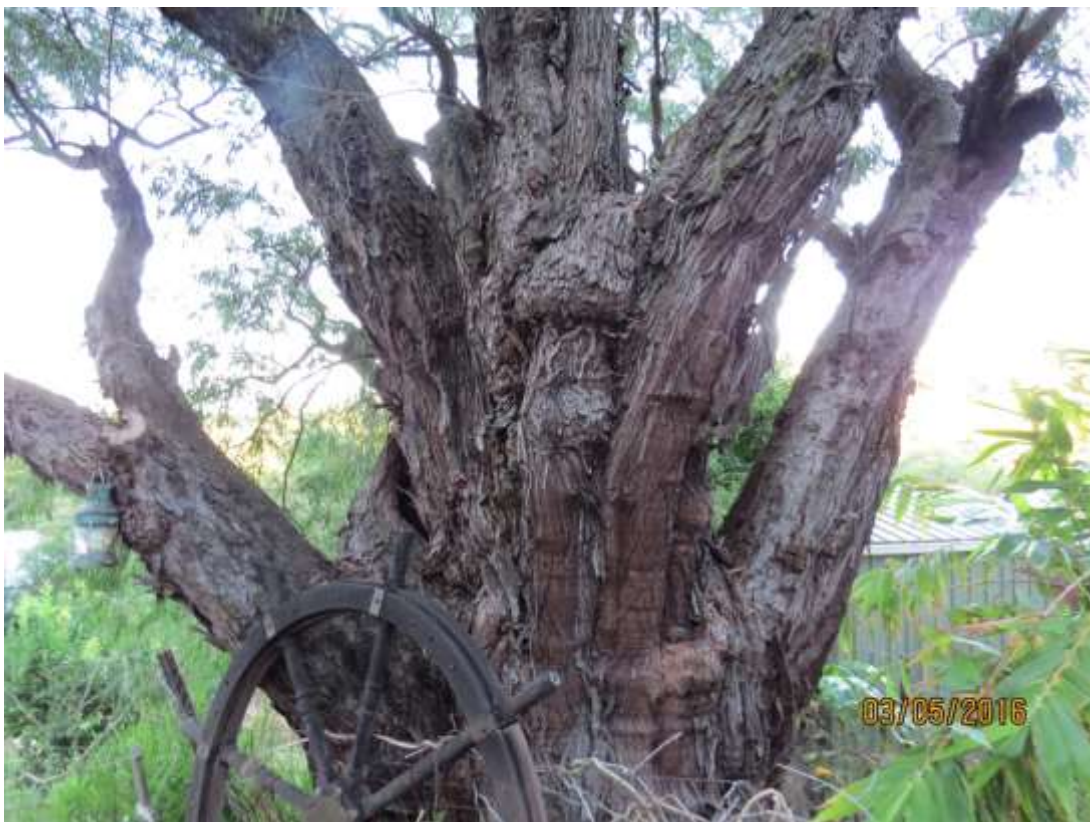
Photo 4 Tree 8 junctions

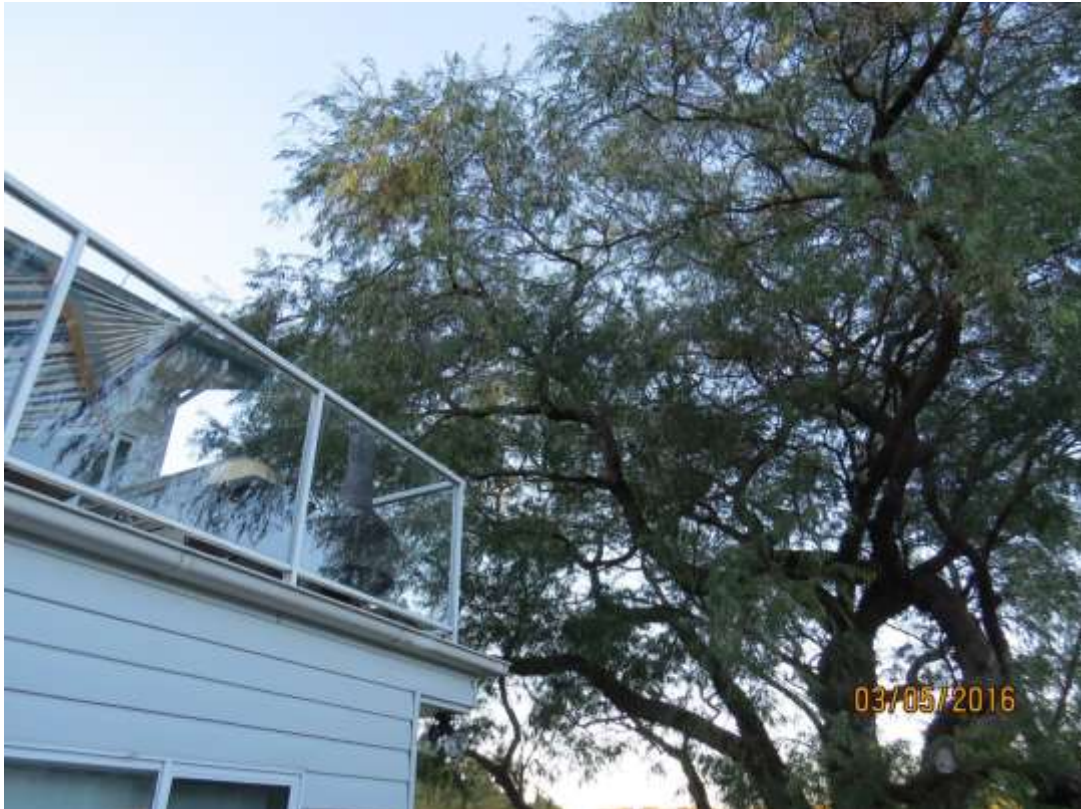
Photo 6 Tree 8 impacting upon existing house

- That trees 1 to 6 trees 10 to 15 be retained and TPZ be installed during construction
- That trees 7, 8 and 9 can be considered for removal
- That a landscape plan be developed
- That the tree Protection Schedule be adopted
- That a wash area situated away from tree 1 and 2 during construction
