Geotechnical Assessment Report for the Proposed Development at 96 Beacon Hill Rd, Beacon Hill NSW 2100

**Client: Michael Nott
Project No.: G1743G**

December 2019

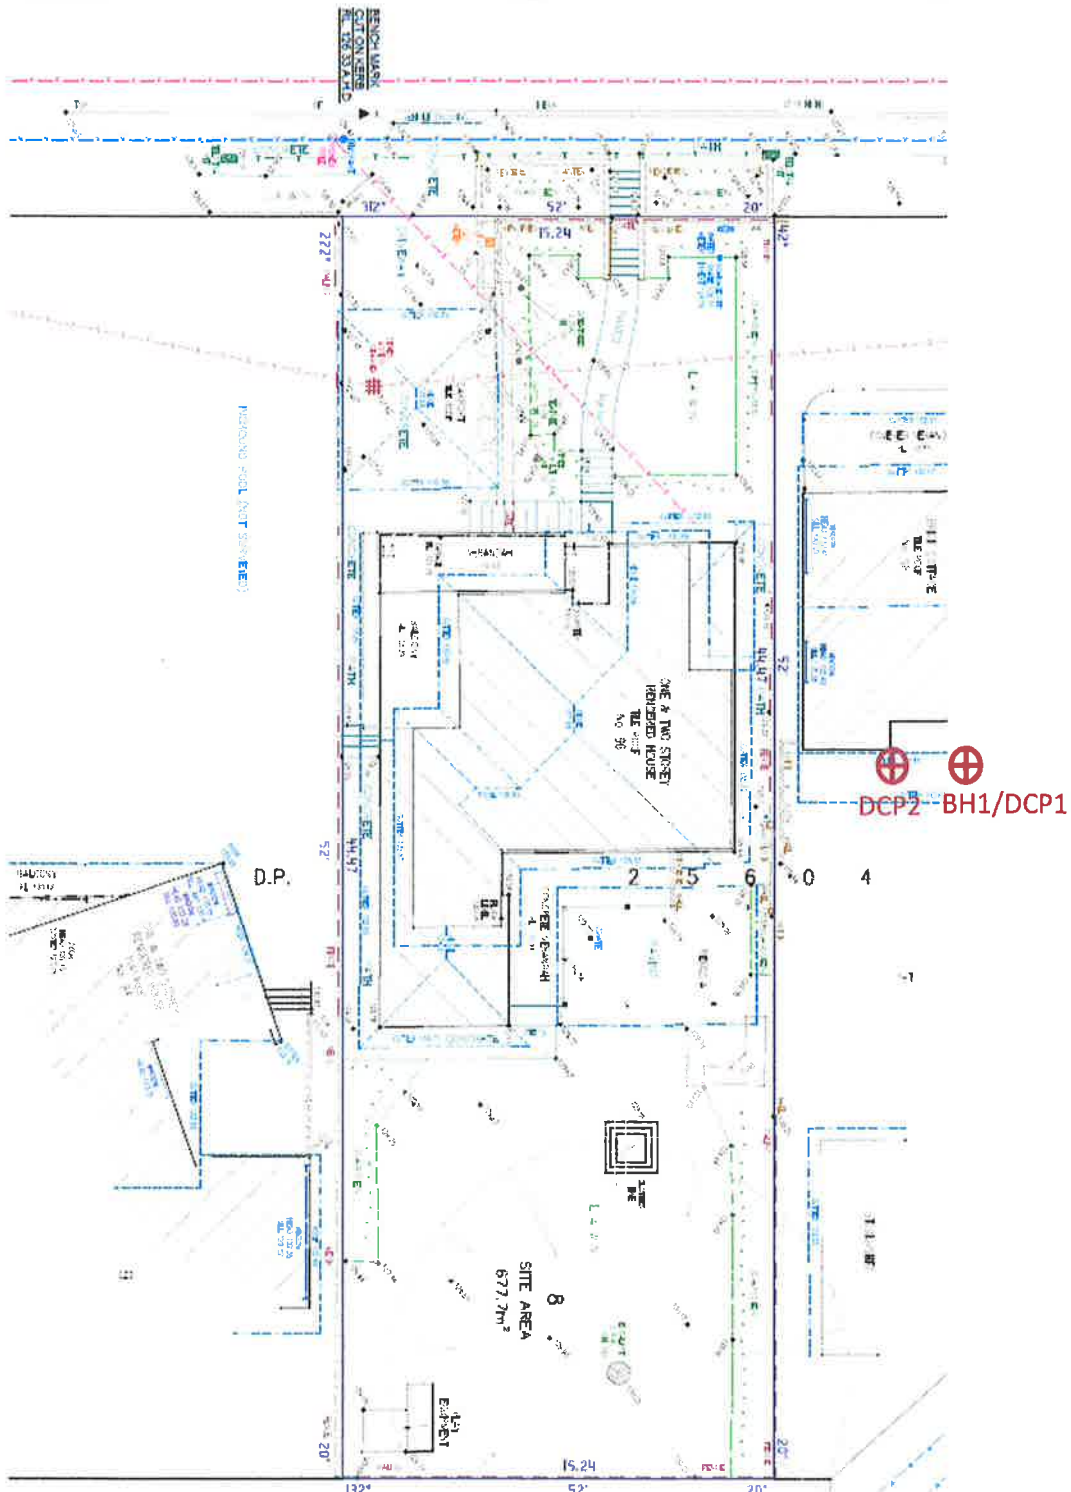
Figure 1 Borehole and DCP tests location

Two Dynamic Cone Penetration (DCP) tests were carried out in the field. The testing was carried out in accordance with 'Australian Standard (AS) 1289: Methods of Testing Soil for Engineering Purposes'. The DCP tests locations are marked in Figure 1 and its results are given in Appendix A. Based on the

One borehole was drilled by using hand auger up to a depth of 0.5 m from the existing ground level. The soils encountered during the investigation were visually classified according to 'Australian Standard (AS) 1726: Geotechnical Site Investigations'. On completion of logging and sampling, the boreholes were backfilled with the obtained soil. The locations of boreholes are shown in Figure 1 and the logs of boreholes are given in Appendix A.

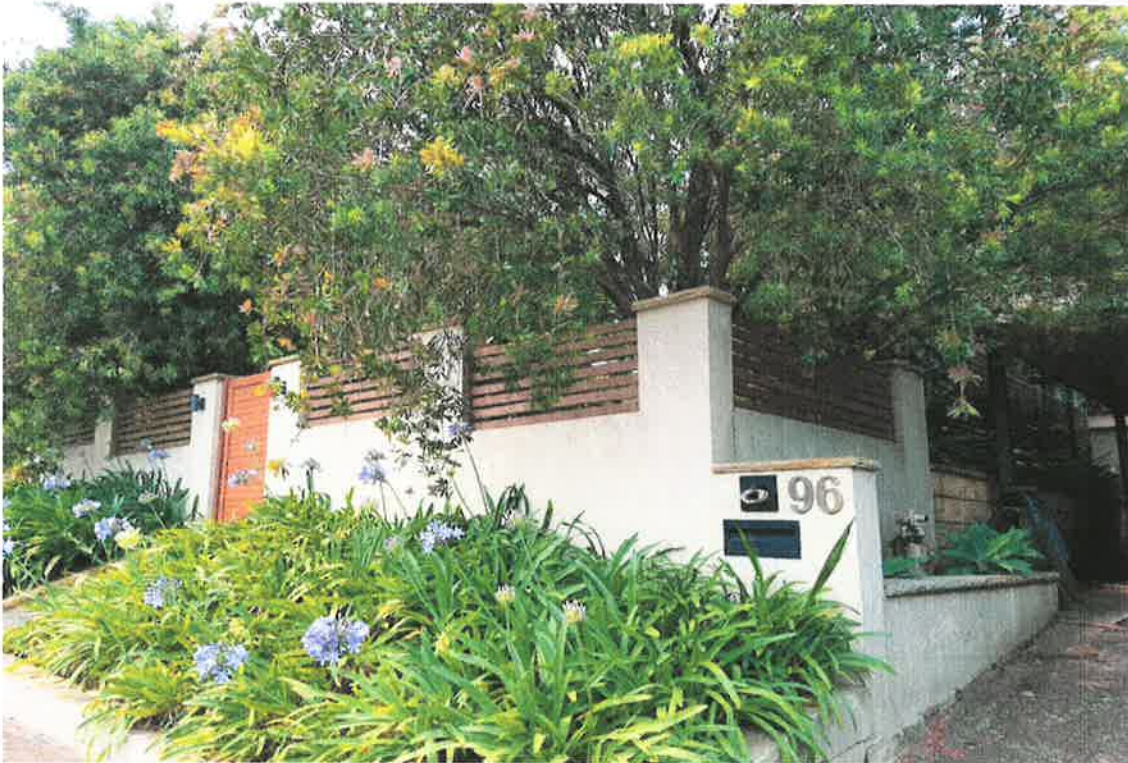
The front side of the site is slightly sloped towards the road as shown in Figure 2. The middle and backyard is almost flat as shown in Figure 3 and Figure 4 respectively. The existing timber pergola adjacent to the house in the northern boundary is shown in Figure 5.

Figure 2 Site photo showing the slope towards the road at front of the existing house

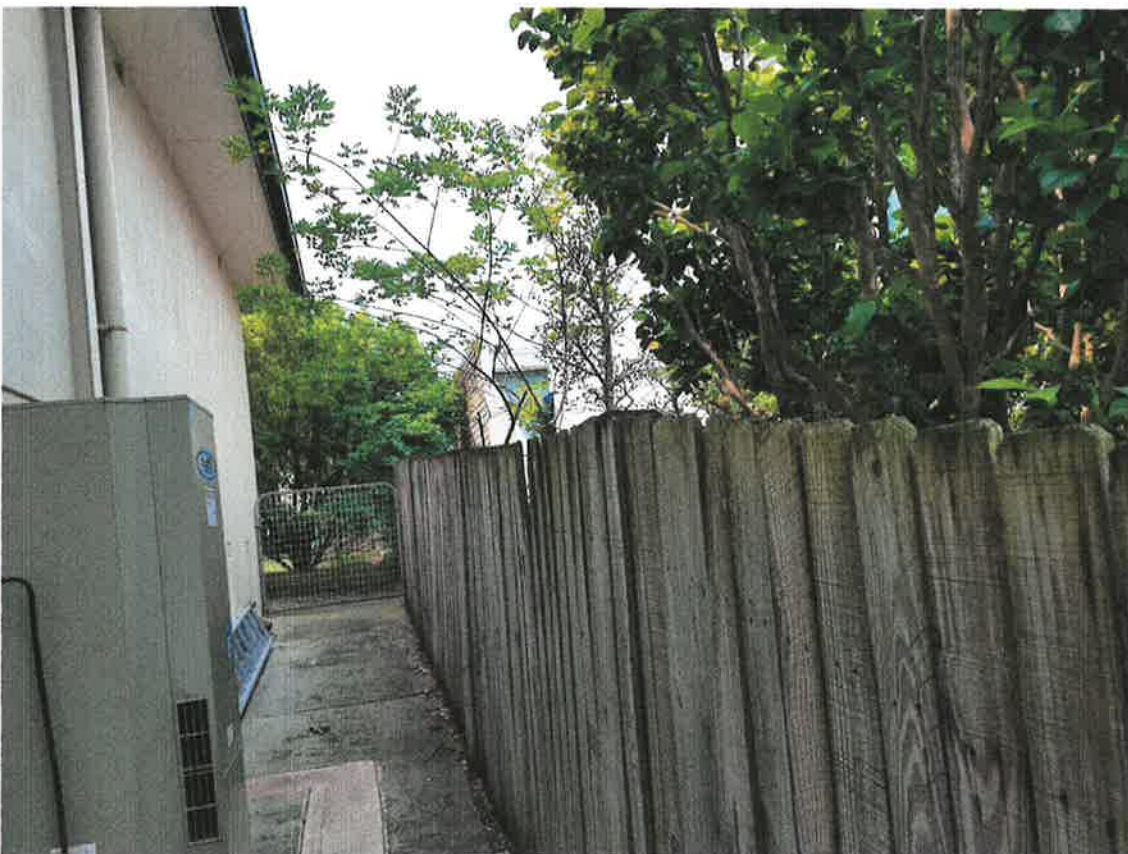
Figure 3 Access to the backyard adjacent to the existing house

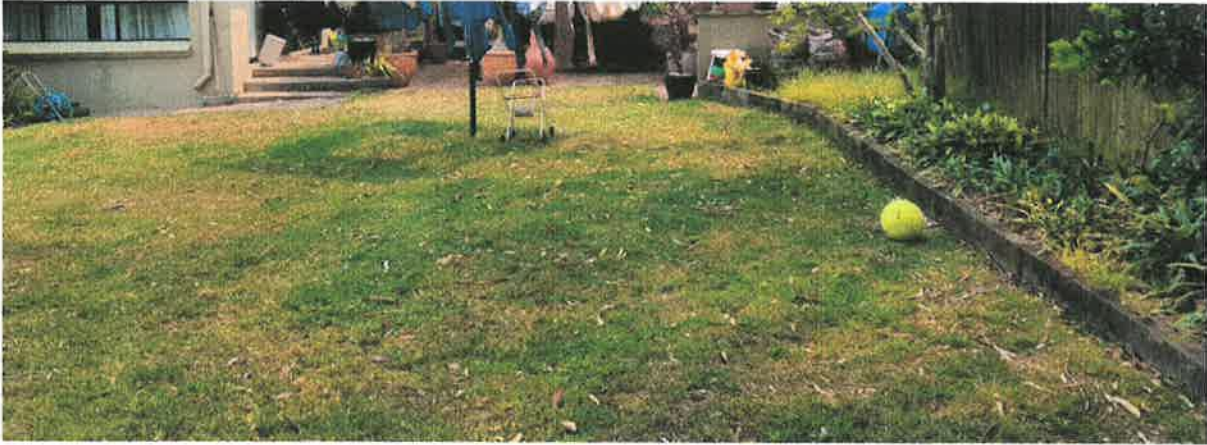
There were no signs of deep-seated slope instability, down slope creep and past ground movements such as tension cracks and slide scarp in this part of the site and the possibility in future is also unlikely. The site is appeared to be relatively well drained.

Figure 4 Backyard – Photo taken from the rear boundary

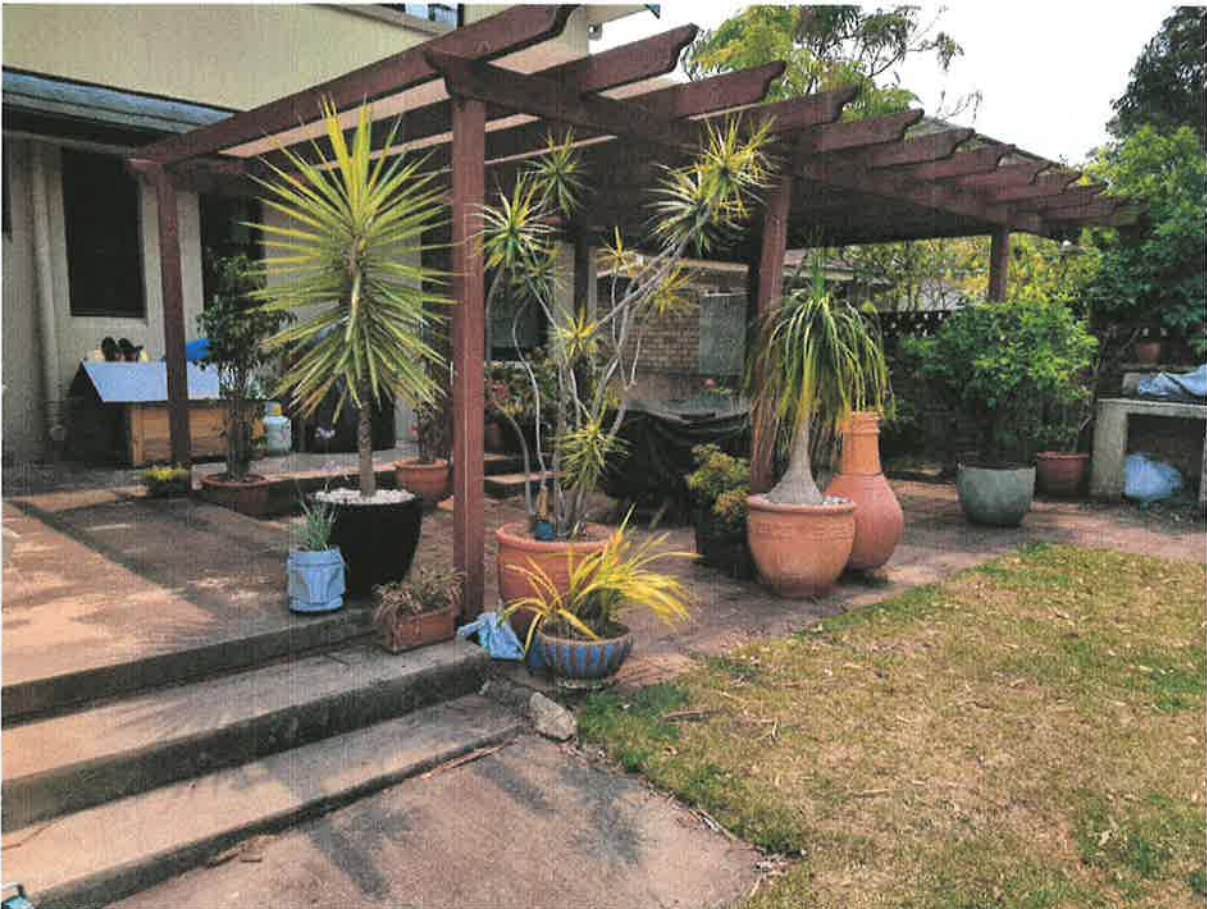
Figure 4 Existing pergola to be replaced by the new pergola
