Development Application for _____ Name of Applicant
Address of site _____ 8 Forest Road, Warriewood, NSW

**REPORT TO
WARRIWOOD VALE PTY LTD**

**ON
GEOTECHNICAL ASSESSMENT
(In Accordance with Pittwater Council Risk
Management Policy)**

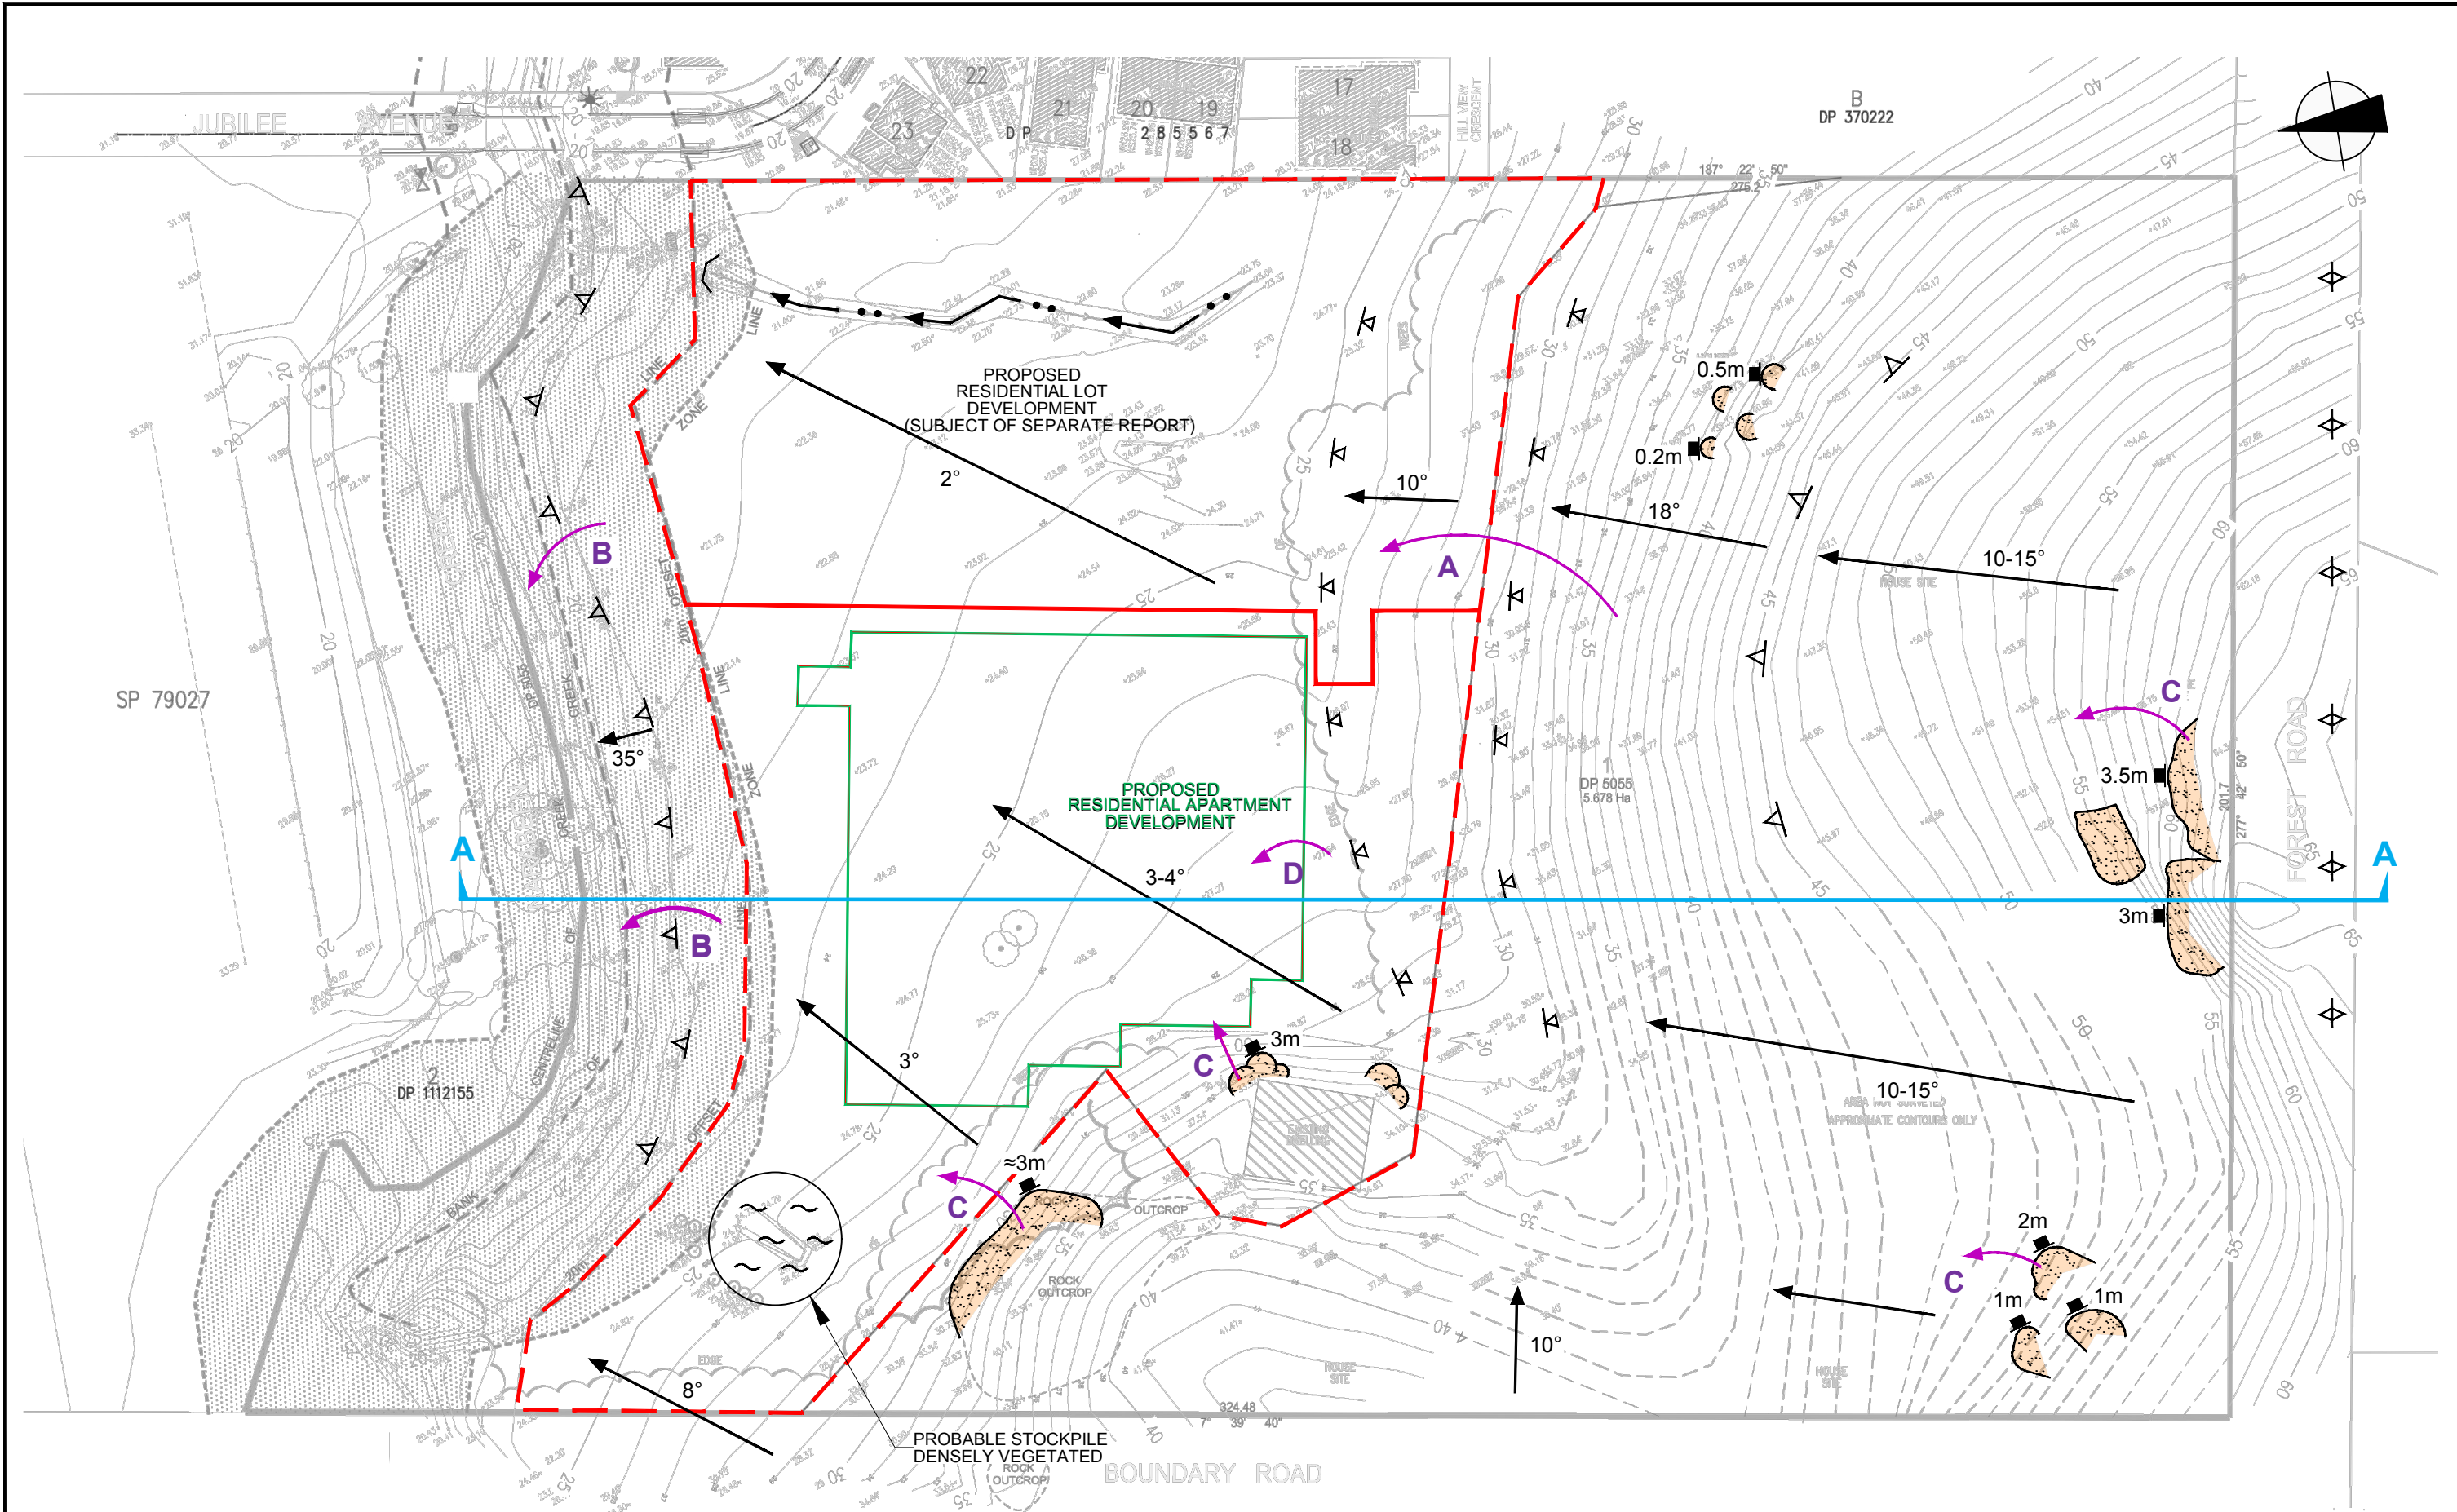
Title: GEOTECHNICAL MAPPING SKETCH SHOWING POTENTIAL HAZARDS	
Location: 8 FOREST ROAD, WARRIWOOD, NSW	
Report No: 33371BMrpt2	Figure No: 2
JKGeotechnics

These potential hazards are indicated in schematic form on the attached Figures 2 and 3.
