27<sup>th</sup> September 2021 Project Number: 17316

## 7 BRUCE AVENUE, MANLY – EXISTING BUILDING CONDITION - STRUCTURAL ADEQUACY

As requested, we have visited the property at 7 Bruce Avenue, Manly to inspect the structure and assess the structural implications of the proposed alterations and additions.

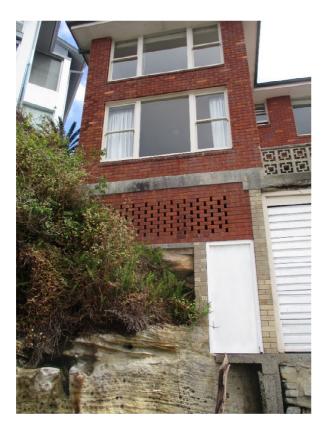
Photograph 1

The existing building is a two-storey brick residence constructed on a block that slopes towards the waterfront of Little Manly Cove (photographs 1 & 2).

Currently the concrete floor slabs extend through the external wall of the building on the South and Eastern sides of the building (eg photographs 1 & 6) and any rectification or demolition of these exposed edges will affect the support of the walls above. The changes proposed to these facades require demolition of large sections of these walls in any case, and it would be therefore preferable to demolish the walls to the floor level prior to re-building in the new configuration.

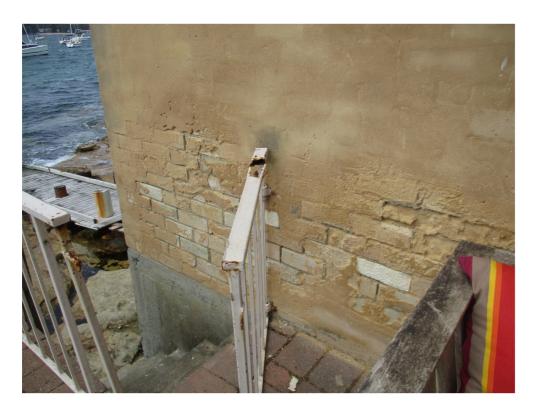
Photograph 3

- 1. Deteriorating masonry and mortar joints (photograph 3)
- 2. Deterioration of exposed concrete on the façade and in other exposed locations (photographs 4 8)
- 3. Deterioration of the loadbearing structure in the sub-floor space beneath the building (photographs 9 & 10)

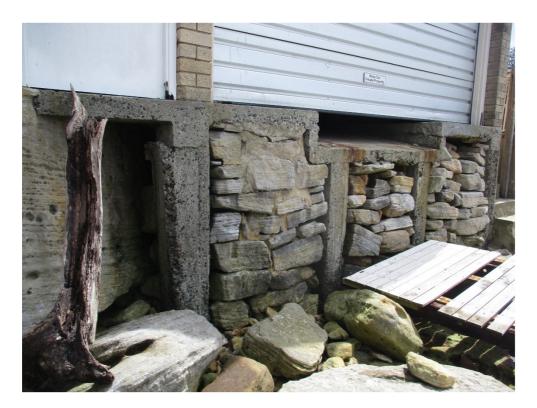
Photograph 11

The structure surrounding the old boat shed that supports the two-storey building is deteriorated (photograph 11) and requires rectification, replacement or strengthening to ensure on-going structural adequacy.

Additional structure will be required through the boatshed and existing sub-floor space to support the loads of the reconfigured house above and ensure the structural integrity of the modified building.
