J3854. 9<sup>th</sup> November, 2021. Page 1.

# PRELIMINARY GEOTECHNICAL ASSESSMENT: 59 Francis Street, Manly

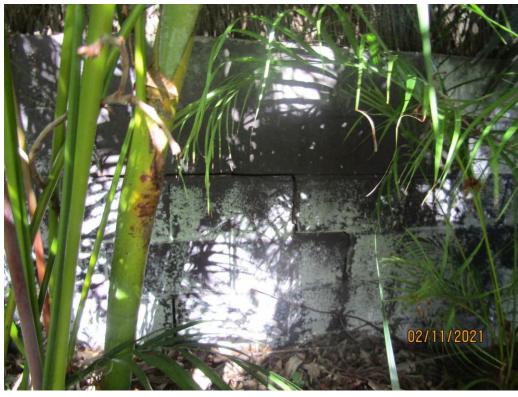
Photo 1

The cracked concrete block retaining wall (Photos 1 to 3) is to be monitored by the owners on an annual basis or after heavy rainfall and prolonged rainfall, whichever occurs first. A photographic record of these inspections is to be kept. Should further movement occur the

wall is to be remediated so it meets current engineering standards. We can carry out these inspections upon request. The retaining wall is located along part of the S and W common boundaries at the SW corner of the property and is set back ~4.5m to ~11m from the proposed pool. See the site plan attached for the location of the retaining wall in relation to the proposed works.

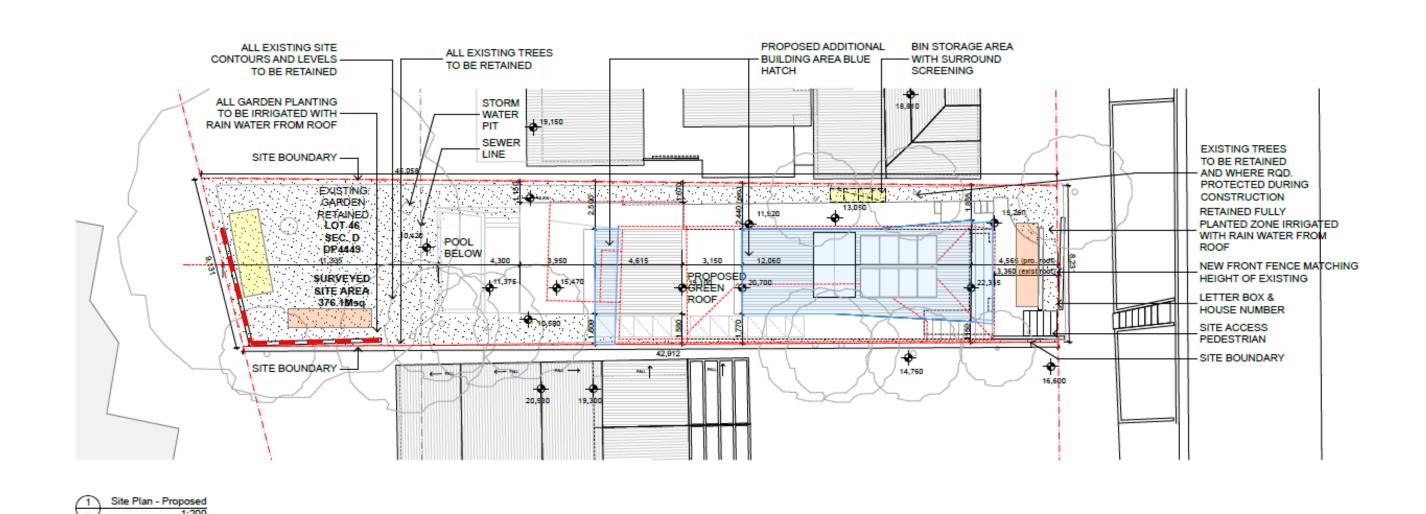
Location of perimeter retaining wall in

relation to the proposed works.
