REPORT ON GEOTECHNICAL ASSESSMENT

PROPOSED ALTERATIONS AND ADDITIONS

29 COOK TERRACE, MONA VALE, NSW

Project No.: 2021-187

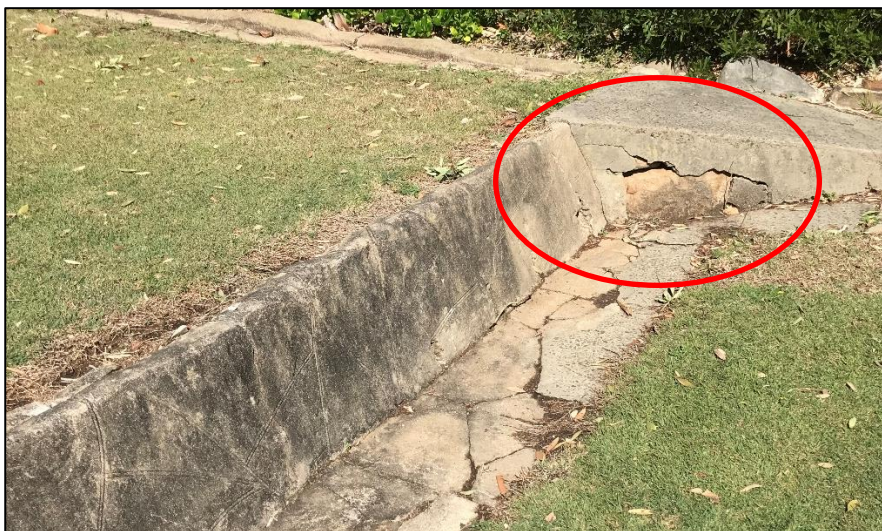
The site is gently sloping and extensive bedrock outcrops were not observed within the property. What may represent in situ bedrock was observed at one location within the rear yard comprising low to medium strength sandstone however it appeared to be relatively limited in extent (See Photograph 4) and may be a boulder.

Photograph 4: Potential bedrock outcrop within the rear garden

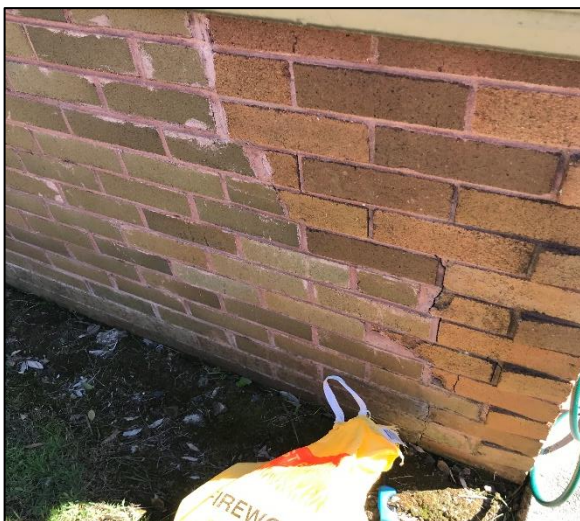
The rear of the site contains a terraced lawn that are supported by a low (<1.0m high) concrete retaining wall which was in relatively good condition. Cracking was observed within the partially inground garage and signs of repair of the brickwork was also observed (See Photographs 5 and 6).

Photograph 5: Possible repair of the garage brickwork

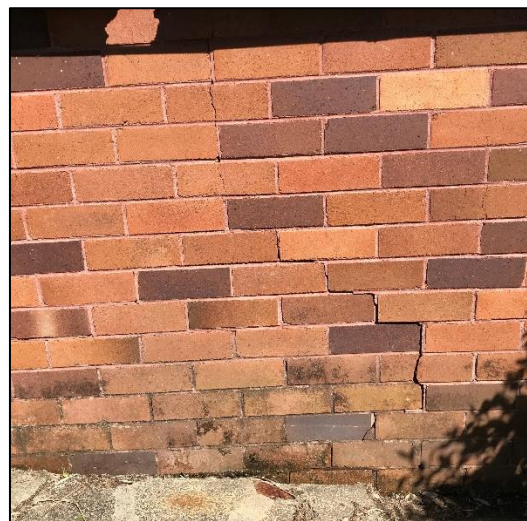
Photograph 6: Cracking in garage brickwork

The site inspection identified that the bedrock may underlie some sections of the site at a shallow depth however the surface is expected to undulate and the cracking observed within the structures within the site may be as a result of variable founding conditions. There were no signs of previous or impending instability identified within the site or adjacent properties.

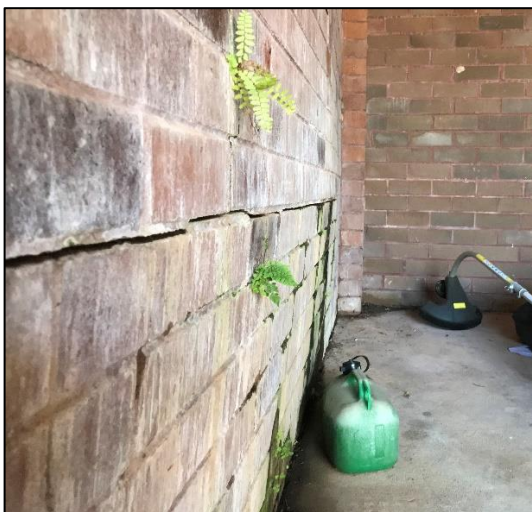
Within the east side of the garage, some deformation of the wall which is also retaining the rear lawn was also observed in addition to signs of excessive moisture content adjacent to the wall (See Photograph 7 and 8).

Photograph 7: Bulging of east wall of garage.

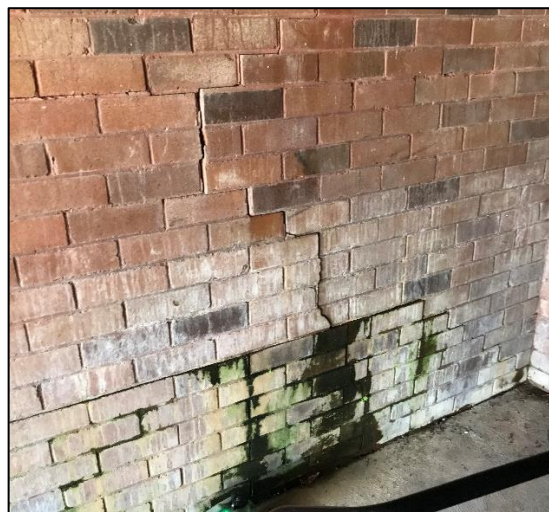
Photograph 8: Moisture and cracking within east wall of garage.

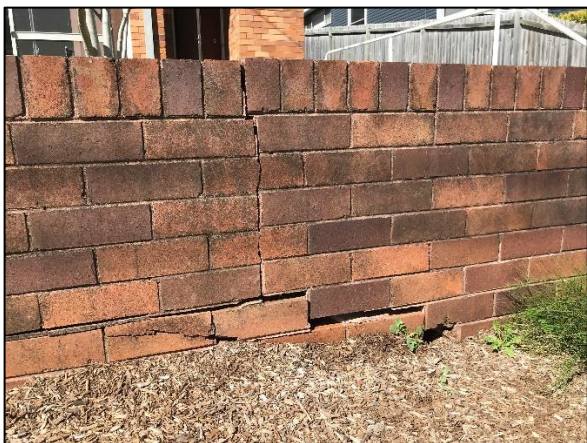
The brick and timber retaining structures within the front of the site appeared to be in good condition with the exception of some minor cracking within the brickwork wall (See Photograph 9).

Photograph 9: Cracking in brick retaining wall within front of property
