## **STAGE 1 (PRELIMINARY) ENVIRONMENTAL SITE ASSESSMENT (ESA)**

**Development Property  
74 Willandra Road  
Narraweena NSW 2100**

**Lot 810 DP 752038**

*(Report ID : EBG-02323.Stage1.ESA)*

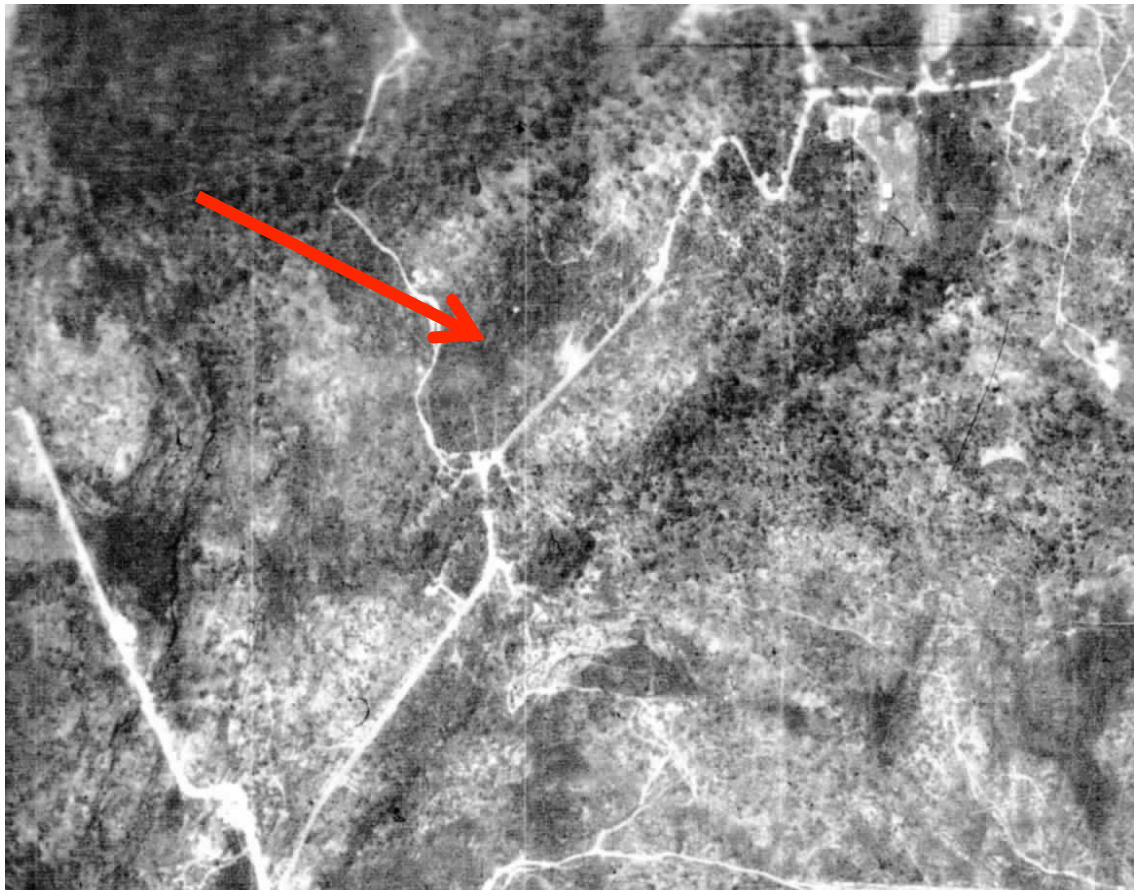
#### **3.9.1 Closeup 1930 Aerial Photo**

Closeup 1930 Aerial Photo: The site appears to be bushland and all surrounding land is un-developed. Willandra Road appears to be unsealed. Very few buildings are visible along the road.

A small track runs from the Willandra Road 'dog-leg' through the property to the north. (The present day Rural fire Brigade is located on the then 'dog-leg' in the road).

Regionally, the area is un-developed except for a number of orchard or agricultural activities between the area and Warringah Road to the south and south east.

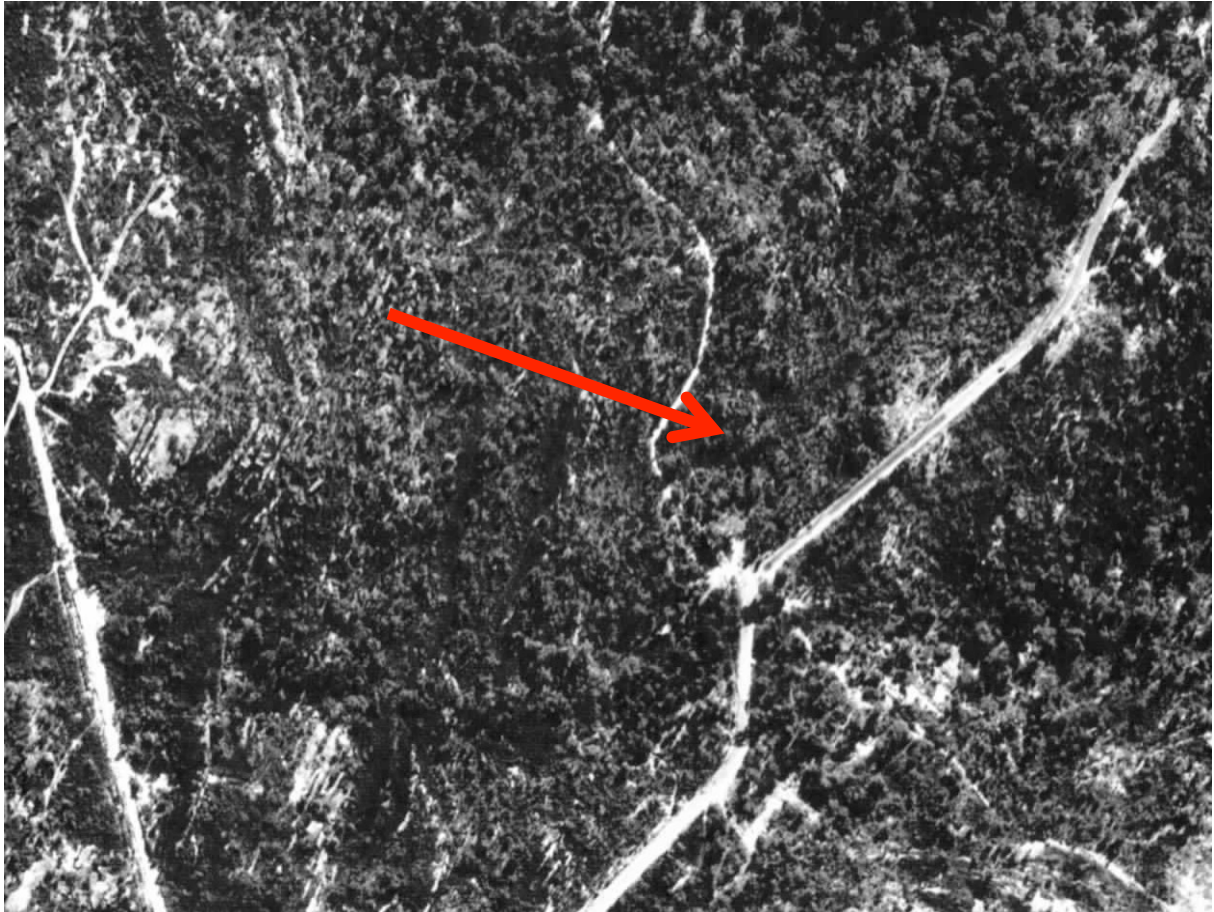
### 3.9.2 Closeup 1961 Aerial Photo

Closeup 1961 Aerial Photo: The site appears to be bushland and all surrounding land is un-developed. Willandra Road appears to be unsealed. Very few buildings are visible along the road.

A small track runs from the Willandra Road 'dog-leg' through the property to the north. (The present day Rural fire Brigade is located on the then 'dog-leg' in the road).

Regionally, no houses are located along Willandra Road, however a number of farms and a major residential development are located to the south and south east of the site.

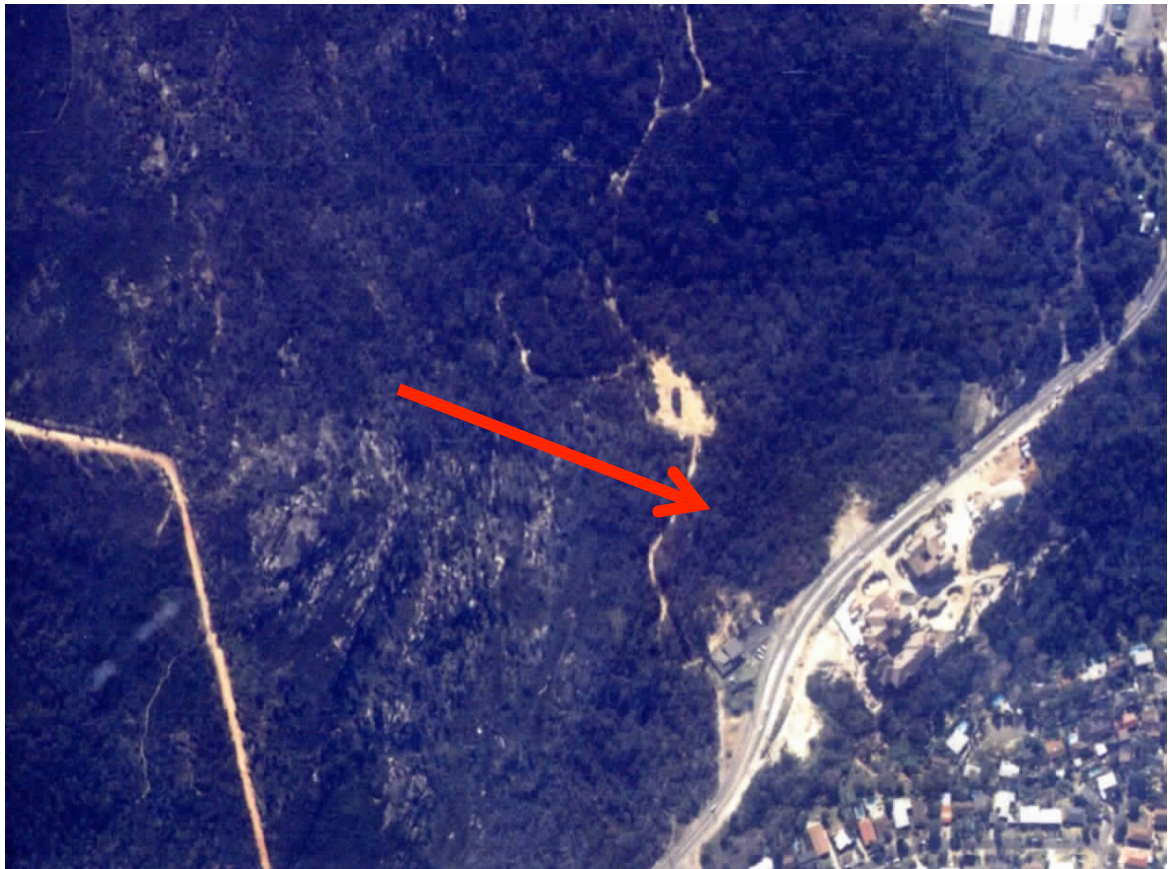
### 3.9.3 Closeup 1986 Aerial Photo

Closeup 1986 Aerial Photo: The 'dog-leg' in Willandra Road has been by-passed and the area that was freed-up now houses the Rural Fire Brigade building.

A small track runs from the Willandra Road through the property to the north.

Regionally, no houses are located along the immediate area north of Willandra Road, however a major residential development is located to the south and south east of the site.

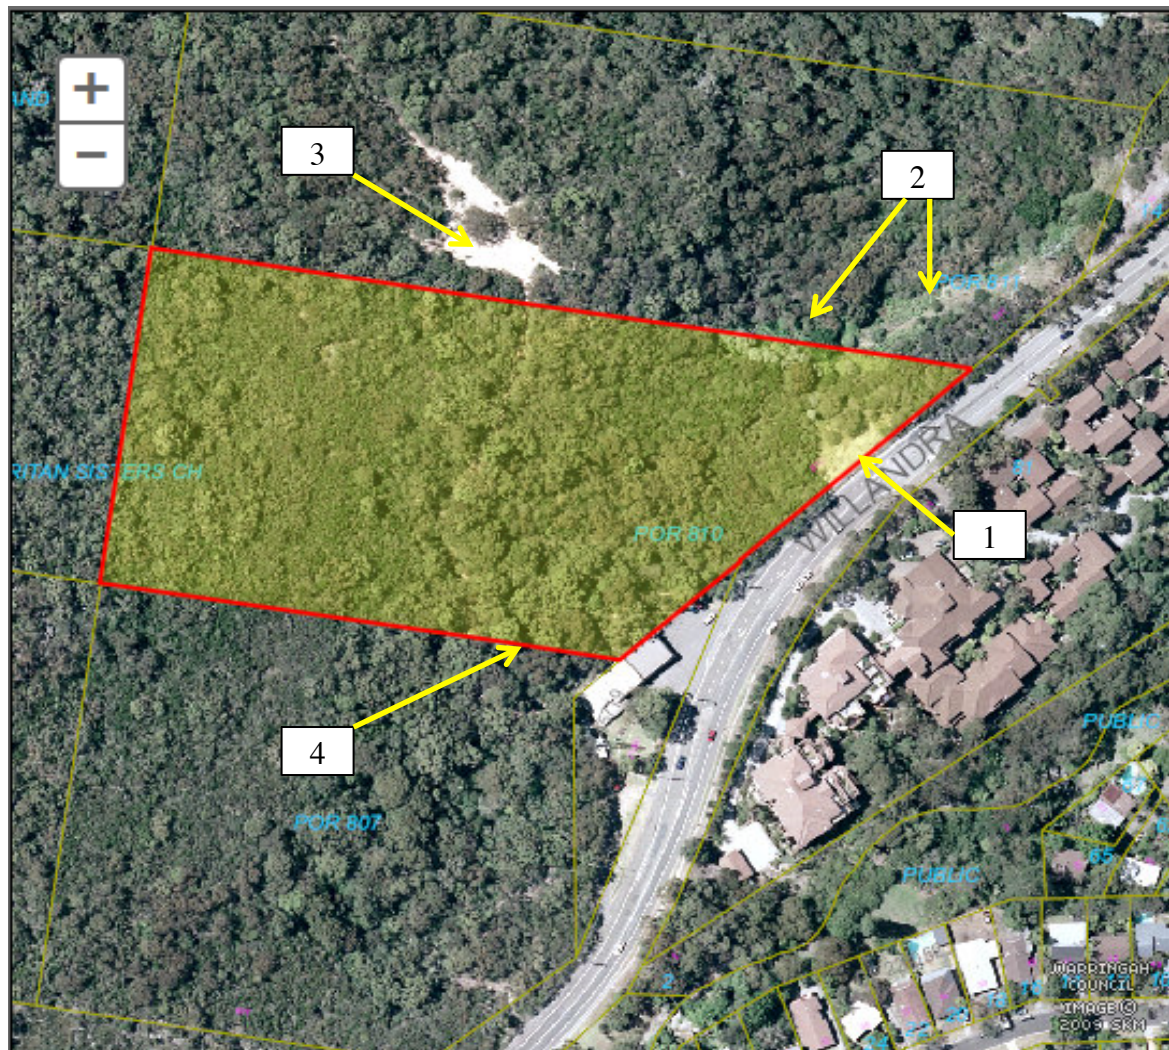
### 3.9.4 Closeup Recent Aerial Photo

Closeup: Recent Aerial Photo: Aerial photo showing the boundaries of the property.

NOTE: A number of small (suspected illegal) piles of dumped material were located near or on the property. Small amounts of asbestos cement pieces were located on or adjacent to these piles. The arrows point to these areas.

#1: Cleared area on side of road behind barrier and within the bounds of the property. Broken sheet lying on ground suspected dumped from road.

#2: Adjacent property to north has been cleared. Soil has been bulldozed to create raised track/embankment trending E/W up to a small sandstone bluff. Isolated pieces of asbestos cement sheeting found within the soil of the embankment. Difficult to ascertain from the ground, however this embankment may impinge onto the property. Should be checked by a surveyor.

Below are three areas located on the property or near the boundaries, where asbestos pieces have been located during the inspection. The locations are shown on the aerial photo in 3.9.4 and the locations cited refer to that aerial photo (Note: Location No. 3 is not included in the recommendations as it sits outside the property boundaries). The recommendations concerning these areas are listed below.

- R1 – Location No. 1: Cleared area on side of road behind barrier and within the bounds of the property. Located approximately 150 metres east of the Rural Fire Brigade building. Broken sheet lying on ground. This can be seen from the road. Suspected dumped from road traffic. The broken asbestos cement sheeting shall be removed as bonded asbestos prior to development as per *Appendix B: Specification for the Removal of Bonded Asbestos*.

- R2 - Location No. 2: The adjacent property to the north has been cleared and a suspected development is being undertaken to accommodate a house or similar. Soil has been bulldozed to create raised track/embankment trending NE/SW and then E/W up to a small sandstone bluff to the rear of the properties. Isolated pieces of asbestos cement sheeting and other building debris were found within the soil of this embankment. It is difficult to ascertain from the ground, however this embankment may impinge onto the property or within the property's northern boundary. Whether this is the case should be checked by a surveyor. If the embankment or part thereof is located within the property boundaries, the pieces of asbestos cement sheeting located within the subject property shall be removed as bonded asbestos prior to development as per *Appendix B: Specification for the Removal of Bonded Asbestos* or alternatively the soil may be removed back into the adjacent property (its suspected origin).

- R3 - Location No. 4: Small pile of rubbish behind Rural Fire Building. Small pieces asbestos cement sheeting on ground (Located approx. 50m west of building within bush). The pile consists of typical household waste (plastic, bottles etc) and has been placed there some time ago. Isolated pieces of asbestos cement sheeting were found within the pile. The broken asbestos cement sheeting shall be removed as bonded asbestos prior to development as per Appendix B: Specification for the Removal of Bonded Asbestos).
