## **Geotechnical Assessment**

**Project:** New Dual Occupancy  
1851 Pittwater Road, Bayview NSW

**REF: AG 21412**  
2 December 2021

For New Dual Occupancy at  
**1851 Pittwater Road, Bayview NSW**

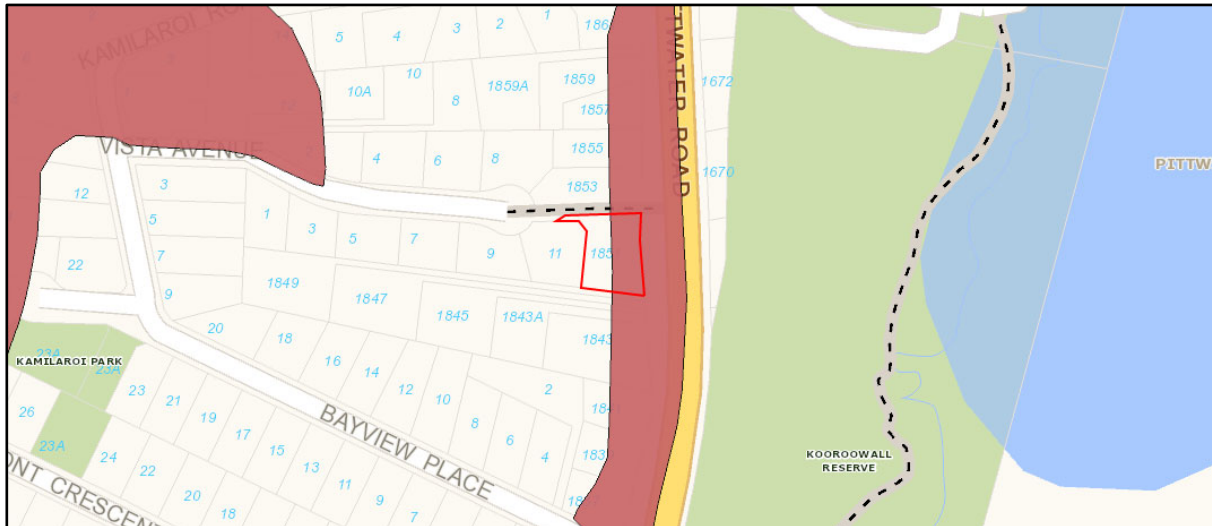
**Image 2.** PLEP Geotechnical Hazard Map  
– 1851 Pittwater Road, Bayview NSW (NBC Maps).

- No evidence of significant soil creep, tension cracks or landslip instability were identified across the site or on adjacent properties as viewed from the subject site at the time of our inspection.
- Based on reference to the plan entitled “Geotechnical Hazard Mapping” (Ref. P21DCP-BC-MDCP2002, dated 2007) prepared by GHD LONGMAC on behalf of Pittwater Council, the site is mapped as a **Geotechnical Hazard H1** area.

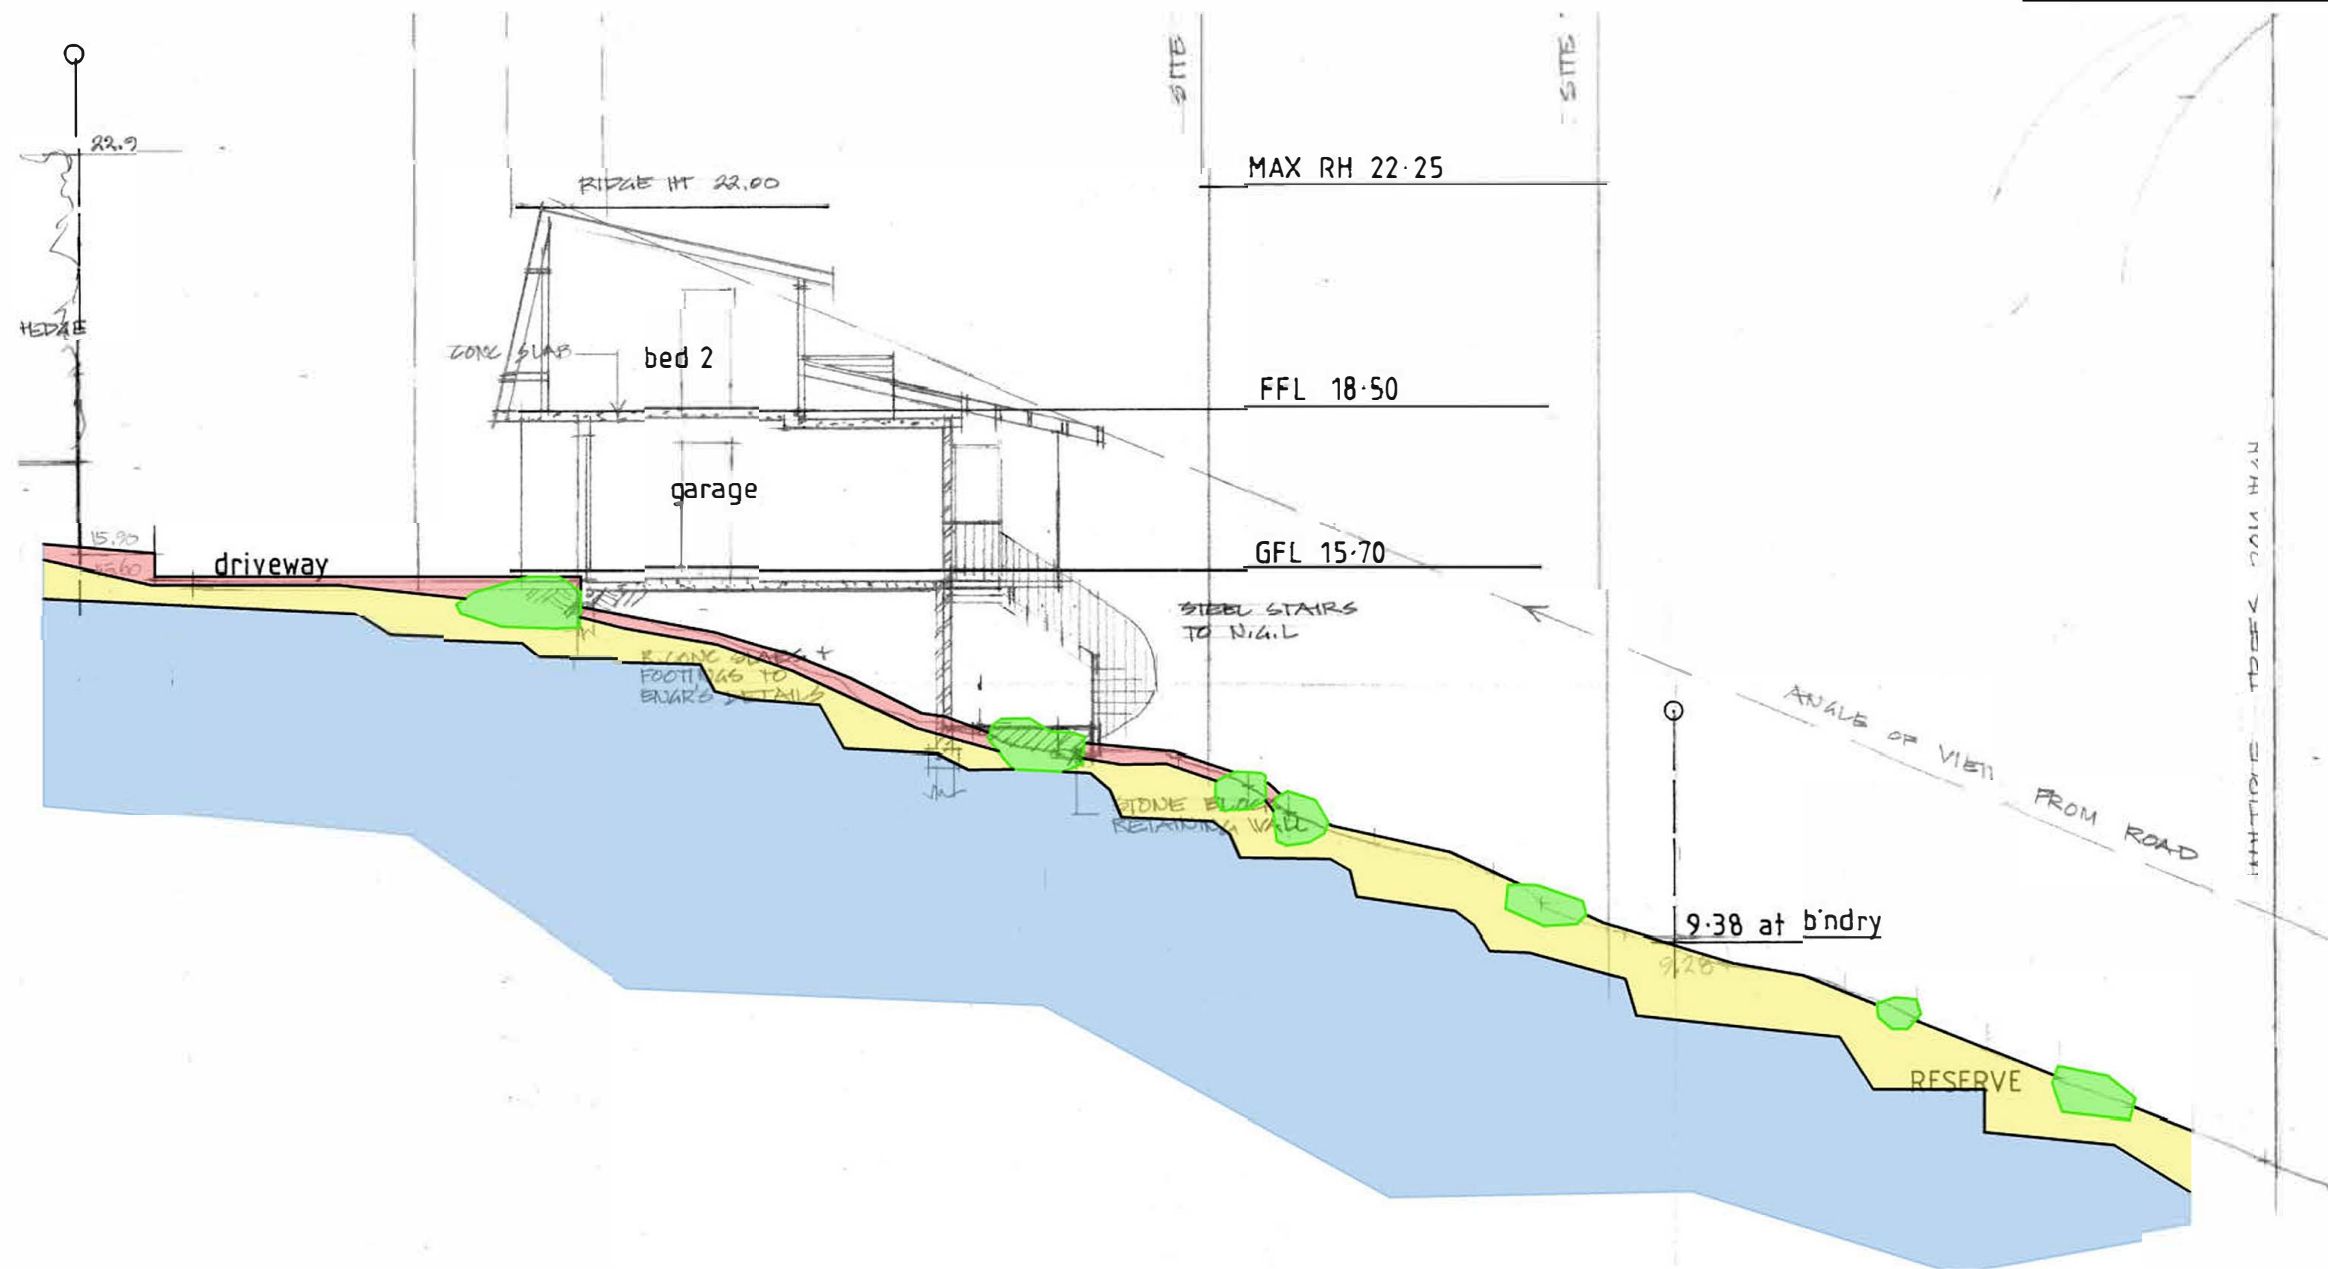
**INFERRED GEOLOGICAL SECTION**  
SCALE NTS

INTERPRETED SUBSURFACE SECTION ONLY.  
ACTUAL GROUND CONDITIONS MAY VARY.
