## **GEOTECHNICAL INVESTIGATION:**

New Pool at 10 Beverly Place, Curl Curl

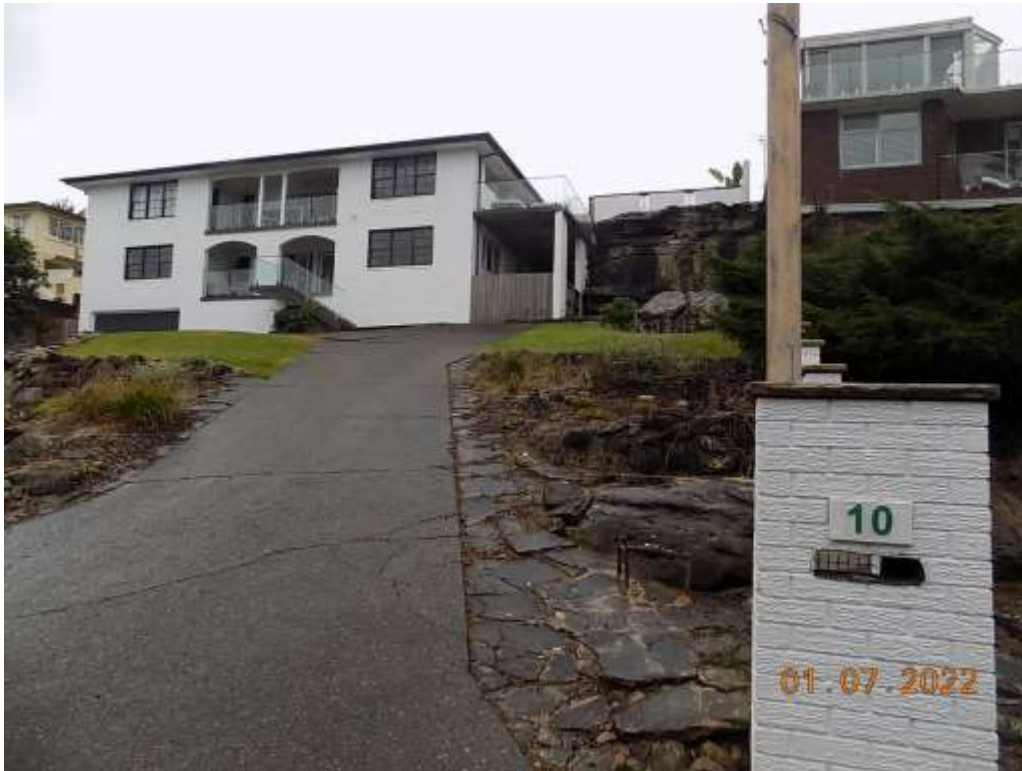
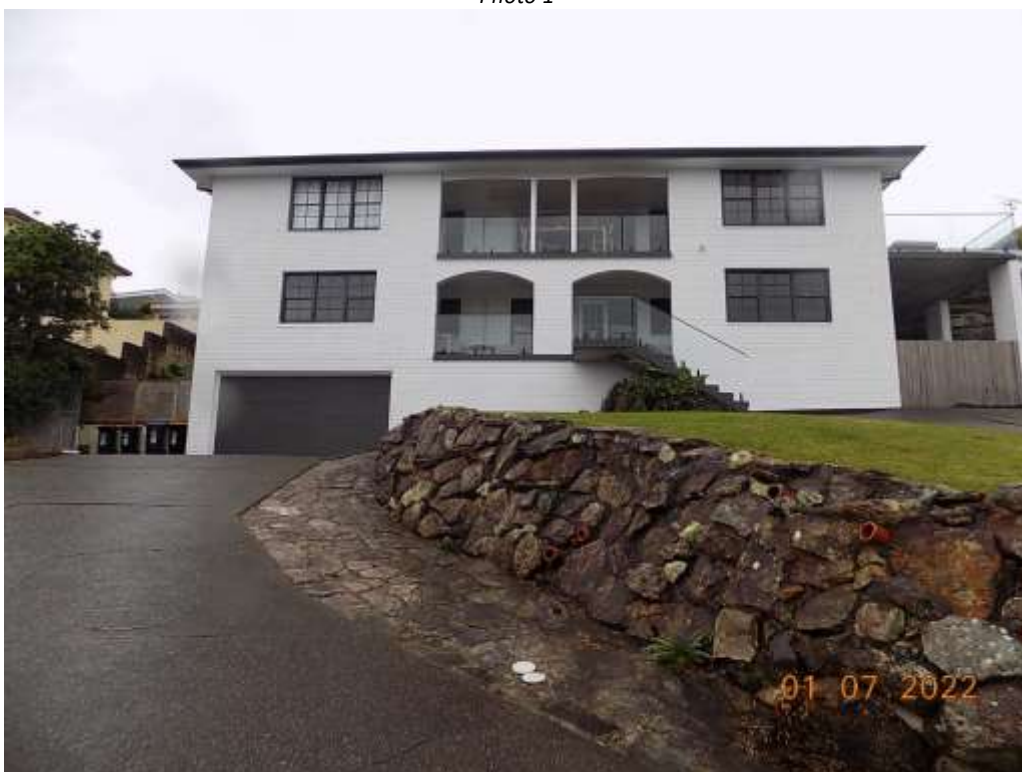
Photo 1

- 2.3 At the road frontage, a concrete driveway runs to a garage and carport underneath the downhill side of the house (Photos 1 & 2). A fill for a lawn area in between the lower common boundary and the house is lined by a ~2.0m high sandstone flagging wall. The two-storey rendered brick house is supported on external brick walls. The external brick walls show no significant signs of movement. The cut to create the level platform for the house has been taken through Competent Medium Strength Sandstone (Photo 3). A ~4.0m high rock face steps up the N side of the property (Photo 4 & 5). The outcrop was observed to be slightly undercut on the E face but is considered stable. There is a cavity on the S side of the rock face that is

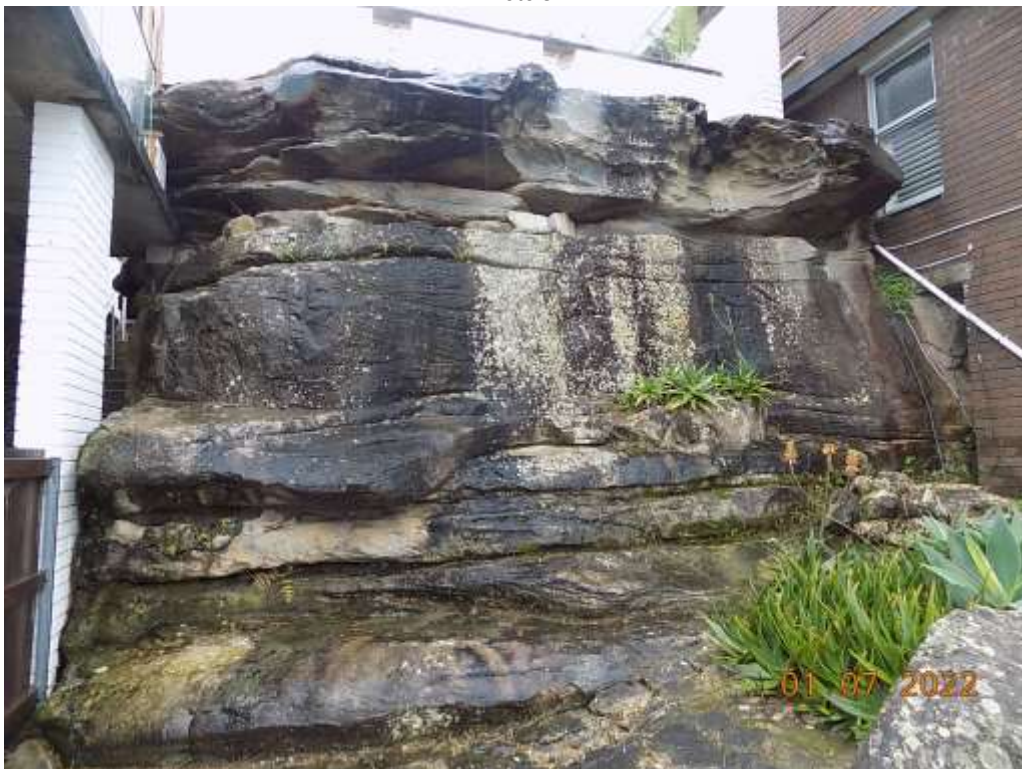
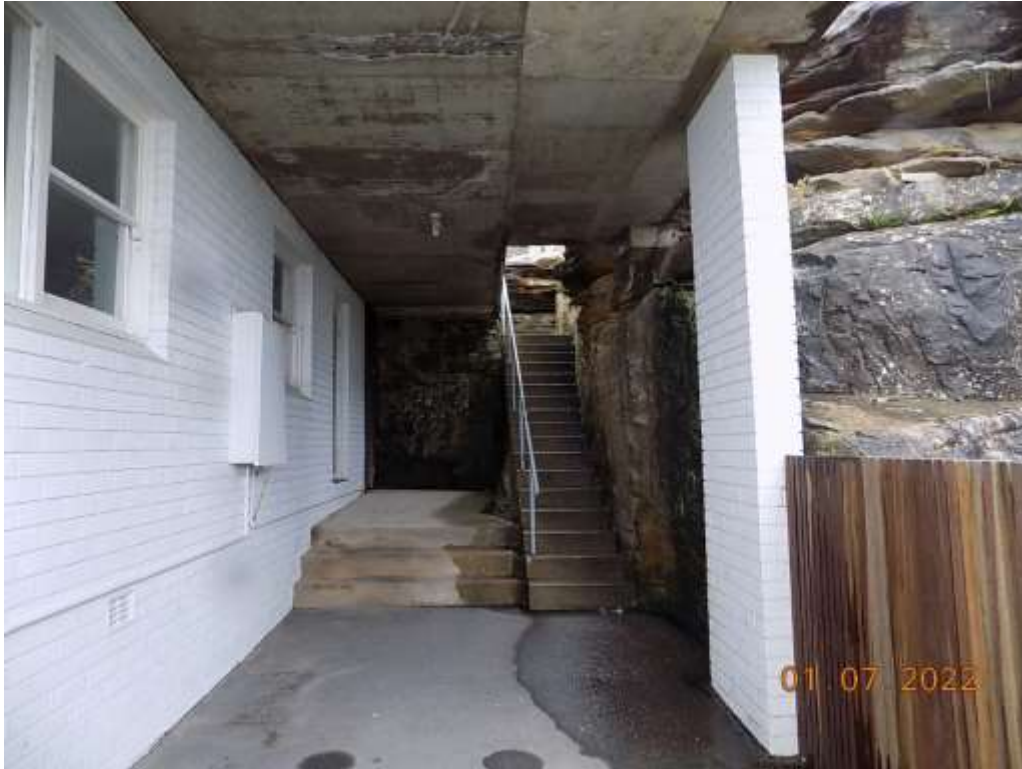
Photo 4

| HAZARDS | Hazard One | Hazard Two |
|---|---|---|
| TYPE | The moderate to steep slope that rises across the property and continues above and below failing and impacting on the proposed works. | The sandstone face that steps ~4.0m up the slope failing and impacting on the proposed works (Photo 4 & 5). |
| LIKELIHOOD | 'Unlikely' ( $10^{-4}$ ) | 'Unlikely' ( $10^{-4}$ ) |
| CONSEQUENCES TO PROPERTY | 'Medium' (12%) | 'Medium' (25%) |
| RISK TO PROPERTY | 'Low' ( $2 \times 10^{-5}$ ) | 'Low' ( $2 \times 10^{-5}$ ) |
| RISK TO LIFE | $8.3 \times 10^{-7}$ /annum | $2.9 \times 10^{-7}$ /annum |
| COMMENTS | This level of risk is 'ACCEPTABLE'. | This level of risk is 'ACCEPTABLE'. |

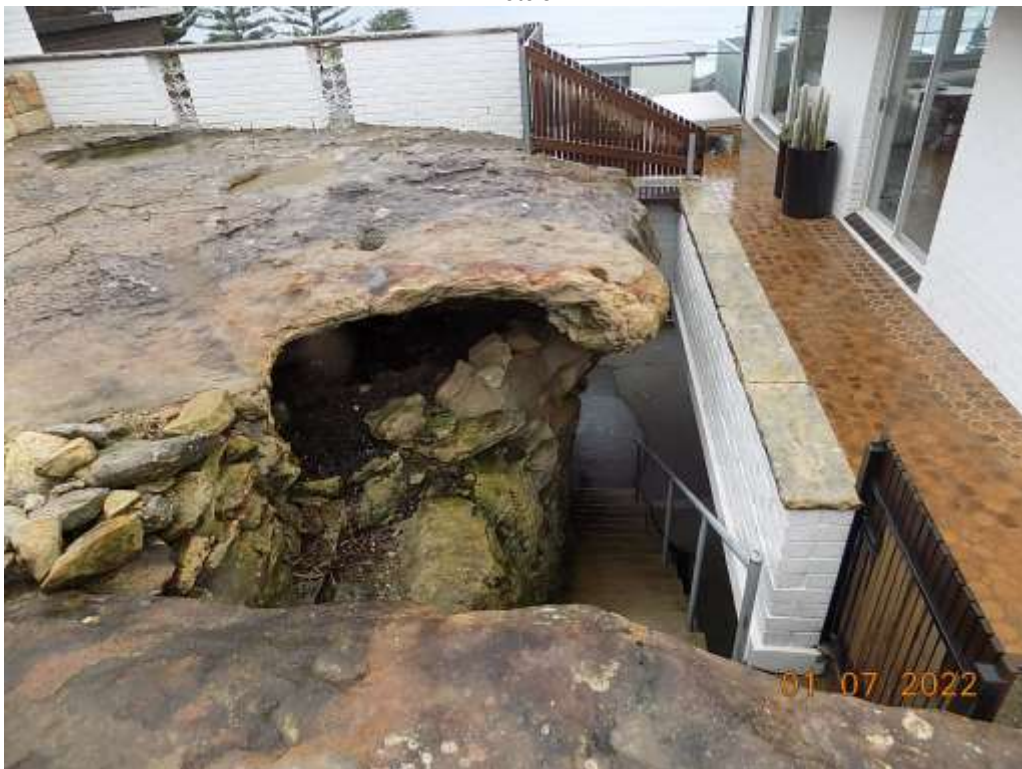
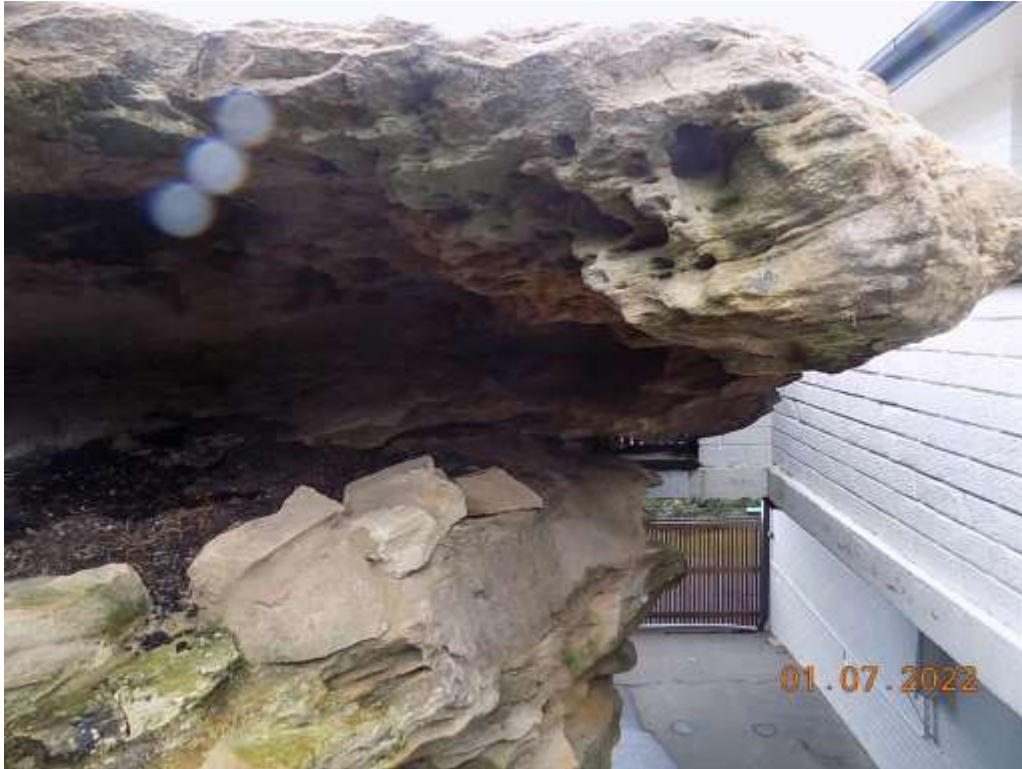
Photo 6

undercut to ~1.5m and overhangs ~0.5m from the bulk rock face below (Photos 6 & 7). The cavity is bridged on both sides and considered currently stable however the overhang will likely need to be removed as part of the proposed excavation works. Competent Medium Strength Sandstone outcrops above the house and extends to a ~1.3m high stable stack rock retaining wall that lines the upper common boundary (Photo 8). A ~stable 0.6m high sandstone block retaining wall supports a fill for a level lawn area in the upper NE corner of the property (Photo 9).

The cavity and overhang (Photos 6 & 7) on the S side of the excavation are likely to be destabilised during the excavation. As such, the overhanging portion of the rock is to be cut with rock saws and demolished prior to the commencement of the pool excavation. See site plan for location of overhanging rock to be removed.

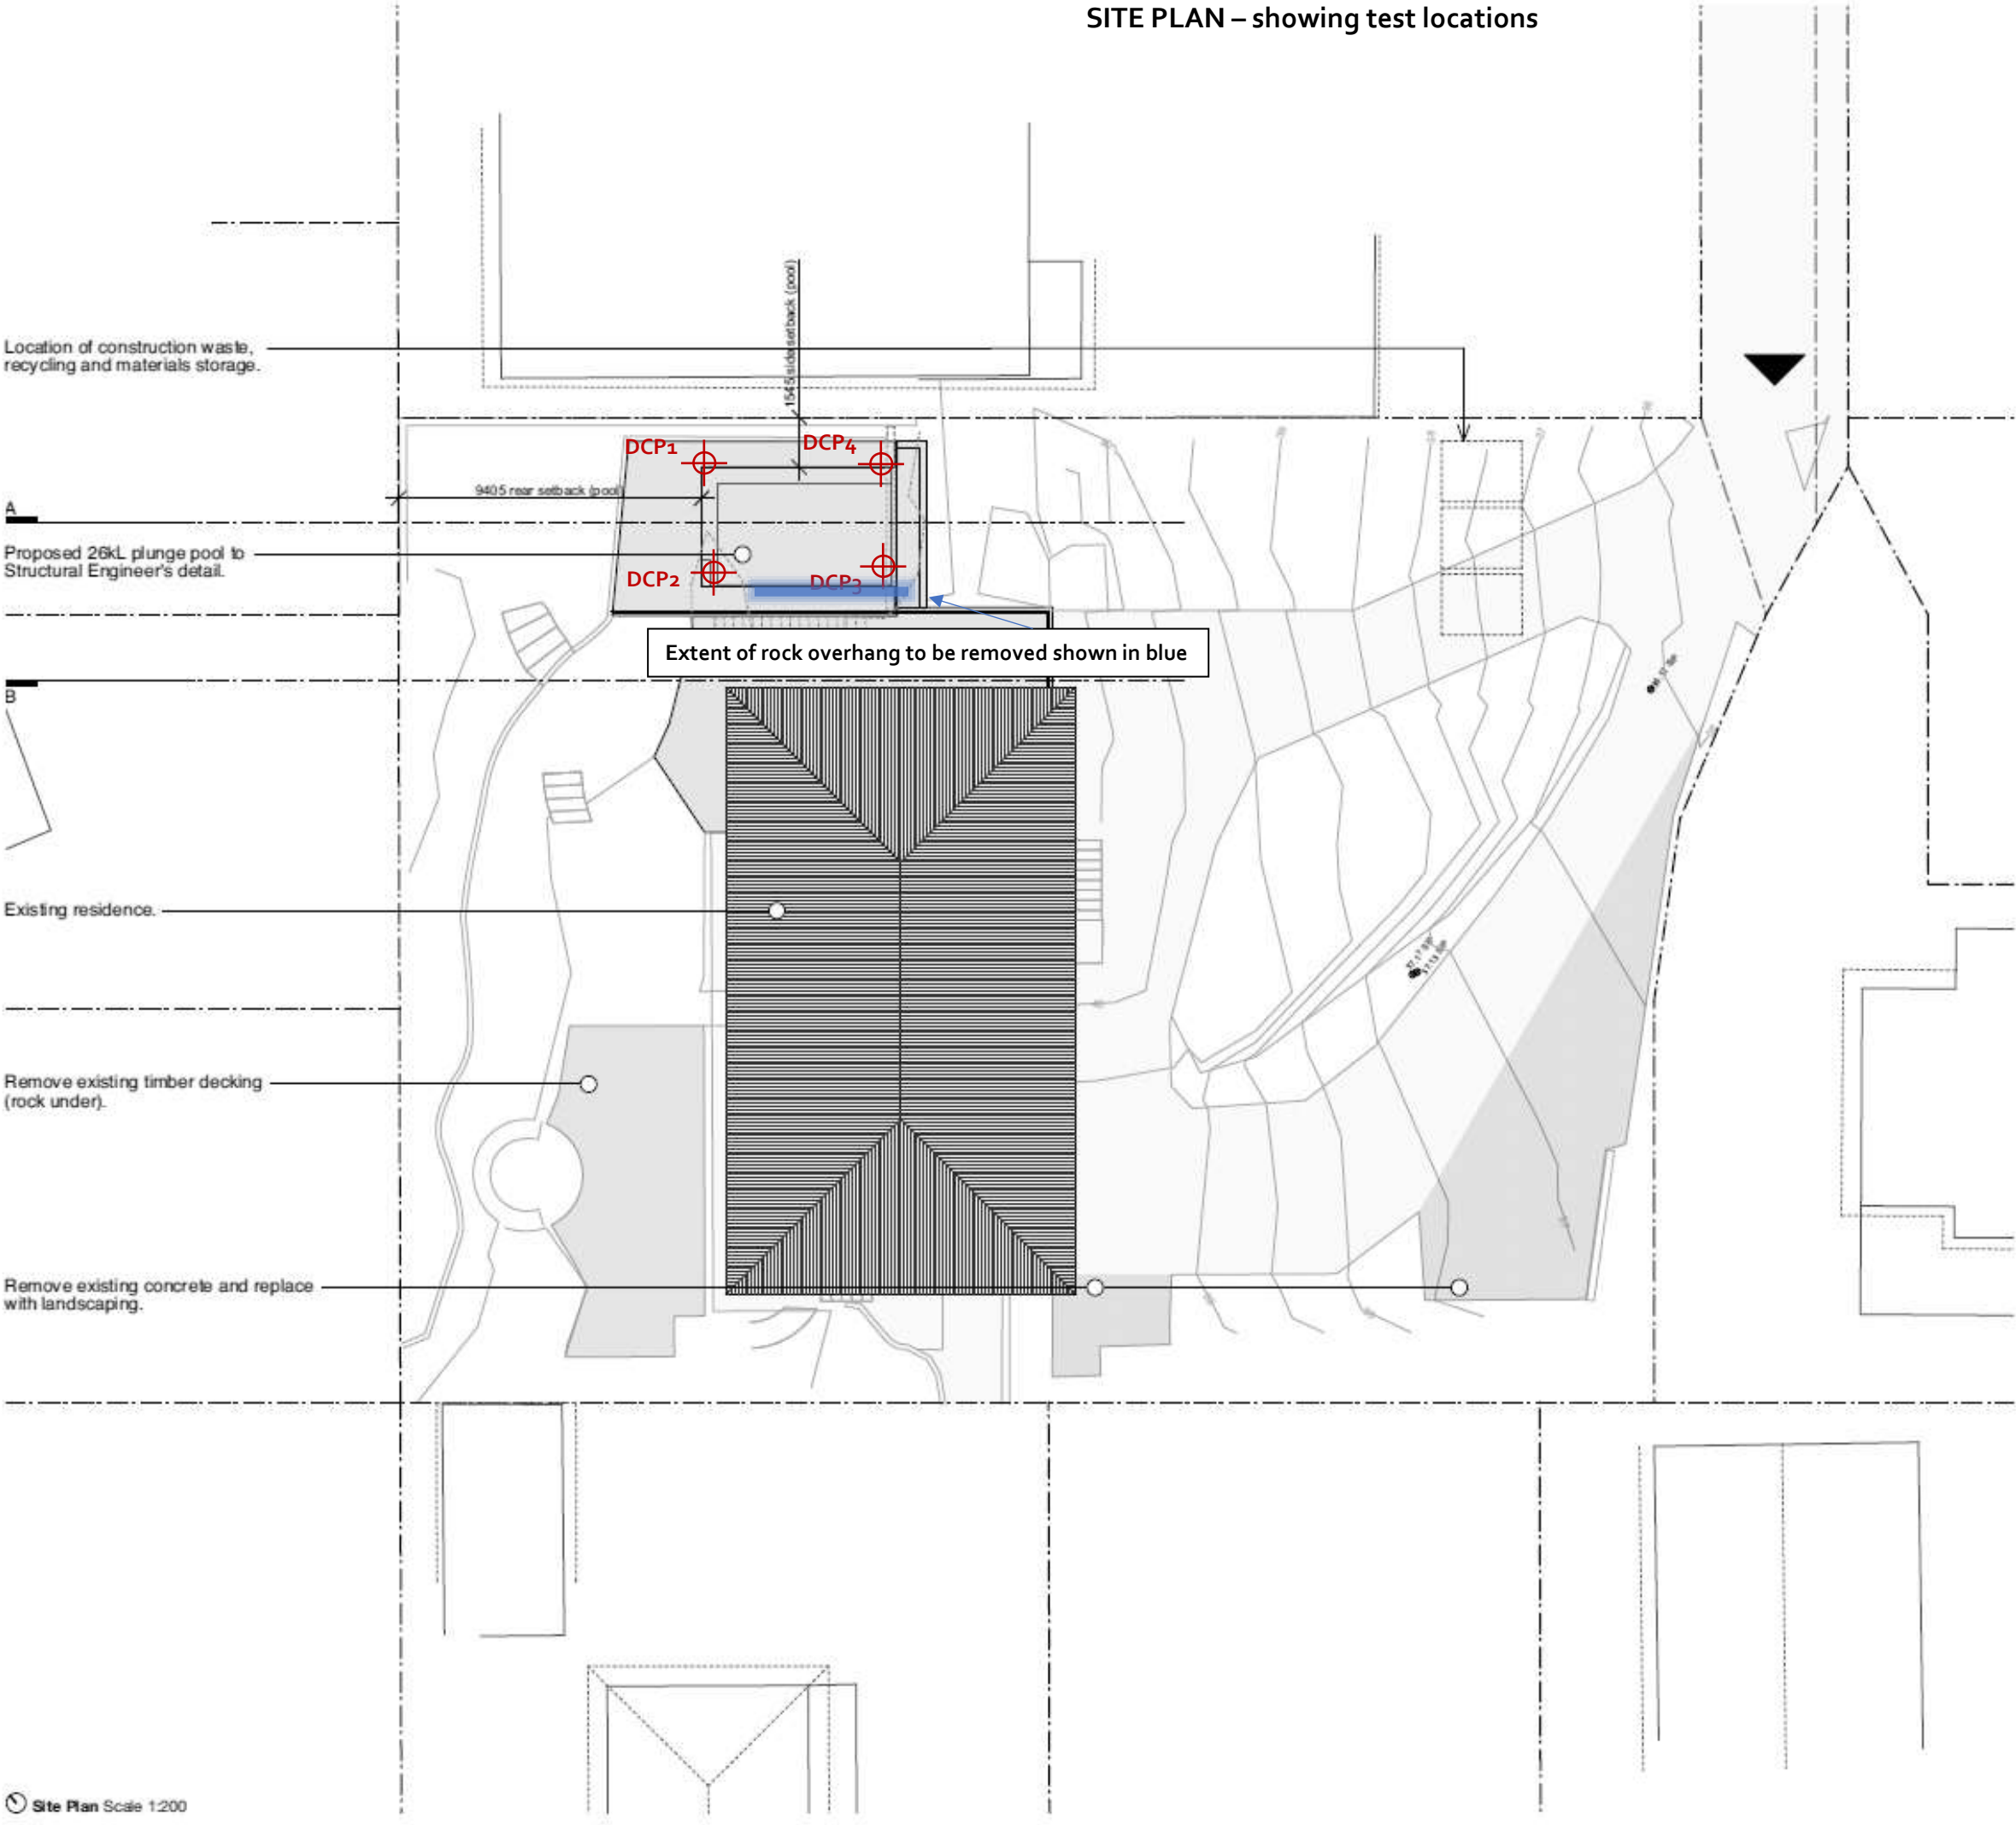
SITE PLAN – showing test locations

Four Dynamic Cone Penetrometer (DCP) tests were put down to determine the relative density of the overlying soil and the depth to bedrock. The locations of the tests are shown on the site plan attached. It should be noted that a level of caution should be applied when interpreting DCP test results. The test will not pass through hard buried objects so in some instances it can be difficult to determine whether refusal has occurred on an obstruction in the profile or on the natural rock surface. This is not expected to be an issue for the testing on this site. However, excavation and foundation budgets should always allow for the possibility that the interpreted ground conditions in this report vary from those encountered during excavations. See the appended "Important information about your report" for a more comprehensive explanation. The results are as follows:

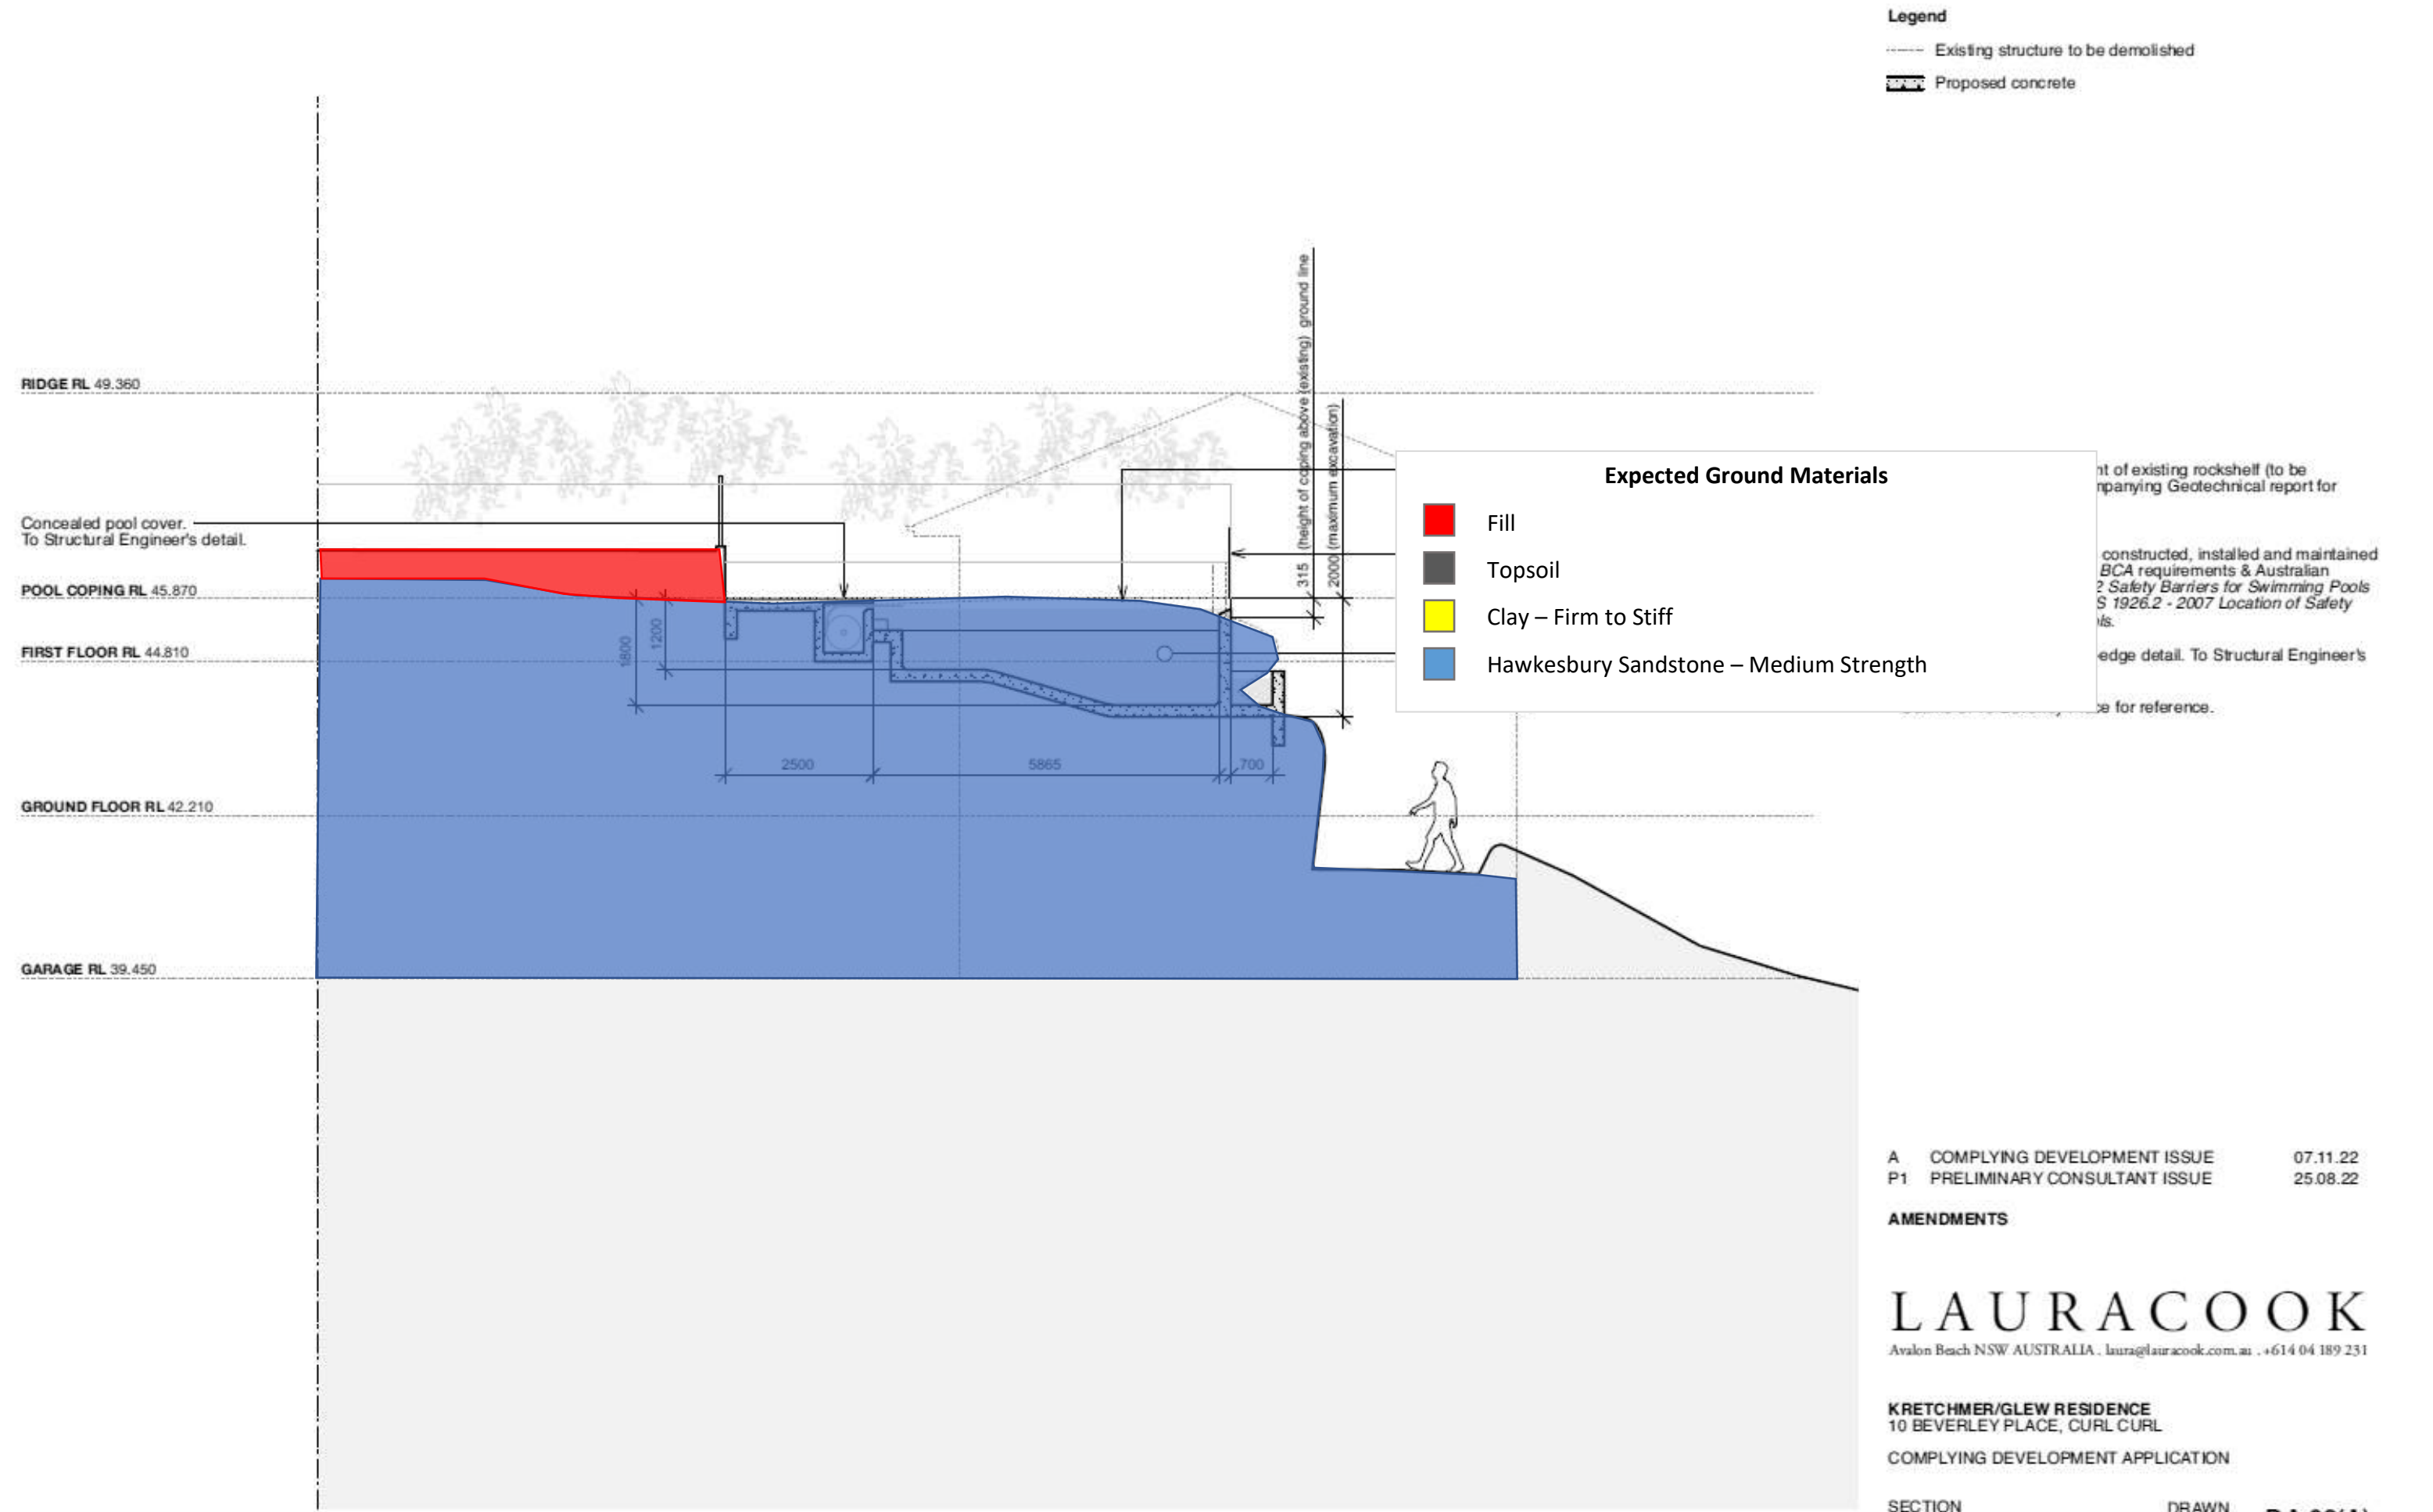
TYPE SECTION – Diagrammatical Interpretation of expected Ground Materials

The surface features of the block are controlled by the outcropping and underlying sandstone bedrock that steps up the property forming sub-horizontal benches between the steps. Where the grade is steeper, the steps are larger and the benches narrower. Where the slope eases, the opposite is true. Where the rock is not exposed, it is overlain by fill and sandy soils that fill the bench step formation. Filling has been placed near the upper common boundary for a level lawn area and garden beds. In the test locations, competent Medium Strength Sandstone bedrock was entirely exposed. The outcropping sandstone on the property is estimated to be medium strength or better and similar strength rock is expected to underlie the entire site. See Type Section attached for a diagrammatical representation of the expected ground materials.
