Geotechnical Investigation Report for Reggie's Residential Design & Drafting At 71 Alexandra Crescent, Bayview, NSW 2104

Job No: G-00182

Date: 23rd March 2021

Revision B, 7th June 2021

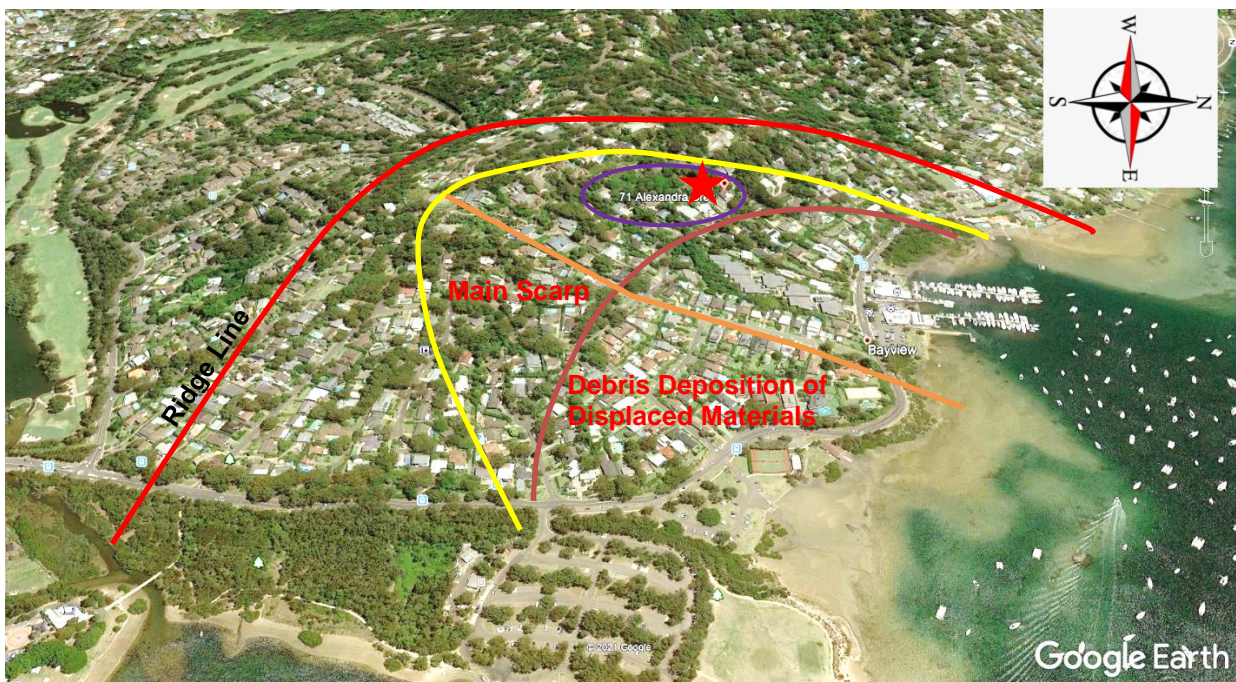
As can be seen from the below snippet obtained courtesy Google earth for the area under investigation, the site is located in an old landslide precisely in the Main Scarp.

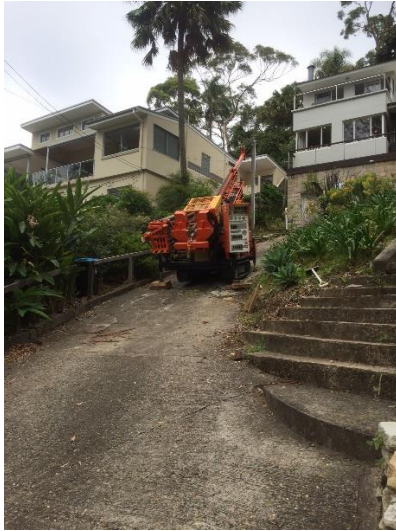
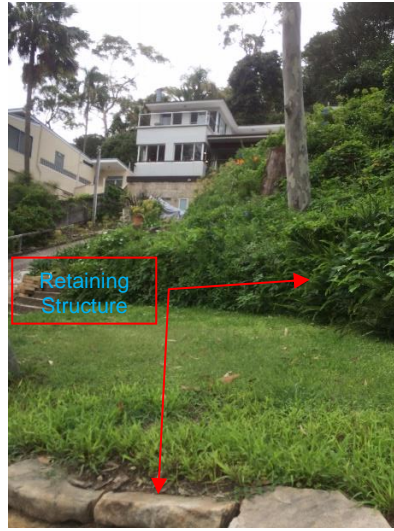
It is our observation that the site has a mild slope of 15° on an average, varying between 14° to 17°. There is a decent vegetation cover on soil slopes (ref- Series 3, **Appendix M**). It is strongly advised to keep the vegetation clearance to a reasonable minimum as it has been eminently seen that the existing trees, and to a lesser extent the existing ornamental smaller vegetation seems to have taken substantial quantities of water out of the ground to keep it stable to the present condition. This in fact has lowered the ground water table which is also clear from the fact that we did not encounter ground water during our investigation). Further it has aided to maintain the stability of the present ground slope despite the soil being of medium plasticity. It is strongly recommended to avoid large scale clearance of vegetation. This may result in a rise in water table from what it is at the present condition with a consequent increase in the likelihood of landslip or a landslide (Geo-Guide LR5).

Series-3: A view of the Sloped Profile of the Property

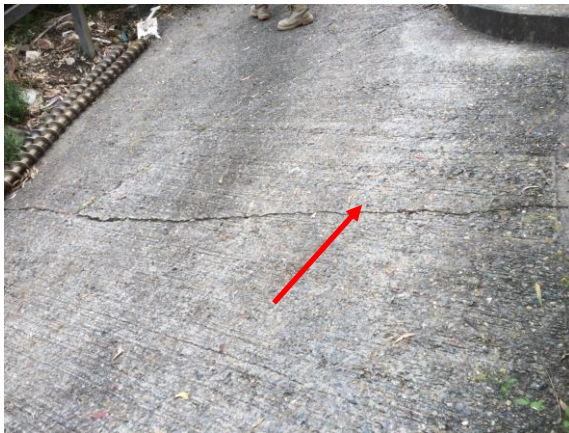
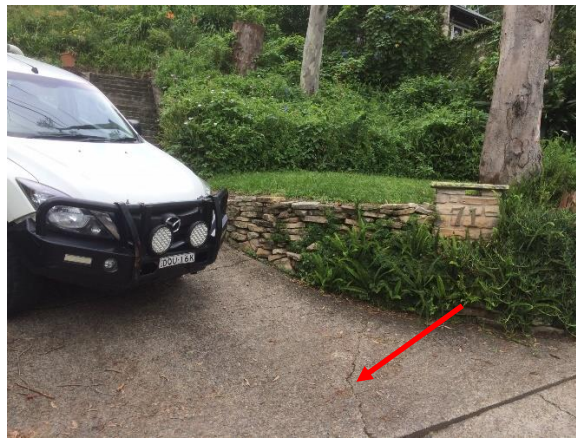
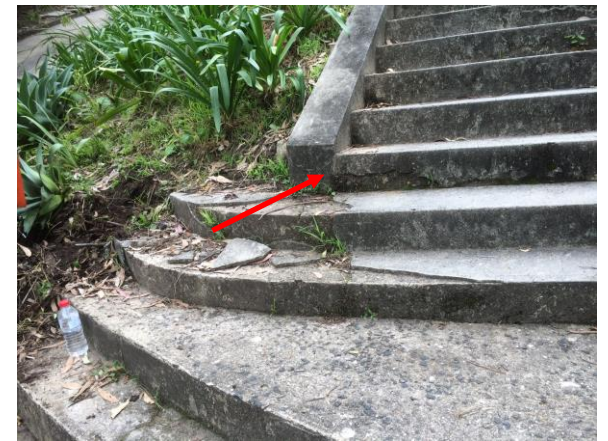
- There are visible evidences of cracks in existing driveway and the steps up to the existing main entrance of the house (Series 4 & 5, **Appendix M**). The most significant is a 50mm wide crack near to the location of second borehole (**Appendix A**) at the front of the existing property which could be probably due to insufficiently founded concrete block experiencing repetitive vibrating motion as the space was seen to be used as motorcycle parking. Cracks in the driveway however can't be used to indicate any subsurface movement as it could most possibly be as a result of vehicular load and vibrations, or minor piping erosion.

Series-4: Signs of movement in and around the Property

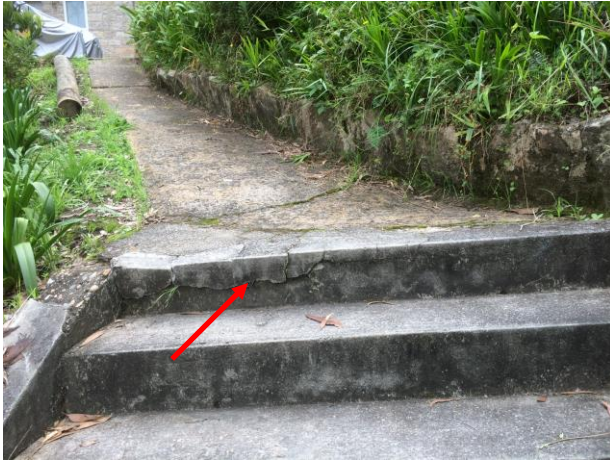
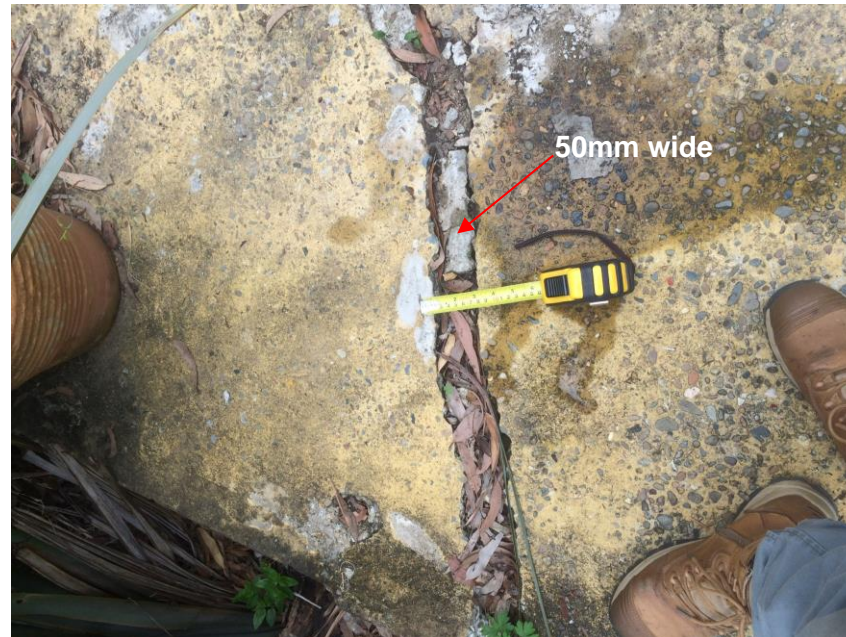
Series-5: Signs of movement in and around the Property (Contd...)
