Arboricultural Impact Assessment

**Pittwater House
c/- Neeson Murcutt Architects
70 South Creek Road
Collaroy NSW**

23 October 2019

C91571 Rev 2

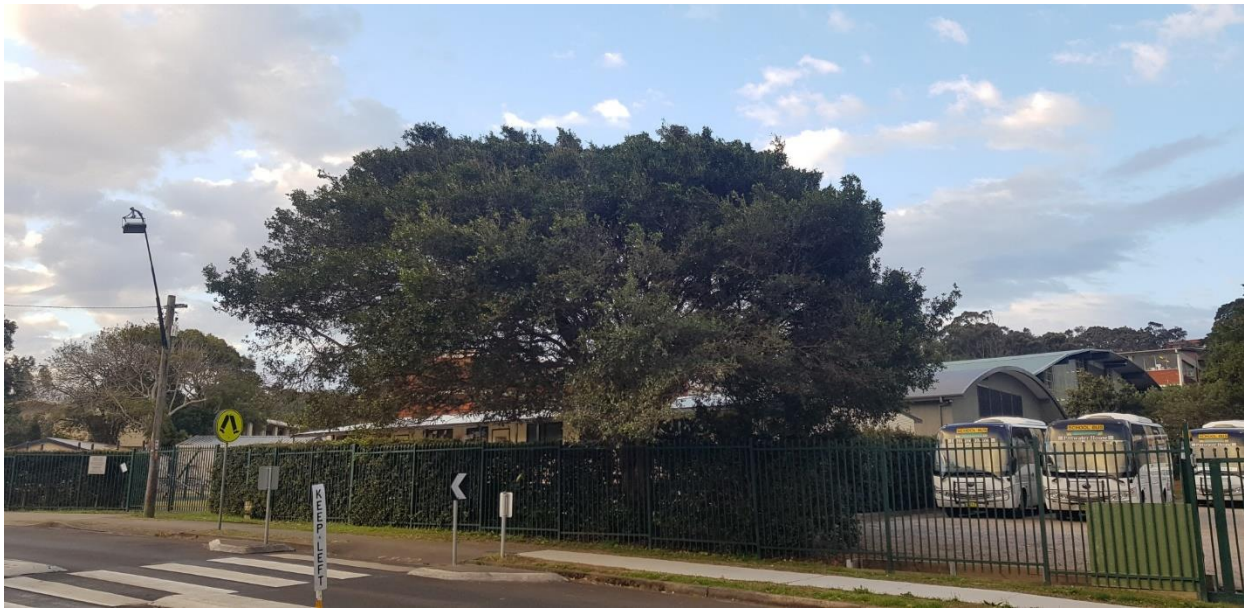
- 6.2.3 Tree 93 was a Magenta Brush Cherry (*Syzygium paniculatum*). The tree was located within the minibus depot on the southern side of the site and contributes significantly to the streetscape screening value and forms a significant feature within the landscape.
- 6.2.4 Tree 93 was of good health and fair structure and has a life expectancy of 25–50 years.
- 6.2.5 The TPZ for Tree 93 was 8.2m measured at a radial distance from the centre of the trunk.

Figure 5. View to north of Tree 93, *Syzygium paniculatum* in its growing environment. (Jamie Oates, 22 August 2019).

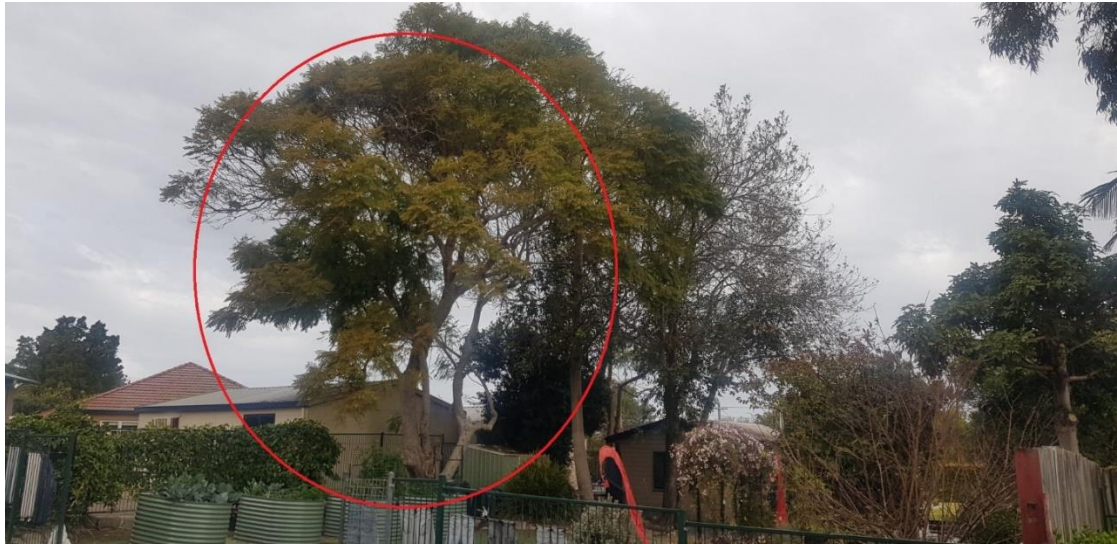
- 6.2.9 Tree 99 was a Jacaranda (*Jacaranda mimosifolia*). The tree was located within the garden area on the southern side of the site and forms a significant feature within the landscape.
- 6.2.10 Tree 99 was of good health and fair structure and has a life expectancy of 15–25 years.
- 6.2.11 The TPZ for Tree 99 was 9.8m measured at a radial distance from the centre of the trunk.

Figure 6. View to south of Tree 99, *Jacaranda mimosifolia* in its growing environment. (Jamie Oates, 22 August 2019).

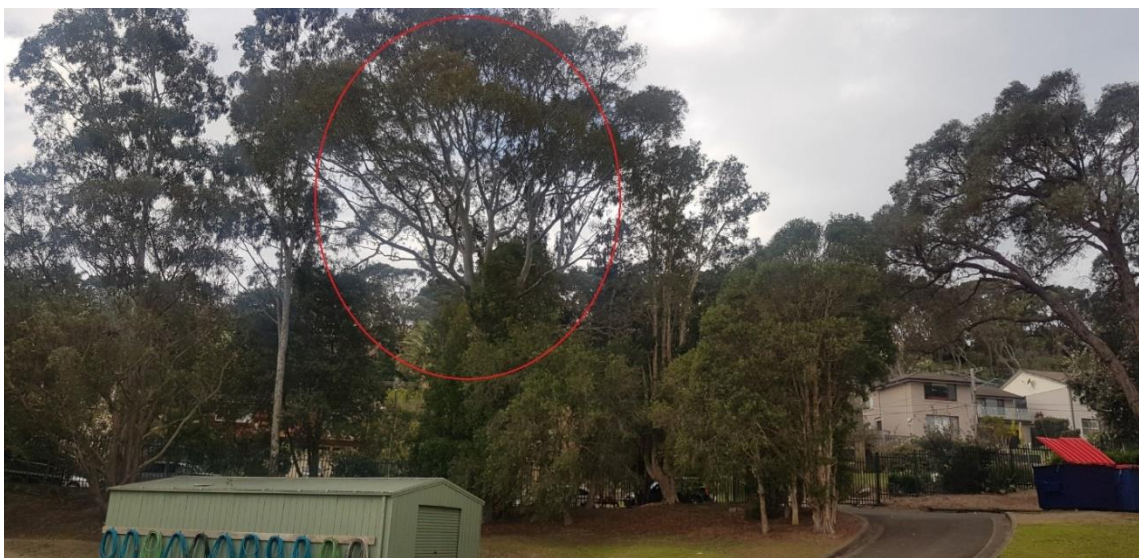
- 6.2.12 Tree 40 was a Spotted Gum (*Corymbia maculata*). The tree was located amongst other medium to large trees on the northern boundary of the site and forms a significant feature within the landscape and contributes greatly to the ecological and amenity value of the site.
- 6.2.13 Tree 40 was of good health and fair structure and has a life expectancy of 25–50 years.
- 6.2.14 The TPZ for Tree 40 was 10.8m measured at a radial distance from the centre of the trunk.

Figure 7. View to north of Tree 40, *Corymbia maculata* in its growing environment. (Jamie Oates, 22 August 2019).

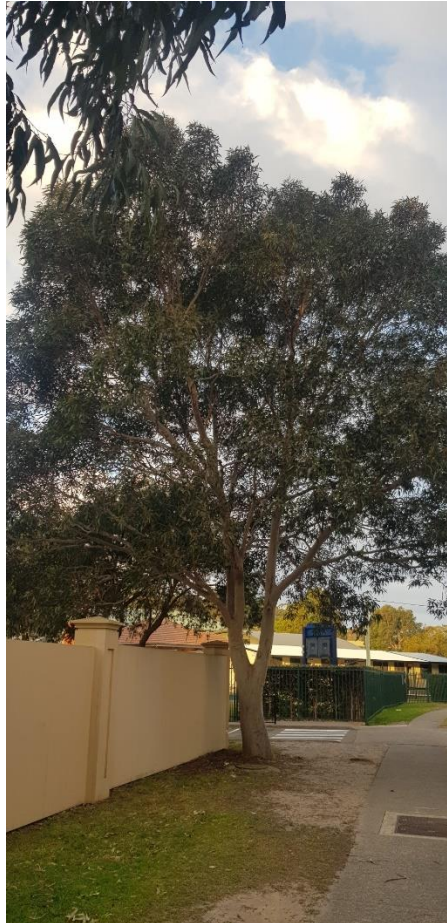
- 6.2.15 Tree 104 was a Spotted Gum (*Corymbia maculata*). The tree was located on the council verge just outside the southern boundary fence adjacent to the southern car park. This locally endemic species significantly contributes to the amenity and ecological value of the site and the streetscape.
- 6.2.16 Tree 104 was of good health and structure and has a life expectancy of >50 years.
- 6.2.17 The TPZ for Tree 104 was 5.9m measured at a radial distance from the centre of the trunk.

Figure 8. View to east of Tree 104, *Corymbia maculata* in its growing environment. (Jamie Oates, 22 August 2019).

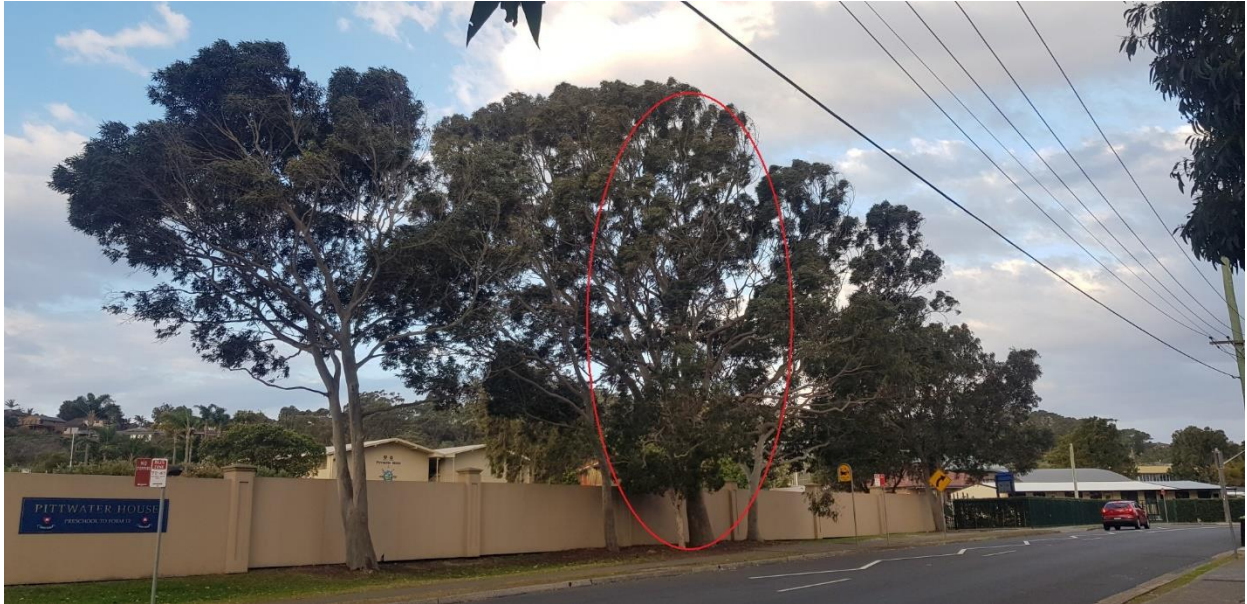
- 6.2.21 Tree 106 was a Lemon-scented Gum (*Corymbia citriodora*). The tree was located on the council verge just outside the southern boundary fence adjacent to the southern car park. The tree contributes significantly to the streetscape and forms a significant feature at the southern entrance of the site.
- 6.2.22 Tree 106 was of excellent health and good structure and has a life expectancy of 25–50 years.
- 6.2.23 The TPZ for Tree 106 was 10.0m measured at a radial distance from the centre of the trunk.

Figure 9. View to north-east of Tree 106, *Corymbia citriodora* in its growing environment. (Jamie Oates, 22 August 2019).

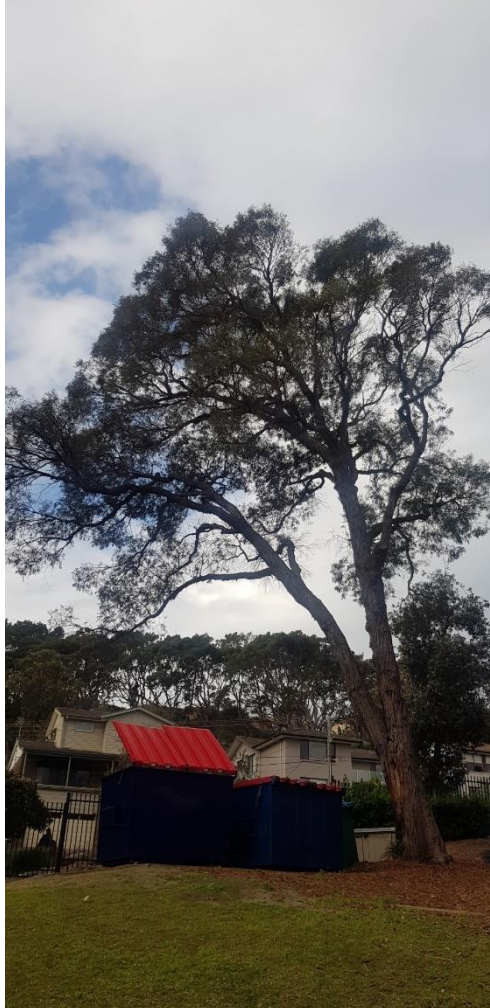
- 6.3.3 Tree 47 was a Narrow-leaved Black Peppermint (*Eucalyptus nicholii*). This relatively shorted lived Eucalyptus species is endemic to the New England area of NSW. This tree was of mature size and in good health and fair structure. Active termites were observed as well as a large trunk wound that potentially harbours decay. The tree has a ULE of 10–15 years only.
- 6.3.4 The TPZ for Tree 47 was 9.4m measured at a radial distance from the centre trunk.

Figure 11. View to north of Tree 47, *Eucalyptus nicholii* in its growing environment. (Jamie Oates, 22 August 2019).

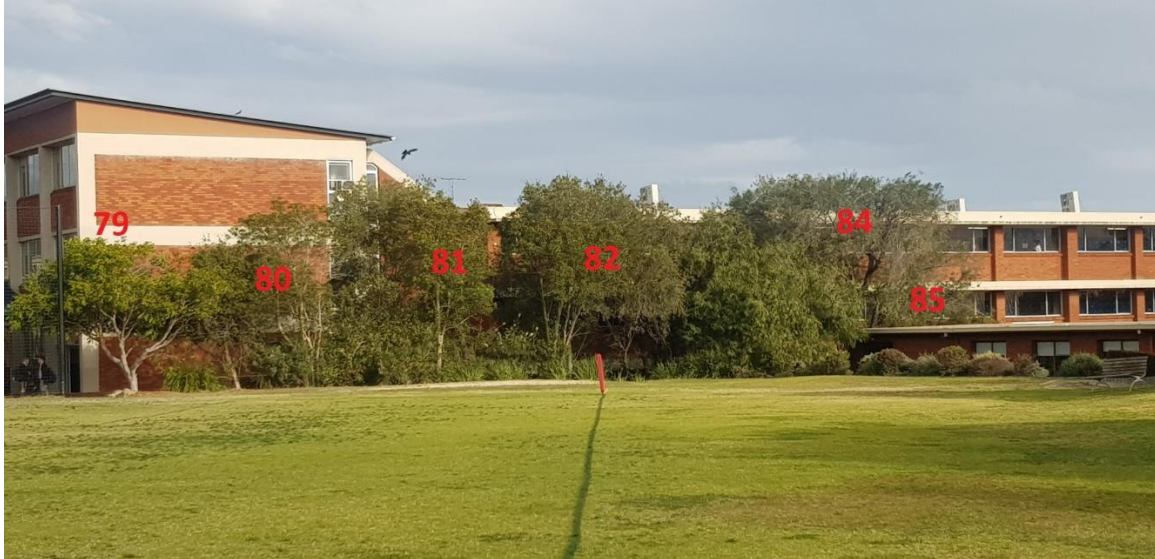
- 6.4.3 Trees 79, 80, 81, 82, 84 and 85 are all examples of Category C trees. Species include Weeping Bottlebrush (*Callistemon viminalis*), Willow Myrtle (*Agonis flexuosa*) and Kanooka (*Tristaniopsis laurina*). These species' have a relatively small mature size potential. Whilst they offer some screening and amenity value, they are easily replaceable, hence their Low Retention Value.
- 6.4.4 As an example, the TPZ for Tree 82 was 2.5m measured at a radial distance from the centre trunk.

Figure 13. View to east of Trees 79, 80, 81, 82, 84 and 85 in their growing environment. (Jamie Oates, 22 August 2019).

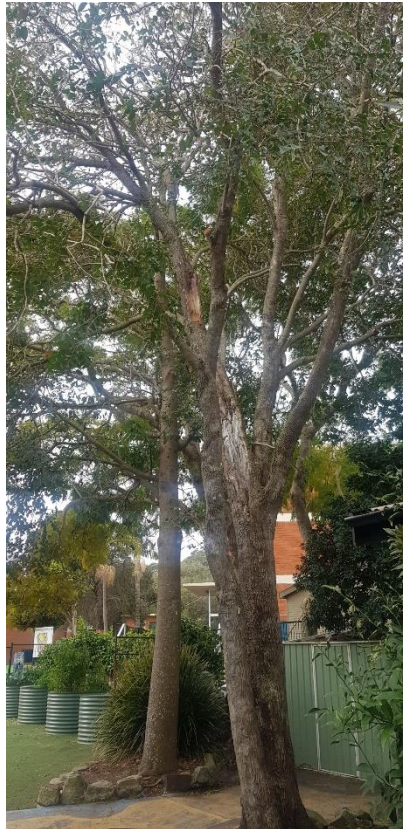
6.5.3 Tree 96 was a Cheese Tree (*Glochidion ferdinandi*) tree located within the garden area on the southern side of the site. The tree has experienced multiple stem failures resulting in poor structure and a low ULE. This tree is recommended for removal irrespective of any further development.

Figure 15. View to north of Tree 96, *Glochidion ferdinandi* in its growing environment. Note the large failure wounds. (Jamie Oates, 22 August 2019).

- 8.1.1 Twenty-two (22) trees would require removal to facilitate this development. These are trees 19, 20, 21, 22, 24, 41, 42, 44, 45, 46, 47, 86, 88, 89, 90, 94, 95, 97, 98, 100, 101 and 102.
- 8.1.2 Four (4) trees were recommended for removal irrespective of future development on the site. These are Trees 43, 83, 87 and 96.

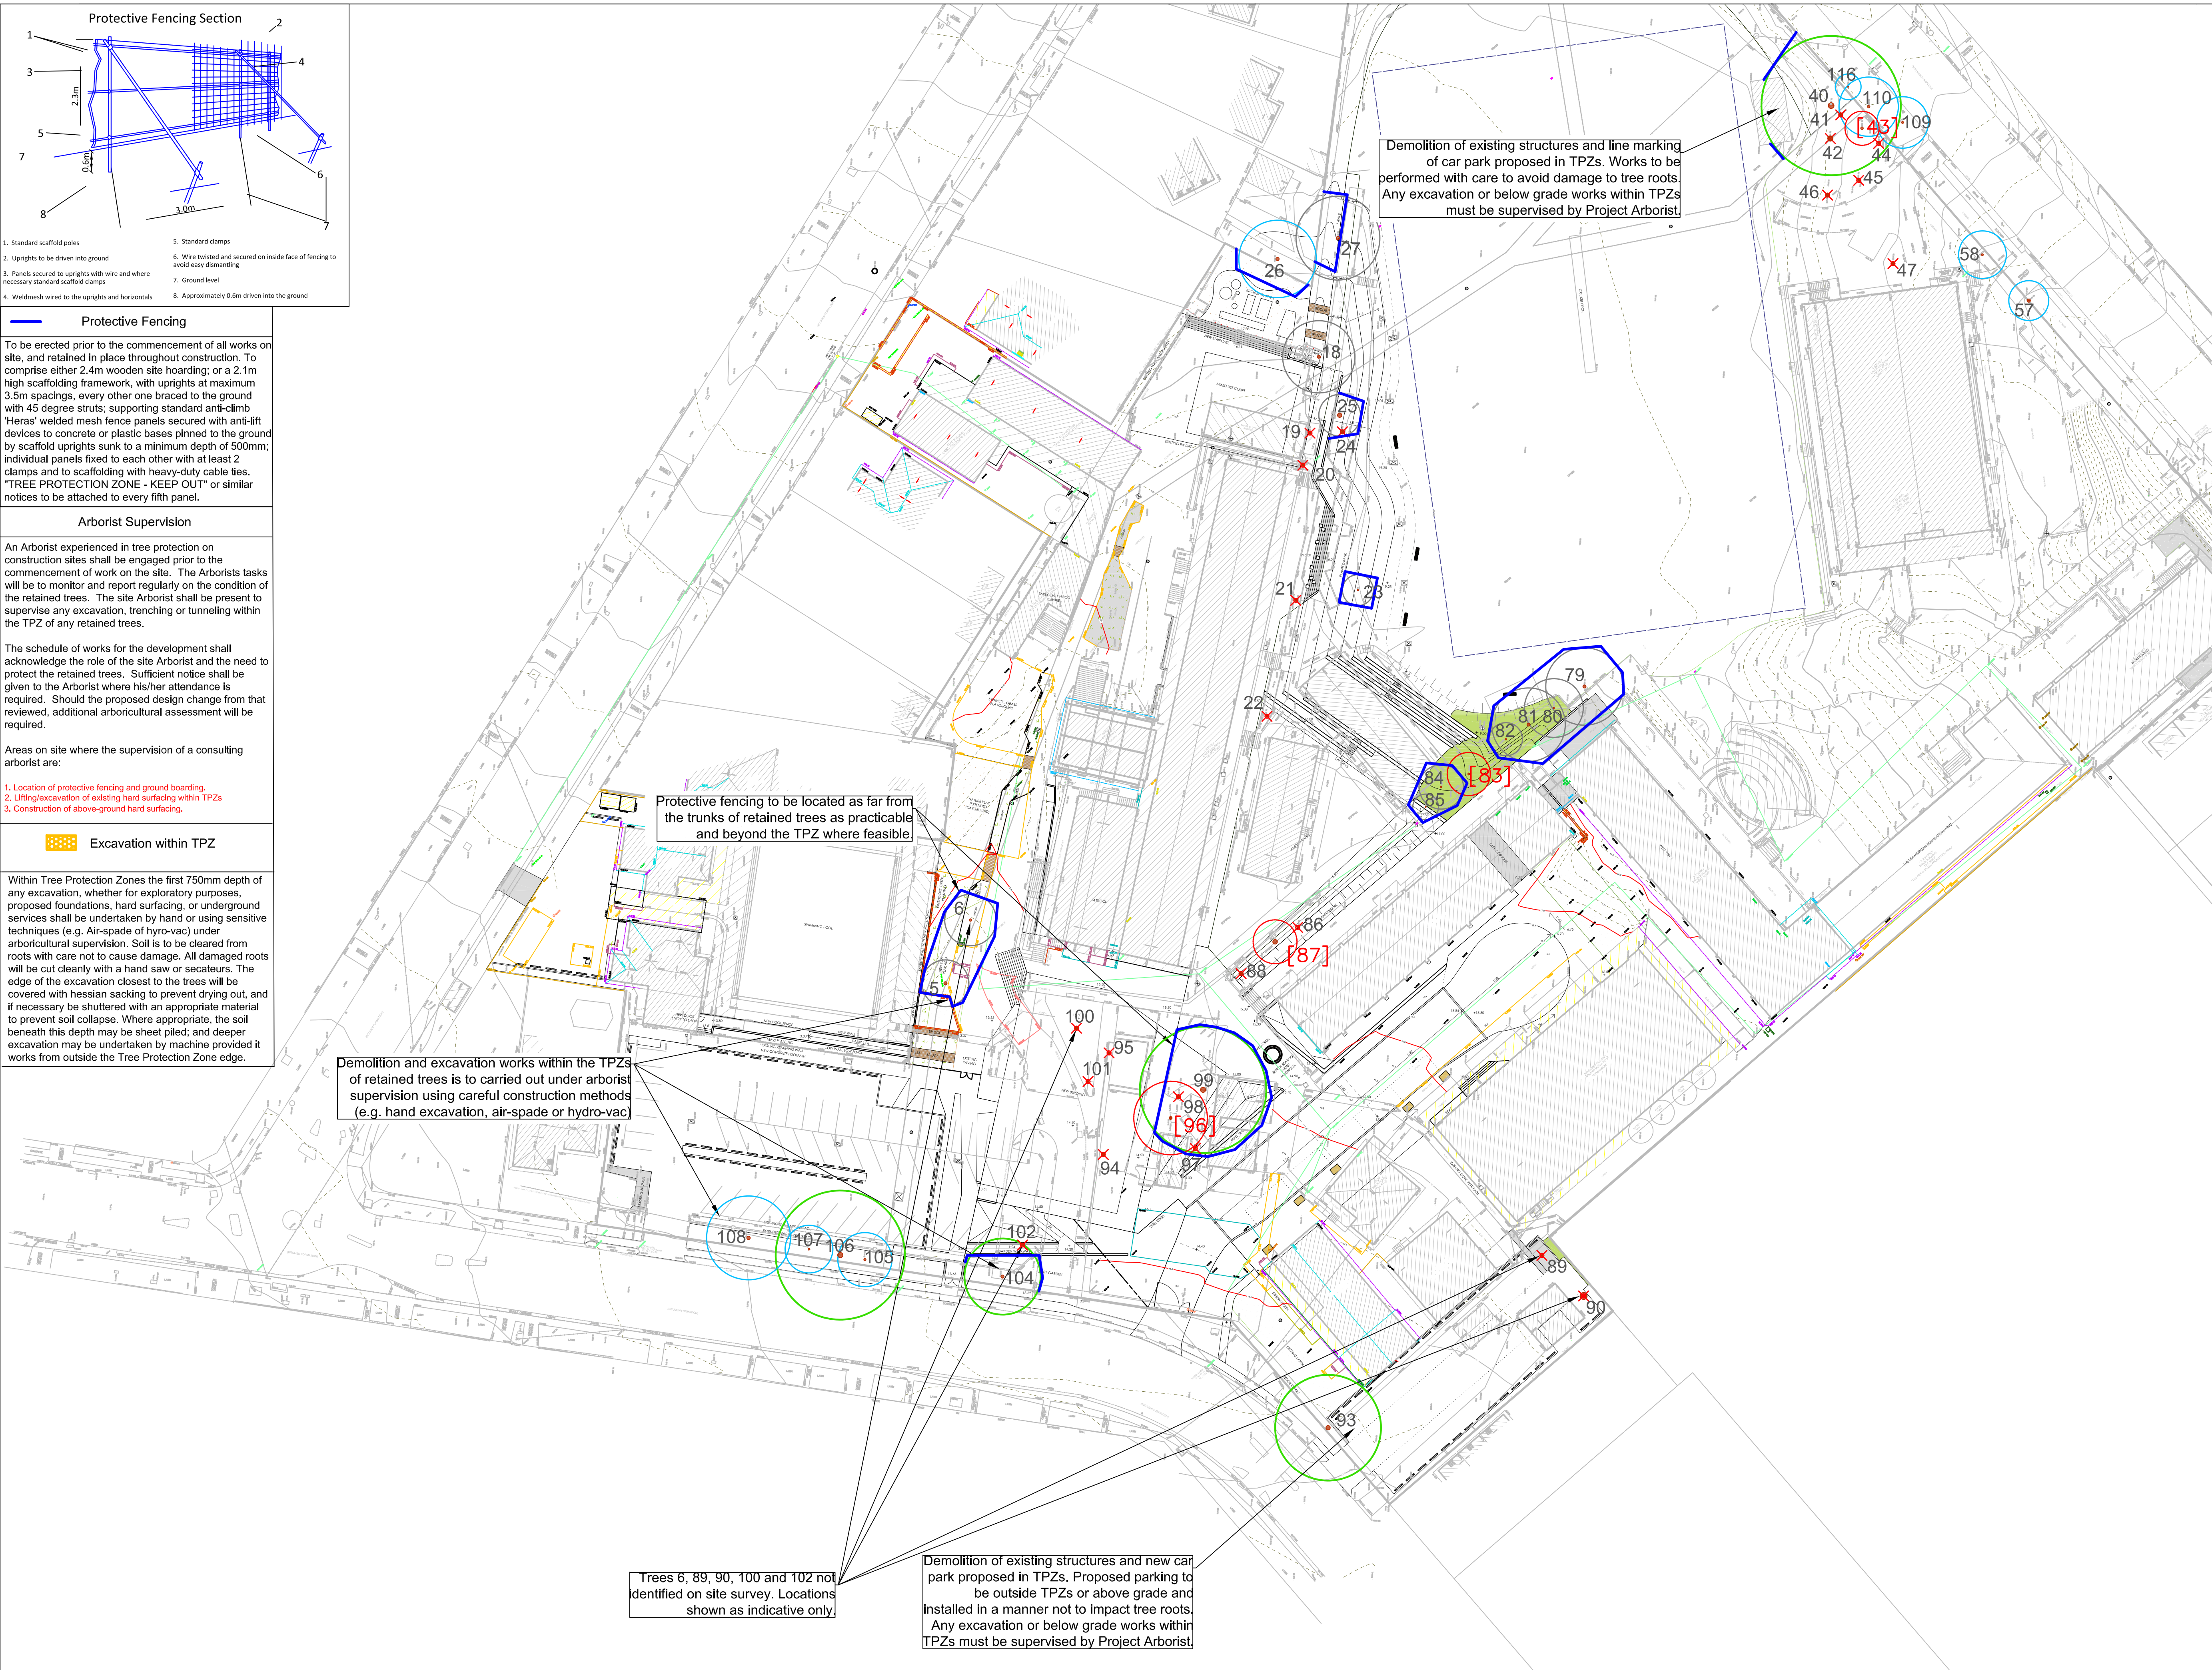
Demolition of existing structures and new car park proposed in TPZs. Proposed parking to be outside TPZs or above grade and installed in a manner not to impact tree roots. Any excavation or below grade works within TPZs must be supervised by Project Arborist.

Demolition and excavation works within the TPZs of retained trees is to be carried out under arborist supervision using careful construction methods (e.g. hand excavation, air-spade or hydro-vac)

Protective fencing to be located as far from the trunks of retained trees as practicable and beyond the TPZ where feasible.
