Geotechnical Investigation and Slope Stability Risk Assessment

Proposed New Residence

Lot 03, 10 Fern Creek Road, Warriewood NSW

Report No. R22009.03.Rev0

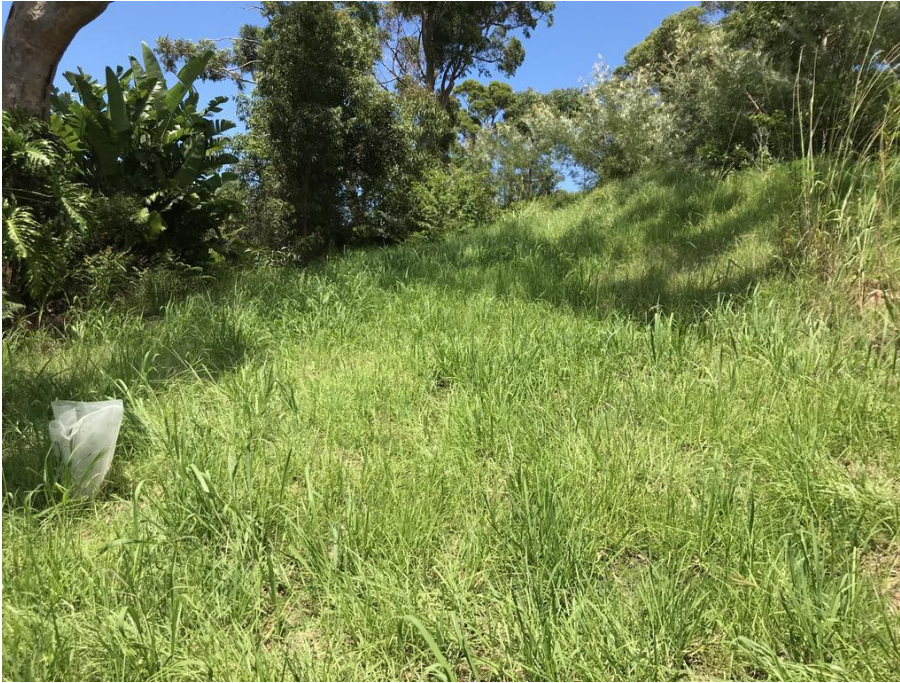
Photograph 1 – General site conditions, looking south

Topographically, the allotment is situated along the lower slope of a hill. The ground surface across the site moderately slopes downward to the north-east and had a fall approximately 6 – 7 m. However, the construction area of the allotment had a difference in elevation of approximately 4 – 5 m. At the time of field works, there were no existing structures within the allotment.

Site vegetation comprised grasses, weeds and scattered native trees. The trees were in upright position. The following site photographs show the general site conditions at the time of field work:
