Report Title: Geotechnical Report 102 Wakehurst Parkway, Elanora Heights

Report Date: 13/9/18

GEOTECHNICAL INVESTIGATION:

Subdivision and Alterations and Additions at **102 Wakehurst Parkway, Elanora Heights.**

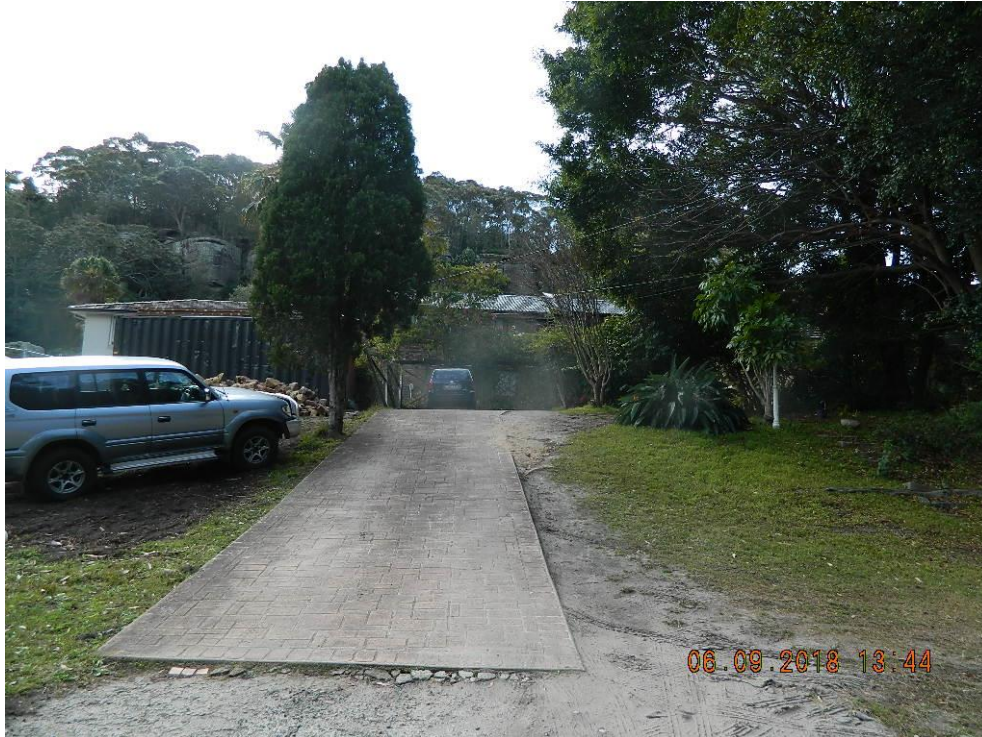
Photo 1

- 2.3** At the road frontage, a concrete driveway runs to a paved parking area and garage on the S side of the house (Photo 1). Gardens and a lawn area encompass the house frontage (Photo 2). The two storey brick and timber framed and clad house is supported on a concrete slab, brick walls and timber beams (Photo 3). A portion of the W side of the house will be demolished as part of the proposed works. A gently sloping lawn area rises from the uphill side of the house halfway up the property (Photo 4).

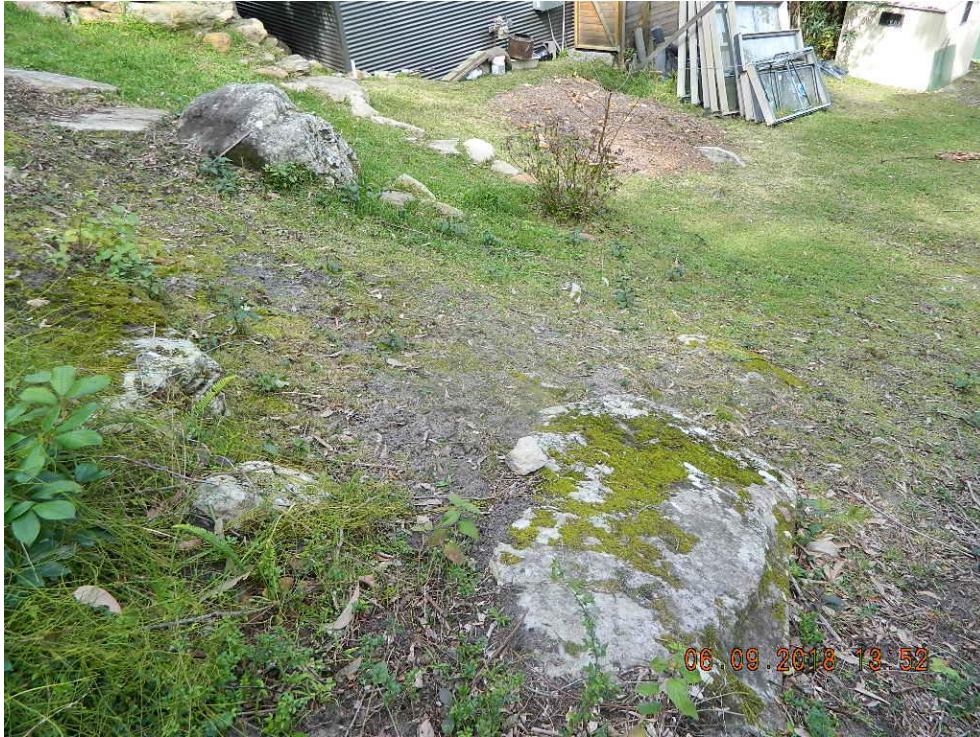
Photo 5

Sandstone floaters are scattered on the uphill side of the lawn area (Photo 5). A Storage shed and garden shed lie on the E side of the lawn area (Photo 6). From the uphill extent of the lawn area the property is densely vegetated and a ~6.0m sandstone cliff face marks the top of the escarpment (Photo7). The cliff face is made up of widely jointed massive medium strength sandstone. Some minor undercutting was observed along a bedding plane halfway up one of the large joint blocks but no significant geological defects that could impact the stability of the rock face were observed above the property. The rock face is considered stable in this location (Photo 8). The property continues for another ~40m to the uphill boundary and could not be accessed due to the rock face. No significant signs of movement that could have occurred in recent geological history were observed on the property. No geotechnical hazards that could impact on the subject property were observed on the neighbouring properties as seen from the subject property and the road.

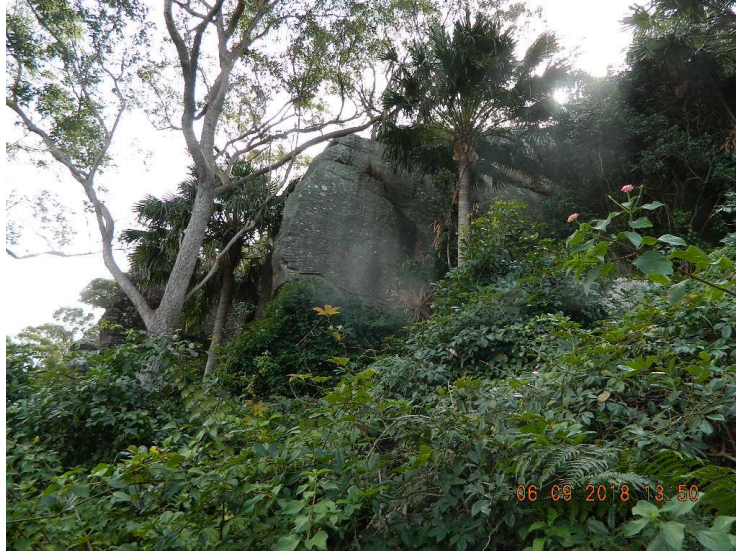
Photo 7

No geotechnical hazards were observed below or beside the property. The large sandstone rock face that rises at the northern end of the block is a potential hazard (**Hazard One**).

HAZARDS	Hazard One
TYPE	The large rock face failing and impacting on the subject house and property (Photo 7 & 8).
LIKELIHOOD	'Rare' (10^{-6})
CONSEQUENCES TO PROPERTY	'Major' (60%)
RISK TO PROPERTY	'Low' (2×10^{-6})
RISK TO LIFE	6.7×10^{-7} /annum
COMMENTS	This level of risk is 'ACCEPTABLE' subject to the recommended inspections being carried out in Section 12 .

To be prudent and due to the scale of the cliff face and its position immediately above the developed portion of the block, to ensure ongoing stability into the future we recommend it

be inspected and the stability reassessed by a geotechnical consultant at 10 year intervals. The risk assessment in **Section 8** is subject to these inspections being carried out.

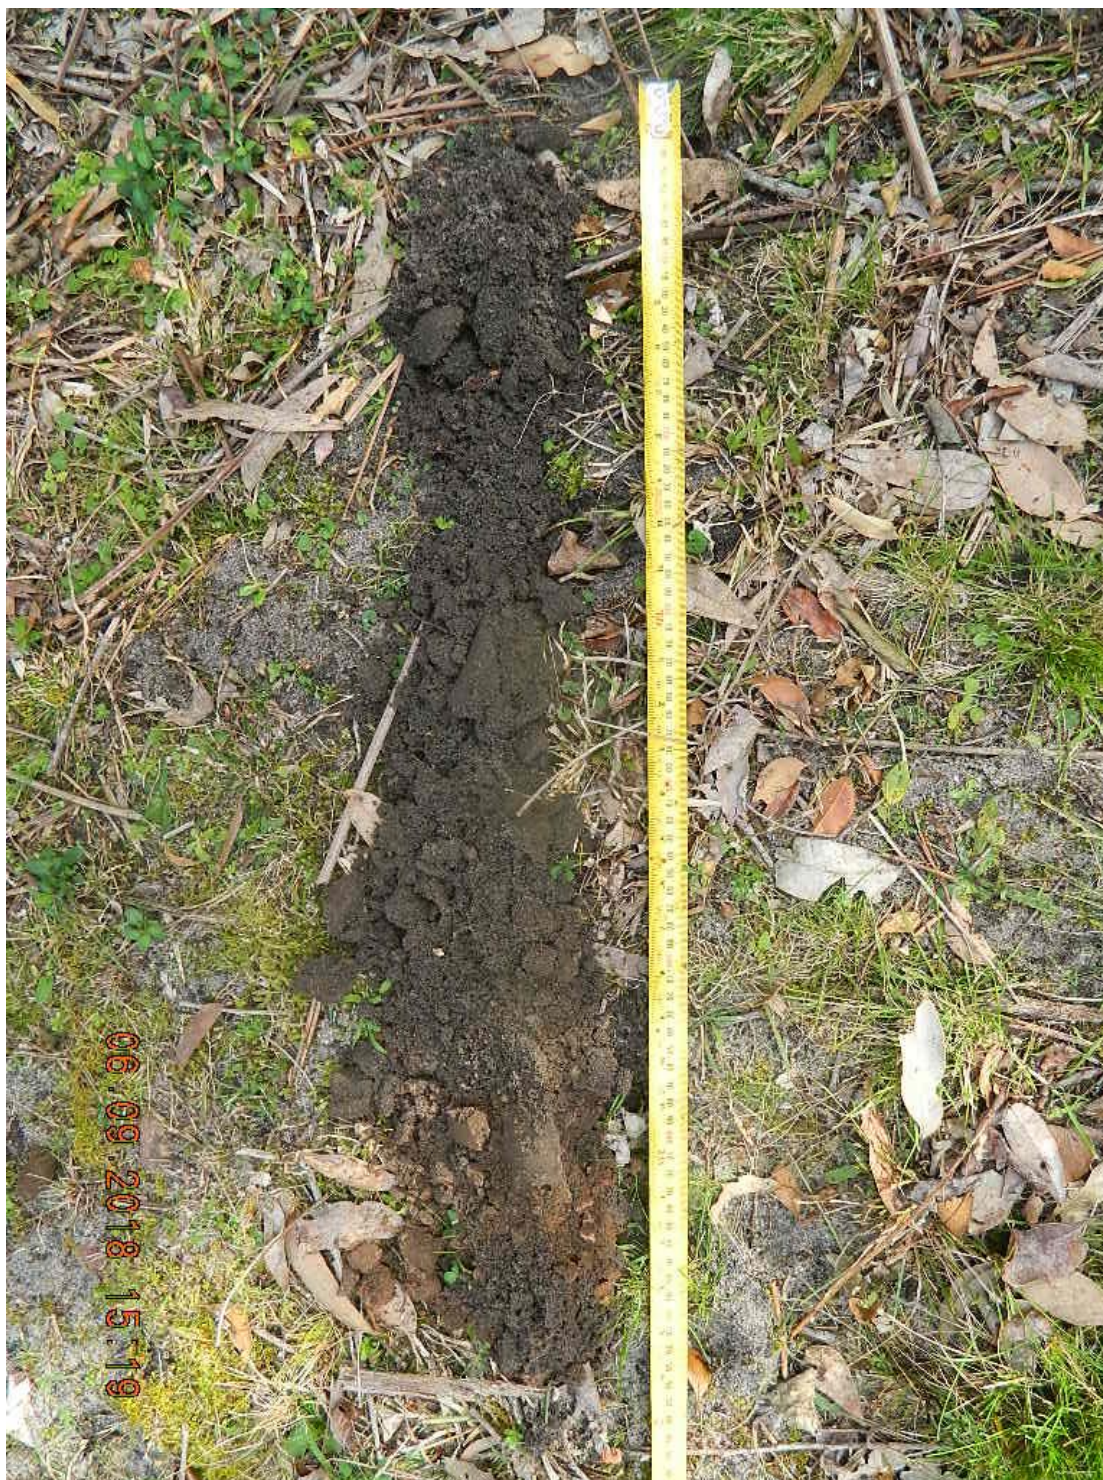
AUGER HOLE 1 (~RL12.5) – AH1 (Photo 9)

Depth (m)	Material Encountered
0.0 to 0.6	TOPSOIL , dark brown/black, fine to medium grained, organic matter throughout, loose, dry.
0.6 to 0.7	SANDY SOIL , brown and orange, sand/weathered sandstone, sandstone rock fragments, fine to medium grained, loose.

Refusal @ 0.7m in sandy soil, Auger grinding on rock. No watertable encountered.

Photo 9: AH1 – Downhole is from top to bottom
