Arboricultural Impact Statement.

**Location: 4 Bellara Avenue NORTH
NARRABEEN NSW 2101**

For: Sydney Water Corporation Pty Ltd
C/- RJK Architects
On. 22/9/2023

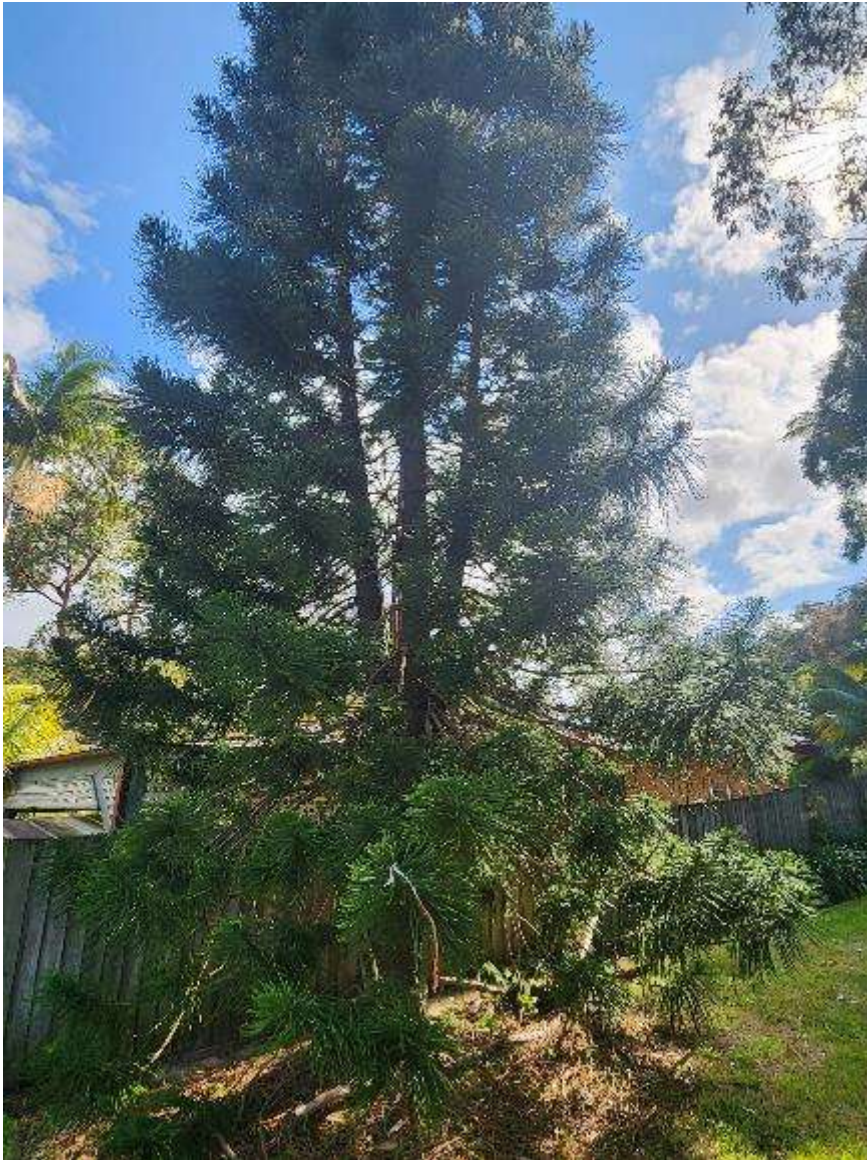
4.1 Tree **T1** is an *Araucaria heterophylla* or 'Norfolk Island Pine' which is a native conifer endemic to Norfolk Island and widely planted in the Sydney Region and the Northern Beaches Council LGA (See Fig. 2). The specimen has a significant defect in the main stem at approx. 2m from the ground where the main stem differentiates into three stems which adjoin in 'V' shape stem unions³.

Fig. 2. Photo of T1 a *Melaleuca quinquinervia* to the Northwest of the Site

6.1. It is concluded that, for the development to proceed as planned, trees **T1, T4, T5 & T6** will need to be removed.

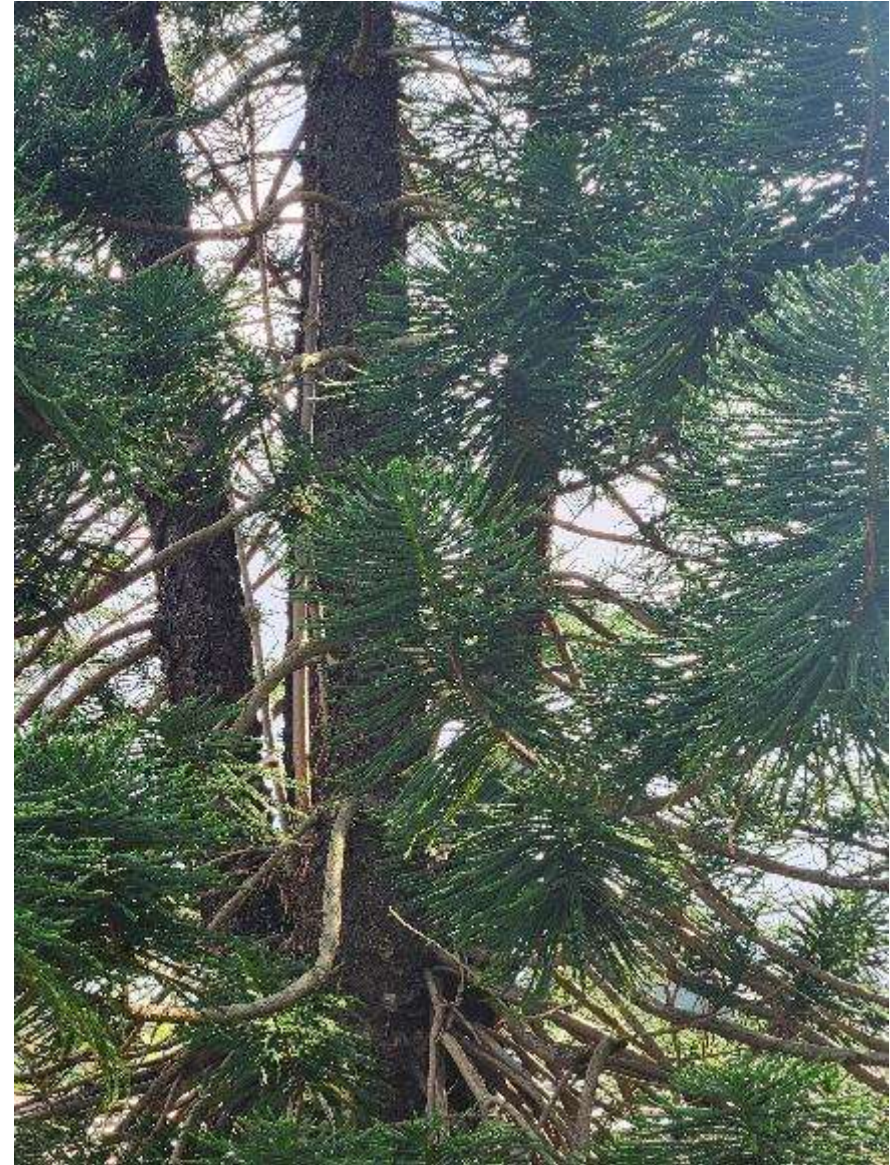
- 5.1** It is considered that the trees noted in this report are all planted specimens
- 5.2** Trees **T1** has a significant defect in the form of 'V' shaped stem junctions where the main stem differentiates into three smaller stems. This is considered to be a weak union which will be inclined to failure as the stems increase in size and weight. Previously this tree was recommended for retention dependant on the results of a tree root investigation however it is considered that this would be irrelevant in view of the afore mentioned defect in the stems.

Fig. 3. Photo of structural defect in the form of 3 stems adjoining in 'V' shape

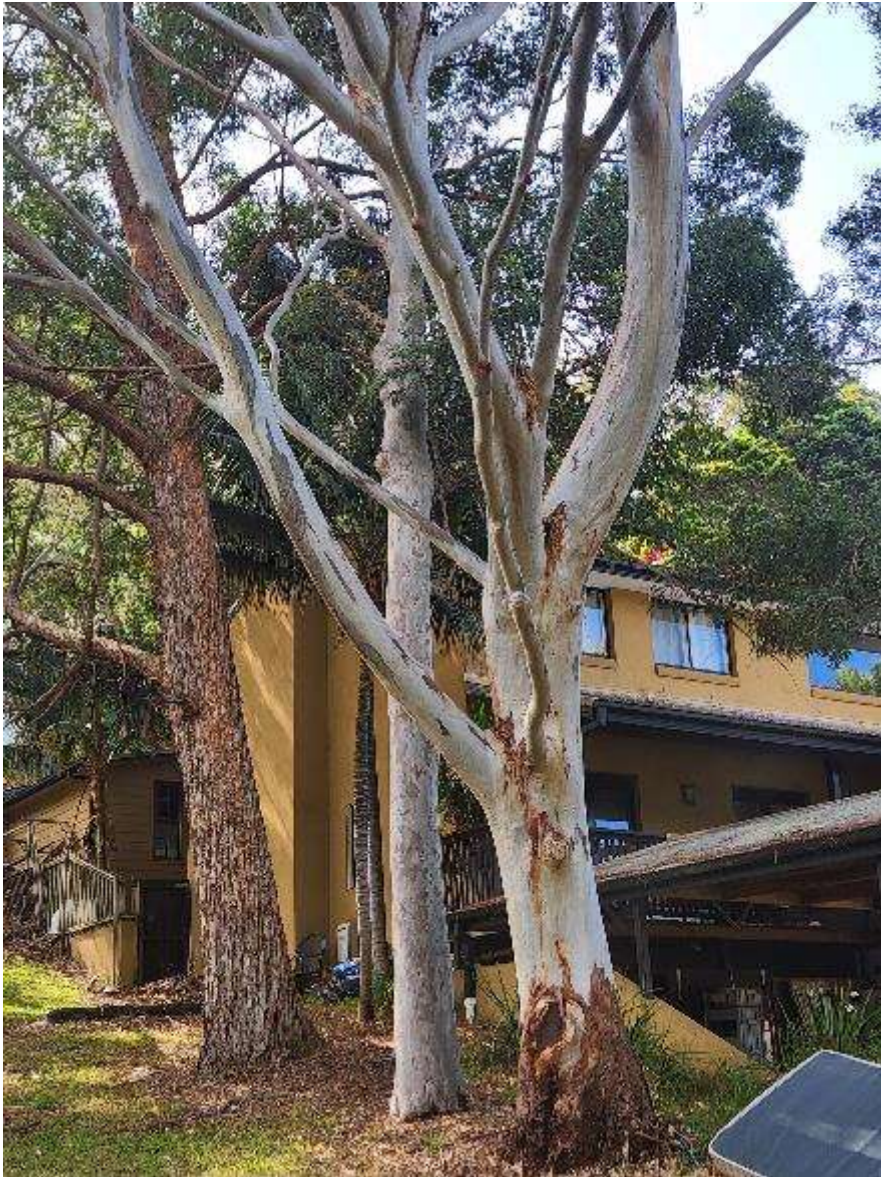
Fig. 4. Photo of T3, T4 & T5 a *E. saligna*, *C. citriodora* & *E. microcorys*

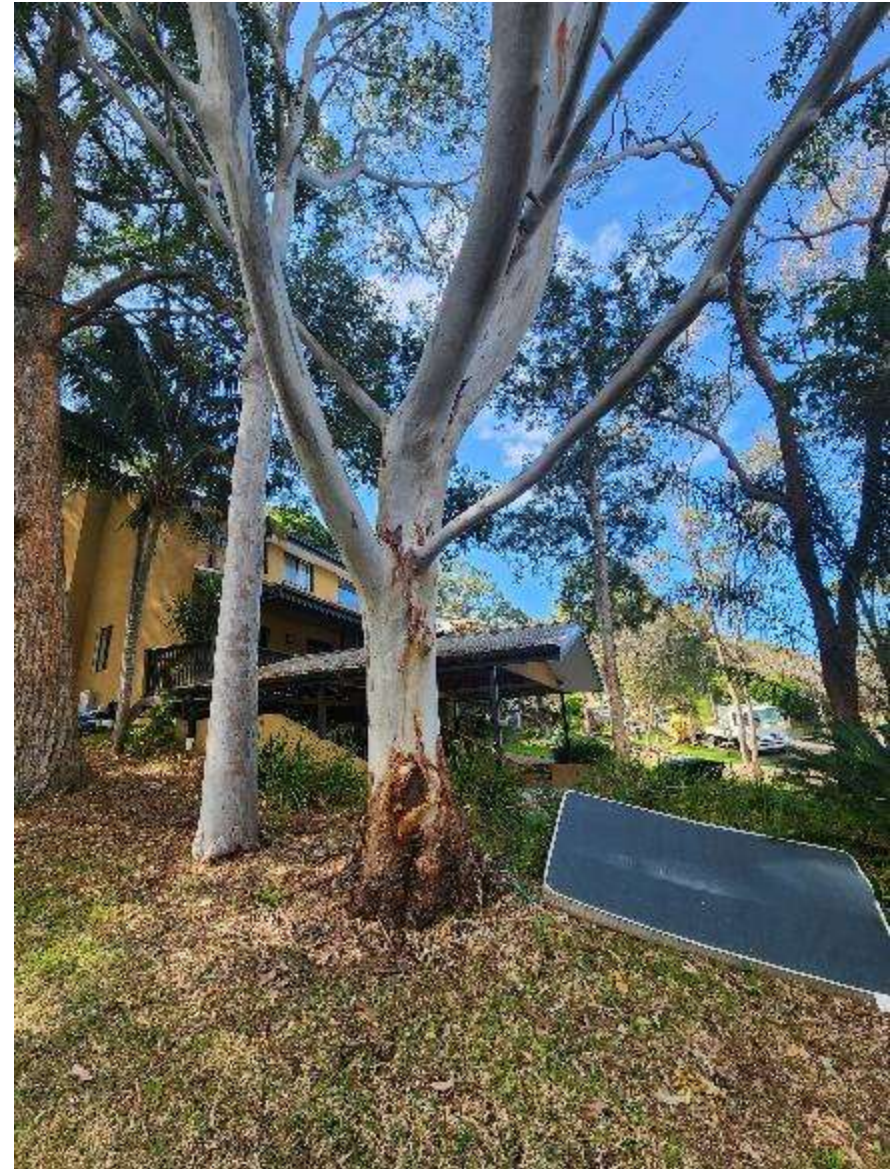
4.2 Tree **T2** is a *Eucalyptus saligna* or 'Sydney Blue Gum' which is an endemic species common to the Sydney Region and the Northern Beaches Council LGA (See Figs. 4 & 5). The specimen has been planted in the Eastern portion of the Site in a row and in close proximity to trees T3 and T4. There is a large scar at the base and has formed an asymmetric canopy with a bias to the South due to overarching branches from tree **T3** that are blocking the sunlight. The tree will have formed a corresponding asymmetric root plate due to its proximity to tree **T3** with which it will be competing for space, water and nutrients below ground level.

This tree will be subjected to a Minor Encroachment into its TPZ from the proposed new driveway (See Appendix 2).

Fig. 5. Photo of tree T2 a *Eucalyptus saligna* (In centre of the frame).

- 5.3** Trees **T2 & T3** will suffer Minor Encroachment into their relative TPZs and SRZs from the new driveway and I concur with the findings in the previous report that these specimens be retained (See Appendix 2). Nonetheless these trees can be inadvertently damaged by deliveries, trades vehicles and the passage of plant equipment and so a protective fence and signage is recommended for these trees (See Appendix 4a & 4b).

6.2 Trees **T2 & T3** are to be retained and protected throughout the duration of the development by fencing with signage as depicted in Appendix 4a and 4b.

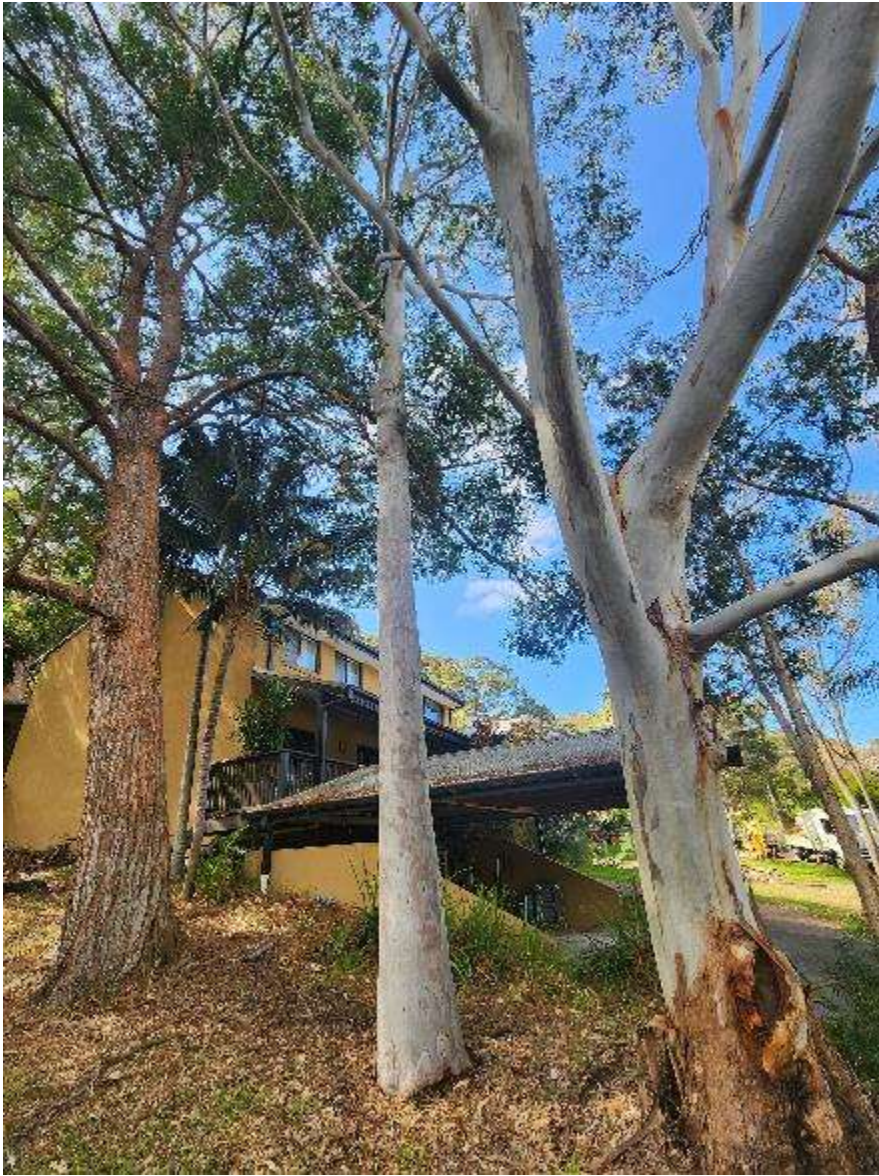
4.3 Tree **T3** is a *Corymbia citriodora* or 'Lemon scented Gum' which is a native species common to the coastal areas of Northeastern NSW and Queensland (See Figs. 4 & 6). The specimen has been planted in the Eastern portion of the Site in a row and in close proximity to trees **T3** and **T4**. The tree will have formed an asymmetric root plate due to its proximity to tree **T2** and **T4** with which it will be competing for space, water and nutrients below ground level. There are some dead limbs in the canopy.

This tree will be subjected to a Minor Encroachment into its TPZ from the proposed new driveway (See Appendix 2).

Fig. 6. Photo of T3 a *Corymbia citriodora* In center of the frame.

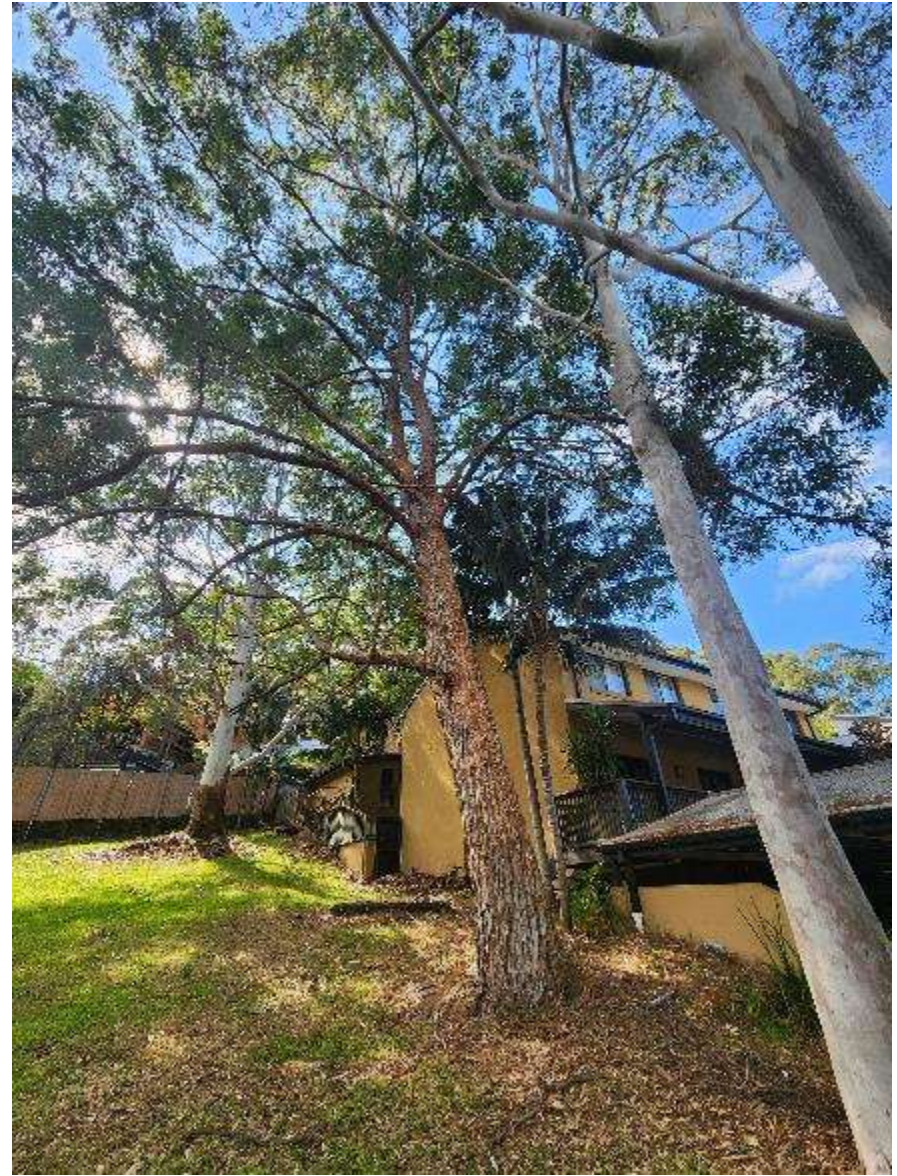
4.4 Tree **T4** is a *Eucalyptus microcorys* or 'Tallowwood' which is a native species common to the coastal areas of Northeastern NSW and Queensland (See Figs. 4 & 7). The specimen has been planted in the Eastern portion of the Site in a row and in close proximity to trees **T2** and **T3**. The tree will have formed an asymmetric root plate due to its proximity to tree **T2** and **T4** with which it will be competing for space, water and nutrients below ground level. There are some dead limbs in the canopy. Also an eastern buttress in the lower stem is located 2m from the neighbour's carport (See Figs. 13, 14 & 15).

This tree will be subjected to a Major Encroachment into its TPZ from the proposed new building footprint and retaining walls. It is anticipated that many roots from this tree will be severed during excavation for these proposed structures. (See Appendix 2).

- 5.4** Tree **T4**, which is the main subject of Council's request for further information, is a large growing species of *Eucalyptus* which can attain heights of 40m (occasionally 60m)⁴ and I have personally observed them in their natural habitat to have diameters greater than 2m. This

tree is already 2m from the neighbour's carport to the easternmost buttress and it is anticipated that it will increase in girth which will further decrease the distance between the tree and the structure and increase the risk of damage to that structure from tree roots. This tree will be subjected to root severing from retaining walls and the new building footprint which would further weaken its structural integrity on the Northwestern side and may cause stem failure were the tree to fail.

Fig. 7. Photo of tree T4 a *Eucalyptus microcorys* in the center of the frame.

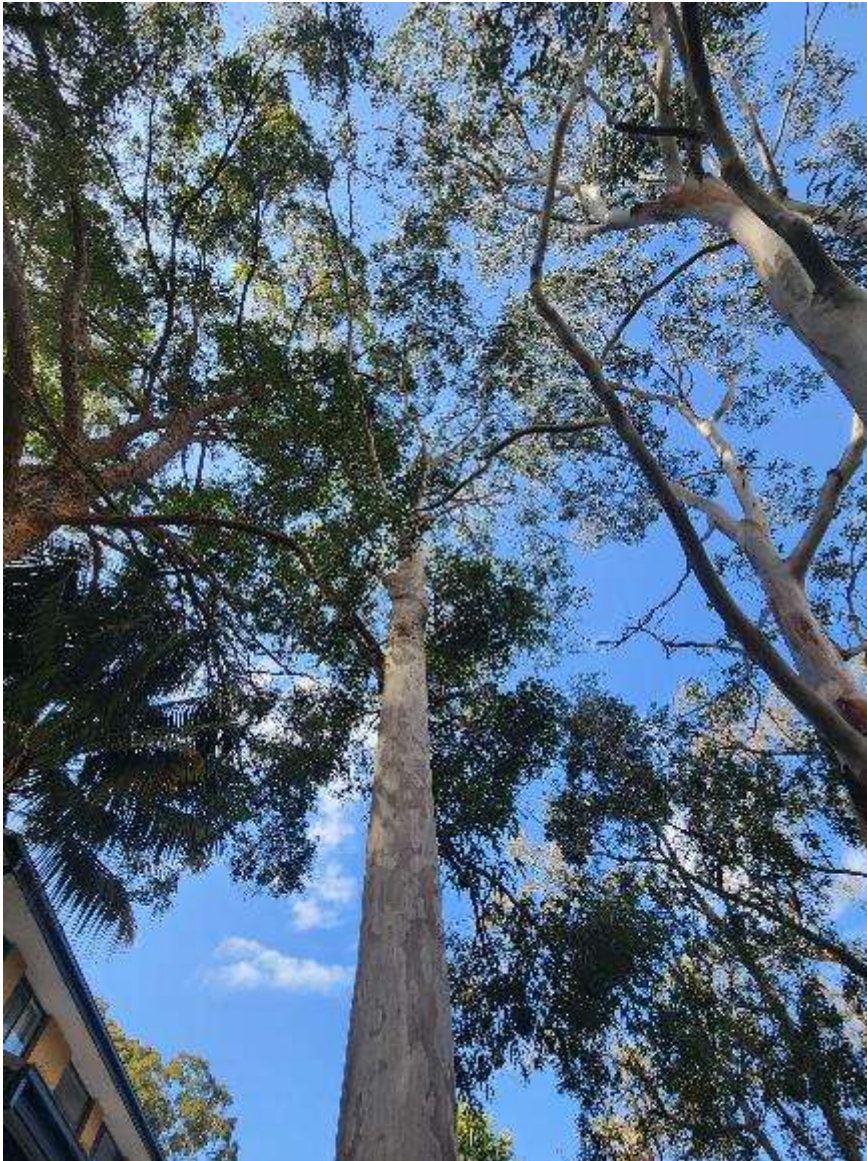
Fig. 8. Photo of the canopy of T3 showing many dead branches.

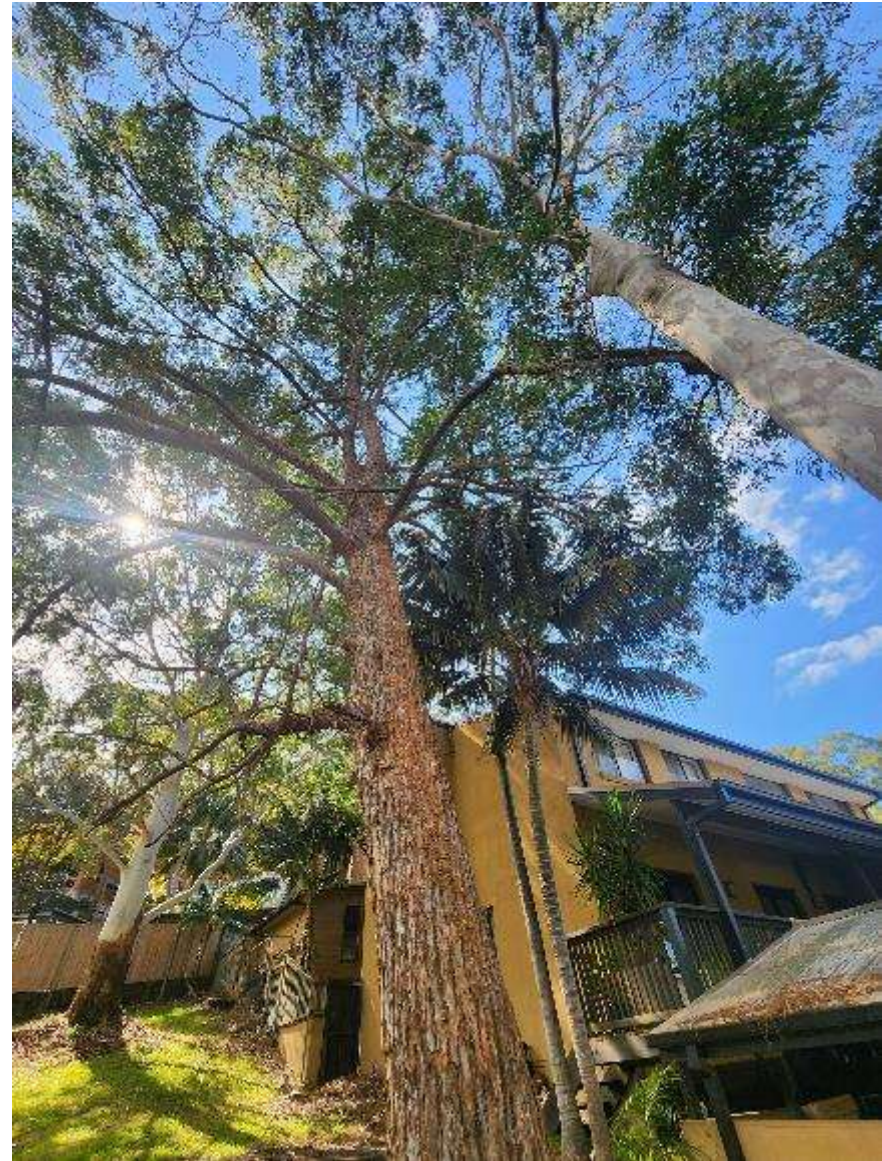
Fig. 9. Photo of the canopy of T4 overhanging the neighbour's dwelling.

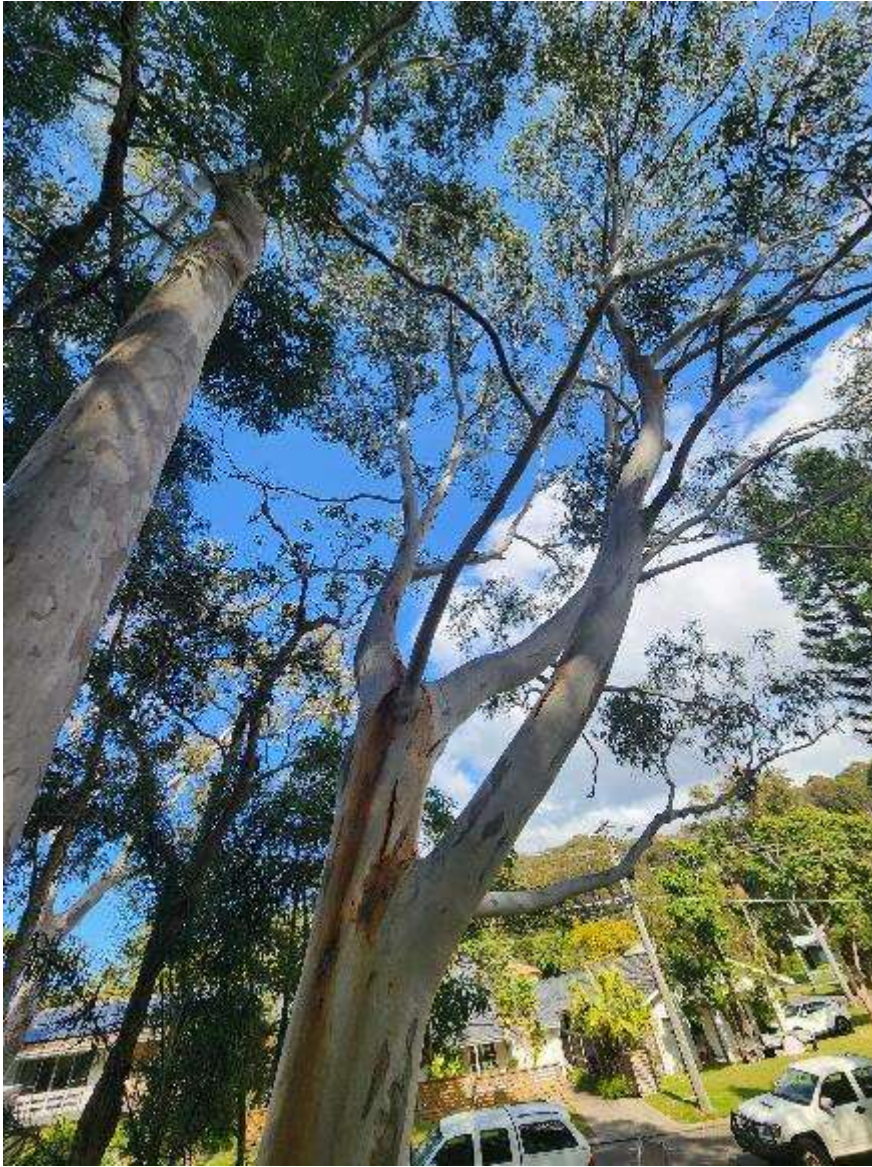
Fig. 10. Photo of the canopy of T2 showing dead limbs and resin

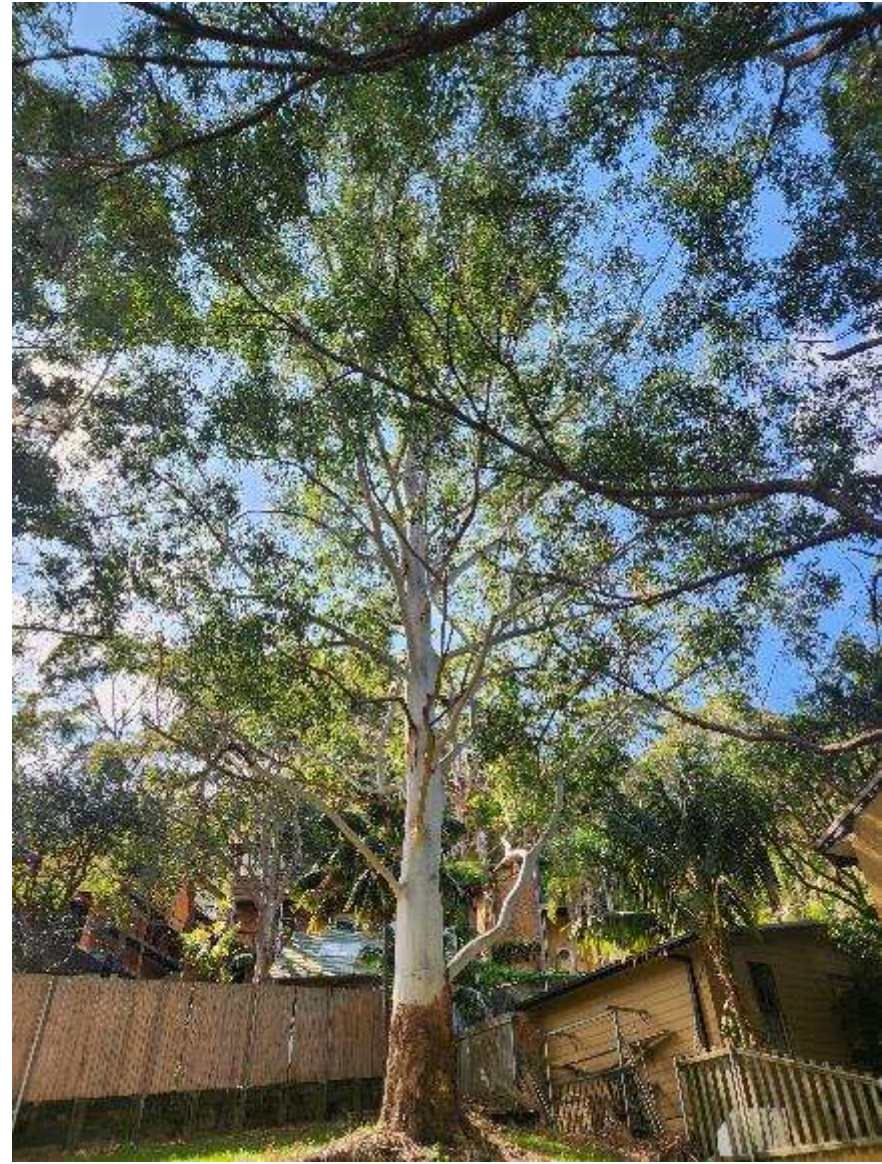
- 4.5** Tree **T5** is a *Eucalyptus saligna* or 'Sydney Blue Gum' which is an endemic species common to the Sydney Region and the Northern Beaches Council LGA (See Fig. 11). The specimen has been planted in the Northeastern portion of the Site. The tree is already very large and healthy.

This tree will be engulfed by the proposed new dwelling and will need to be removed for the development to proceed as planned (See Appendix 2).

Fig. 11. Photo of tree T5 a *Eucalyptus saligna*

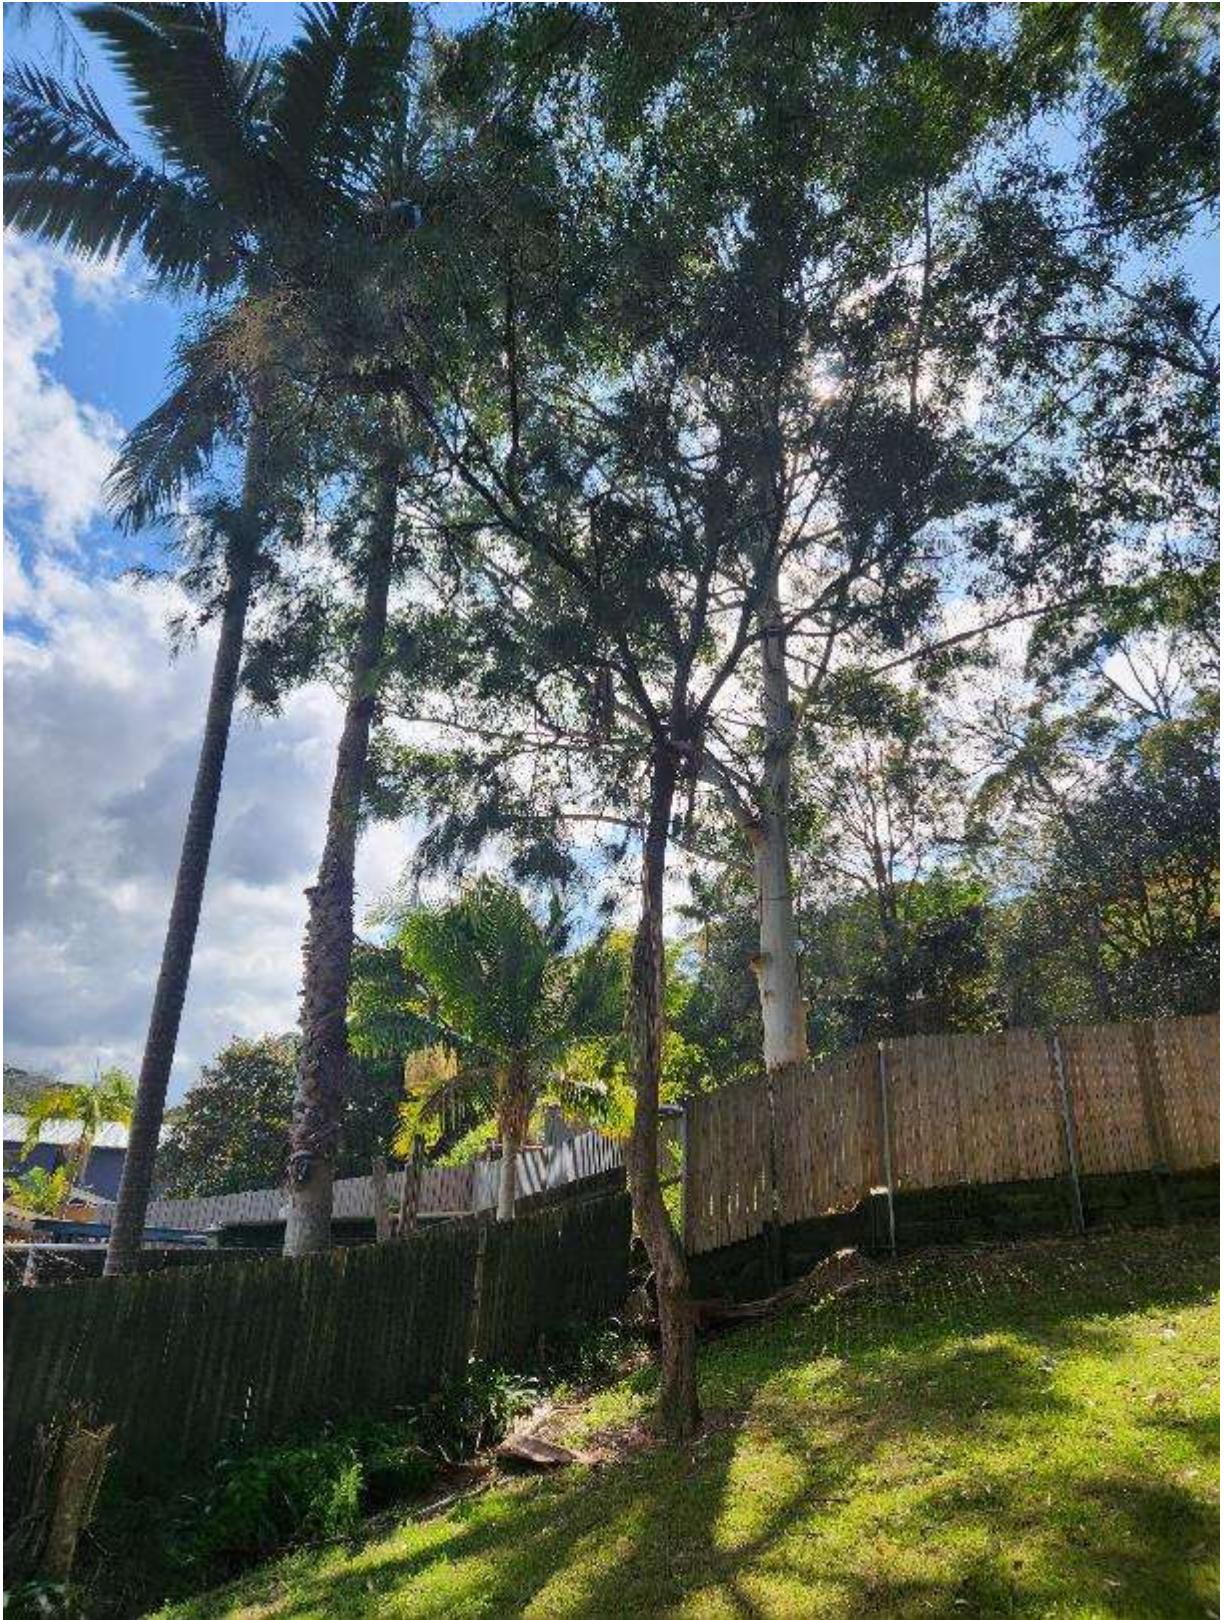
- 4.6** Tree **T6** is a *Casuarina glauca* or 'Swamp Sheoak' which is an endemic species common to the Sydney Region and the Northern Beaches Council LGA (See Fig. 12). The specimen has been planted in the Northwestern portion of the Site. The tree was in good health and condition at the time of my inspection.

This tree will be engulfed by the proposed new dwelling and will need to be removed for the development to proceed as planned (See Appendix 2).

Fig. 12. Photo of Trees T6, T7, T8, T9, T10 and T11

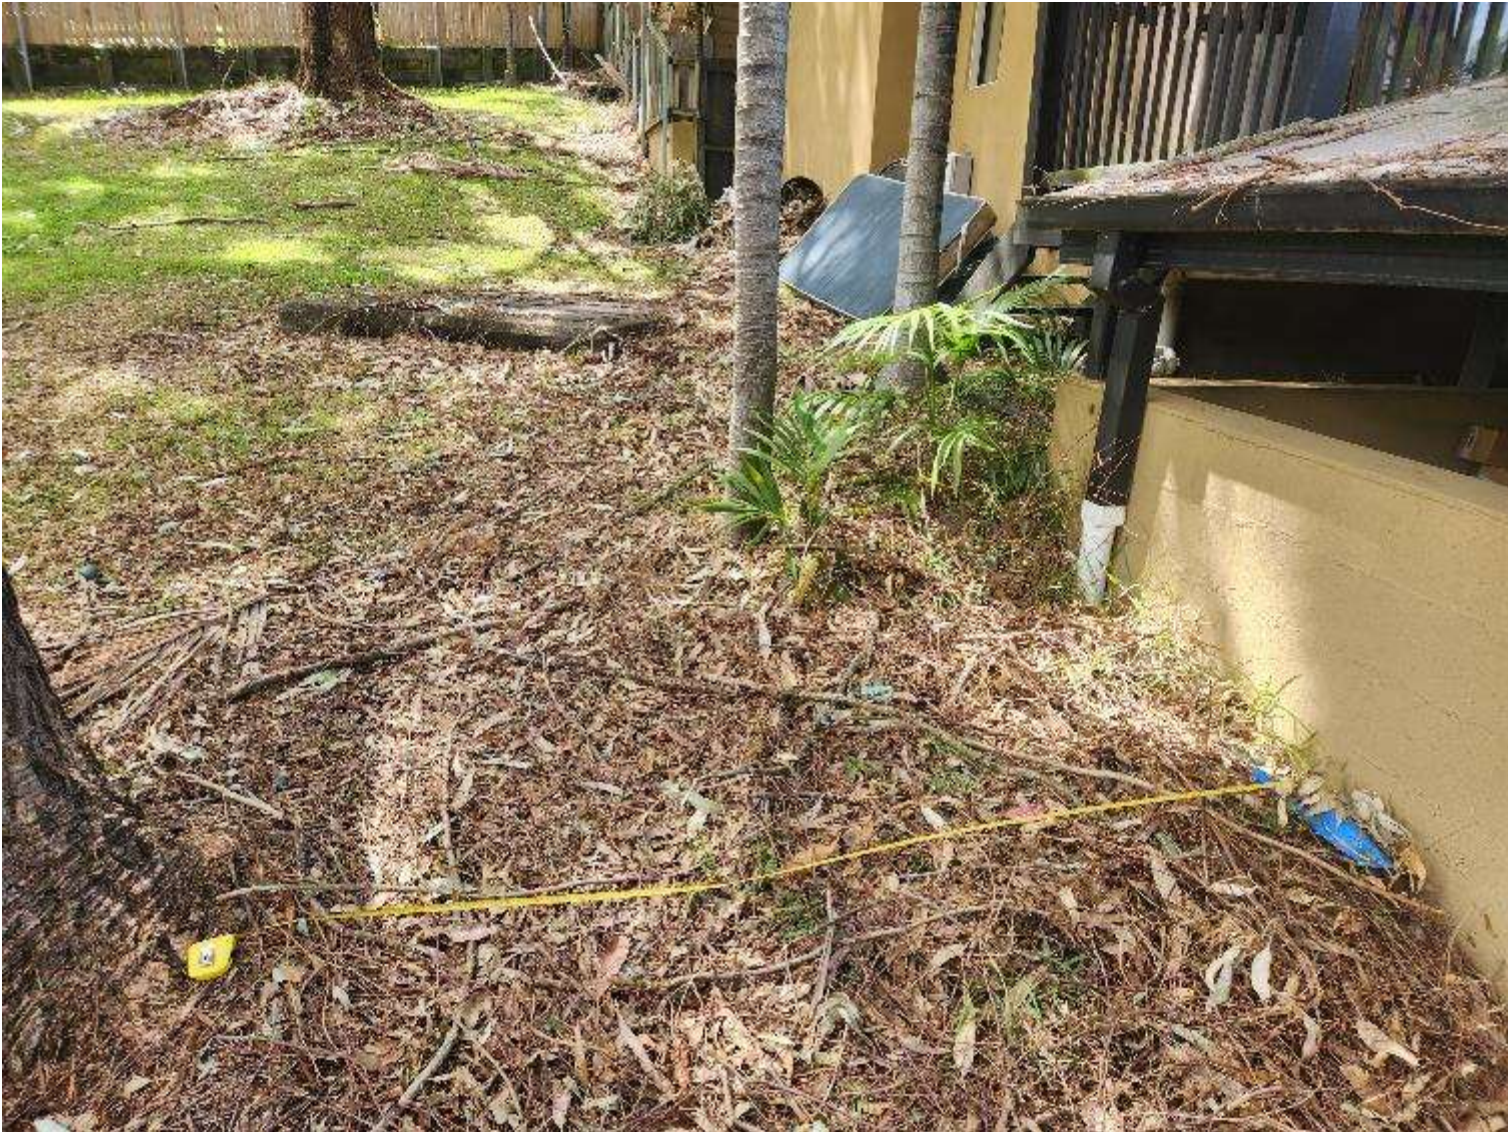
Fig. 13. Photo of tape measure from eave of the neighbour's car port to the buttress roots of T4.

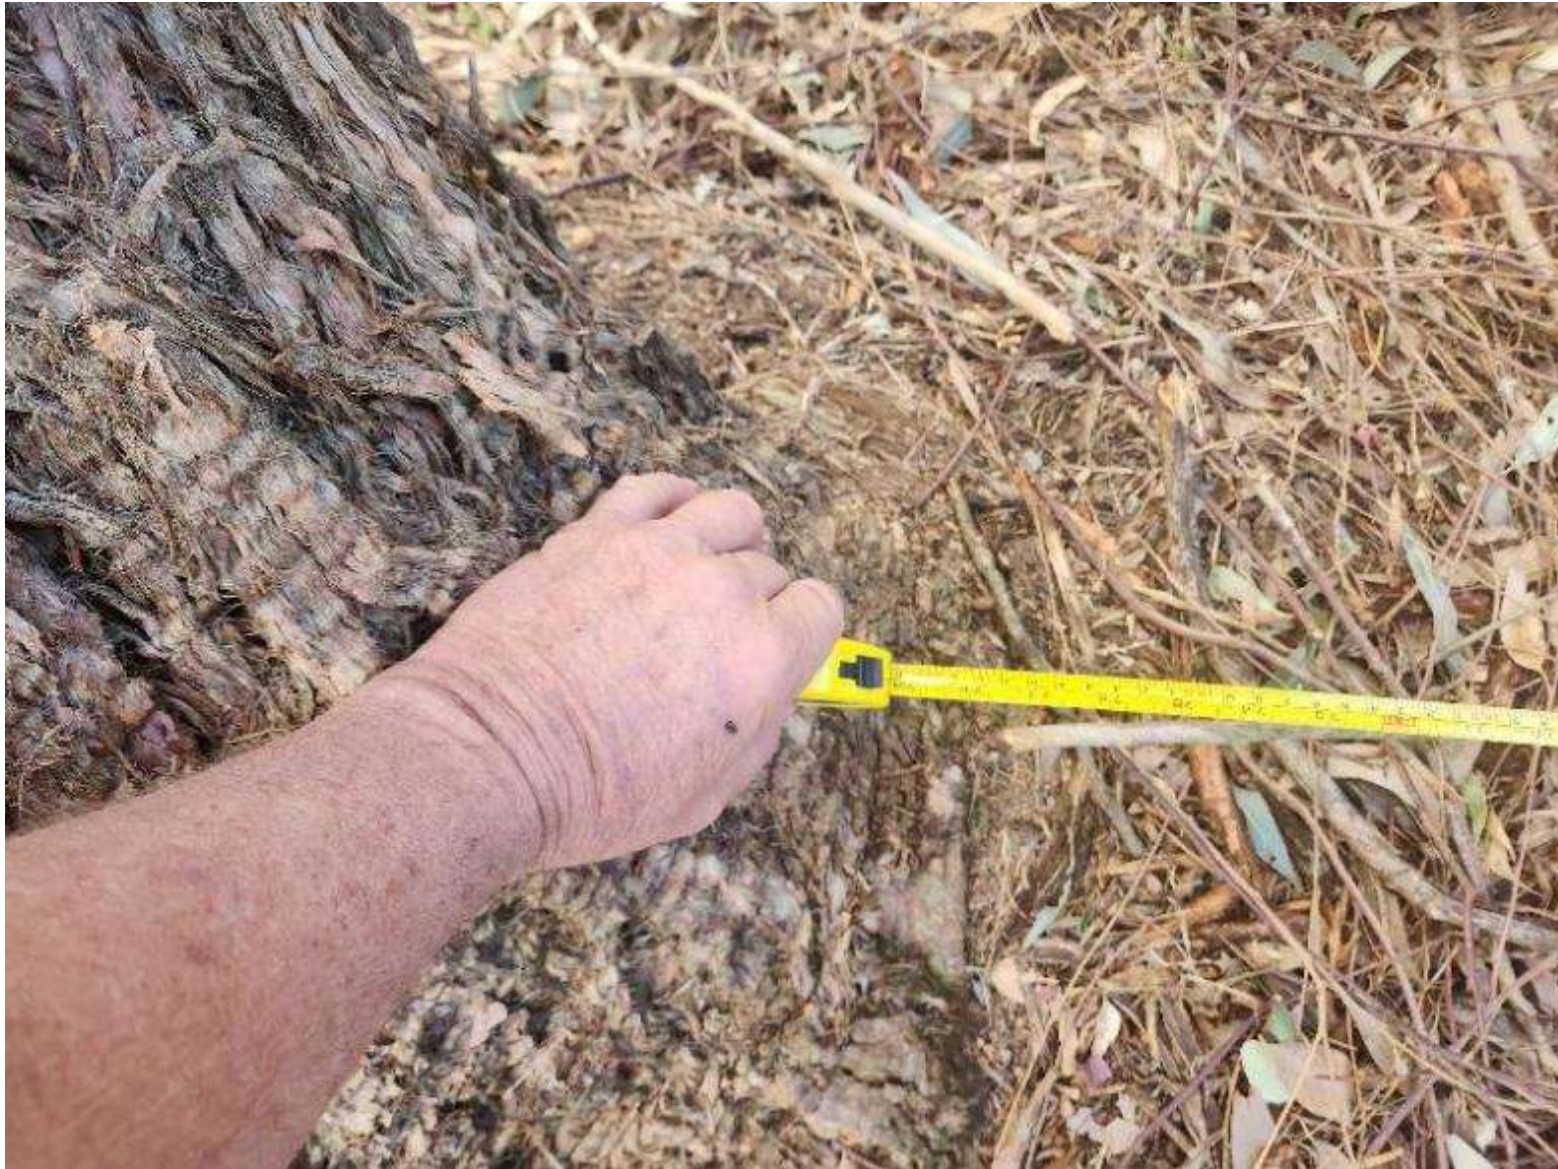
Fig. 14. Photo of tape measure buttress root of T4.

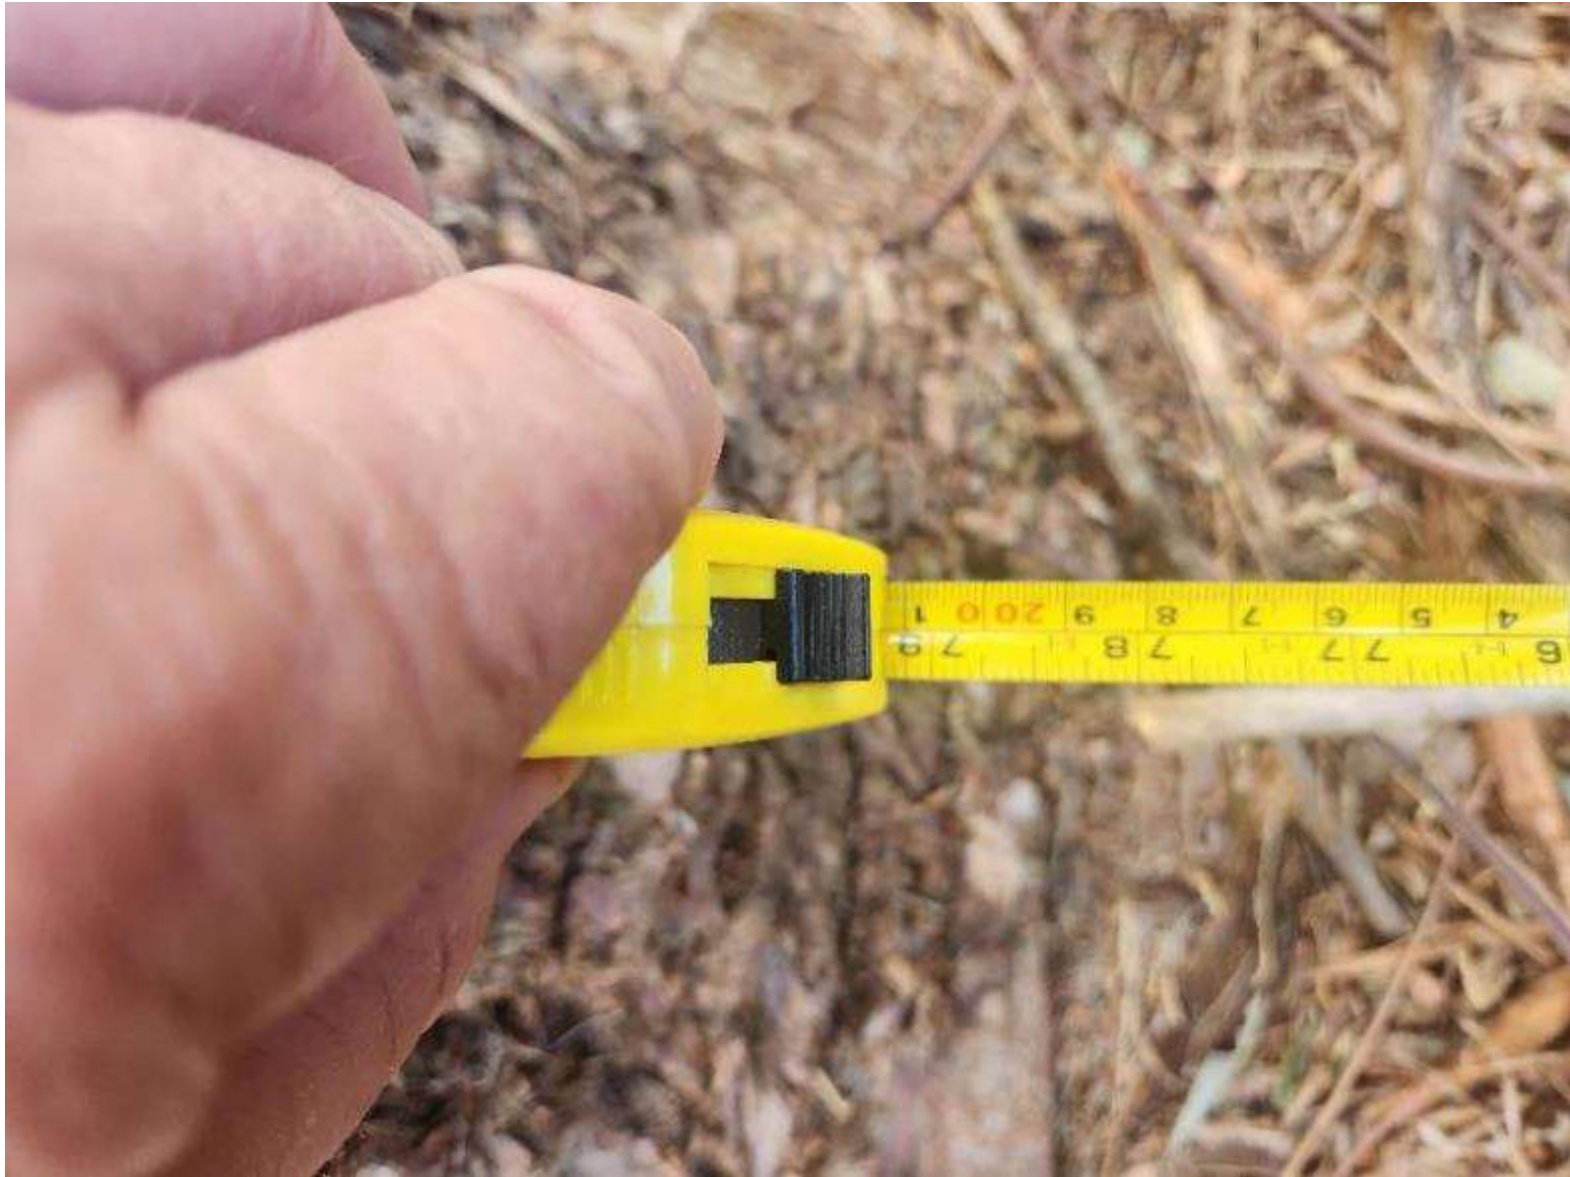
Fig. 15. Photo showing reading of the tape measure of 2m from the buttress to the eave of the carport.
