Report Title: Geotechnical Report 316 Hudson Parade, Clareville
Report Date: 27/11/20
Author: BEN WHITE
Author's Company/Organisation: WHITE GEOTECHNICAL GROUP PTY LTD

GEOTECHNICAL INVESTIGATION:

Alterations and Additions at **316 Hudson Parade, Clareville**

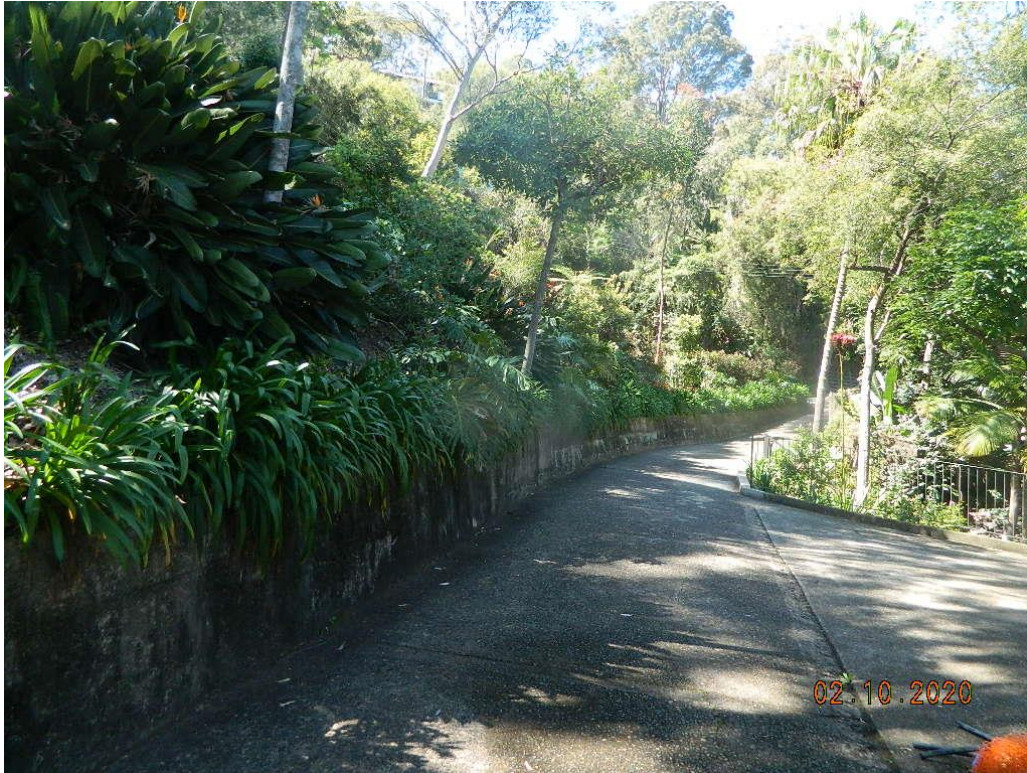
Photo 1

2.3 At the road frontage a steeply graded slope falls to the uphill side of the subject house (Photos 1 & 2). No significant signs of movement were observed in this area. Vehicular access to the property is provided by a shared driveway from the S that cuts across the slope and runs to the existing house and a detached brick garage/studio beside the house (Photos 2 & 3). On the downhill, external supporting wall of the detached garage a vertical crack runs through the supporting concrete footing and brick wall (Photo 4). No deflection was measured in the wall. The structure is currently considered stable and will be demolished as part of the proposed works. Below the detached garage/studio is a sandstone flagging retaining wall that is estimated to be battered back at an angle of $\sim 40^\circ$ from vertical (Photo 5).

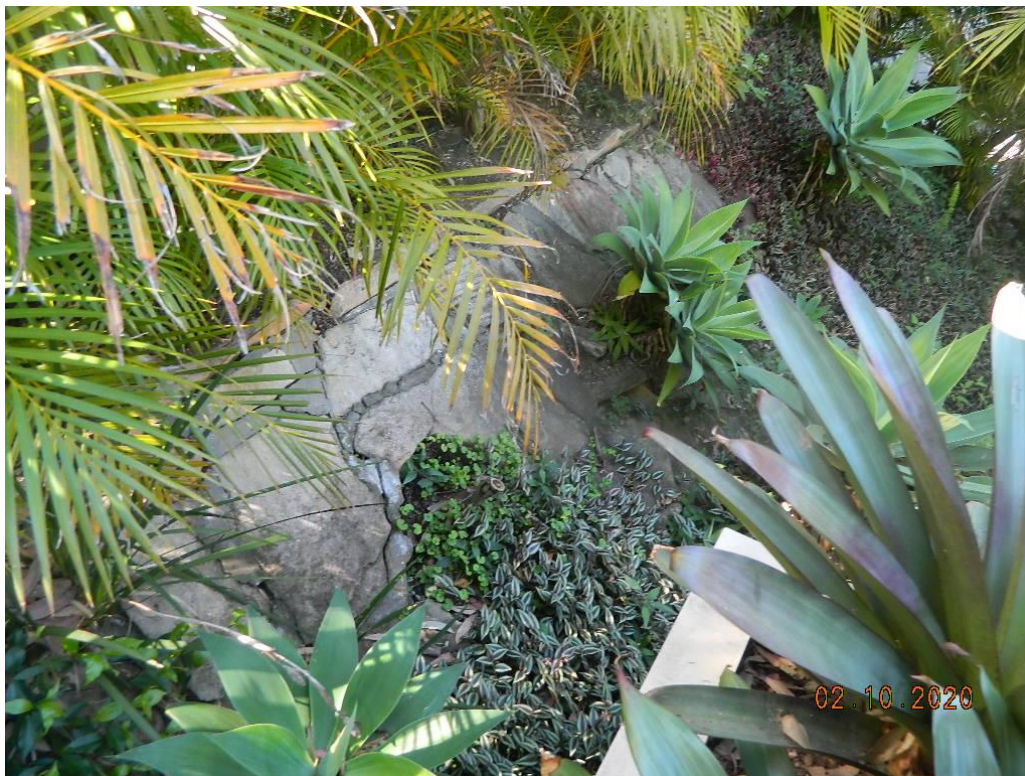
Photo 5

HAZARDS	Hazard Three	Hazard Four
TYPE	The additional surcharge loads from the proposed detached garage/studio transferring onto the existing sandstone flagging retaining wall that leads to failure (Photo 5).	Further movement of the gabion basket retaining wall that lines the S common boundary and leads to failure (Photo 8).
LIKELIHOOD	'Possible' (10^{-3})	'Unlikely' (10^{-4})
CONSEQUENCES TO PROPERTY	'Medium' (35%)	'Medium' (30%)
RISK TO PROPERTY	'Moderate' (2×10^{-4})	'Low' (2×10^{-5})
RISK TO LIFE	5.6×10^{-6} /annum	5.6×10^{-6} /annum
COMMENTS	This level of risk to life and property is 'UNACCEPTABLE'. To move the risk to 'ACCEPTABLE' levels the recommendations in Section 15 are to be followed.	This level of risk to life and property is 'ACCEPTABLE' provided the recommendations in Section 16 are followed.

The proposed detached garage/studio is expected to be seated in Extremely Low Strength Rock or better on the uphill side. On the downhill side the garage/studio is to be supported on piers embedded into Extremely Low Strength Rock or better to maintain a uniform bearing material across the structure. Provided the footings are taken to and embedded into this ground material no surcharge loads from the proposed structure will be transferred onto the existing retaining wall below (Photo 5).

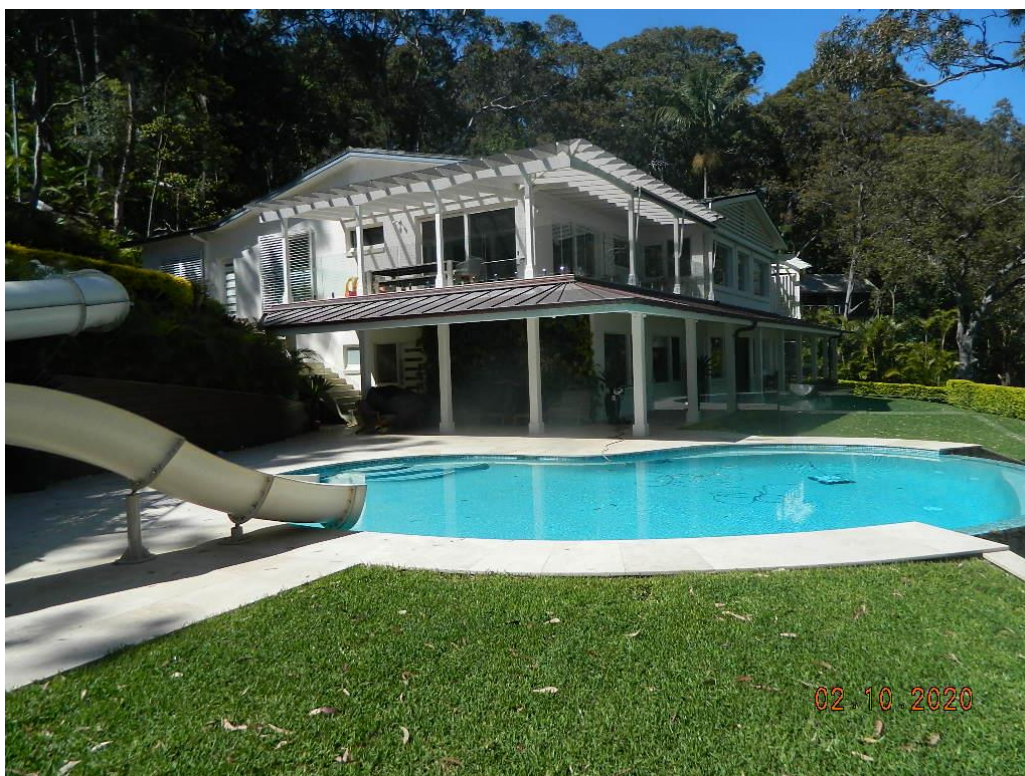
Photo 6

The two storey brick house displays no significant movement in the external supporting walls that could be associated with slope instability (Photo 6). A concrete pool is located below the N side of the house. The pool shell displays no visible signs of movement. The area below the house and beside the pool has been filled for a level lawn area. From visual observations on site the fill reaches a maximum height of $\sim 5.0\text{m}$ on the S side and reduces to $\sim 1.4\text{m}$ on the N end. The S side of the fill is supported by a gabion basket retaining wall (Photos 7 & 8). Where the wall lines the S common

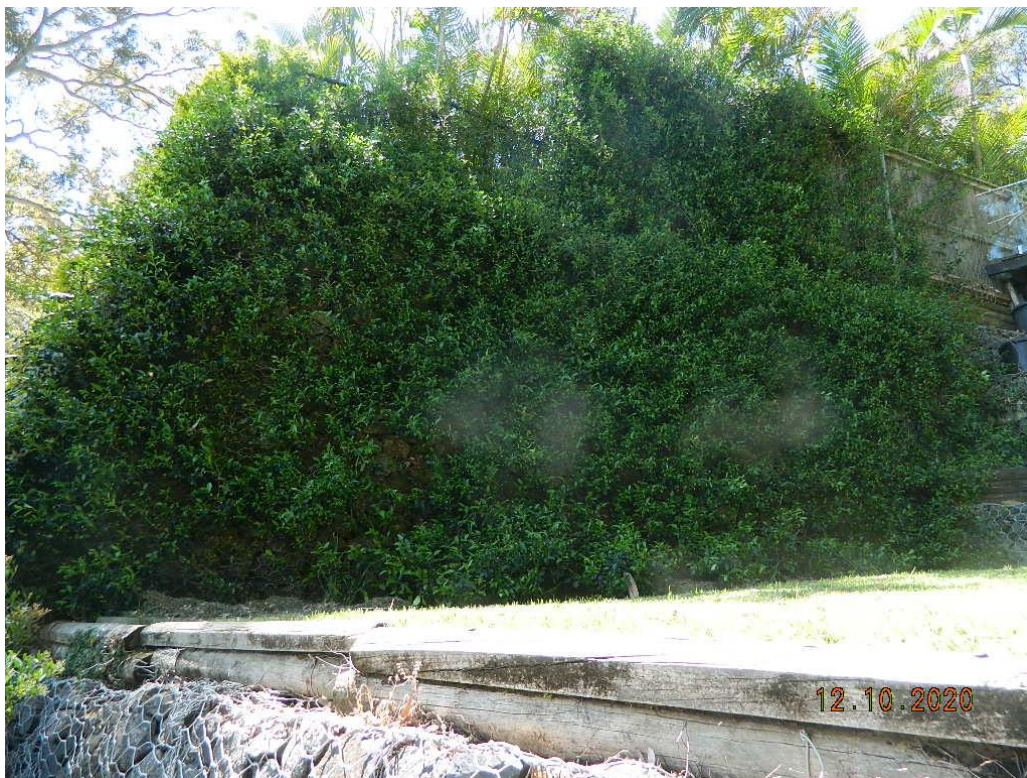
Photo 8

boundary the baskets are slightly bulging. To ensure the ongoing stability of the wall into the future the recommendation in **Section 16** are to be followed. The remaining areas of the wall show no obvious bulging. The N side of the fill is supported by a concrete crib retaining wall that is obscured by thick vegetation (Photo 9). From what could be seen of the wall it appears stable.

The S side of the gabion basket retaining wall is slightly bulging (Photo 8). This structure is currently considered stable but to ensure the ongoing stability into the future we recommend they be inspected by the owners on a biennial basis or after heavy prolonged rainfall, whichever occurs first. A photographic record of the inspections is to be kept. We can carry out these inspections upon request. Should further movement be observed the Geotechnical Consultant is to be engaged to assess the structure and provide remedial advice should it be required.

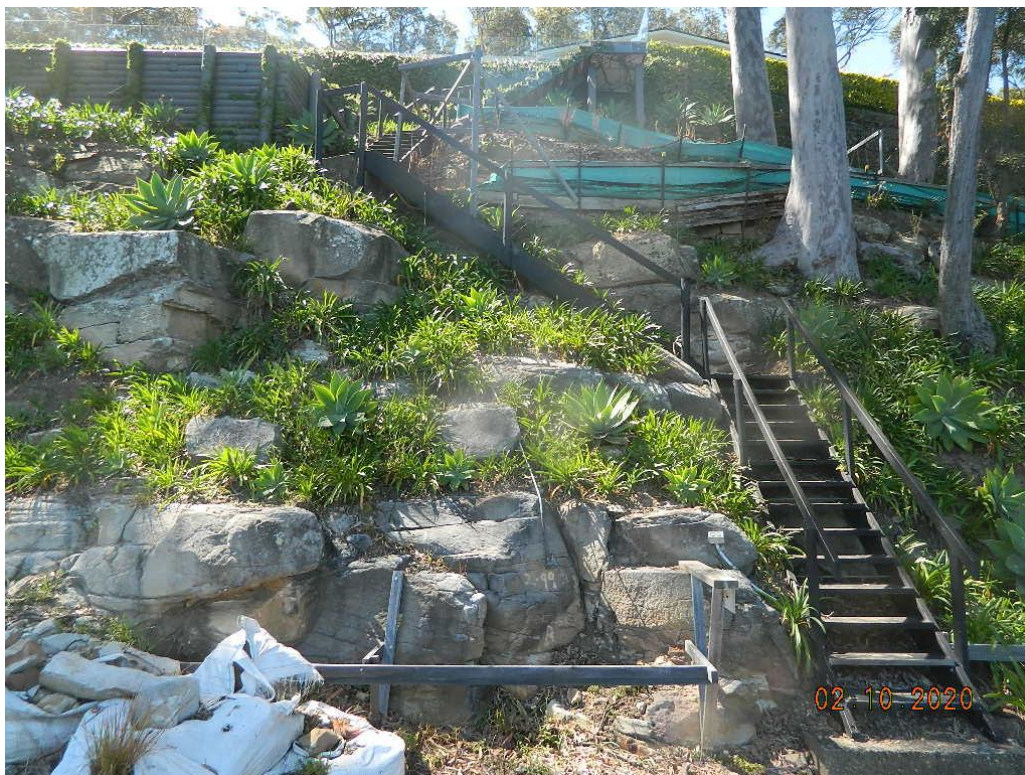
Photo 10

2.4 The area below the property has been partly terraced with treated pine retaining walls that appear well constructed. Below the walls the slope falls steeply to the waterfront. Bands of medium strength sandstone outcrop in this area (Photo 10). The exposed sandstone is fractured and is relatively thinly bedded. The exposed rock does not display any significant undercutting or geological defects that could lead to a significant failure that could impact the retaining walls or house above.
