Arborist Report

Client: Uday Bonu & Kavita Bonu Address: 141 Riverview Road, AVALON BEACH N.S.W 2107

© Abacus Tree Services Ph: 0425 203 049 Project: 141 Riverview Road, Avalon Beach

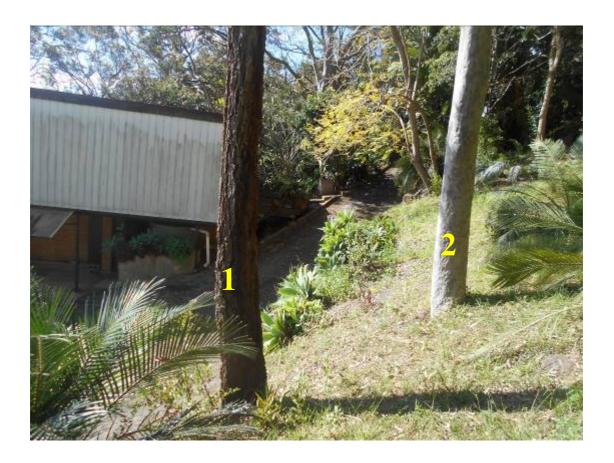
All trees require a S.R.Z and a T.P.Z with Australian Standards 4970- 2009 being used as a guideline. Tree 1 has been given an SRZ and TPZ of 2.13 & 3.30 metres in accordance with Australian Standards 4970 - 2009. Tree 1 will be located inside the proposed deck. In order for the development to proceed in its current format will require removal of Tree1. Tree 1 is earmarked for removal before commencement of building works on site.

Figure 4 – showing the location of Trees 1 & 2 in the backyard of the subject property. Trees 1 & 2 will be located inside the proposed deck area and will require removal before commencement of building works on site.

Tree 2 has been given an SRZ and TPZ of 2.08 & 3.60 metres in accordance with Australian Standards 4970 - 2009. Tree 2 is located towards the back of the subject property. Tree 2 will be located inside the proposed deck area as indicated in Figures 4 & 5. Tree 2 will also be located on the edge of the proposed development. In order to construct the deck & building will require the removal of Tree 2. Tree 2 is earmarked for removal before commencement of building works on site.

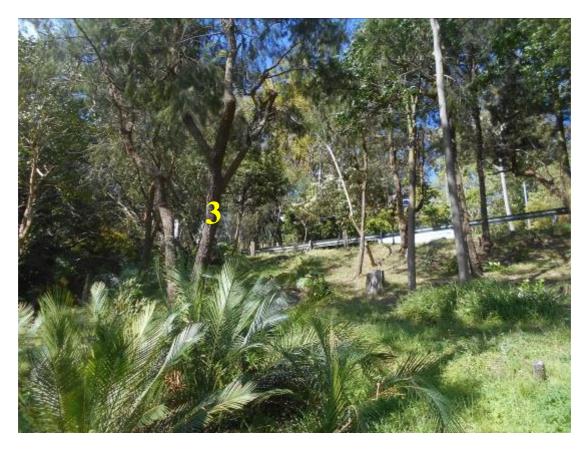
Tree 3 has been given an SRZ and TPZ of 2.32 & 3.72 metres in accordance with Australian Standards 4970 - 2009. Tree 3 will be located inside the proposed building footprint near the entrance to Bedroom 3. In order to construct the proposed development will require the removal of Tree 3. Tree 3 is earmarked for removal before commencement of building works on site.

Figure 5 – showing the location of Tree 3 that will require removal to construct the proposed development.

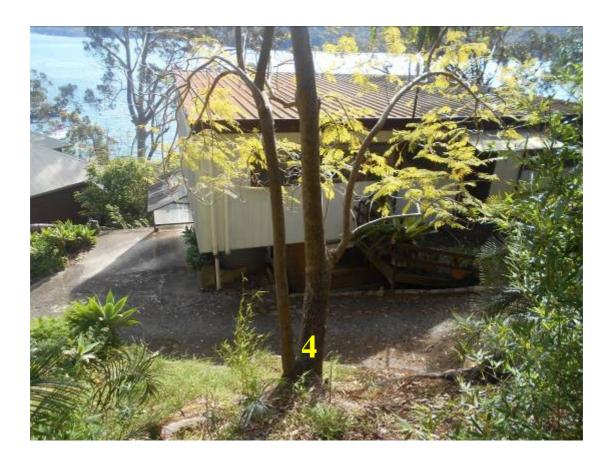
Tree 4 has been given an SRZ and TPZ of 1.94 & 2.40 metres in accordance with Australian Standards 4970 - 2009. Tree 4 has been identified as a non-native species that is located near the boundary fence. Tree 4 is located in the neighbour's property as indicated in Figure 6. This is a young mature species with the potential for extensive future growth. The proposed development is located 1.2 metres to the proposed development. Tree 4 will be located 3.1 metres to the development from the centre of the trunk. The proposed development will be located outside of the TPZ. This species can be retained and incorporated into the development on the proviso that there is no soil changes within the TPZ. This would require the first 1.5 metres inside the subject property from the boundary to be retained inside the TPZ. Tree 4 is earmarked for retention and incorporation into the development.

Figure 6 – showing the location of Tree 4 that can be retained and incorporated into the development.

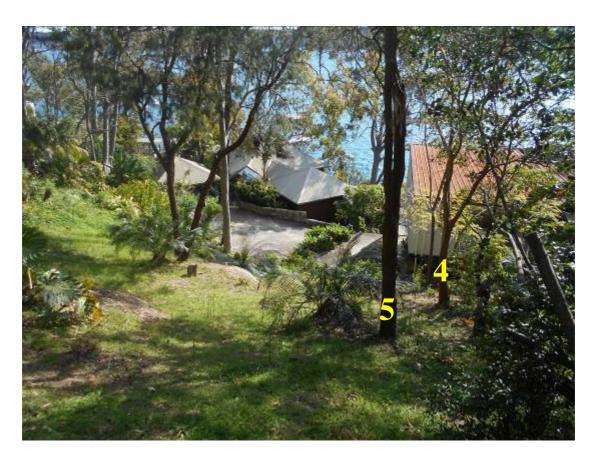
Tree 5 has been given an SRZ and TPZ of 1.68 & 2.00 metres in accordance with Australian Standards 4970 - 2009. Tree 5 is located 0.4 metres to the proposed storeroom/garage. This is an incursion into the SRZ on one side by 70.24% taken from the centre of the trunk. AS 4970 - 2009 indicates that the TPZ radius is taken from the centre of the trunk. The overall area of TPZ has been calculated at 12.57m2. The overall loss of TPZ has been calculated at 34.25% that doesn't comply with AS 4970 - 2009. Major pruning works would also need to be undertaken due to the proximity to the development. The pruning works would need to be in the vicinity of 35 - 40% to allow a spatial separation of 0.5 metres to the building. This amount of pruning is deemed too large and would not pass AS 4373 - 2007. Tree 5 is earmarked for removal before commencement of building works on site.

Figure 7 – showing the location of Trees 4 & 5. Trees 4 is located on the neighbour's property. Tree 5 is located inside the subject property in accordance with the survey.

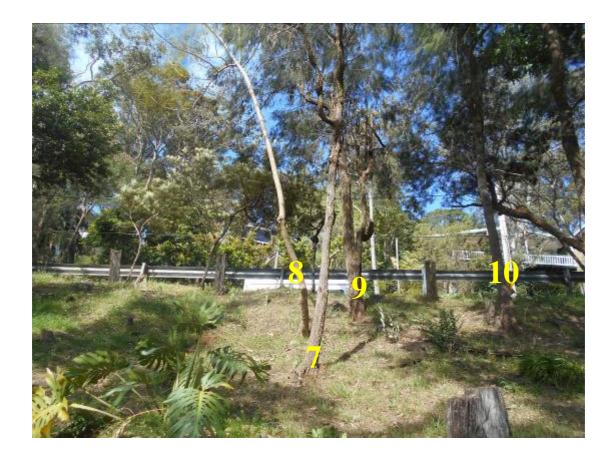
Figure 8 – showing the location of Trees 7 – 10. Trees 7 – 10 will require removal in order for the development to proceed in its current format.

Tree 8 has been given an SRZ and TPZ of 1.57 & 2.00 metres in accordance with Australian Standards 4970 - 2009. Tree 8 is located within the proposed vehicular access crossing. In order to construct the driveway will require the removal of Tree 8

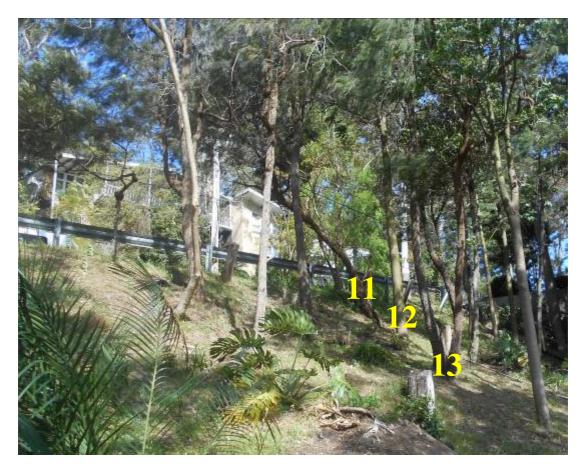
Figure 9 – showing the location of Trees 11 - 13 in the front setback of the subject property. Tree 11 has a severe tropism to the eastern quadrant.

Tree 11 has been given an SRZ and TPZ of 2.00 & 3.00 metres in accordance with Australian Standards 4970 - 2009. Tree 11 is located 2.3 metres from the guard rail at the very top of the subject property. This species is not growing true to form with majority of its canopy extending over the road. This species has an extensive tropism to the eastern quadrant. Tree 11 is outside of all building works and could be retained and incorporated into the development on the proviso that there are no changes to the soil profile within the TPZ. If this can be achieved than Tree 11 can be retained and incorporated into the development. This species is earmarked for removal due to its shorter life span. The removal of Tree 11 will require permission from NBC.

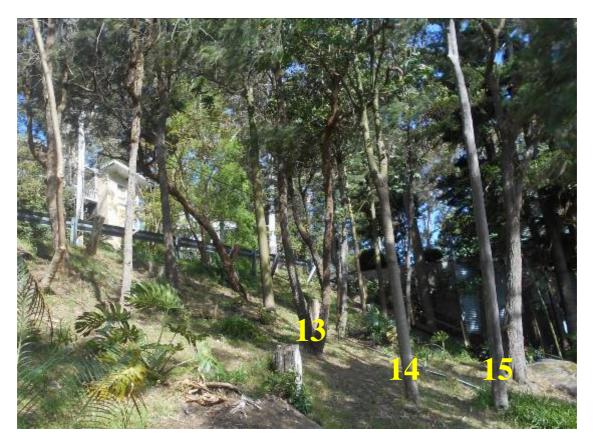
Figure 10 – showing the location of Trees 13 – 15.

Tree 13 has been given an SRZ and TPZ of 2.39 & 3.12 metres in accordance with Australian Standards 4970 - 2009. Tree 13 will be located on the edge of the proposed stairs/pedestrian path at the front of the subject property. There will be major soil changes in this region at the front of the subject property. This species would also require major pruning works due to the proximity to pedestrian path. The pruning works would be an estimated 35 - 40% that would not comply with AS 4373 - 2007. In order to construct the stairs will require the removal of Tree 13. Tree 13 is earmarked for removal before commencement of building works on site.

Tree 14 has been given an SRZ and TPZ of 1.68 & 2.28 metres in accordance with Australian Standards 4970 - 2009. Tree 14 will be located within 0.4 metres to the pedestrian path at the front of the subject property on one side and inside the stairs on the other side. There will be major soil changes in this region at the front of the subject property. This species would also require major pruning works due to the proximity to pedestrian path. The pruning works would be an estimated 35 - 40% that would not comply with AS 4373 - 2007. Tree 14 is earmarked for removal before commencement of building works on site.

Tree 15 has been given an SRZ and TPZ of 1.79 & 2.40 metres in accordance with Australian Standards 4970 - 2009. Tree 15 is located right on the edge of the proposed development. A loss of 50% (minimum) would be required to construct the development. The loss of TPZ would not comply with AS 4970 - 2009. In order for the development to proceed in its current format requires the removal of Tree 15.

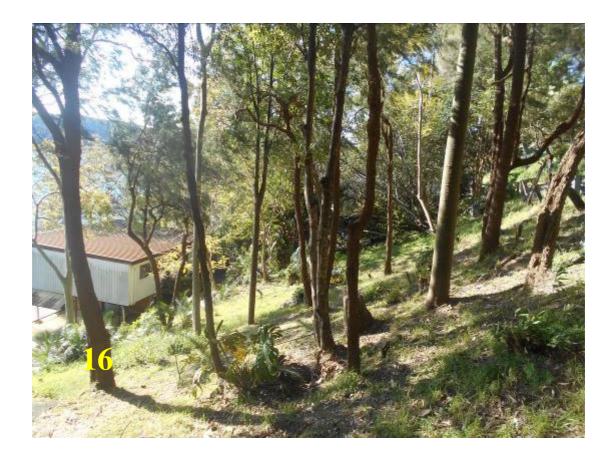
Figure 11 – showing the location of Tree 16 within the proposed building footprint.

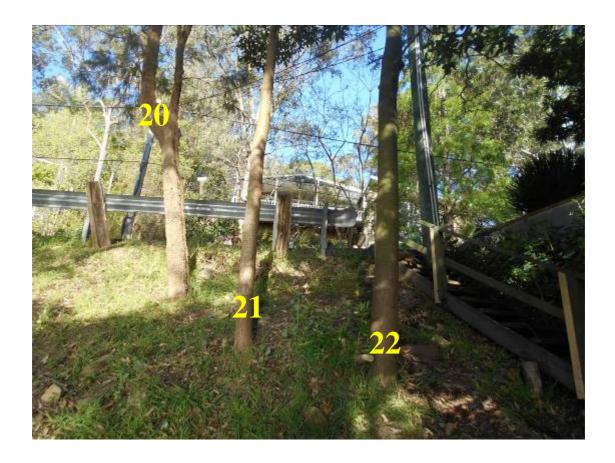
Figure 12 – showing the location of Trees 20 - 22 at the front of the subject property near the existing stairs. Trees 20 - 22 have the potential to be retained on the proviso that the existing soil levels for a minimum of 2 metres in all directions are maintained.

Tree 21 has been given an SRZ and TPZ of 1.57 & 2.00 metres in accordance with Australian Standards 4970 - 2009. Tree 22 has been given an SRZ and TPZ of 1.89 & 2.76 metres in accordance with Australian Standards 4970 - 2009. Trees 21 and 22 are both identified as Illawarra Flame Trees. Trees 21 & 22 are located next to the exiting stairs as highlighted in Figure 12. Trees 21 & 22 are both in a semi mature to young mature phase of their life cycle. These species have the potential to be retained as they are located outside of all development works. Trees 21 & 22 have the potential to be retained and incorporated into the development on the proviso that the existing soil levels can be maintained for a minimum of 2 metres in all directions. The current layout and design would allow for the retention of Trees 21 & 22.

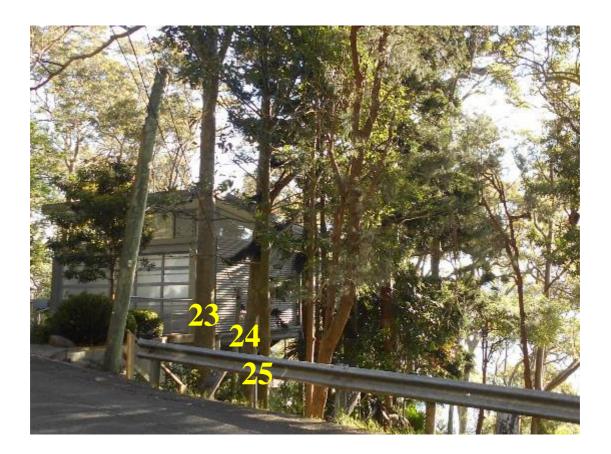
Tree 23 has been given an SRZ and TPZ of 2.61 & 6.12 metres in accordance with Australian Standards 4970 - 2009. Tree 23 is identified as a young mature Corymbia maculata. This species is located on the southern side of the proposed development. This species can reach a TPZ of 10 – 12 metres (minimum) when fully mature. This species will be located 2 metres to the corner of the proposed development. AS 4970 – 2009 indicates that the TPZ radius is taken from the centre of the trunk. This leaves a spatial separation of 2.285 metres to the proposed development. This section of the development is on bearers and joists. An estimated 6 piers within the TPZ at 450mm in diameter is a net loss of 2.7m2. The overall area of TPZ has been calculated at 117.67m2. The loss of TPZ has been calculated 2.29% that complies with AS 4970 - 2009. This is only based on bearers and joists with no other construction works to occur in the TPZ. This includes no other below ground excavation works for services or retaining walls. This area is also to avoid strip footings within the TPZ. Tree 23 has the potential to be retained and incorporated into the development on the proviso that the existing soil levels can be maintained up to the proposed development.

Figure 13 – showing the location of Trees 23 – 25 towards the southern boundary.

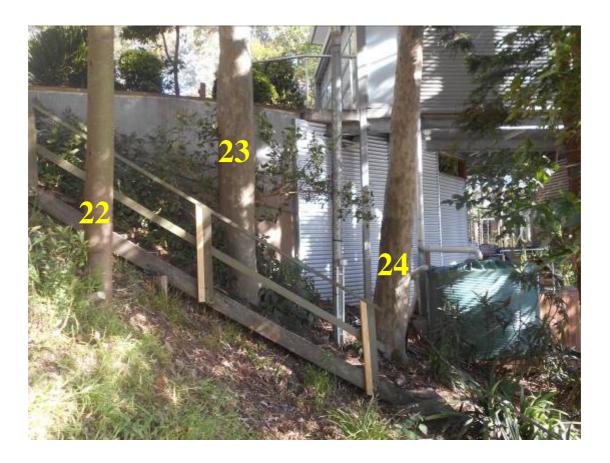
Tree 24 has been given an SRZ and TPZ of 2.46 & 5.40 metres in accordance with Australian Standards 4970 - 2009. Tree 24 is located next to the neighbours water tank and 1.4 metres to the neighbours dwelling. Tree 24 is located next to the existing boundary stairs as indicated in Figure 14. Trees 23 & 24 are located near the boundary as highlighted in Figure 14. Tree 24 is identified as a young mature Corymbia maculata. This species is located on the southern side of the proposed development. This species can reach a TPZ of 10 – 12 metres (minimum) when fully mature. This species will be located 3.485 metres to the corner of the proposed development from the centre of the trunk. The overall loss of TPZ has been calculated at 6.2%. The overall loss of TPZ complies with AS 4970 – 2009 on the proviso that the existing soil levels are retained within the TPZ. This will include bearers and joists on this side of the development within the TPZ. If this can be achieved than Tree 24 can be retained and incorporated into the development.

Figure 14 – showing the location of Trees 23 & 24 at the front of the subject property. These trees are located near the boundary fence. Trees 23 & 24 have the potential to be retained and incorporated into the development. The existing soil levels need to be retained up to the edge of the proposed development in order to retain Tree 24.

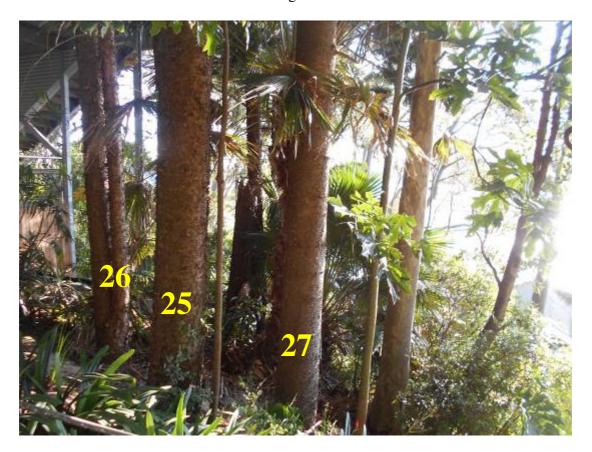
Tree 25 has been given an SRZ and TPZ of 2.49 & 5.40 metres in accordance with Australian Standards 4970 - 2009. Tree 25 is located on a lower tier to Trees 23 & 24 and will be within close proximity to the proposed development. Tree 25 will be located 1.5 metres to the corner of the proposed development. AS 4970 - 2009 indicates that the TPZ radius is taken from the centre of the trunk. This leaves a spatial separation of 1.755 metres from the proposed development to the centre of the trunk. This is a large incursion into the TPZ on one side of the tree. The incursion into the TPZ has been calculated at 67.5%. This species can reach a diameter of 1000mm when fully mature. This would leave the trunk 1.05 metres to the proposed building when fully mature. This species may also require removal due to the proximity to the development and RFS requirements. This species is earmarked for removal before commencement of building works on site.

Figure 15 – showing the location of Trees 25 – 27 near the boundary.

Tree 26 has been given an SRZ and TPZ of 2.18 & 3.60 metres in accordance with Australian Standards 4970 - 2009. Tree 26 is a semi mature species that has the potential to be retained. No excavation work are to occur within 2.18 metres from the trunk of Tree 26. This is to include to all excavation works associated with the bearers and joists construction. If this can be achieved than Tree 26 can be retained and incorporated into the development.

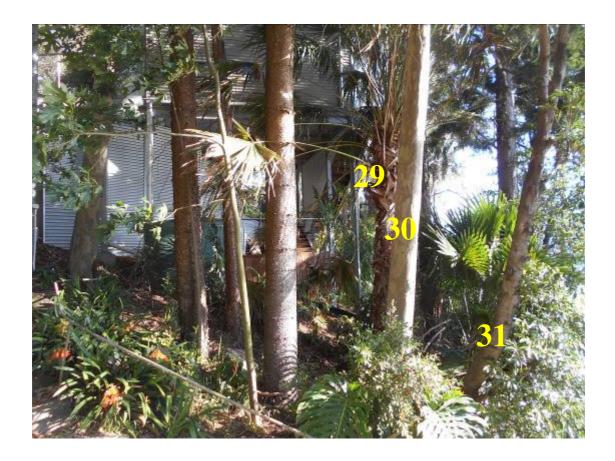
Tree 30 has been given an SRZ and TPZ of 2.37~&~3.96 metres in accordance with Australian Standards 4970 - 2009. Tree 30 has a severe sparse canopy and is in poor health and condition. Tree 30 has a live crown ratio of 30-35% and is not suited for long term retention. Tree 30 is earmarked for removal before commencement of building works on site.

Figure 16 – showing the location of Trees 29 – 31

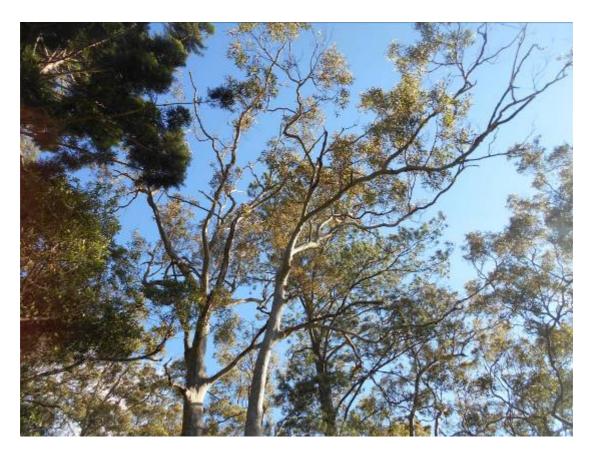
Figure 17 – showing the location of Trees 35 & 36 that are located in the neighbour's property.

Tree 35 has been given an SRZ and TPZ of 2.08 & 3.48 metres in accordance with Australian Standards 4970 - 2009. Tree 36 has been given an SRZ and TPZ of 2.59 & 5.94 metres in accordance with Australian Standards 4970 - 2009. Both these trees are located near the boundary with Tree 36 being right on the boundary line as per the site survey. These trees especially Tree 36 is in poor health and condition. Tree 36 appears to be more on the neighbour's property and therefore will require retention. This species will require retention as it is in the neighbour's property however it is noted that it is in poor condition before commencement of building works. No excavation works is to be undertaken within the TPZ. The current design and outlay factors in the trees and therefore they can be retained. No strip footings for proposed fences and retaining walls are allowed in this zone (TPZ).

- ➤ Tree 18 has low landscape significance and therefore is earmarked for removal. It is noted that Trees 35 & 36 are in poor health and condition. Tree 36 is located in the neighbour's property and therefore will require retention. Tree 35 is earmarked for removal due to its condition before commencement of building works on site.

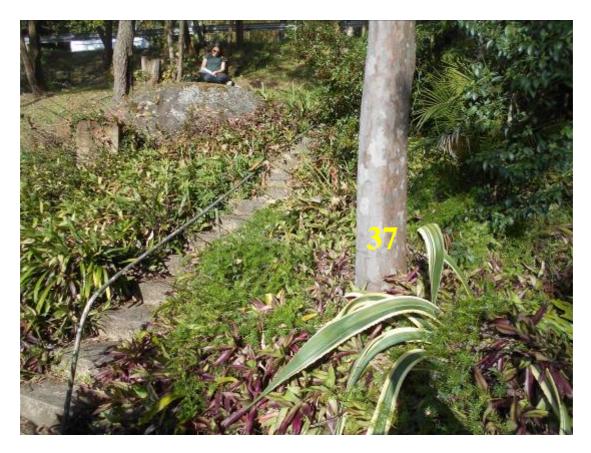
Tree 37 has been given an SRZ and TPZ of 2.18 & 3.72 metres in accordance with Australian Standards 4970 - 2009. Tree 37 is an over mature species in fair health and condition. This species will be located inside the proposed building footprint. In order for the development to proceed in its current format will require the removal of Tree 37.

Figure 18 – showing the location of Tree 37 in the backyard of the subject property. This species will be located inside the proposed building footprint.

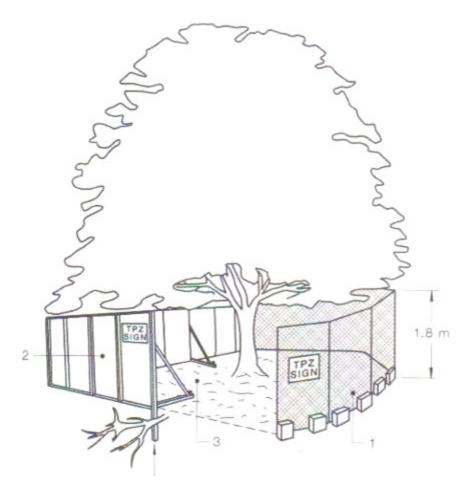
➤ Figure 19 – showing the proposed fencing that is to be put in place before the commencement of building works on site (Trees 4, 6, 20 – 24, 26, 28, 32 – 34 & 36 only).

- ➤ It is recommended that protection measures be put in place that aid in the preservation of Trees 4, 6, 20 24, 26, 28, 32 34 & 36. It is recommended that 1.8 metre inter locking chain wire fencing be installed before commencement of building works on site as indicated in Figure 19. Protection fencing is to be installed on the boundary fence to protect Trees 4 & 6. Protection fencing is to be installed where practical to Trees 20 24, 26, 28, 32 34 & 36. This is to include to the boundary to the southern quadrant and to the outer edge of the development to the other quadrant. A minimum of three metres is recommended to the east and western quadrants. Protection fencing is to be installed before commencement of building works and remain in place until the release of the occupation certificate.
