Project No.: 2019-068

Antonio Rullo
12 Edward Street,
Narraweena
N.S.W. 2099.

Preliminary Landslip Risk Assessment for 12 Edward Street, Narraweena.

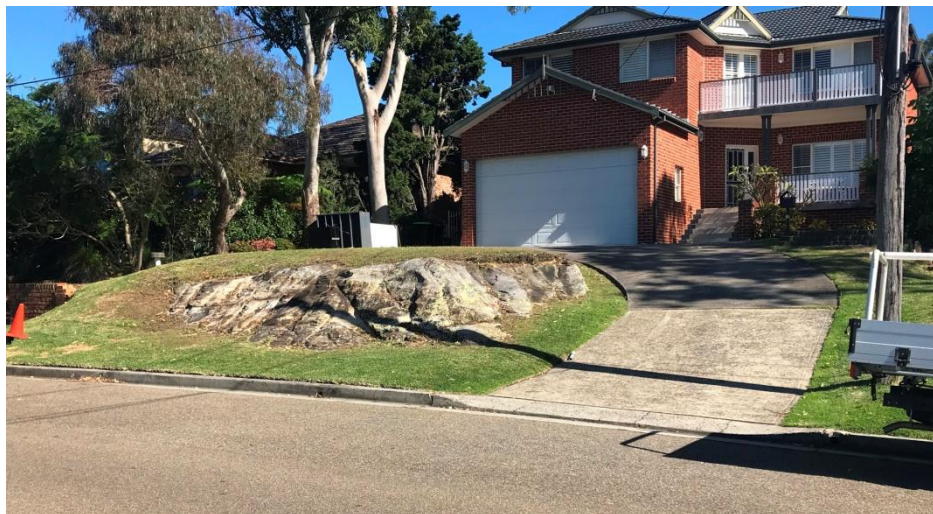
The front of the site contains a lawn a brick paved driveway. Longitudinal cracking was observed within the driveway however it is considered to be the result of wear rather than a stability issue. A general view of the site is provided in Photograph 1.

Photograph 1: View of the site looking west from Edward Street.
