**STANDFAST TREE SERVICES**  
ESTABLISHED 1979

Re Modification DA – 135 Seaforth Crescent, Seaforth

Re Arboricultural Impact Assessment (AIA) for 135 Seaforth Cres, Seaforth

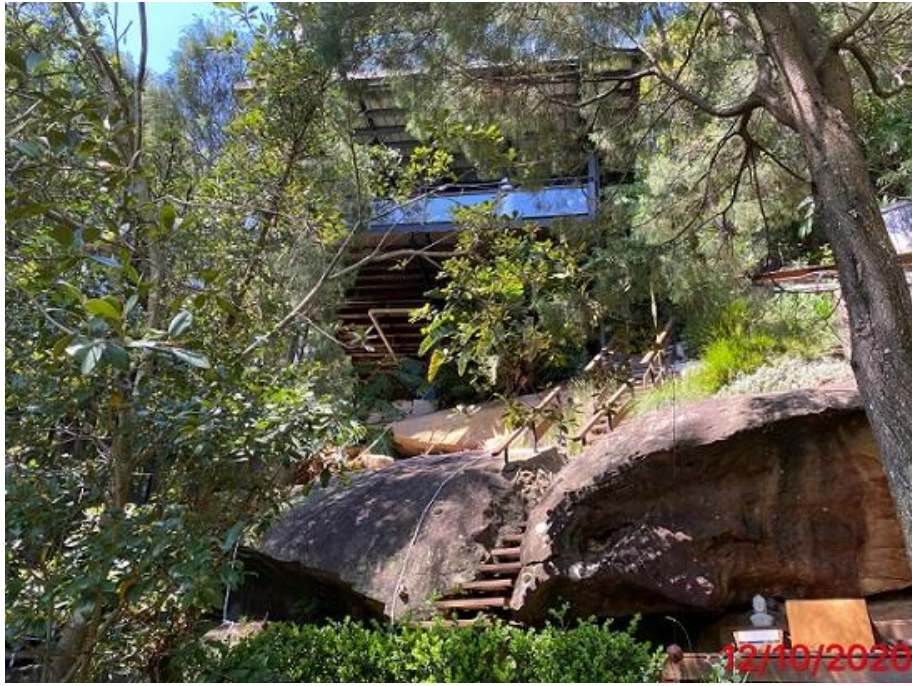
- 1.3.2 The development site is steep and dominated by a large prominent rock. The trees are self-sown, mainly *Callitris* spp and *Glochidion* spp and semi-mature,<sup>4</sup> fig 1.
- 1.4.1 A site visit was undertaken on 12/10/2019 when visual tree assessments (VTAs)<sup>5</sup> from ground level were made of the trees and photographs and measurements were taken.

*Figure 1, proposed development site*

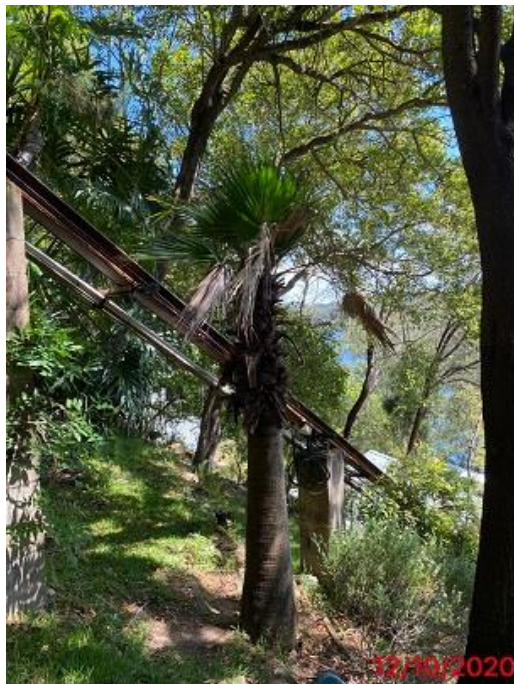
*Figure 2, T1 washingtonia palm*

- 4.1.1 Apply stem protection to T1 and T4<sup>7</sup>
- 4.1.2 Appoint a project arborist with an AQF level 5 qualification to certify that the development complies with construction milestones such as the installation of tree protection measures<sup>8</sup> before the commencement of building activity and certification of retained trees at the end of the project.

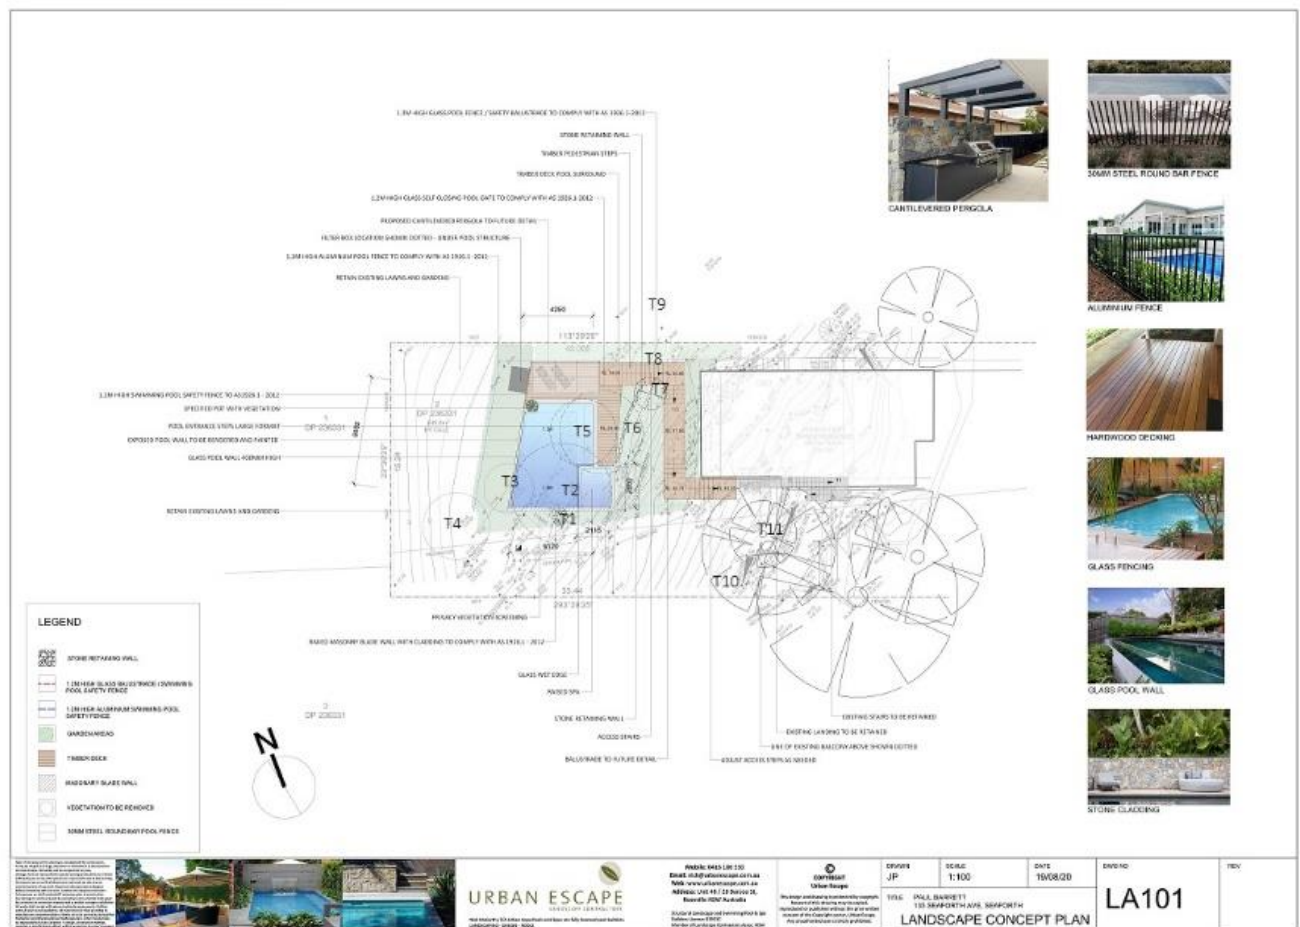
## Appendix 1, Tree Protection Plan (drawing)

- 1.3.1 The Landscape Concept Plan prepared by Urban Escape dated 19/8/2020 has been marked up to position the trees and their proximity to the development, please refer to Appendix 1, Tree Protection Plan (drawing).
