Geotechnical Assessment

Project: Alterations & Additions
163 Wallumatta Road, Newport

REF: AG 21033
17 February 2021

For Alterations & Additions at
163 Wallumatta Road, Newport NSW

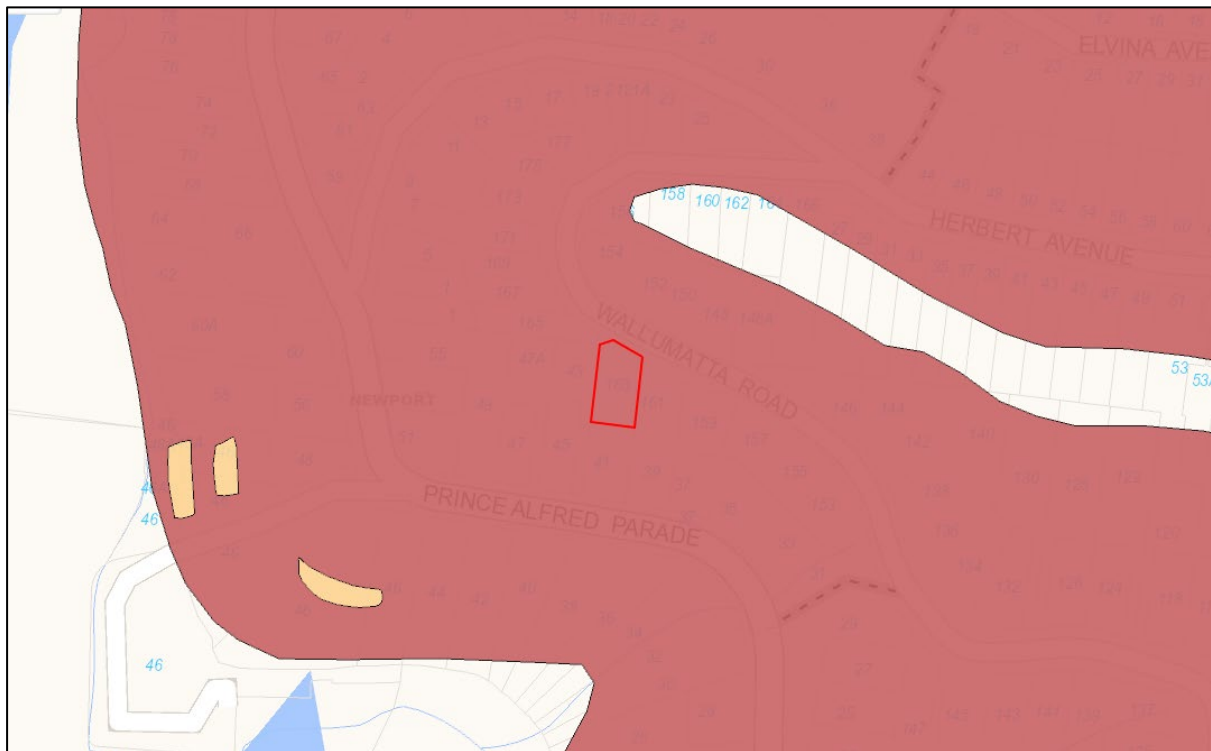
Image 2. PLEP Geotechnical Hazard Map
– 163 Wallumatta Road, Newport NSW

- No evidence of significant soil creep, tension cracks or landslip instability were identified across the site or on adjacent properties, as viewed from the subject site at the time of our inspection.
- The property is classified as **Geotechnical Hazard H1** with reference to Northern Beaches Council PLEP Geotechnical Hazard Map Sheet (**Image 2** below).

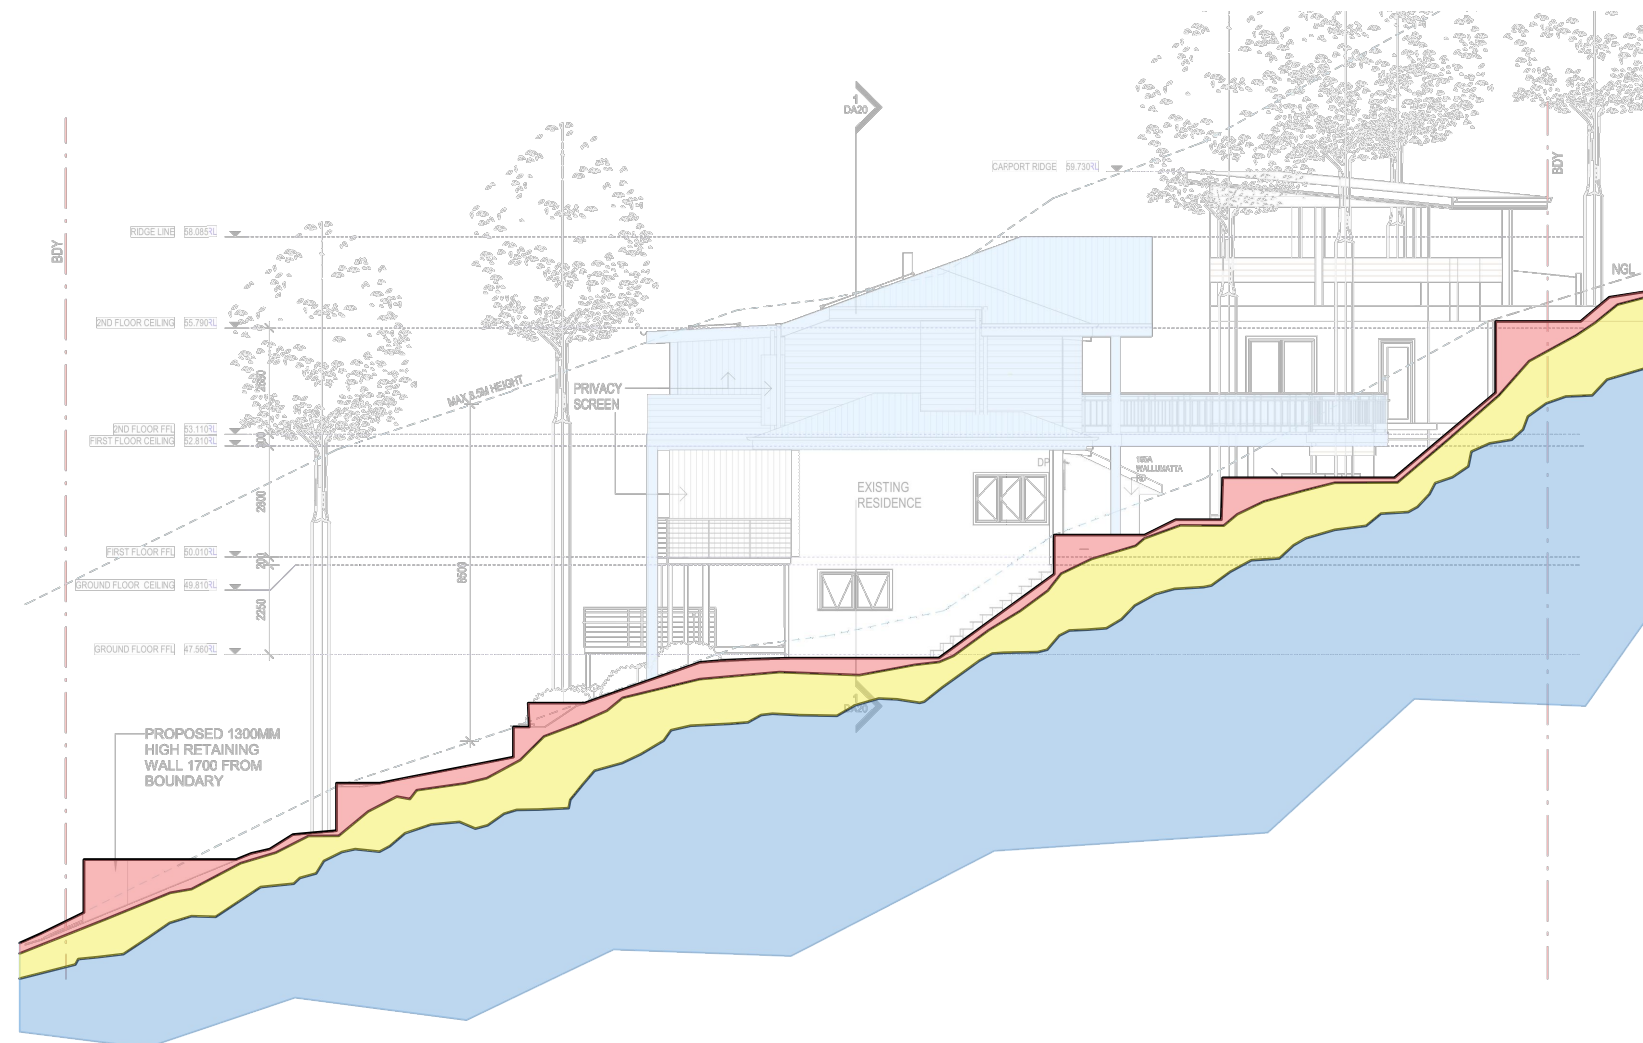
INFERRED GEOLOGICAL SECTION
SCALE NTS

The soil profile consists of shallow uncontrolled fill and silty/sandy topsoils (O & A Horizons), sandy to silty clay (B Horizon), and weathered bedrock (C Horizon) with the possibility of submerged sandstone floaters in the upper soil profile. Based on our review of existing information, and our onsite observations, we would expect competent weathered bedrock, to be found within 1200–2200mm from current surface levels across the area of the proposed works.

INTERPRETED SUBSURFACE SECTION ONLY.
ACTUAL GROUND CONDITIONS MAY VARY.
