# DILAPIDATION REPORT

**Pheasant Place, Warriewood**

## 1. Introduction

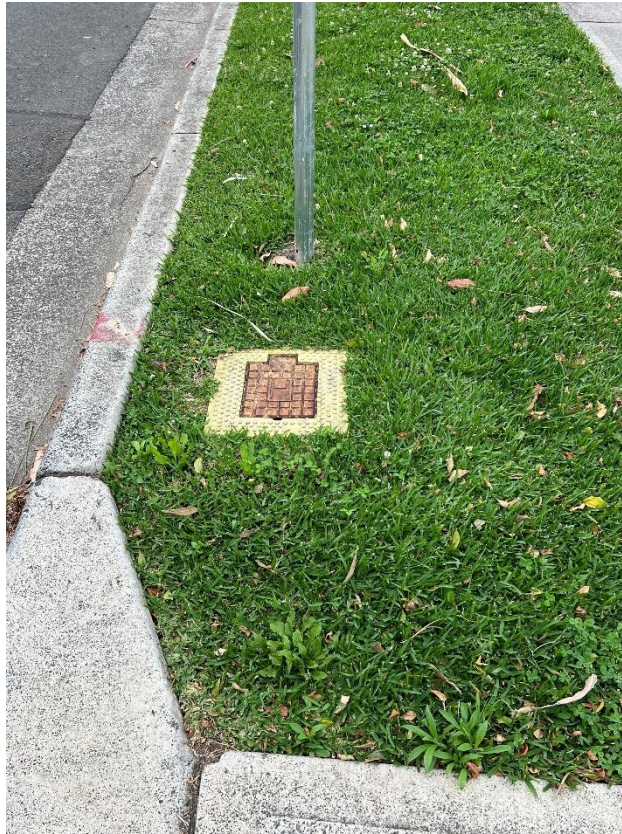
*Figure 1 – General condition of the utility lid.*

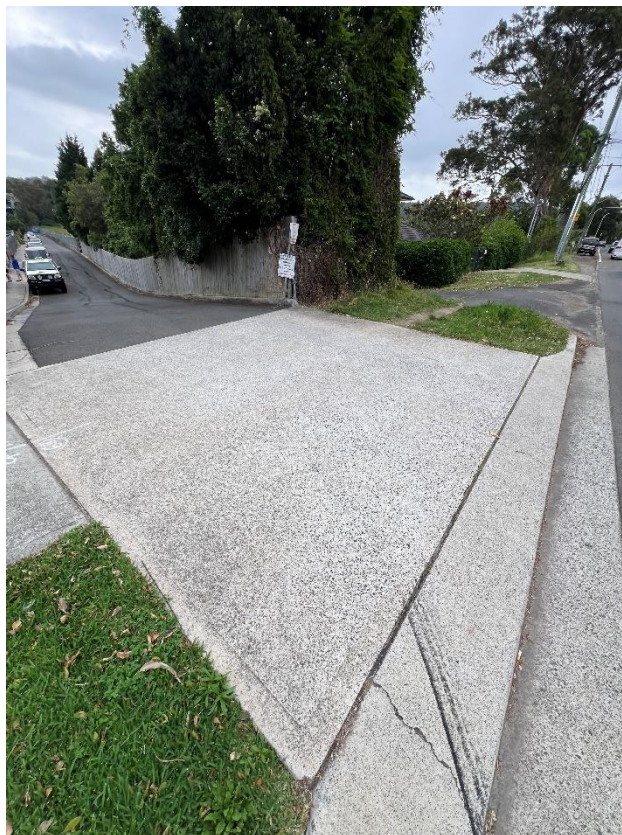
*Figure 2 – Crack is evident to the layback to the outside 85 Pheasant Place, Warriewood.*

The council assets were found to be in a fair condition with evidence of crack to the layback, footpath, driveway, and road.

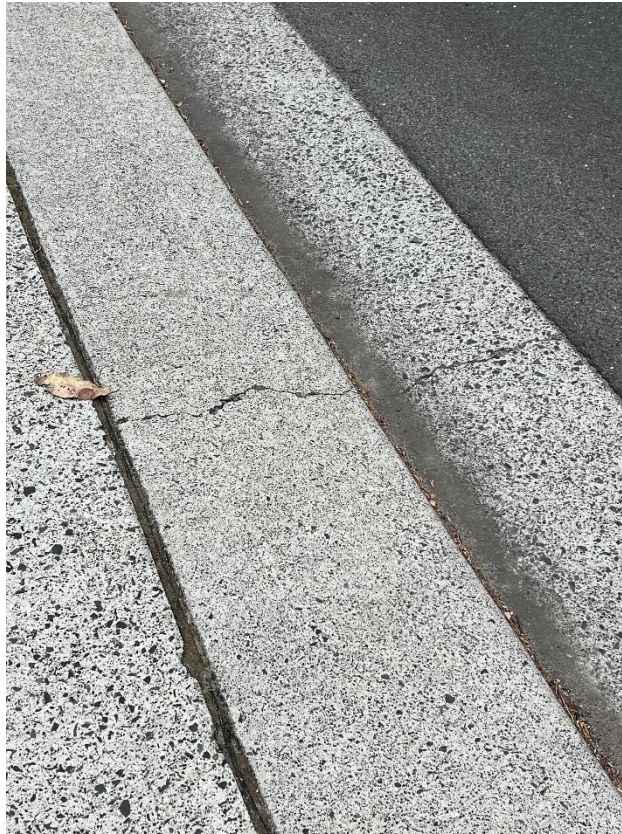
*Figure 3 – Crack is evident to the layback to the outside 85 Pheasant Place, Warriewood.*

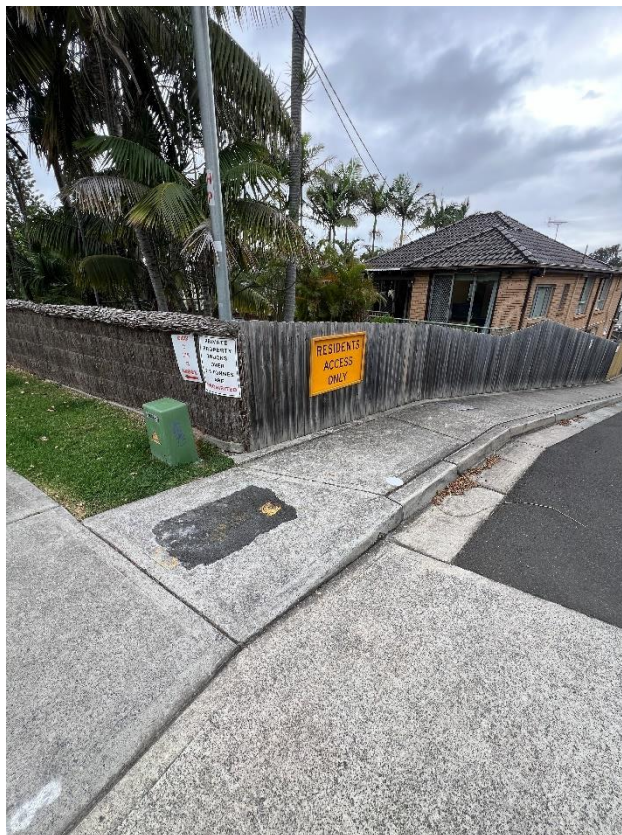
*Figure 4 – General condition of the footpath.*

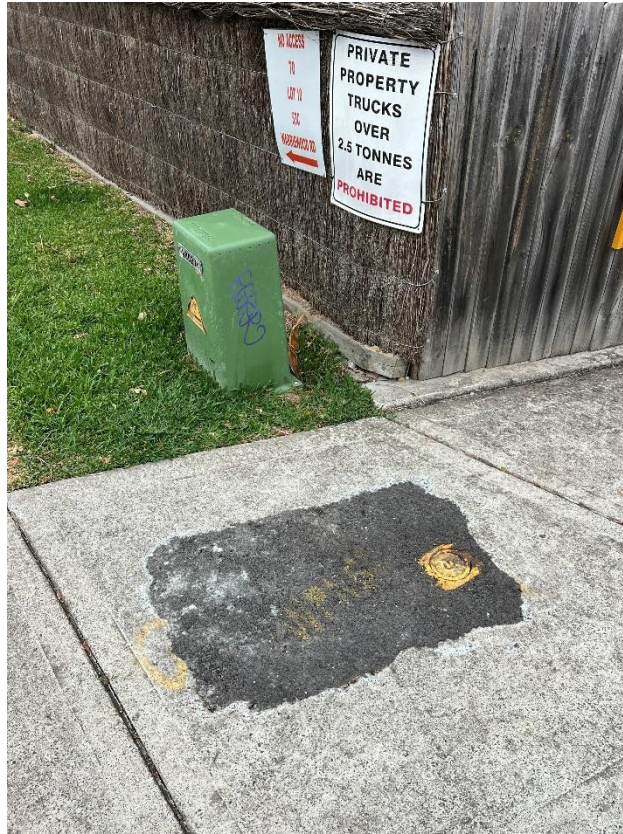
*Figure 5 – General condition of the utility lid.*

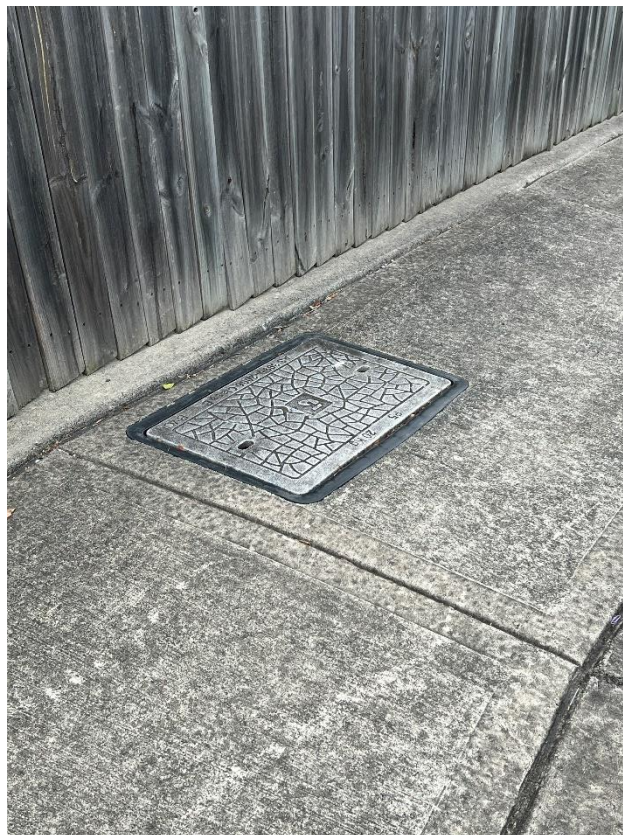
*Figure 6 – General condition of the pit.*

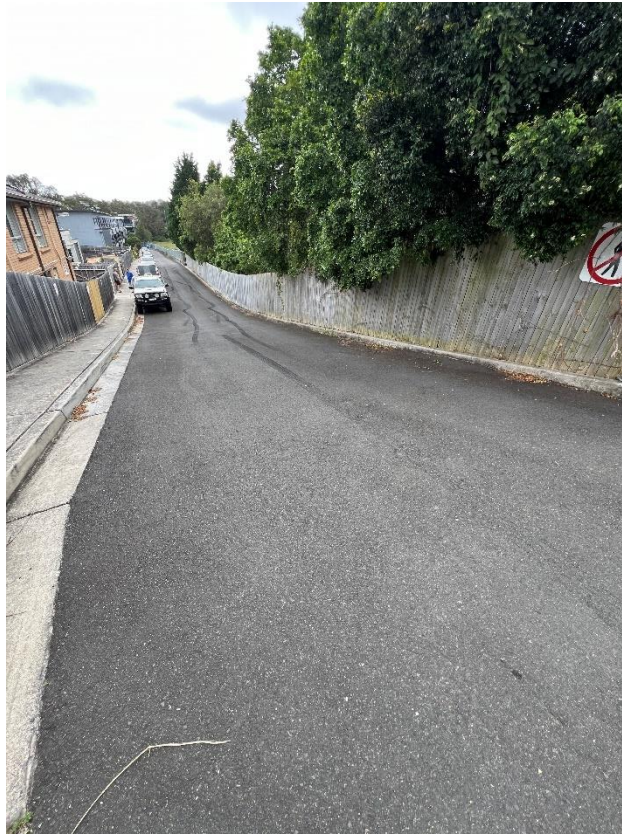
*Figure 7 – General condition of the road.*

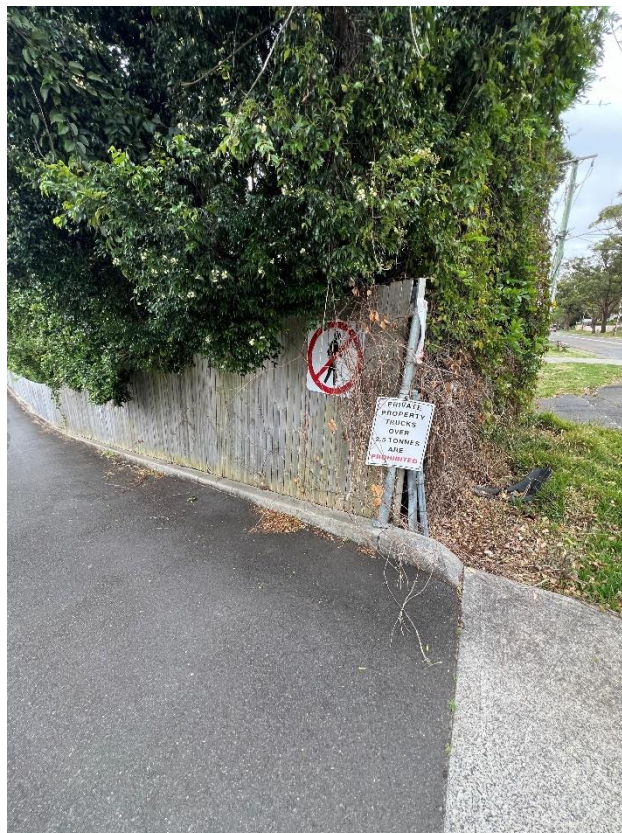
*Figure 8 – General condition of the kerb/street signpost.*

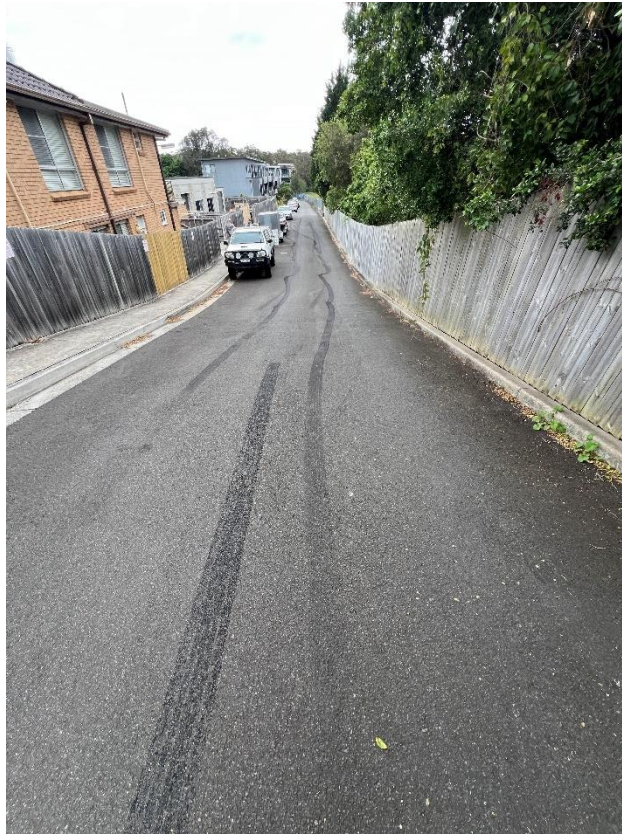
*Figure 9 – General condition of the road.*

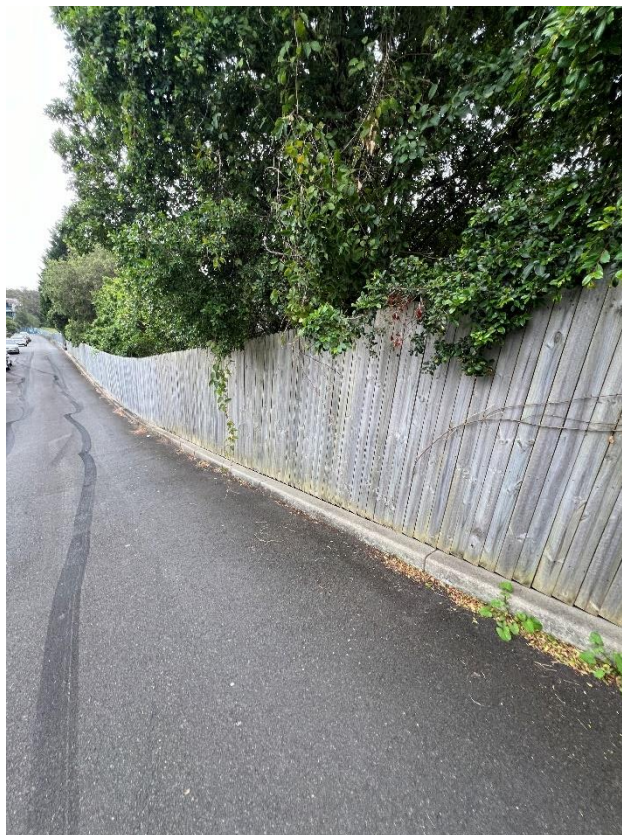
*Figure 10 – General condition of the road/kerb.*

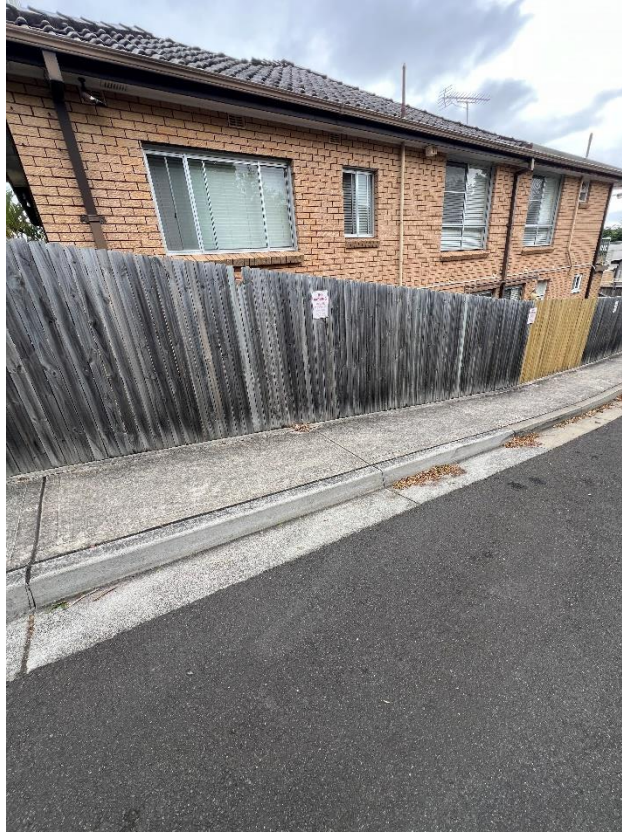
*Figure 11 – General condition of the footpath/kerb.*

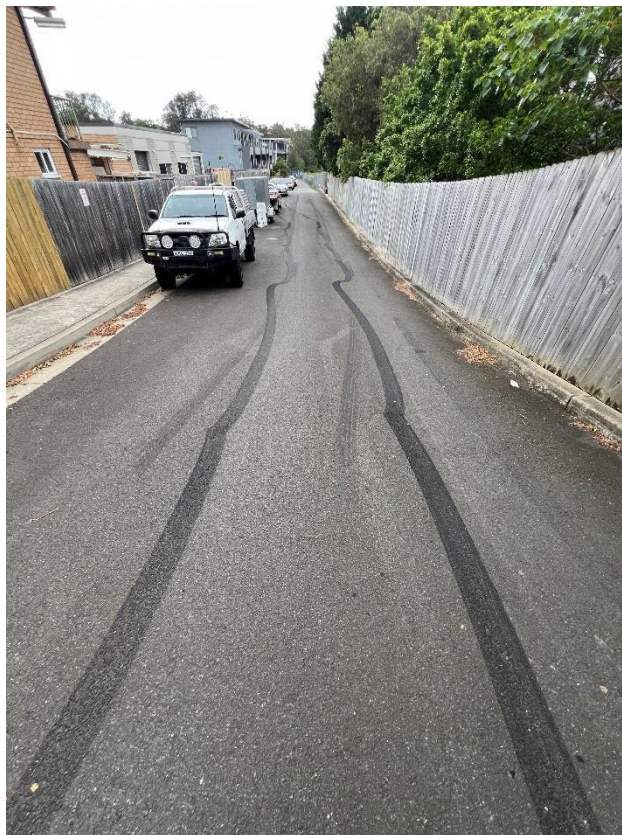
*Figure 12 – General condition of the road.*

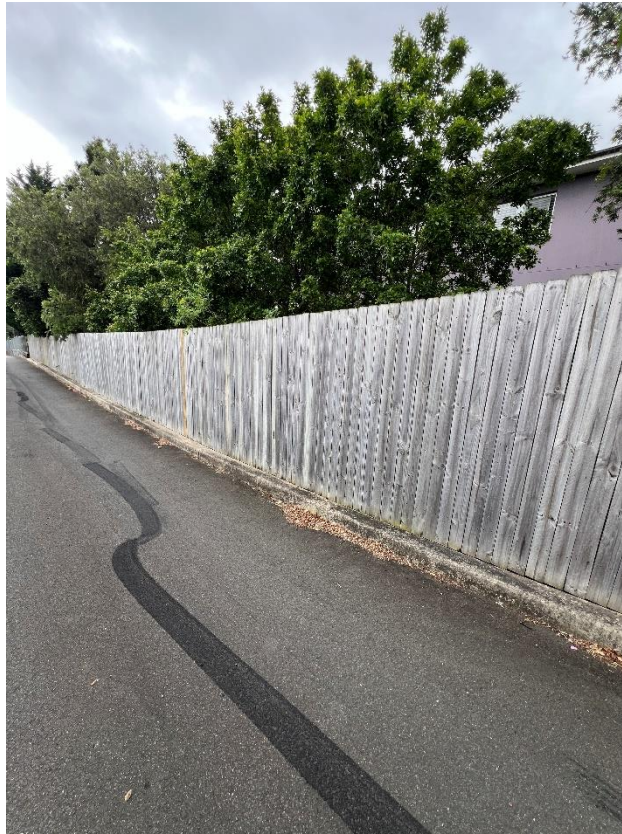
*Figure 13 – General condition of the kerb/timber fence.*

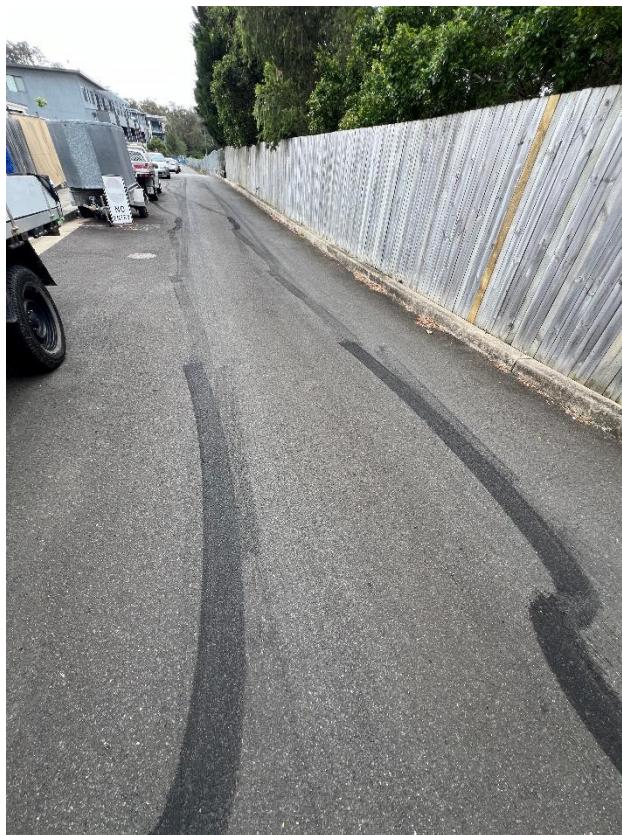
*Figure 14 – General condition of the road.*

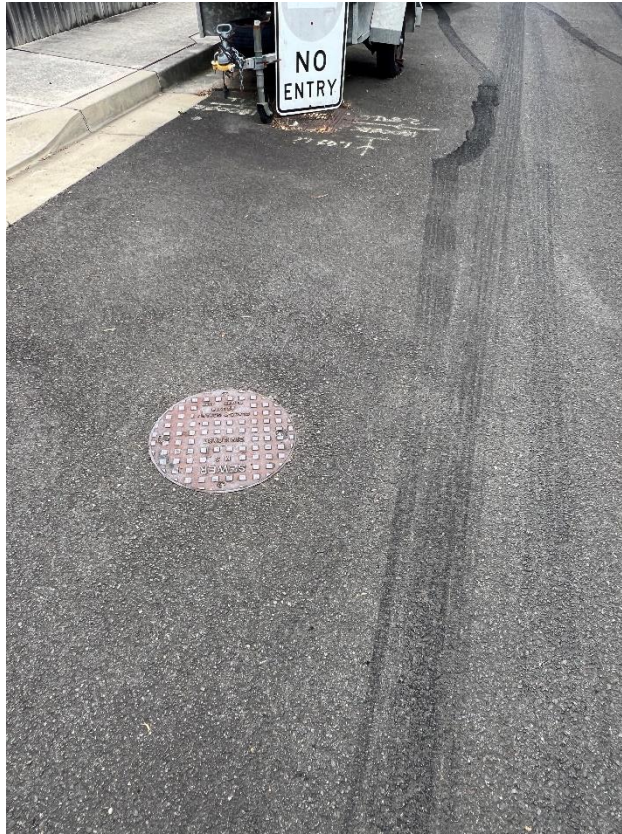
*Figure 15 – General condition of the pit.*

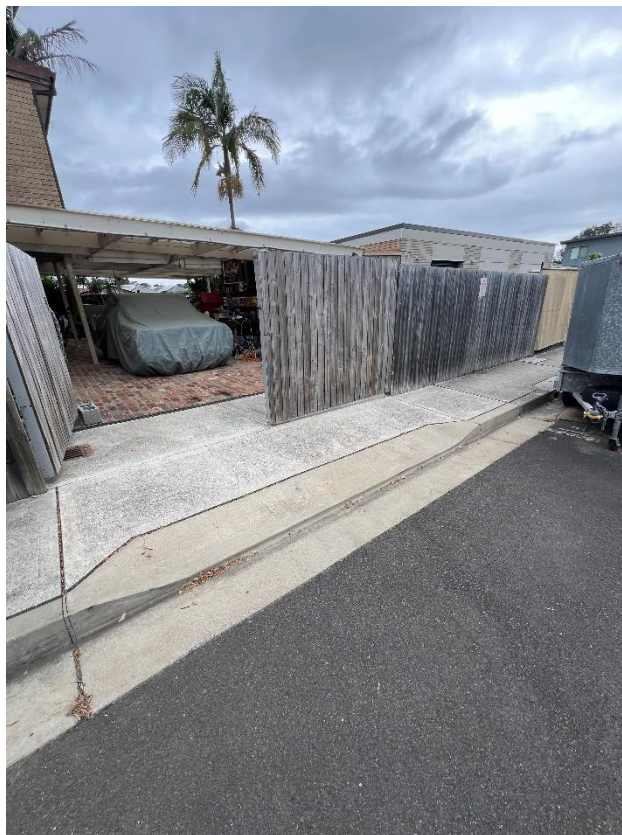
*Figure 16 – General condition of the driveway.*

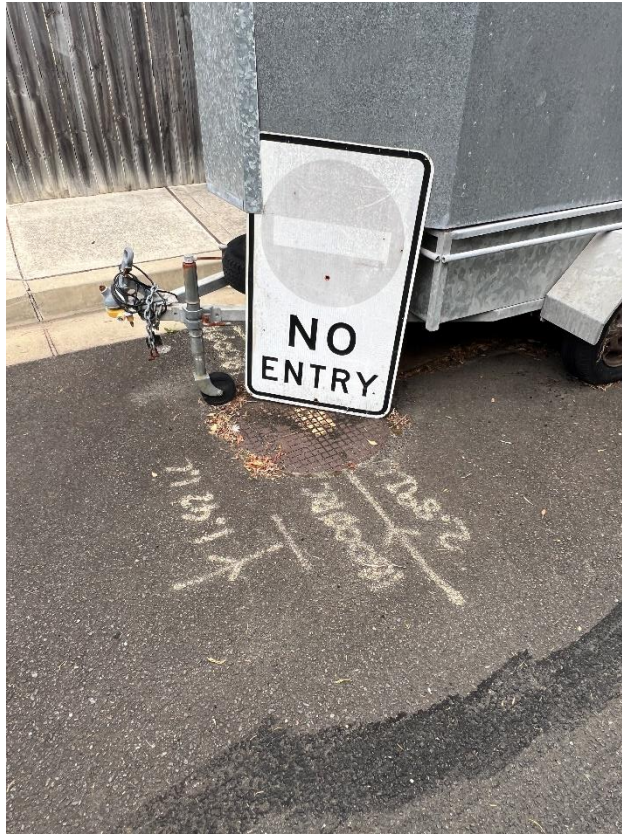
*Figure 17 – General condition of the traffic signpost.*

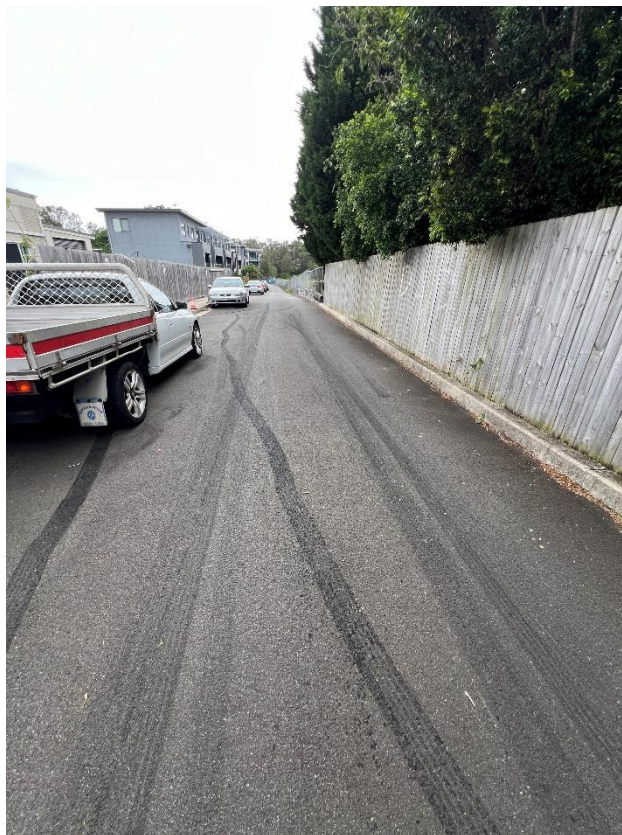
*Figure 18 – General condition of the road.*

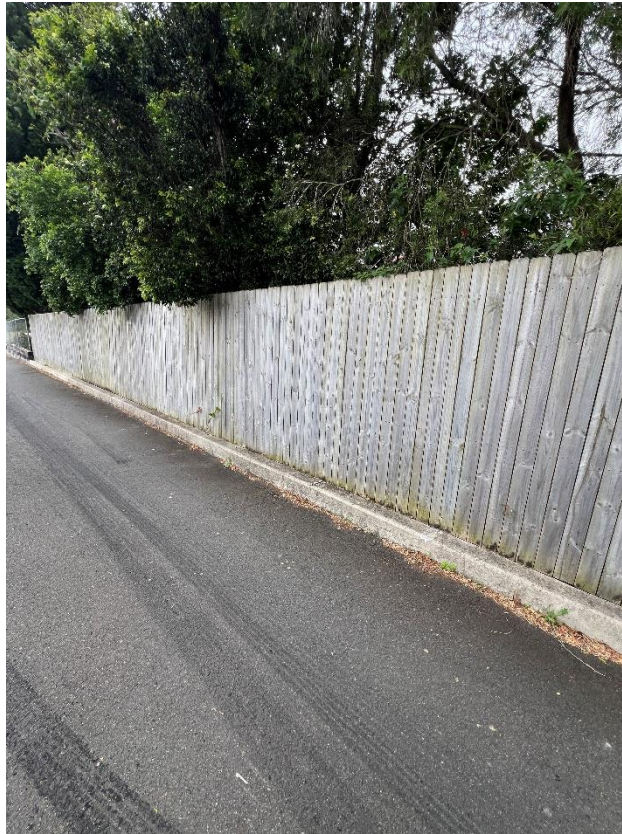
*Figure 19 – General condition of the kerb/timber fence.*

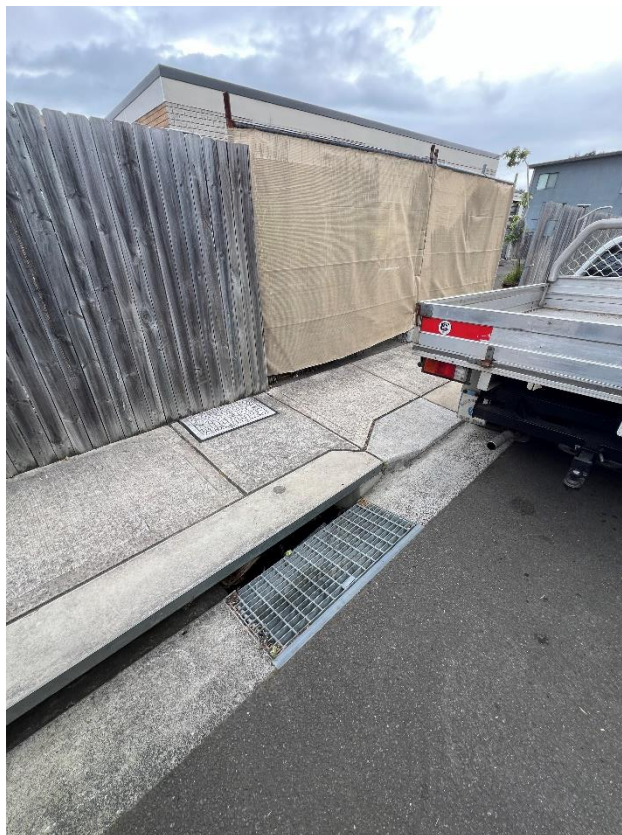
*Figure 20 – General condition of the kerb/pit.*

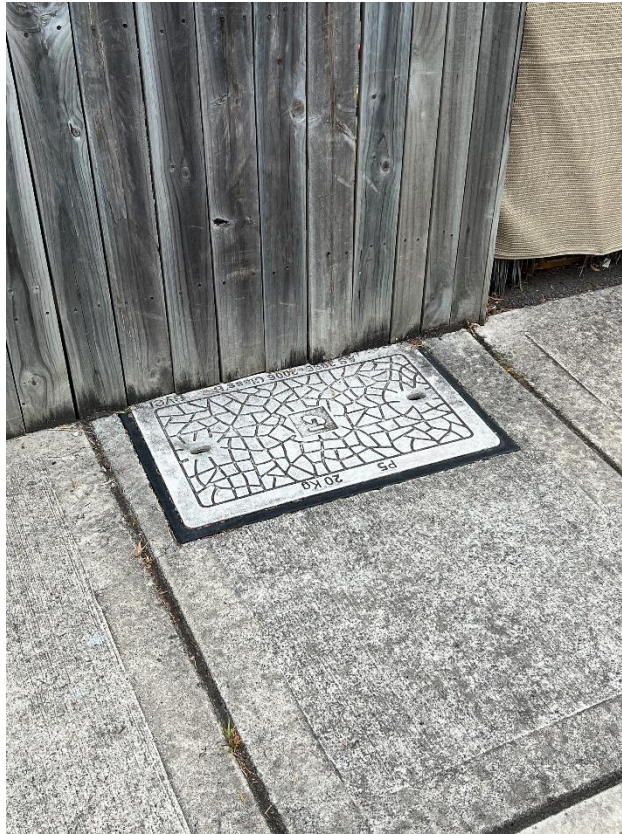
*Figure 21 – General condition of the pit.*

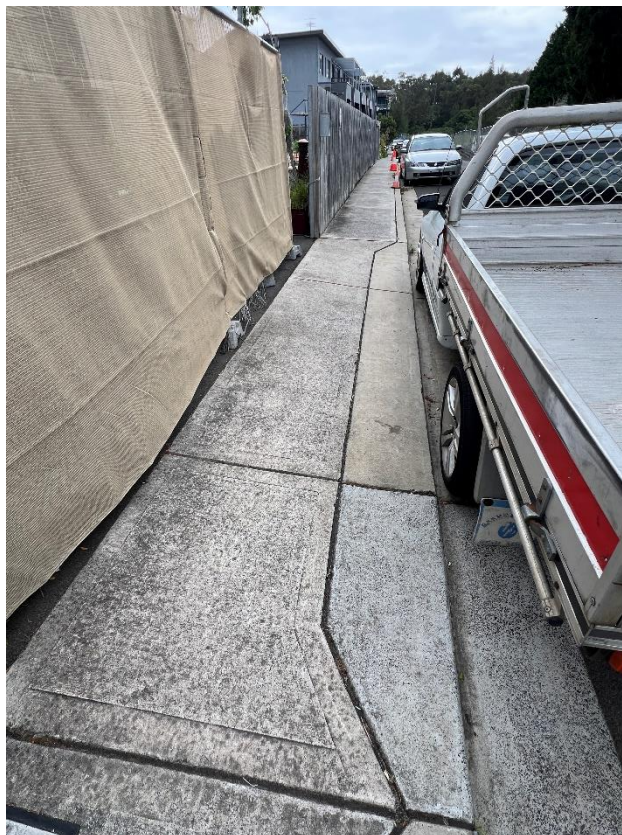
*Figure 22 – General condition of the footpath.*

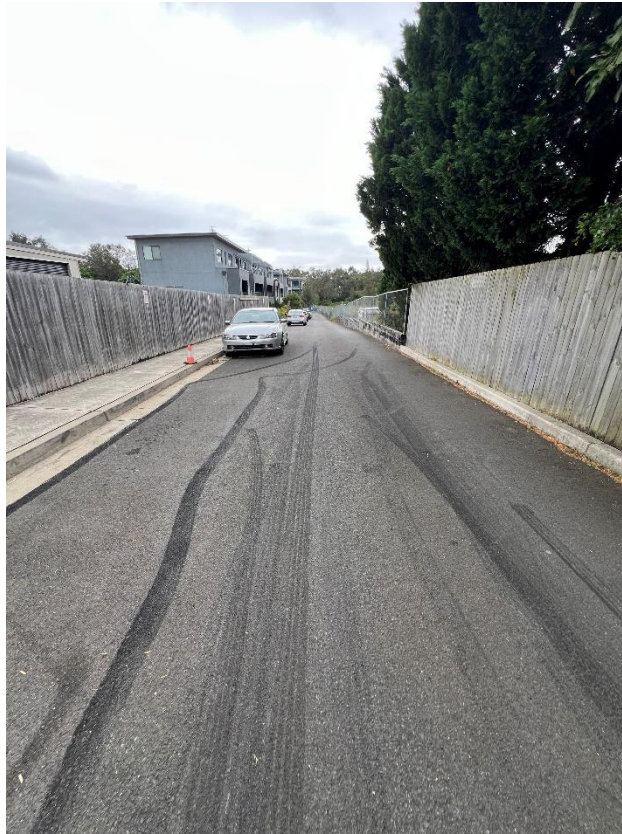
*Figure 23 – General condition of the road.*

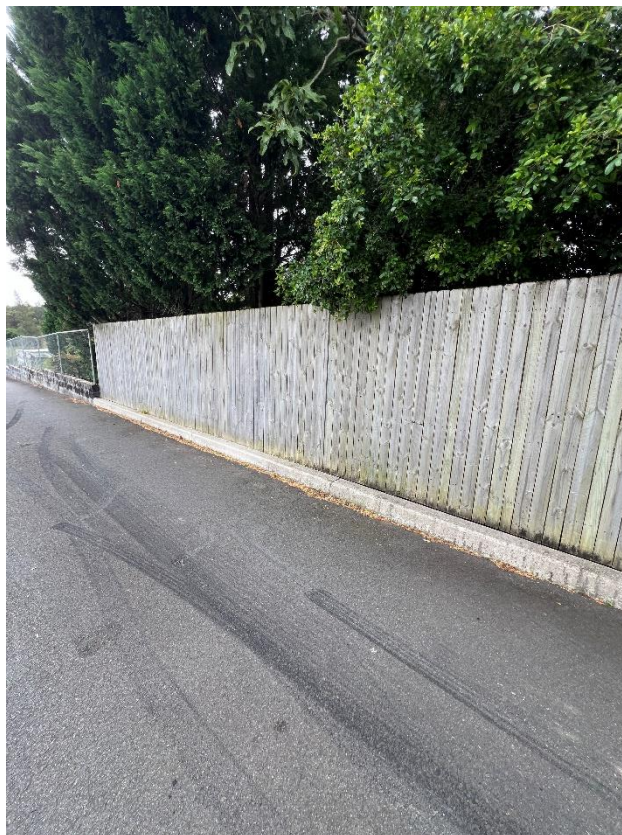
*Figure 24 – General condition of the road/kerb.*

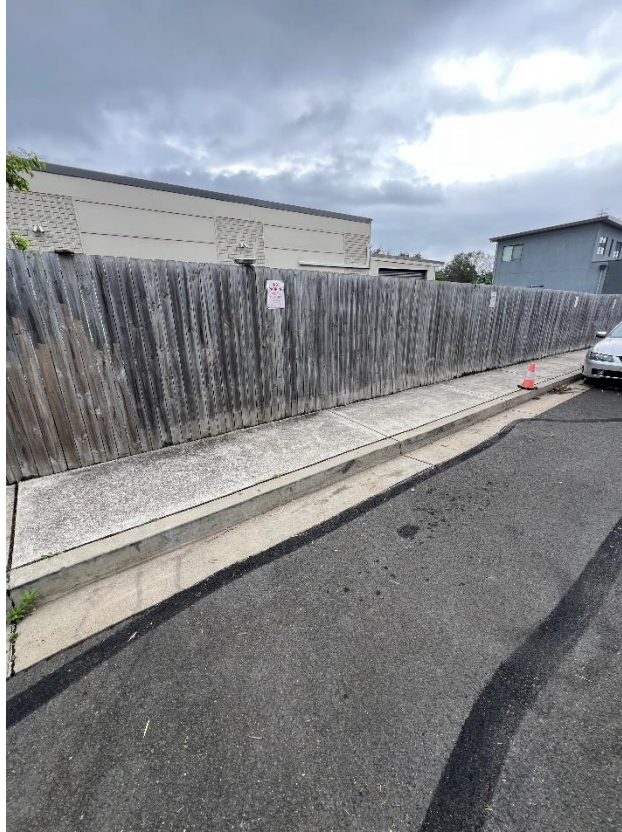
*Figure 25 – General condition of the footpath/kerb.*

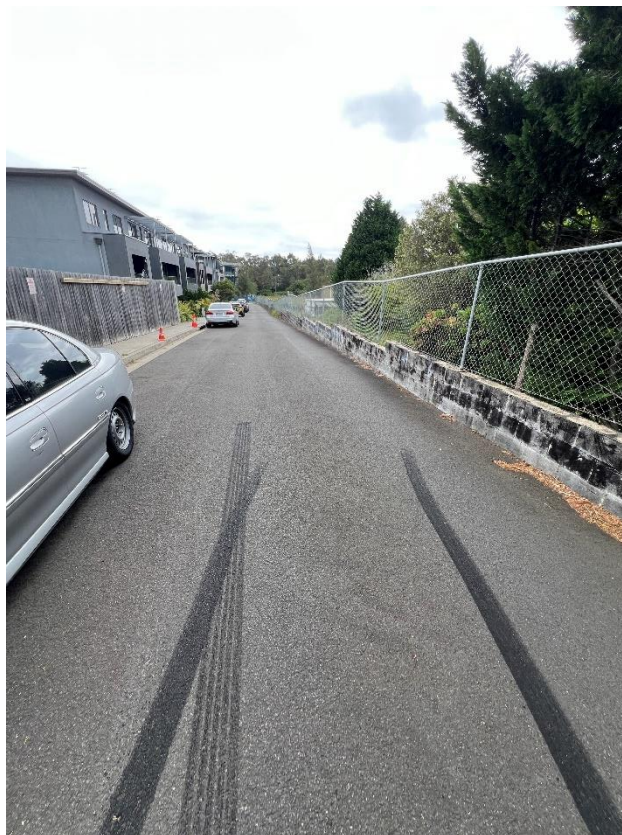
*Figure 26 – General condition of the road.*

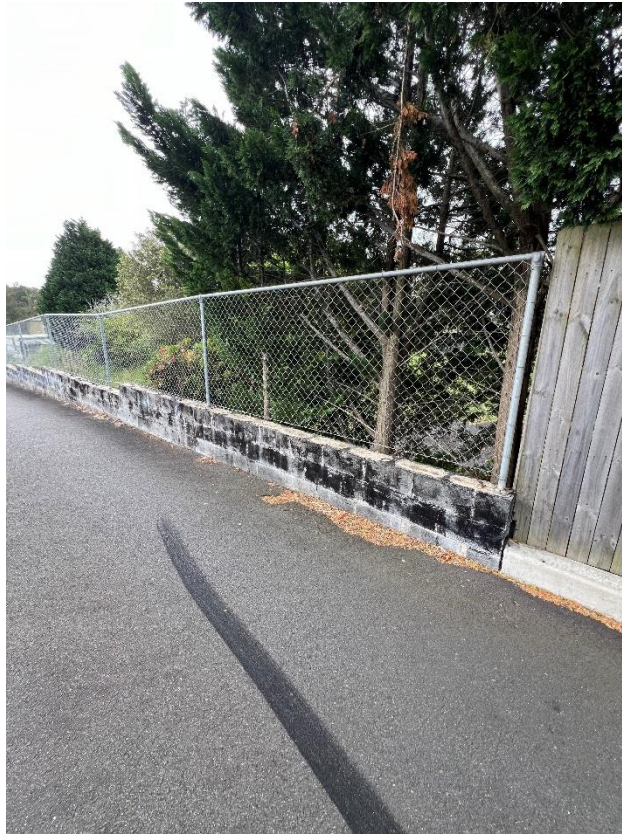
*Figure 27 – General condition of the retaining wall.*

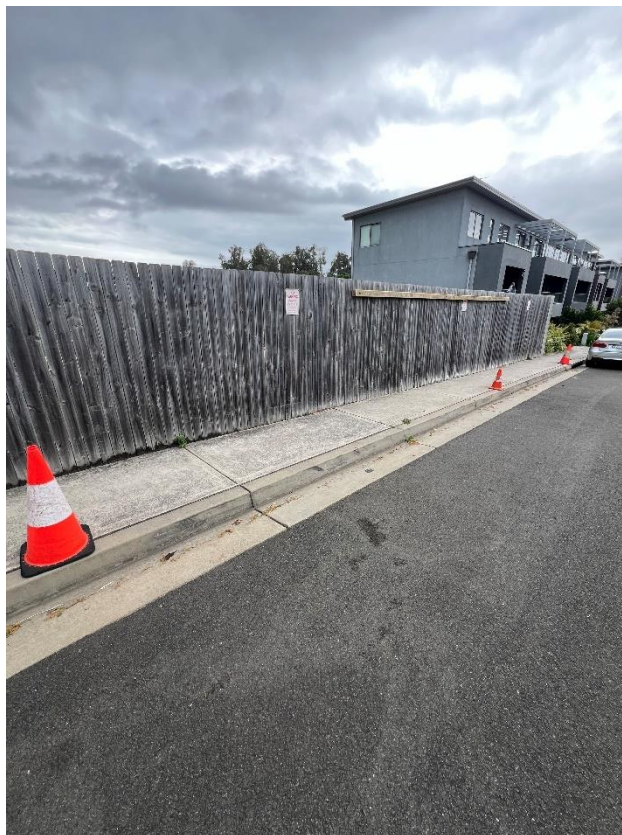
*Figure 28 – General condition of the footpath/kerb.*

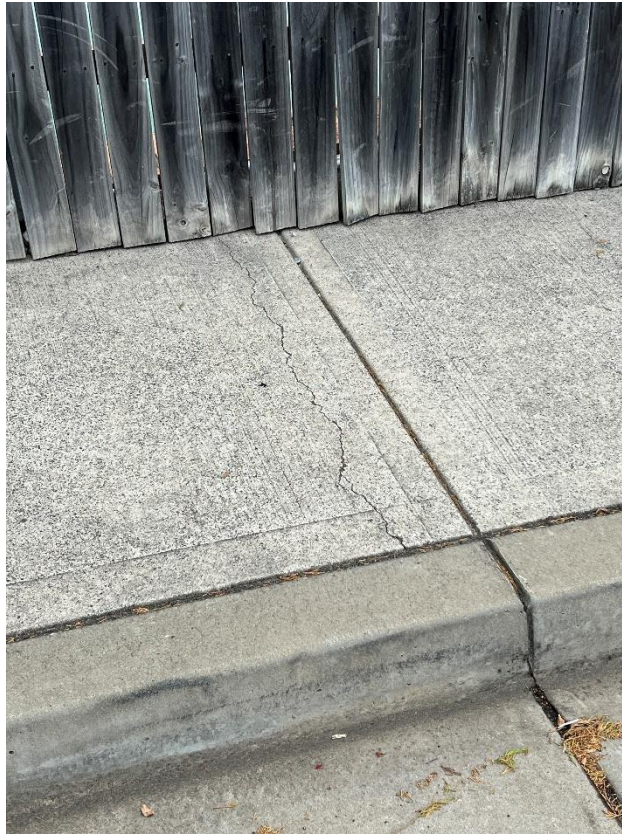
*Figure 29 – Crack is evident to the footpath between 14 & 12 Pheasant Place, Warriewood.*

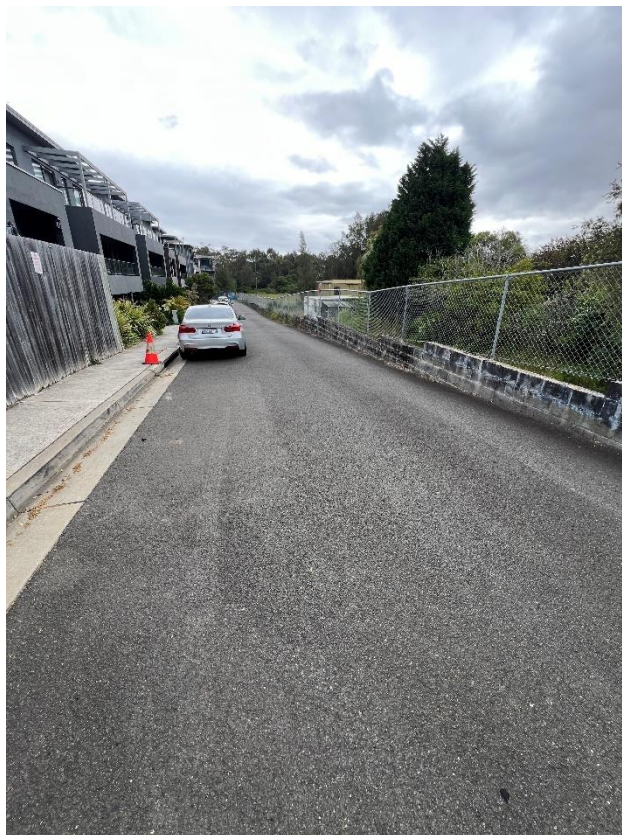
*Figure 30 – General condition of the road.*

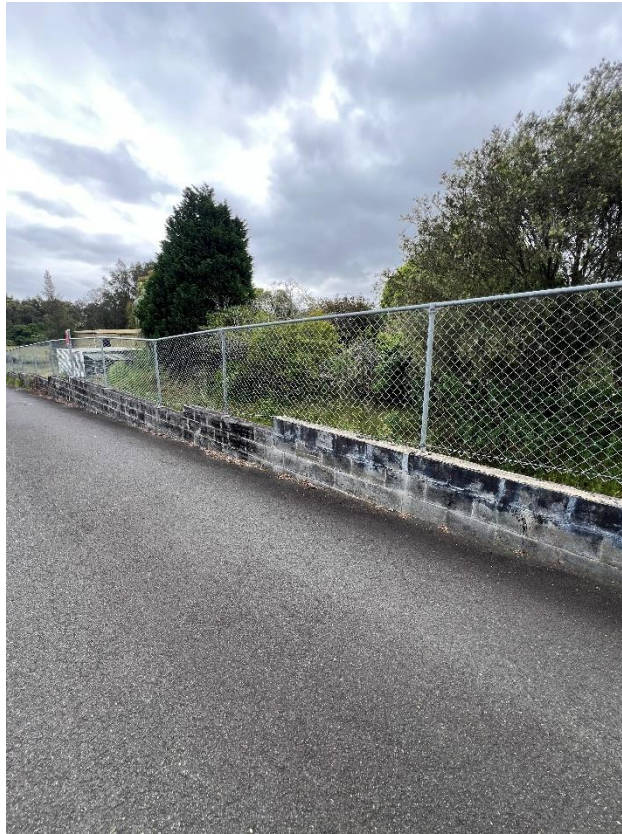
*Figure 31 – General condition of the road/retaining wall.*

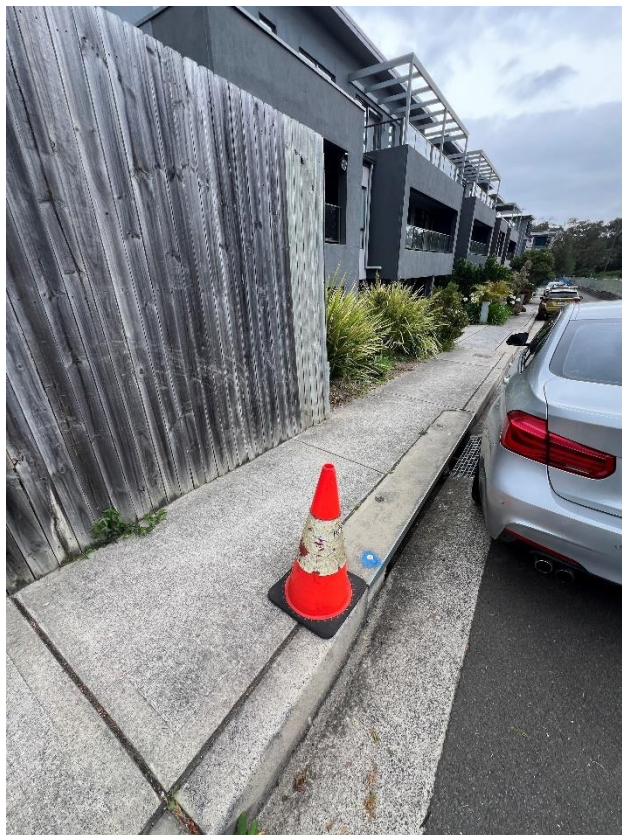
*Figure 32 – General condition of the kerb/footpath.*

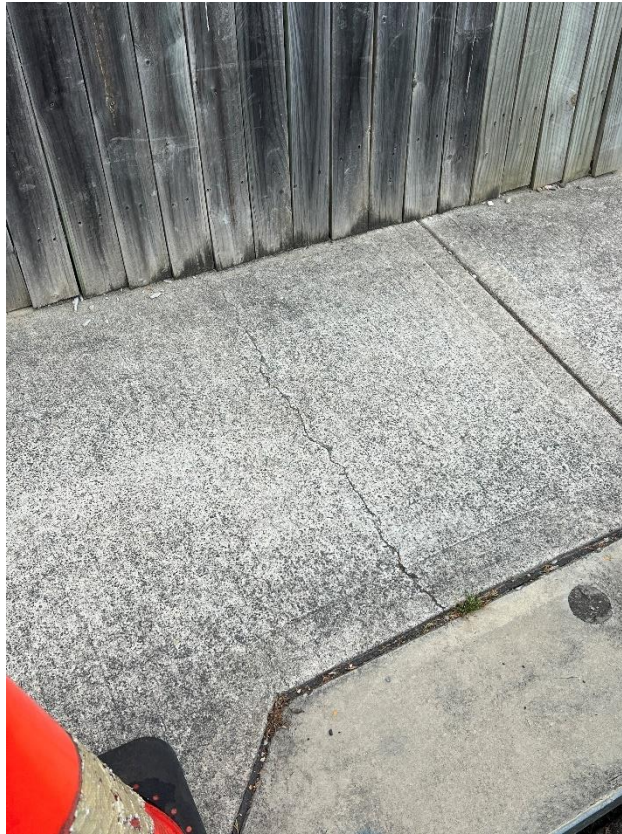
*Figure 33 – Crack is evident to the footpath besides at 12 Pheasant Place, Warriewood.*

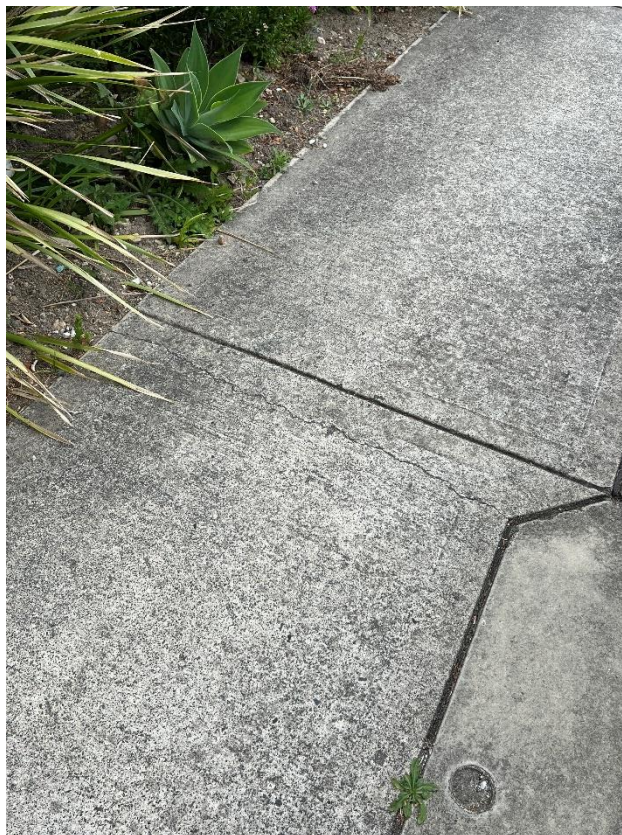
*Figure 34 – Crack is evident to the footpath in front at 12 Pheasant Place, Warriewood.*

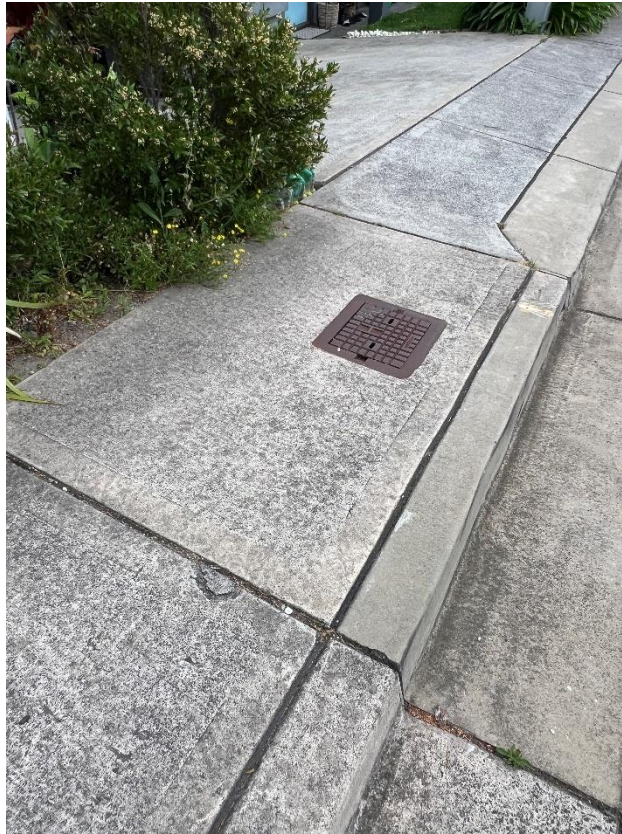
*Figure 35 – General condition of the footpath/utility lid.*

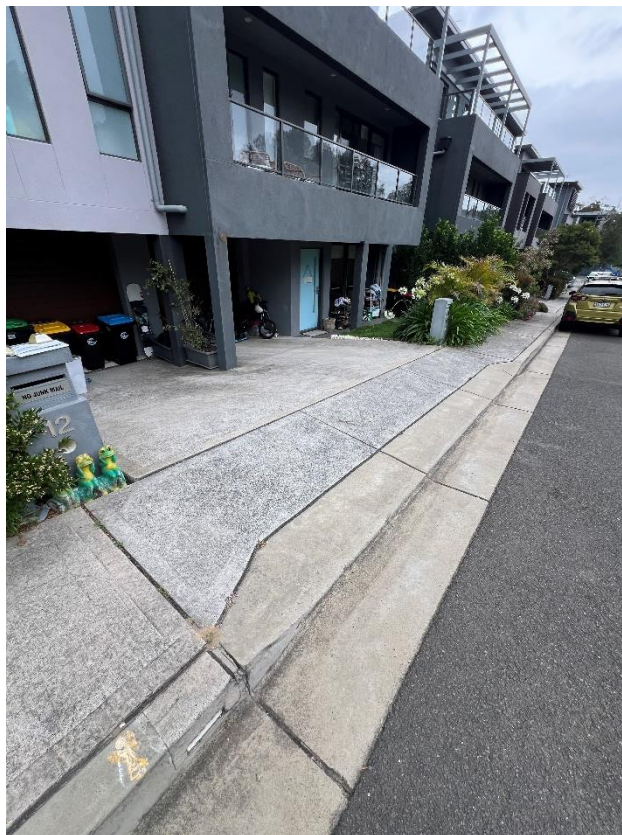
*Figure 36 – General condition of the driveway.*

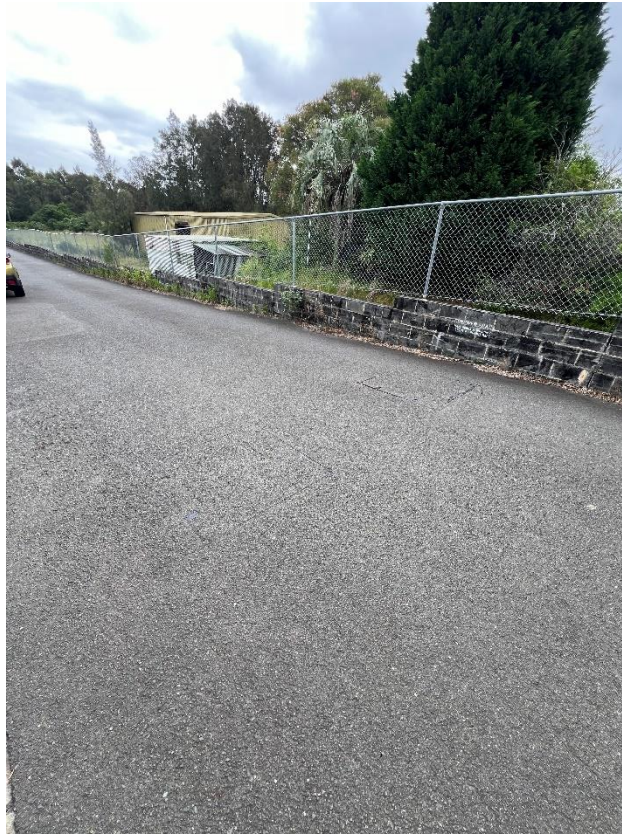
*Figure 37 – General condition of the road.*

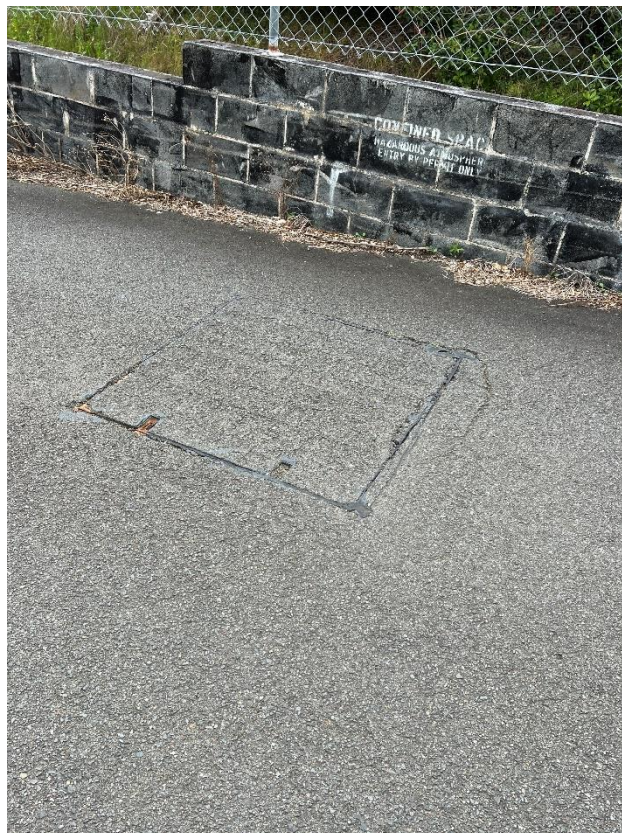
*Figure 38 – General condition of the pit.*

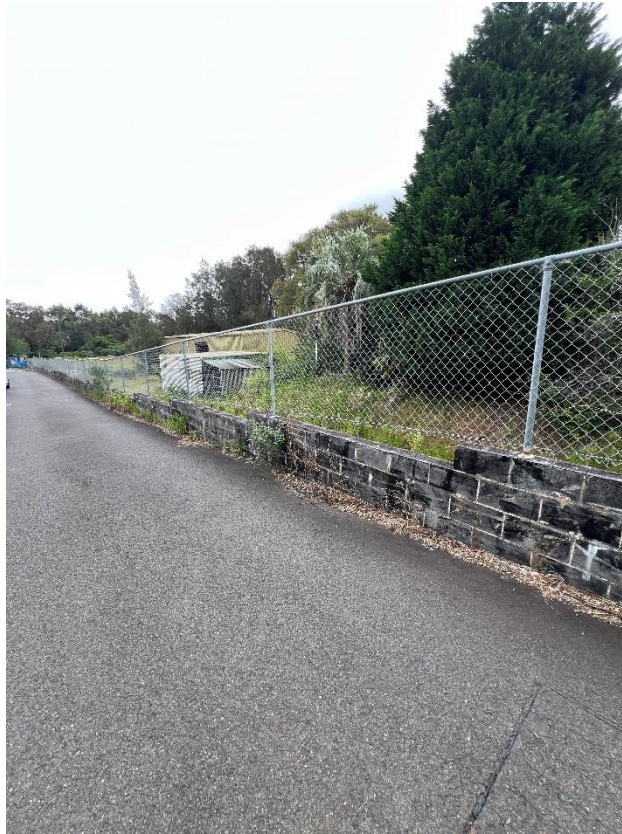
*Figure 39 – General condition of the road/retaining wall.*

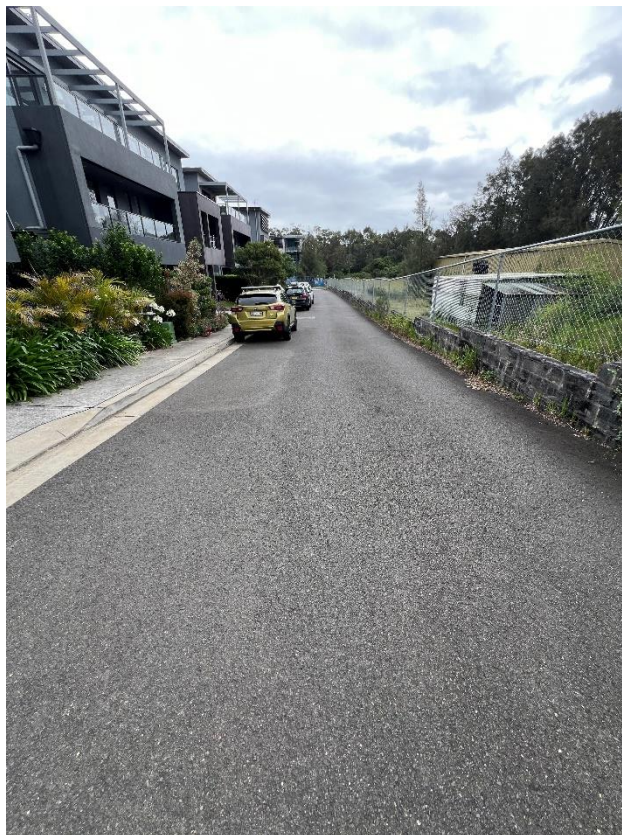
*Figure 40 – General condition of the road.*

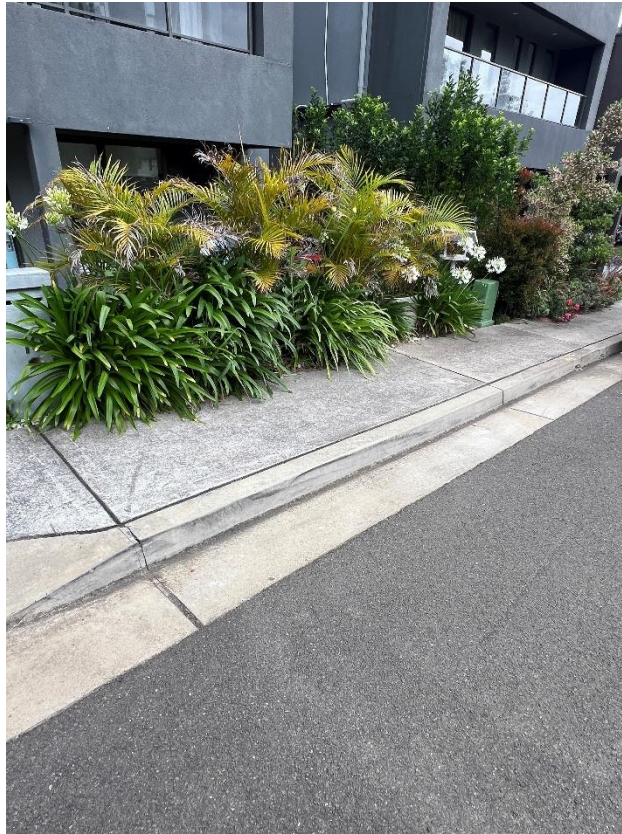
*Figure 41 – General condition of the footpath/kerb.*

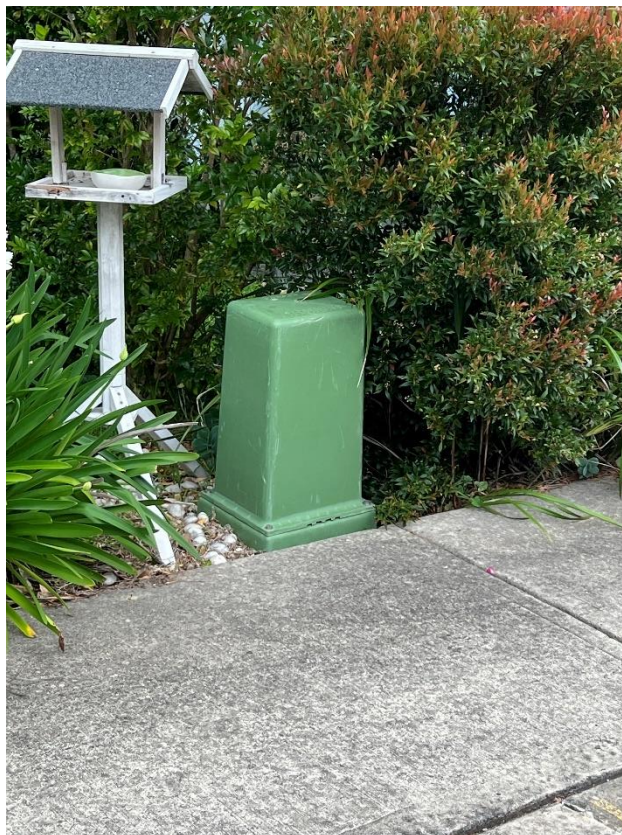
*Figure 42 – General condition of the transformer box.*

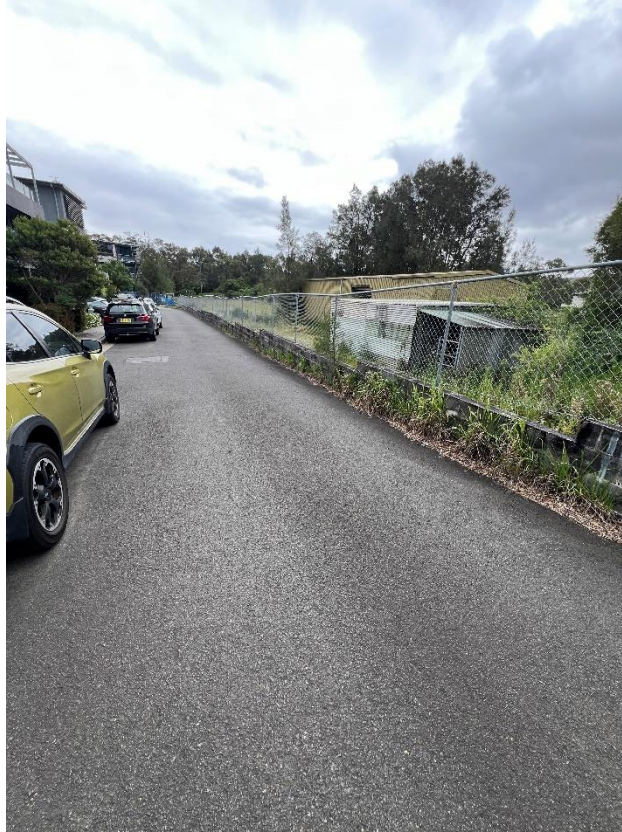
*Figure 43 – General condition of the road.*
