# DILAPIDATION REPORT

**Pheasant Place, Warriewood**

## 1. Introduction

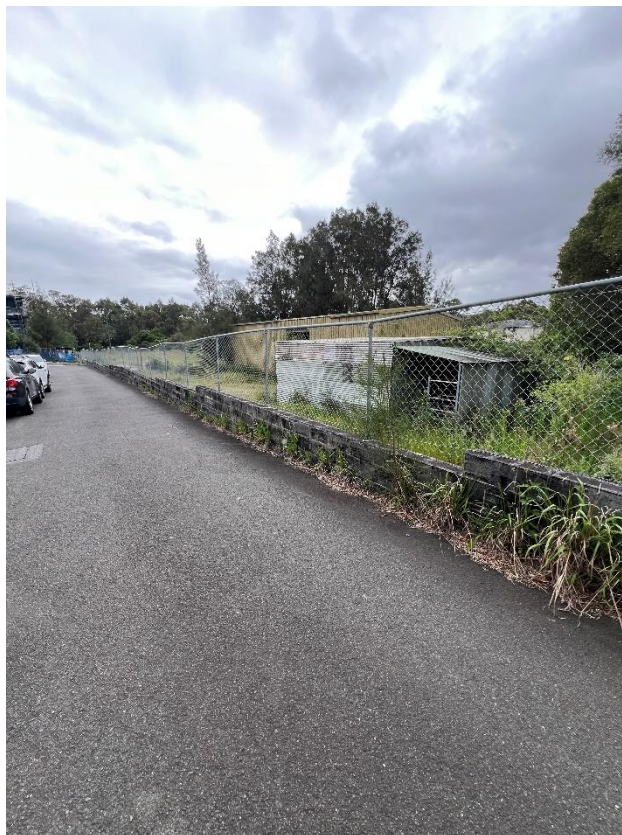
*Figure 44 – General condition of the road.*

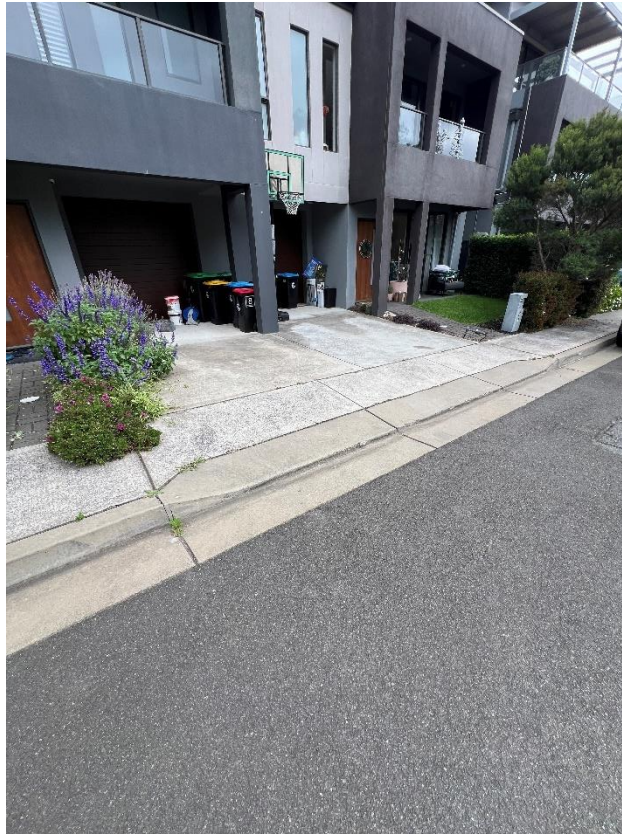
*Figure 45 – General condition of the driveway.*

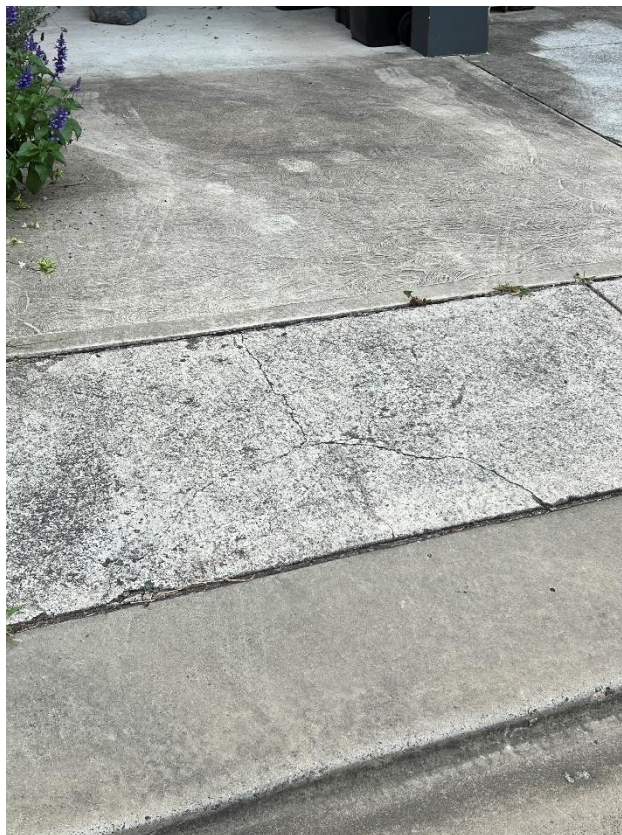
*Figure 46 – Crack is evident to the driveway/lapback inside driveway at 8 Pheasant Place, Warriewood.*

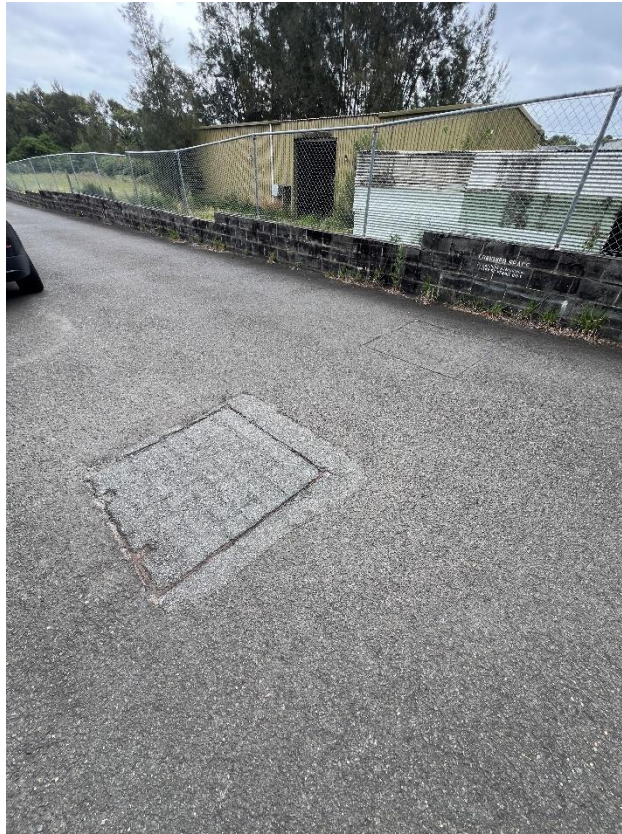
*Figure 47 – General condition of the road/pit.*

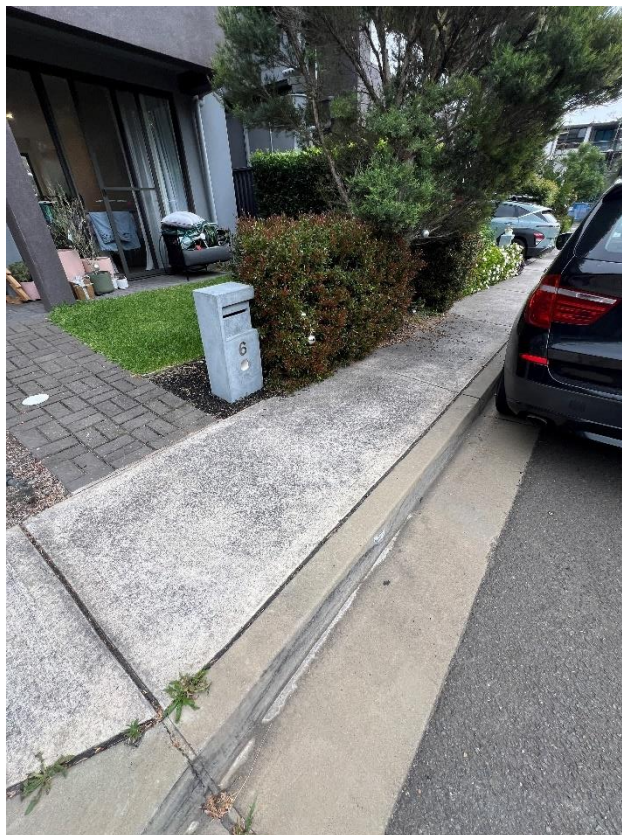
*Figure 48 – General condition of the footpath/kerb.*

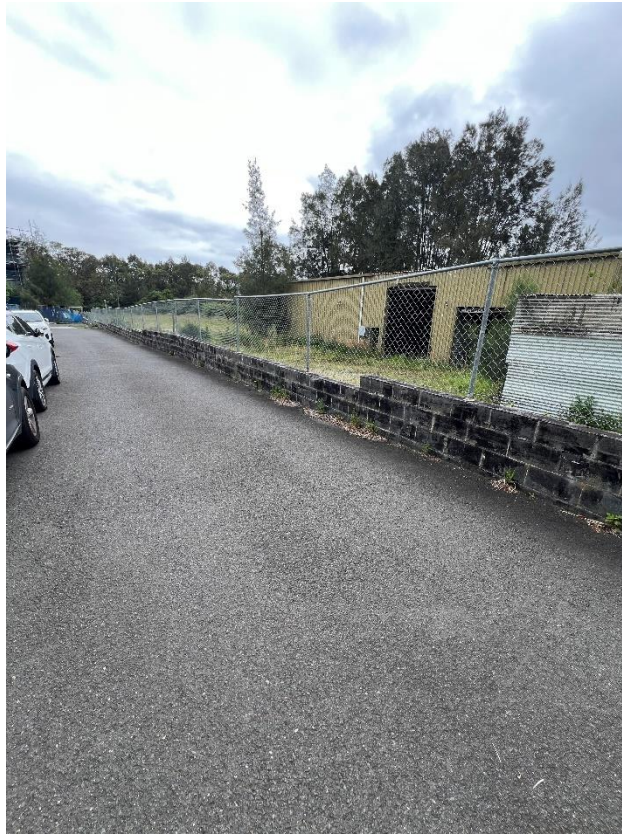
*Figure 49 – General condition of the road.*

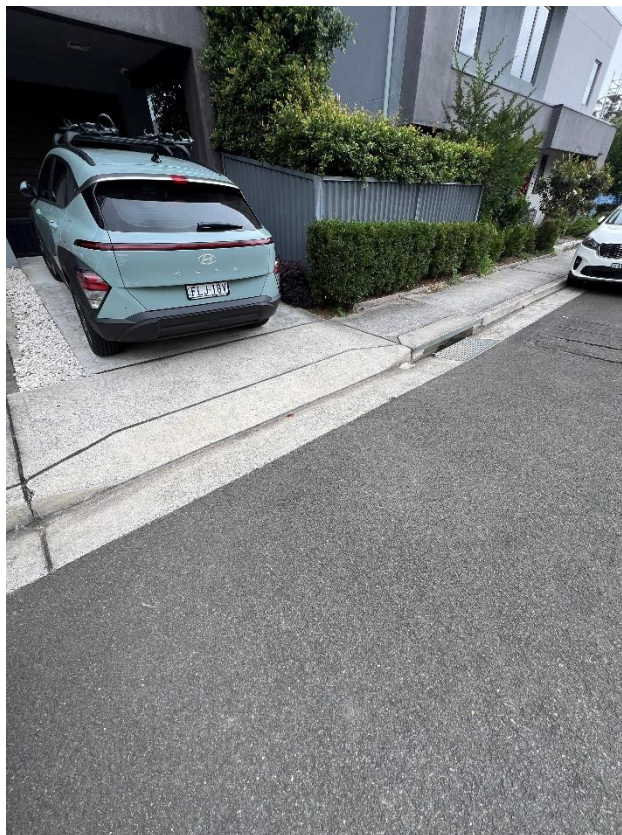
*Figure 50 – General condition of the driveway.*

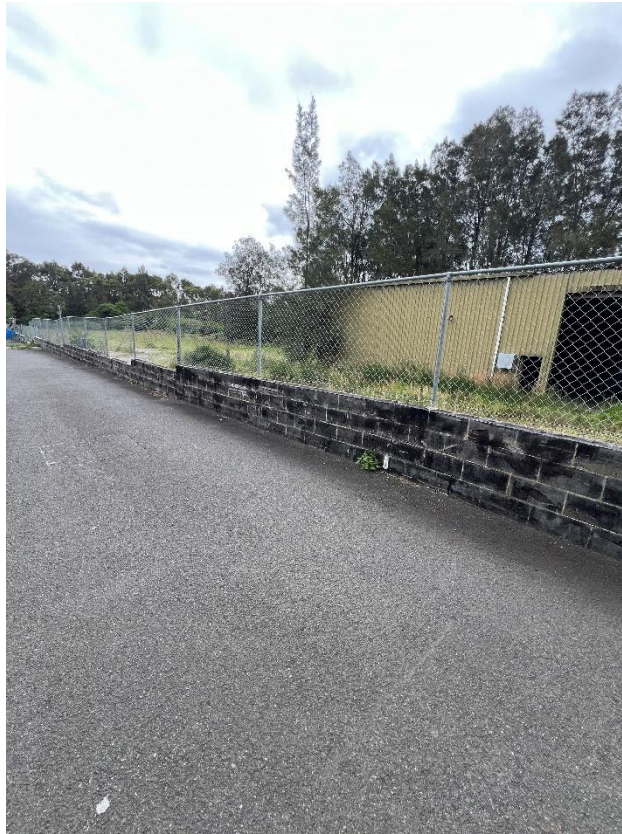
*Figure 51 – General condition of the road.*

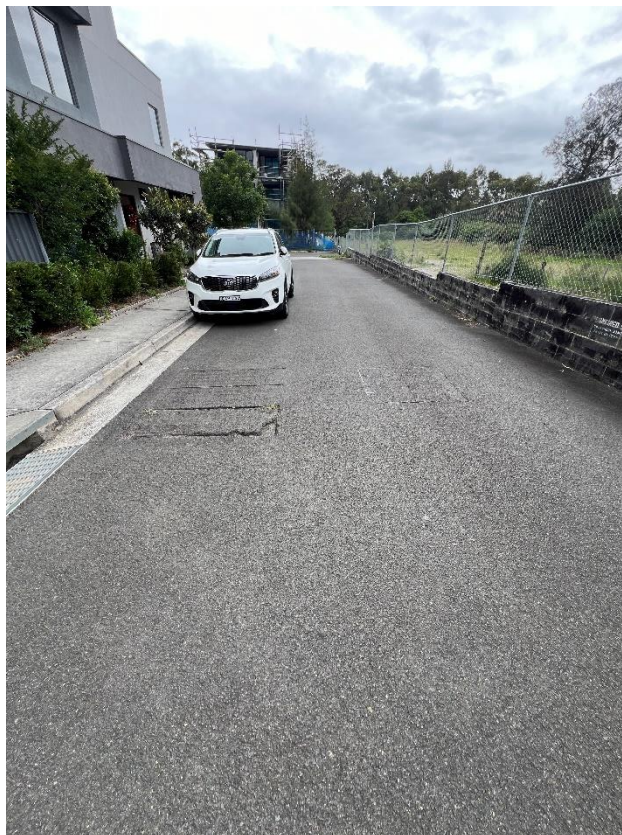
*Figure 52 – General condition of the road.*

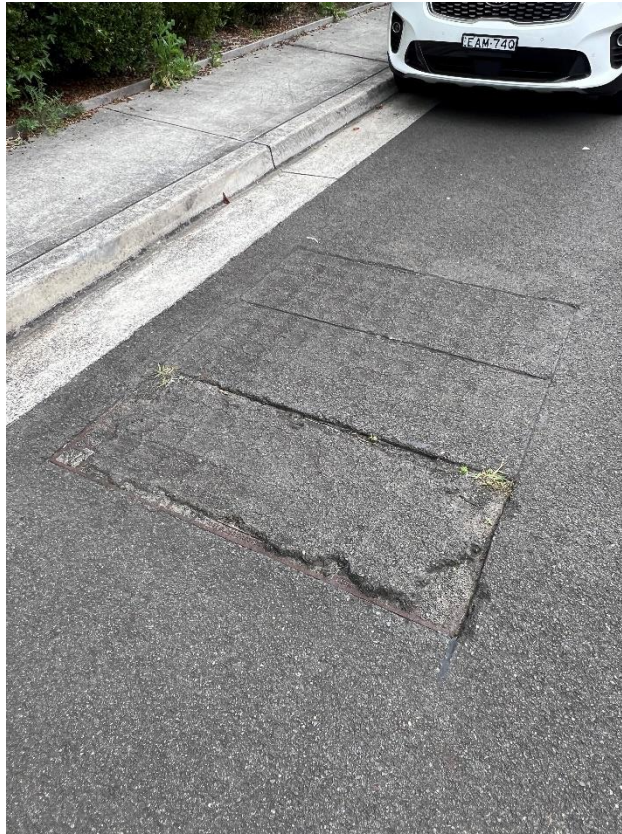
*Figure 53 – Crack is evident to the road along the driveway at 4 Pheasant Place, Warriewood.*

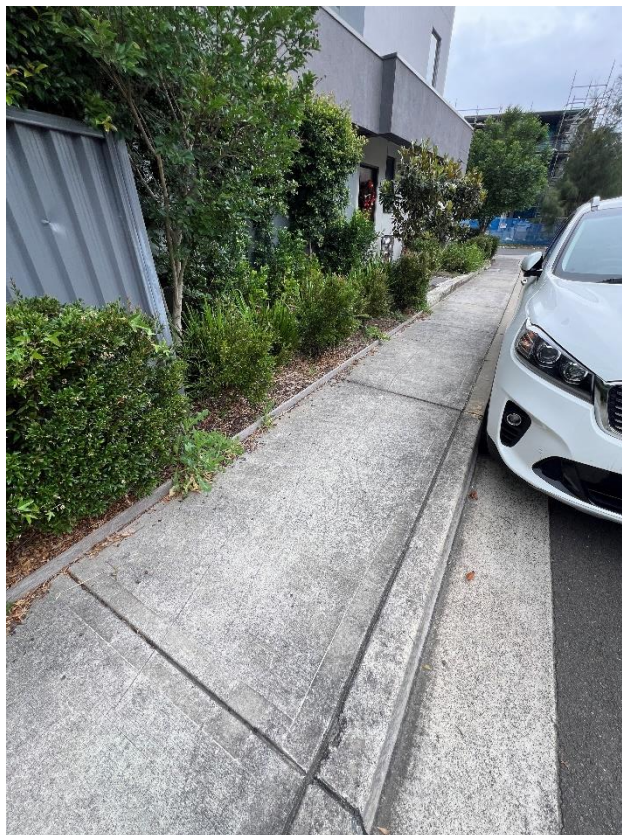
*Figure 54 – General condition of the footpath/kerb.*

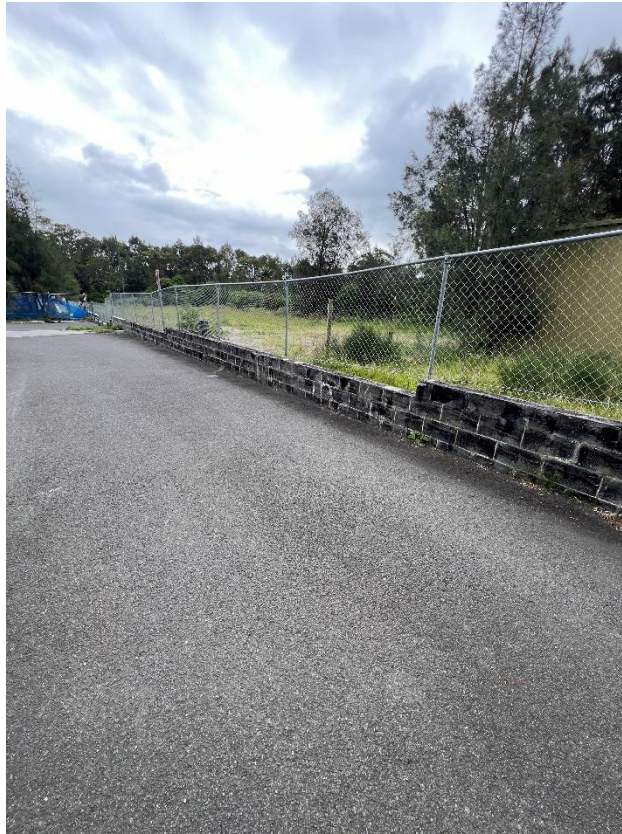
*Figure 55 – General condition of the road.*

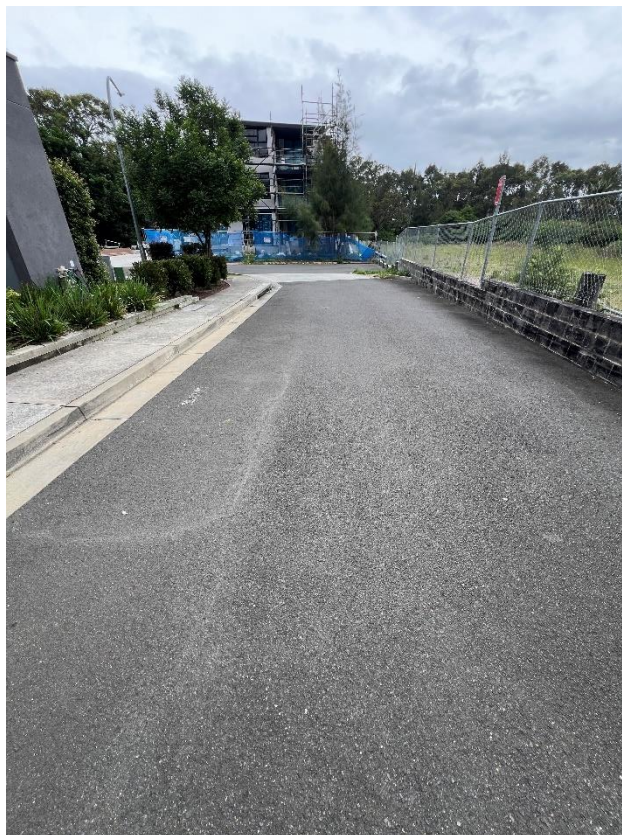
*Figure 56 – General condition of the road.*

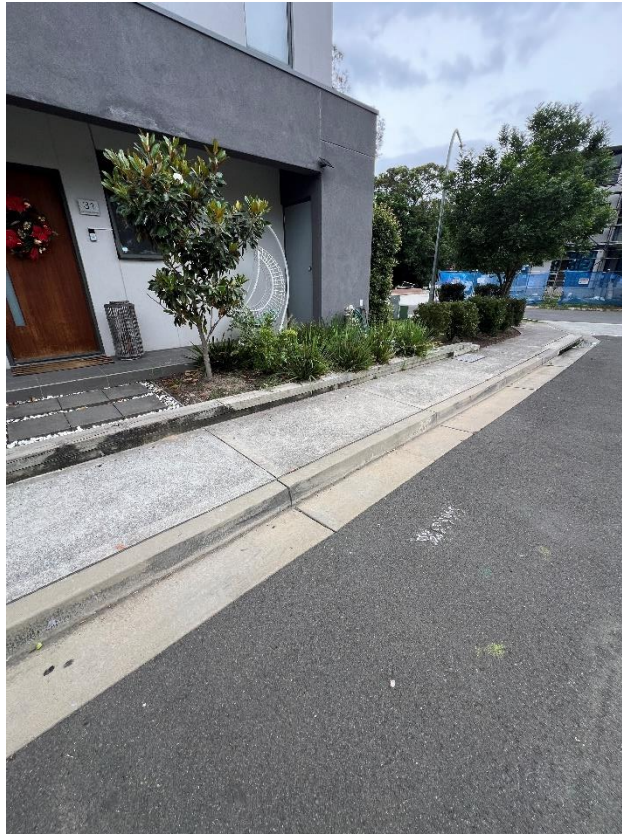
*Figure 57 – General condition of the footpath/kerb.*

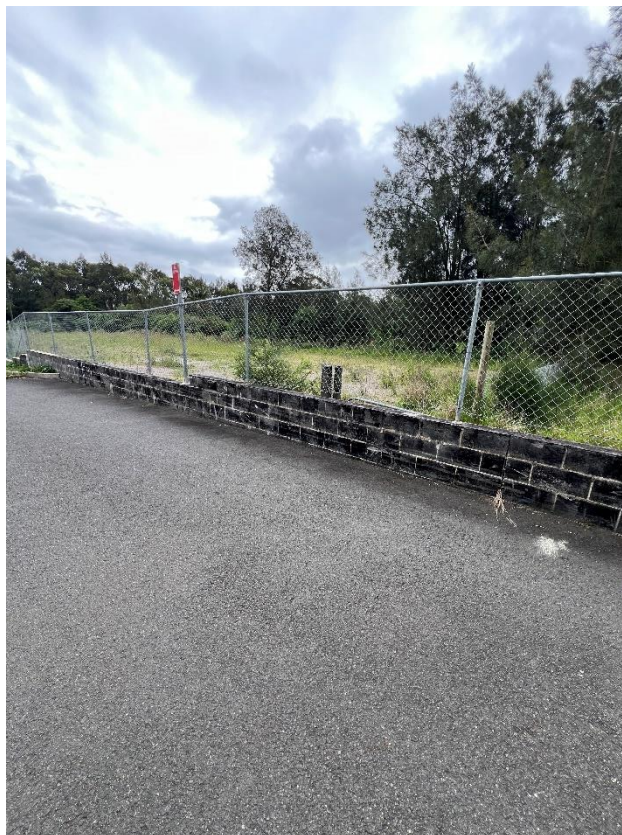
*Figure 58 – General condition of the road/retaining wall.*

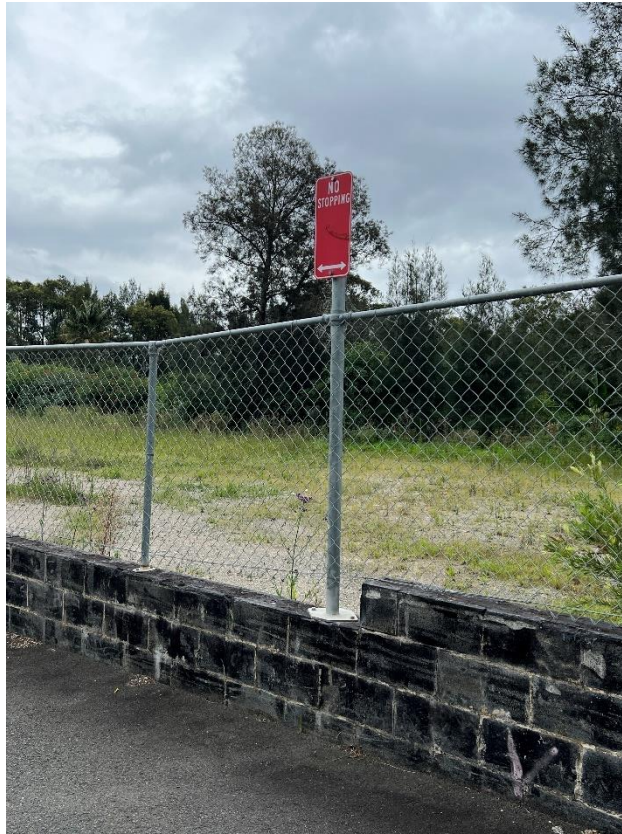
*Figure 59 – General condition of the traffic signpost.*

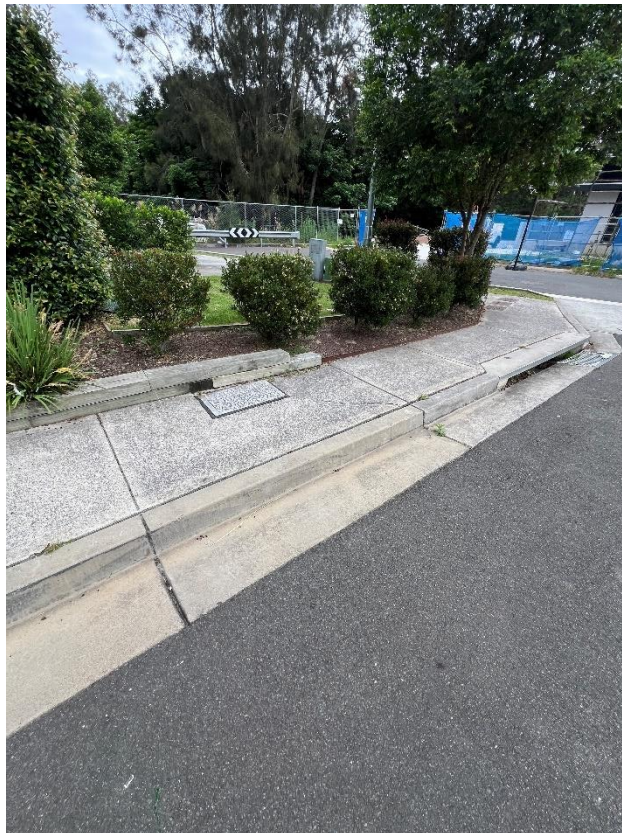
*Figure 60 – General condition of the footpath/kerb.*

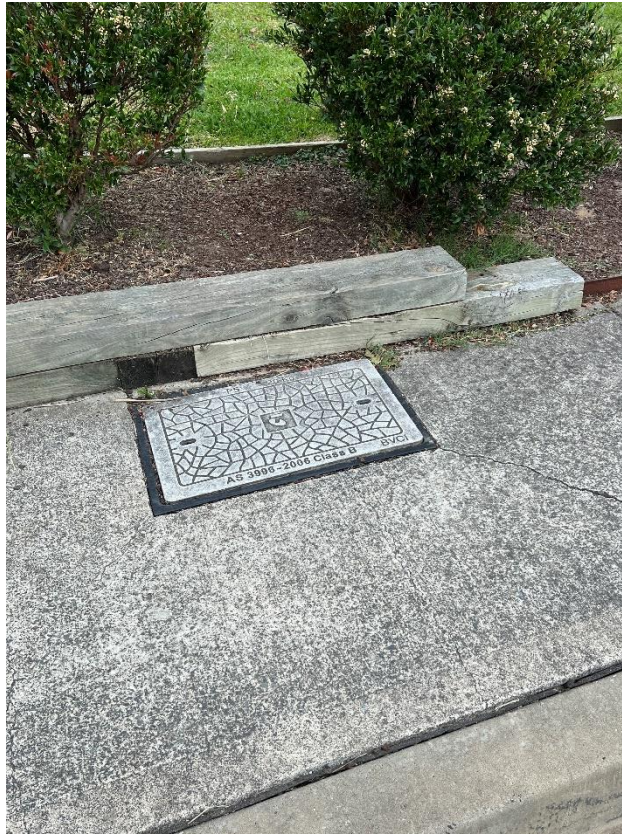
*Figure 61 – General condition of the pit.*

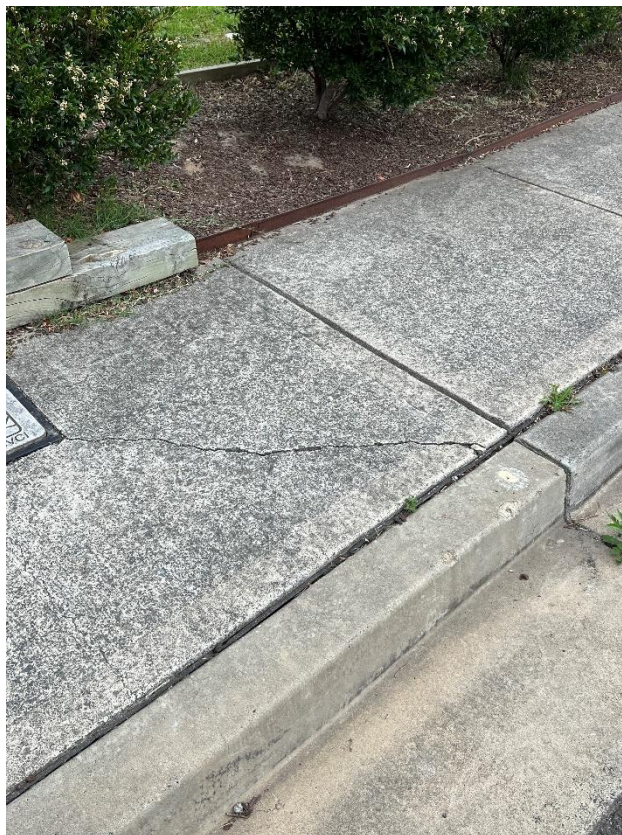
*Figure 62 – Crack is evident to the footpath along the driveway at 4 Pheasant Place, Warriewood.*

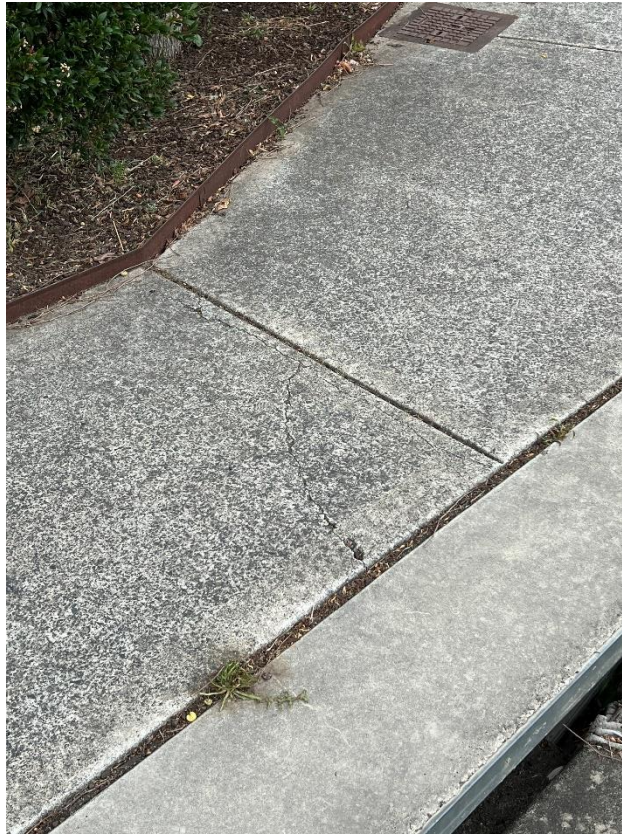
*Figure 63 – Crack is evident to the footpath along the driveway at 4 Pheasant Place, Warriewood.*

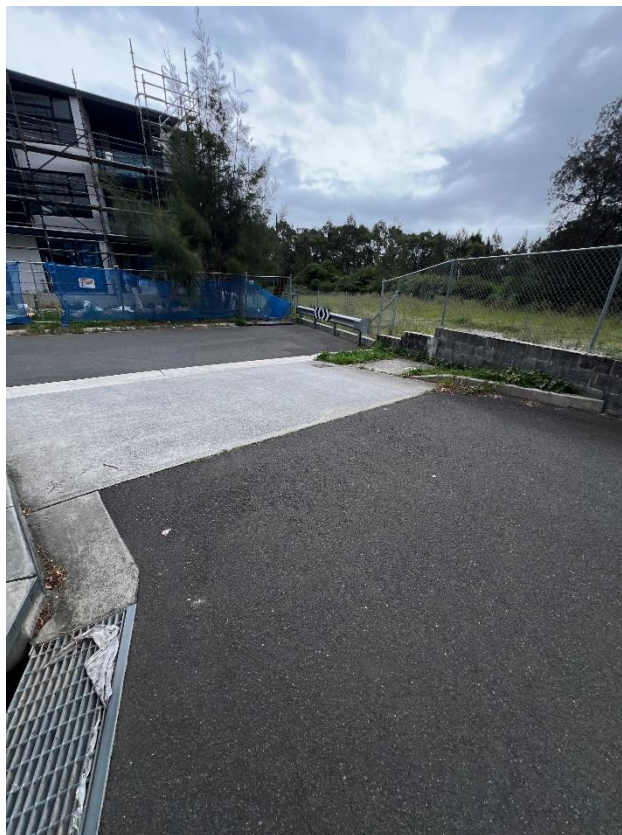
*Figure 64 – General condition of the driveway.*

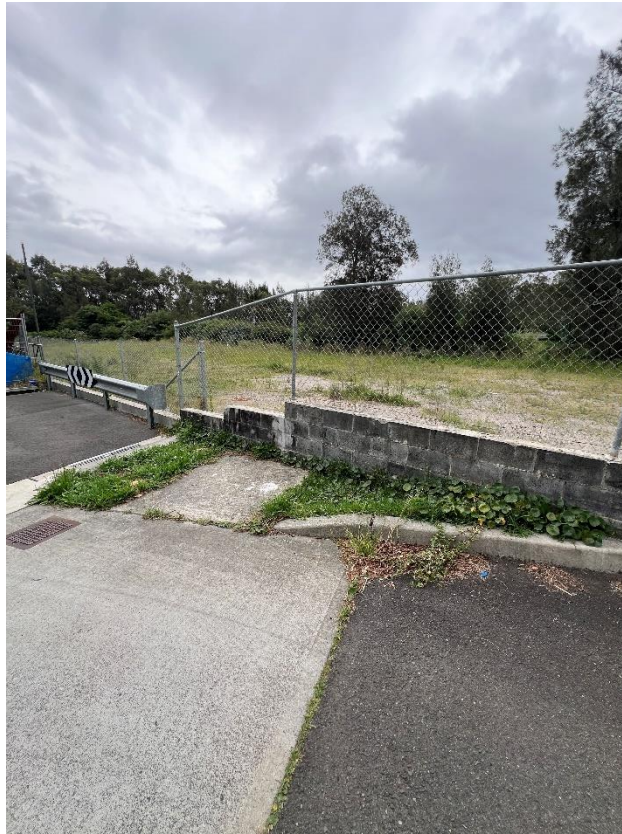
*Figure 65 – General condition of the kerb/retaining wall.*

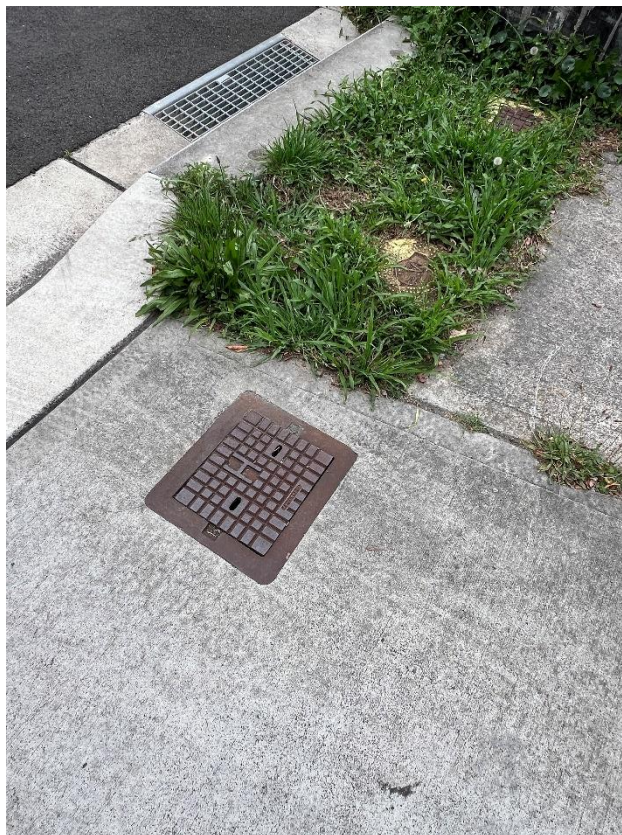
*Figure 66 – General condition of the utility lid.*

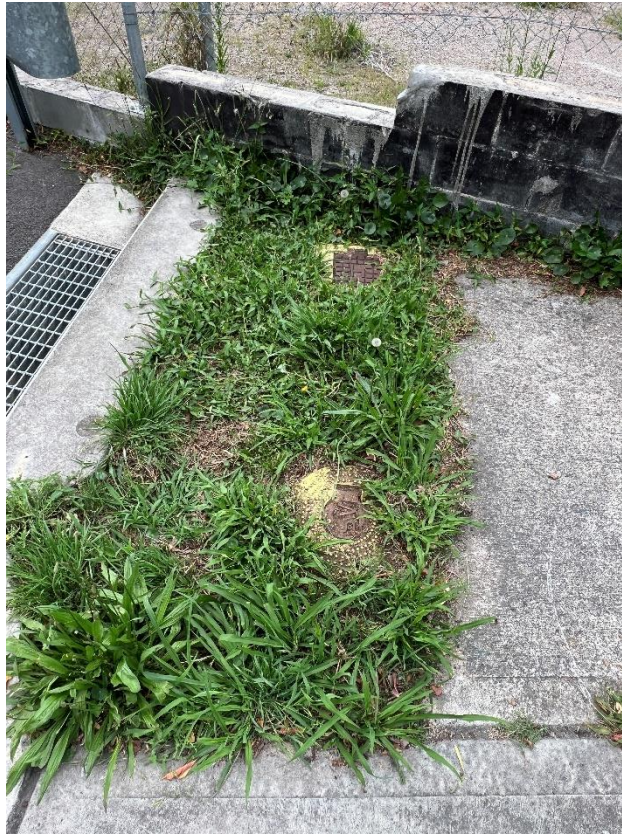
*Figure 67 – General condition of the utility lid.*
