# ARBORICULTURAL IMPACT ASSESSMENT

27 Alan Avenue, Seaforth.

Prepared for: Buck & Simple

Date: February 6<sup>th</sup> 2021.

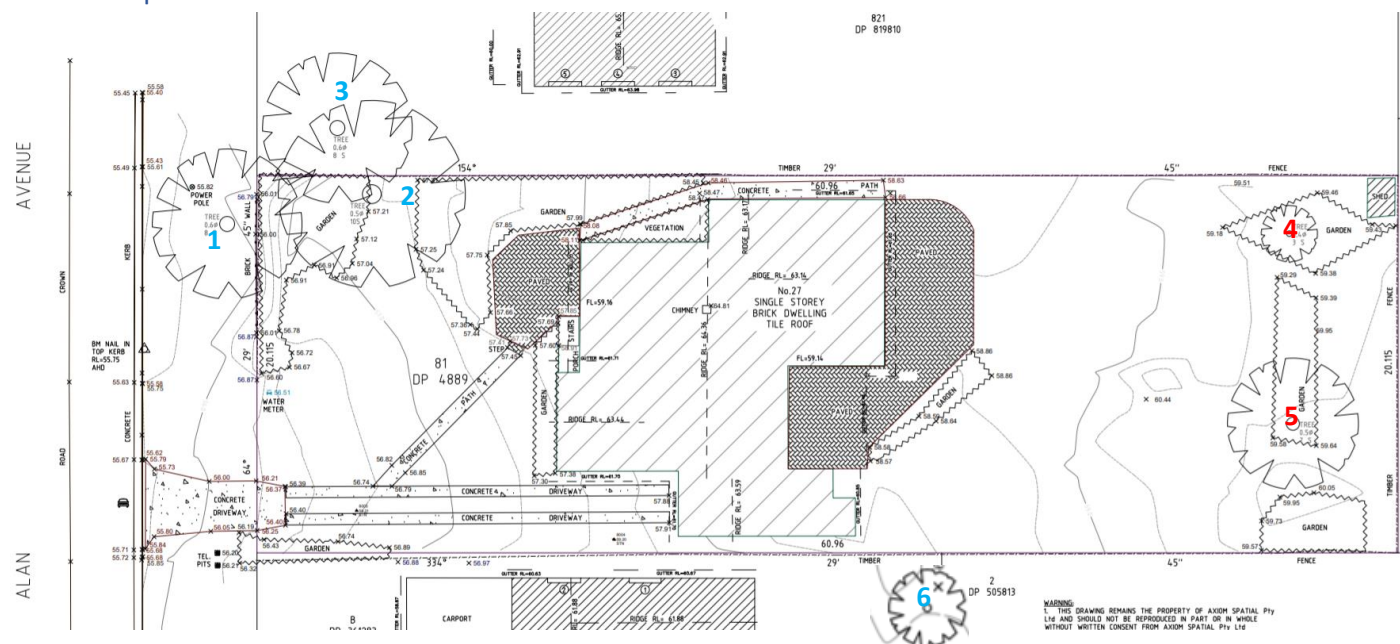
Figure 9-Site survey showing existing dwelling and trees to be retained (blue) and removed (red).

Tree #	Species	Height/spread	TPZ/SRZ	Health & vigour	Structure	Defects	Sig.	U.L.E	Comments
1	<i>Lophostemon confertus</i> -Brush Box	10m 14x8m	8.0m 2.8m	Good	Poor	Poor pruning for power lines	Moderate	15-40 years	Council street tree. Moderate retention value. Driveway crossing 3.6m from centre of tree. May require pruning for driveway clearance.
2	<i>Ficus rubiginosa</i> -Port Jackson Fig	7m 10x8m	4.3m 2.4m	Good	Good	No significant defects	Moderate	15-40 years	2.6m from proposed retaining wall for driveway.
3	<i>Lophostemon confertus</i> -Brush Box	12m 10x9m	7.2m 2.8m	Fair	Good	No significant defects	Moderate	15-40 years	Neighbours tree. 6.6m from proposed retaining wall for driveway.
4	<i>Melaleuca armillaris</i> -Bracelet Honey Myrtle	9m 4 x 4m	3.0m 2.1m	Fair	Fair	Recently exposed by removal of adjacent trees	Low	5-15 years	Poor specimen providing minimal amenity. Would be negatively impacted by the swimming pool area.

5	<i>Eucalyptus nicholii</i> -Narrow-leaved Black Peppermint	8m 10x9m	5.2m 3.0m	Fair	Poor	Dominant stem is dead, remaining leaders poorly attached	Very Low	Hazardous	Exempt species
6	<i>Macadamia integrifolia</i> -Macadamia	8m 6 x 6m	4.9m 2.2m	Good	Poor	Multi-stemmed at 0.5m	Moderate	15-40 years	Neighbours tree. 3.5m back from fence.

Retention value	
High	N/A
Medium	1, 2, 3, 6
Low	4
Very low	5

Proposed for	Tree number
Trees proposed for removal	4, 5
Trees proposed for retention	1, 2, 3, 6

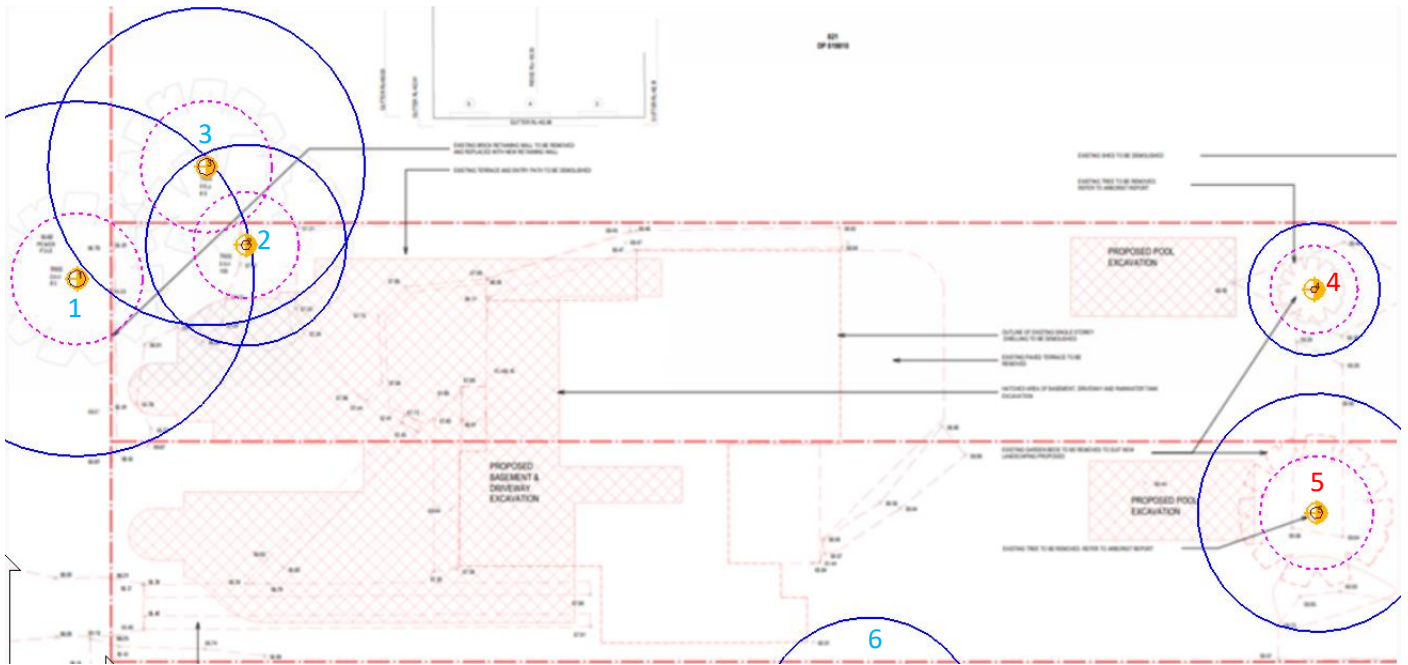
Figure 12- Drawing showing the encroachments upon retained trees (blue numbering) and trees proposed for removal (red numbering).

Tree #	Impacted by
1	Driveway crossing / New masonry front fence /pedestrian entry / Driveway retaining wall
2	Driveway retaining wall / Entry stairs
3	New masonry front fence / Driveway retaining wall / Entry stairs
4	Swimming pool area
5	Swimming pool area
6	Planter boxes / dwelling

Tree one (1) is a council street tree specimen of *Lophostemon confertus*- Brush Box which will be encroached upon by the proposed driveway crossing and retaining wall into lot A and the removal and replacement of the existing front brick fence/retaining wall. The driveway bisects the tree protection zone (TPZ) of tree #1 at 3.6m from the centre of the tree, resulting in a calculated encroachment of around 22%. The front boundary fence is already an established structure so there will be no new encroachment to this area, however tree protection measures to mitigate any potential impacts will be required. The pedestrian entry and driveway retaining wall provide further minor encroachments, however these are relatively minor and given the raised soil levels inside the property boundary, significant tree roots from tree one are unlikely to be impacted. This species of tree is considered as being very tolerant of root disturbance, but non-destructive excavation will be required to assess the roots that will be impacted by the driveway crossing. The front wall will need to be carefully demolished by hand and reinstated using pier and beam or other sensitive construction methods to bridge over and retain any significant roots which are discovered. The demolition of the existing wall and reinstatement of a new wall will require Arborist supervision. Minor pruning of the tree canopy may be required to provide clearance over driveway crossing.

Tree two (2) is a semi-mature *Ficus rubiginosa*- Port Jackson Fig which will suffer an encroachment of approximately 20% from the retaining wall adjacent to the driveway and the steps into the property. The entry steps are to be constructed of timber decking or of lightweight structure to minimise impacts upon tree #2. The footings for the stairs must be individual hand-dug piers and must be supervised by an AQF level 5 Consulting Arborist. All piers must

be located a minimum of 200mm from any significant tree root greater than 50mm in diameter. The portion of the driveway retaining wall which imposes the encroachment to tree two (2) will require non-destructive excavation to assess the number and size of roots that will be affected by the wall. The wall is bordering on the allocated SRZ for this tree. Ficus trees are considered as being tolerant of root disturbance and given its current condition, this level of encroachment is unlikely to have any significant impact upon the tree.

Tree three (3) is a neighbours' *Lophostemon confertus*- Brush Box and will receive a minor encroachment of approximately 5% for the driveway retaining wall and entry stairs and a further 5% for the front boundary wall. This level of encroachment is well within the tolerances for this species of tree and there are unlikely to be any significant impacts.

Tree five (5) is a poorly structured *Eucalyptus nicholii*- Narrow-leaved Black Peppermint which will suffer a major encroachment for the swimming pool terrace and also for the levelling of the rear yard. This tree is an exempt species and also has hazardous structure. This tree will require removal.

1. Trees 4 & 5 should be removed to enable the development to proceed.
2. Trees 1, 2, 3, 6 are currently proposed for retention and protection.
3. Tree protection fencing and signage must be installed in accordance with AS4970-2009 and located as depicted in appendix 3- Tree protection plan.
4. Ground protection and trunk and branch protection will be required for trees 1 & 2, as shown in appendix 3- Tree protection plan.
5. The removal of tree four (4) will result in the need for at least one replacement planting.
6. Three replacement plantings are proposed and at least one should be one of the replacement species shown in appendix 4- Native tree selection.
7. All tree protection measures must be completed in accordance with AS4970-2009, appendix 2 of this report and appendix 3- Tree protection plan.
