ARBORICULTURAL IMPACT ASSESSMENT REPORT

45 Lantana Avenue Wheeler Heights

17th October 2020

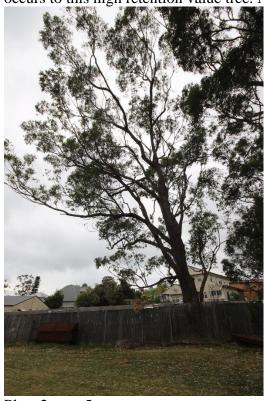
Plate 2: tree 5

3. Tree 5 *Eucalyptus botryoides* shows good vitality with an elevated canopy form, being located in the eastern neighbour's property. The basement excavation has less than 10% encroachment within this tree's TPZ & outside the SRZ – refer Annexure C. It is proposed to construct dwelling 1 on piers to avoid increasing the development impacts on this tree – refer Annexure C. Plus the landscaping shall be low level impact by using permeable pavement and soft landscape features. By employing these design considerations retention of this tree will be achieved. All works within the TPZ shall be under the direct supervision of the Project Arborist to ensure no damage occurs to this high retention value tree. Note for retention and protection in the TMP.

- a) Remove the following exempt trees on site: Tree 1, 3, 4, 8 & 9.
- b) Remove the following tree on site: Tree 2 & 10.
- c) Retain the following trees on site: Tree 6, 7, 11, 12.
- d) Retrain the following neighbour's trees: Tree 5 & 13.
- e) Tree removal work shall be carried out by an experienced tree surgeon in accordance with Safe Work Australia Guide for Managing Risks of Tree Trimming and Removal (2016).
- f) Trunk protection shall consist of a padding material such as hessian or thick carpet underlay wrapped around the trunk. Timber planks (50mm x 100mm or similar) shall be placed over the padding and around the trunk of the tree at 150mm centres. The planks shall be secured with 8-gauge wire or hoop steel at 300mm spacing. Trunk protection shall extend a minimum height of 2 metres on Tree 7– refer Annexure D.

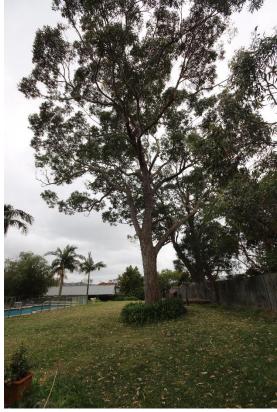
Plate 3: tree 7

- 5. Tree 7 *Eucalyptus botryoides* shows good vitality with an elevated canopy form, being located in the middle east of the site refer plate 3. The basement has been designed to have less than 10% encroachment within this high retention value tree refer Annexure C. The landscaping shall be low level impact by using permeable pavement and soft landscape features. By employing these design considerations retention of this tree will be achieved. All works within the TPZ shall be under the direct supervision of the Project Arborist to ensure no damage occurs to this high retention value tree. Note for retention and protection in the TMP.

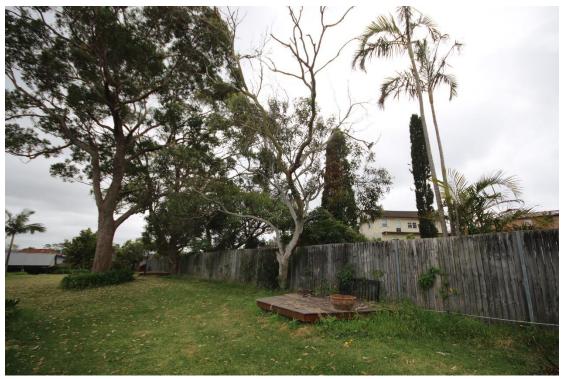
Plate 4: tree 10

6. Tree 10 *Eucalyptus haemastoma* is in declining vitality with over 40% of it's branches and foliage being dead or dying – refer plate 4. It is better to remove this tree as part of the site establishment and then replant another tree in the landscape works which will have greater longevity. Note this tree for removal in the TMP with a replacement tree.
