Report Title: Geotechnical Report 171D Barrenjoey Road, Newport  
Report Date: 25/6/21  
Author: BEN WHITE  
Author's Company/Organisation: WHITE GEOTECHNICAL GROUP PTY LTD

## **171D Barrenjoey Road, Newport**

### **Minor Works Assessment**

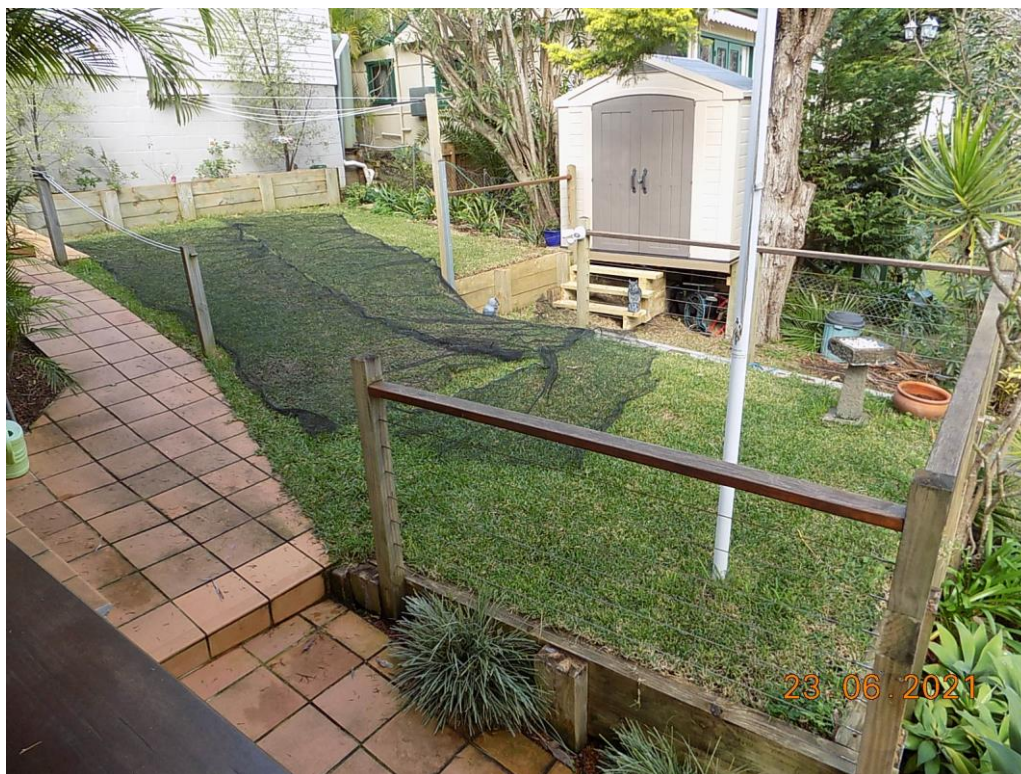
Photo 4

walls reaching a maximum height of ~1.1m (Photo 4). Filling has been placed on the N side of the pool for a tile-paved area. The fill is supported by a concrete block retaining wall ~1.0m high (Photo 5). See **Section 3** for recommendations regarding this wall. The slope above the property eases to the crest of the slope. The slope below the property eases to more gentle angles and appears in good order as observed from the subject property. The likelihood of the land surface on or above the property failing and impacting on the house is assessed as 'Unlikely' ( $10^{-4}$ ). The consequences to property of such a failure are assessed as 'Medium' (15%). The risk to property is 'Low' ( $2 \times 10^{-5}$ ).

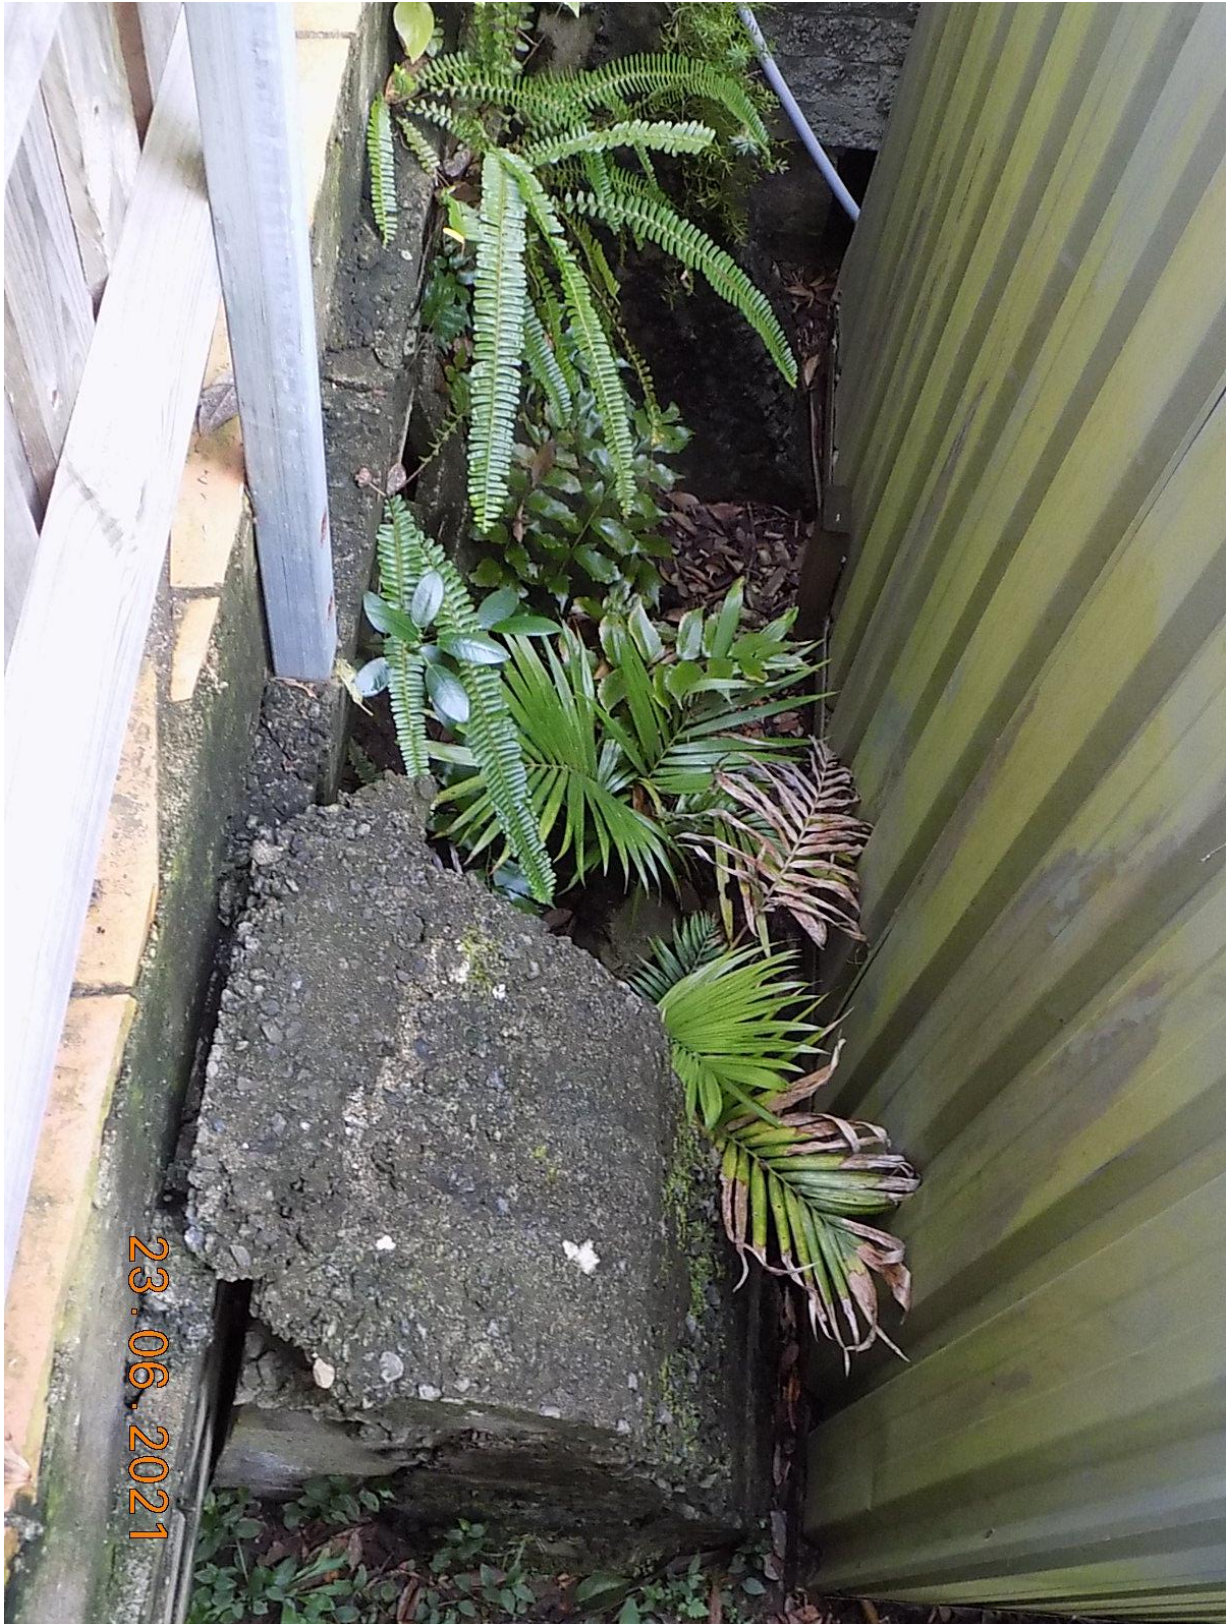
Photo 5

Apart from the retaining wall supporting the fill for the tile-paved area on the N side of the pool, the retaining walls on the property are in good condition.

The retaining wall supporting the tile-paved fill on the N side of the pool was observed to be tilting slightly downslope. The wall appears to have been remediated in the past with two concrete block buttresses. The N buttress has separated from the wall and is tilting downslope. To be prudent, we recommend the retaining wall be inspected by the owners on an annual basis or after heavy prolonged rainfall, whichever occurs first, keeping a photographic record of the inspections. We can carry out these inspections upon request. Should any new movement be observed, the retaining wall is to be remediated or rebuilt to current engineering standards.
