Site Classification:

New House at **Lot 2, 6-6A Orchard Street, Warriewood**

The aim of this assessment is to classify the site in accordance with AS2870-2011 and to provide footing recommendations.

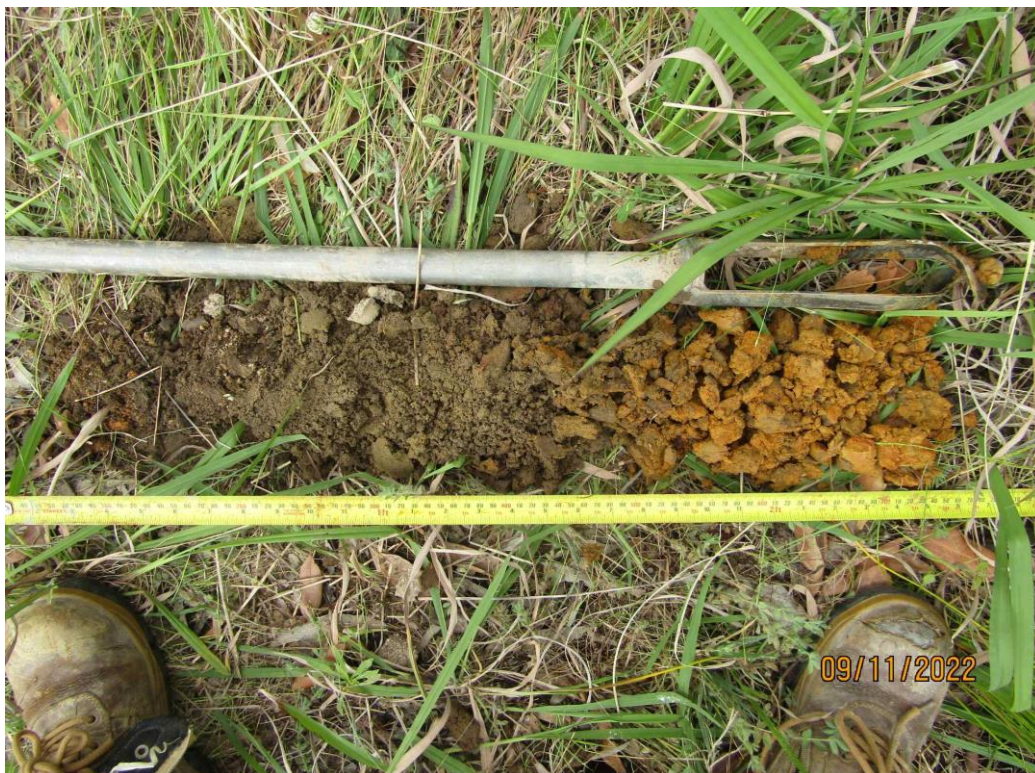
AUGER HOLE 1 (~RL19.6) – AH1 (Photo 1)

Depth (m)	Material Encountered
0.0 to 0.5	FILL , sandy soil, with rock and concrete fragments, brown, orange, grey, dry to moist, fine to coarse grained.
0.5 to 0.8	CLAY , light orange, firm to stiff, moist.

End of hole @ 0.8m in firm to stiff clay. No watertable encountered.

Photo 1: AH1 – Downhole is from left to right.
