Report Title: Geotechnical Report 60-62 Chisholm Avenue, Avalon Beach
Report Date: 4/3/21

GEOTECHNICAL INVESTIGATION:

New Driveway and Garage at **60-62 Chisholm Avenue, Avalon Beach**

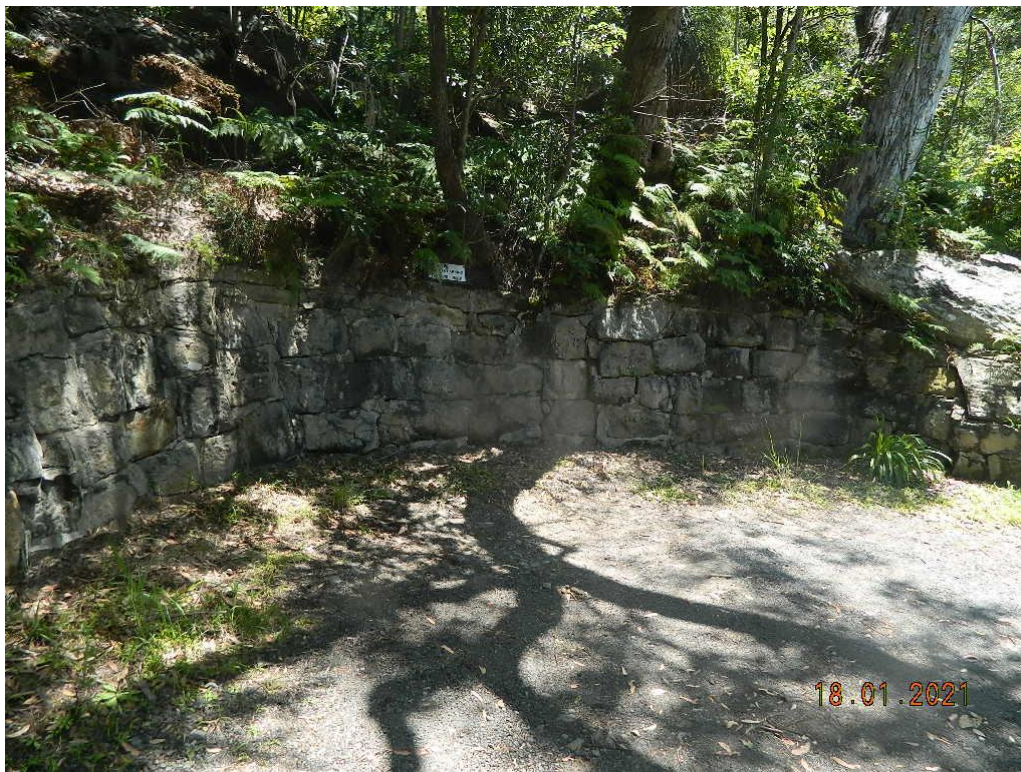
Photo 1

- 2.3** A turning circle is located at the road frontage (Photo 1). The cut for the road and turning circle is supported by a sandstone block retaining wall up to ~1.5m high. The wall displays bulging in places (Photos 2 & 3). See 'Section 16 Ongoing Maintenance'. Medium Strength Hawkesbury Sandstone Bedrock is outcropping at the road frontage (Photo 4). Sandstone bedrock is exposed at the surface and dislodged joint blocks are embedded in stable positions in the steep vegetated slope between the road frontage and the houses (Photos 5 to 7).

Part of the bulging sandstone block retaining wall (Photos 1 to 3) will be demolished as part of the proposed works. The remaining portion is in poor condition. It is recommended it be repointed/rebuilt to meet current engineering standards as part of the works, if this is not already planned.

The excavation requires the removal of an existing sandstone block retaining wall (Photo 1). The wall is to be demolished from the top down prior to the excavation commencing. The soil and

clay behind the wall is to be lowered and battered at 1.0 Vertical to 1.7 Horizontal (30°) as the wall is demolished.

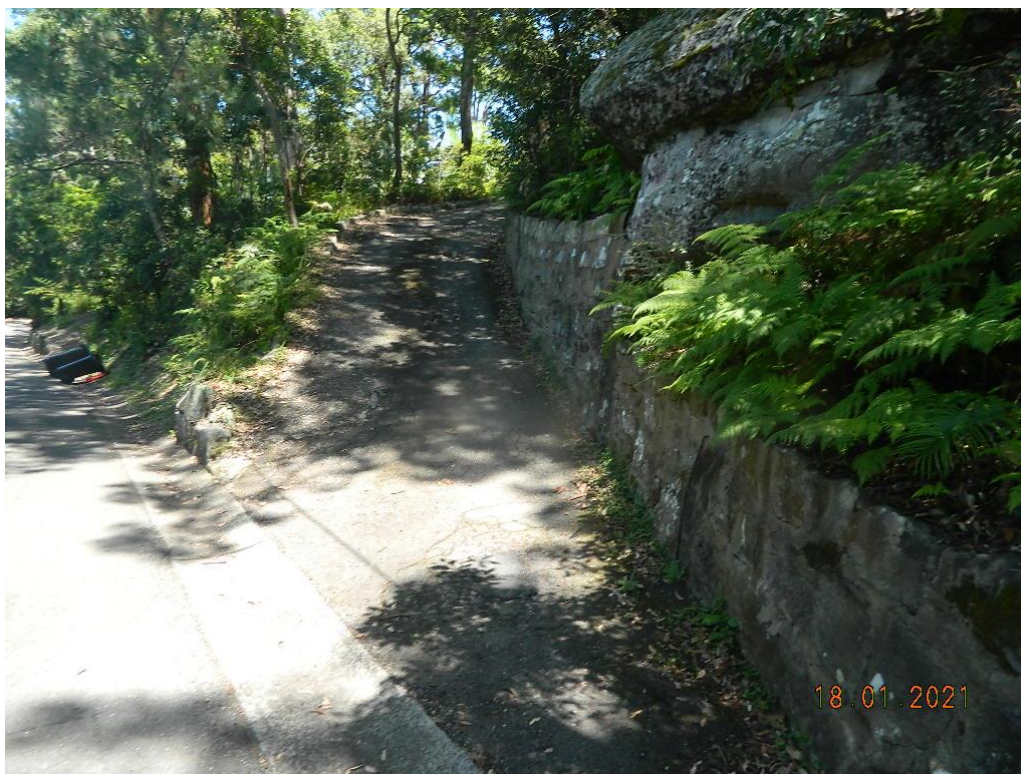
Photo 8

The house at 62 Chisholm Ave is accessed by a bitumen right of carriageway (ROW) and sandstone driveway (Photos 8 & 9). A sandstone dressed concrete block garage in good condition is located on the W side of the house (Photo 10). The old single storey sandstone block house is supported by sandstone block walls and sandstone piers (Photo 11). The supporting walls and piers stand vertical and display no significant signs of movement (Photo 12). The house is supported on exposed sandstone bedrock on the crest of the slope. A moderately sloping lawn on the NW side of the house is terraced by stable sandstone block retaining walls up to ~1.5m high. Sandstone bedrock is outcropping on the steep slope on the NW side of the property. A portion of the rock is undercut by up to ~3.5m (Photos 13 & 14). The undercut has a relatively thin cantilever arm in relation to its overhang length however has stood in its present state for at least hundreds of years. In the unlikely event that the undercut fails, it will fall onto the area immediately below. Given the location of the undercut and provided no one spends time under it, it is not considered a significant threat to life or property.

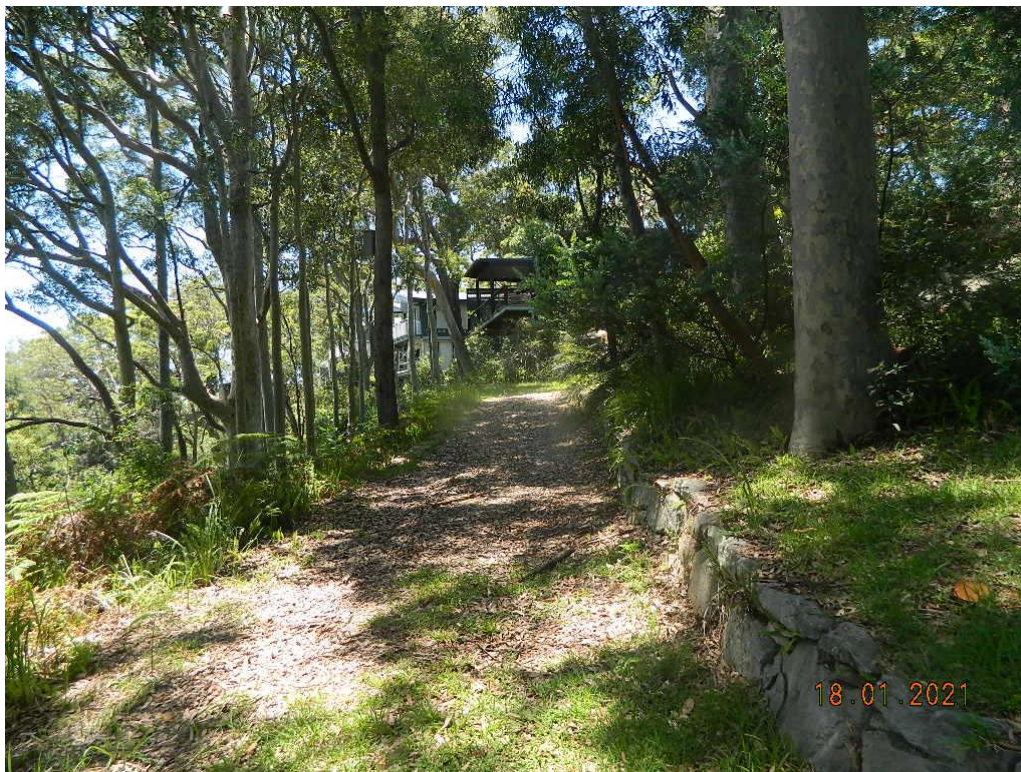
Photo 15

The ROW extends to the house at 60 Chisholm Ave (Photo 15). A pool in good condition is located on the W side of the house (Photo 16). A stable sandstone block retaining wall up to ~2.2m high supports fill on the downhill side of the pool. The part two storey timber clad house is supported by steel posts and concrete block walls (Photos 17 & 18). The supporting posts and walls stand vertical and show no significant signs of movement.
