“GROWING MY WAY”

Construction Impact & Management Statement

November 2020

Site:	Lot 5 in DP 16260 1 Yachtview Avenue NEWPORT, NSW
Client:	Paul Godfrey & Vanessa Naderi c/ Michael Finch 1 Yachtview Avenue NEWPORT, NSW 2106
Author:	Kyle A Hill Registered (Arb Aus #1884) Practising & Consulting Arborist Post Graduate Certificate in Arboriculture, Uni of Melb Diploma of Horticulture-Arboriculture TAFE, Grow SA Certificate of Horticulture, TAFE Certificate Advanced Tree Care TAFE Founder -Growing My Way Tree Services (1977) Member of International Society of Arboriculture Member of Arboriculture Australia

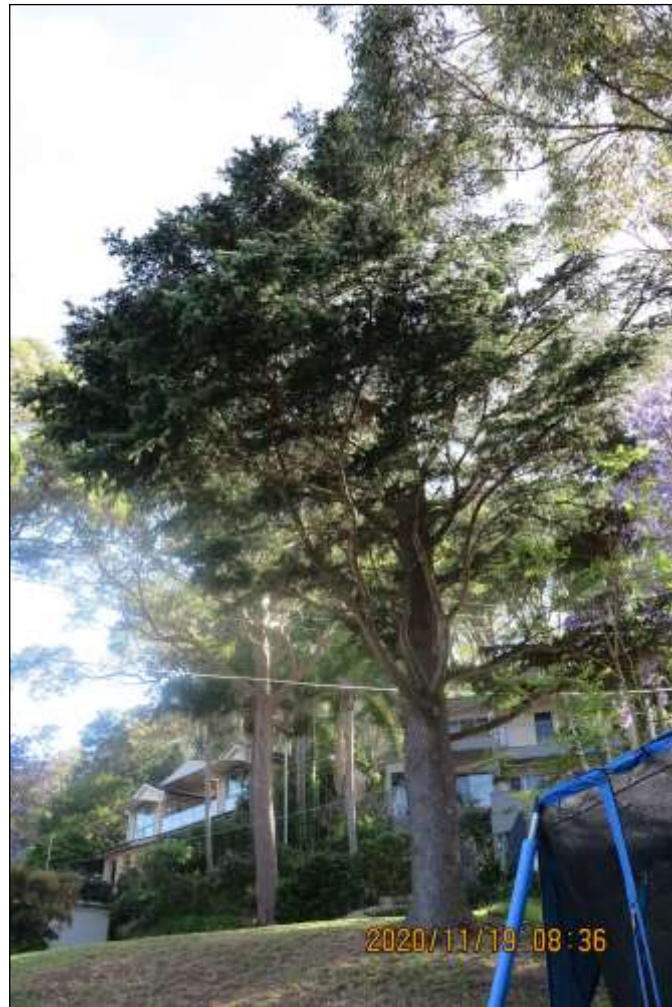
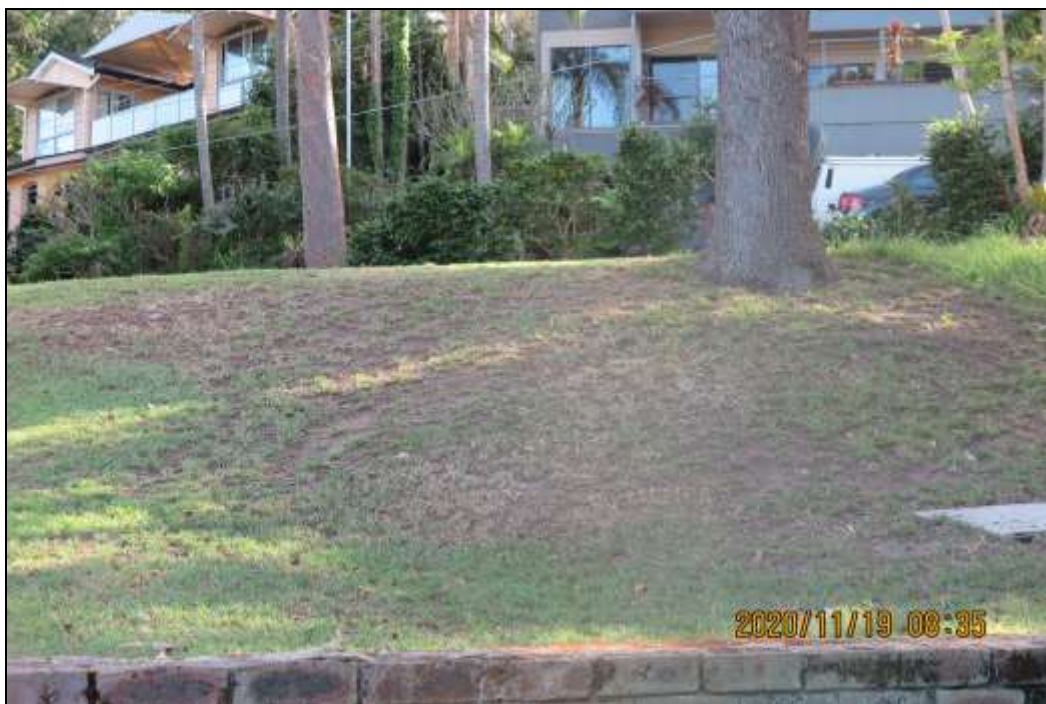
Figure 6: Illustrates condition & location of discussed Tree #1.

Identification	Height (m)	Crown (m)	DBH (m)	TPZ (m)	SRZ (m)	Age	Health/Vigour	Structure	Significance/Retention Values	Comments
1	<i>Cedrus deodara</i> Himalayan Cedar	<14.00	<9.00	0.58	6.96	2.78	Mature	Good & Good	Typical/ Crown Raised Pruned	Moderate/ Moderate	Replace: The as proposed works equate to a mathematical ‘major encroachment’ of the total TPZ surface area. This is considered as likely to adversely impact upon the ULE of this tree. As such, the local environment would benefit from a new locally indigenous tree being planted as a replacement within the subject site.
2	<i>Viburnum odoratissimum</i> (x3) Viburnum <i>Radermachera sinica</i> (x1) China Doll	<3.50 <5.00	N/A	N/A	N/A	N/A	Mature	Good & Good	Typical	Moderate/ Moderate	Retain, Protect & Manage: Tree/Shrubs within adjoining lands. Located significantly lower than the existing/proposed subject site ground level changes. No TPZ fencing is specified as existing masonry common boundary retaining wall isolates these plants from the as proposed works.

Discussed Tree #1 is confirmed to be approximately 2.55m from the as proposed new entry stairs. The proposed works equate to an *Australian Standard (AS4970-2009 Protection of trees on development sites)* 'Major Encroachment', i.e. way greater than a potentially acceptable 10% of total Tree Protection Zone surface area (152.18m²). Additionally, the proposed works breach the tree's calculated Structural Root Zone radial distance of 2.78m by approximately 250mm (0.25m). This fact, combined with the Tree Protection Zone radial distance of 6.96m being subjected to the described 'Major Encroachment' is at a desktop level unacceptable.

Taking the proposed works & the discussed tree Genus/species into consideration; it is best to propose Tree #1 to be replaced with respect to the as proposed works & the NBC objective of over the long term increasing the total 'Green Footprint' within the NBC local government area.

It is possible this tree may be retained if the required excavation for the as proposed new entry from road reserve to main entry for dwelling does not require the severance of significant diameter (defined as being greater than 50mm in diameter) 'live supporting/structural roots'.

- Tree Removal must be undertaken by suitably experienced & qualified tree removal practitioners in compliance with the abide at all times to the "*WorkCover NSW Industry Code of Practice, (1998)*".
- New tree specimens are to be sourced from growers/suppliers whose stock meets the production benchmarks of the *Australian Standard (AS2303.2015 Tree stock for landscape use)*.
- New tree specimens are to be professionally planted & maintained for a minimum period of six (6) months once installed.

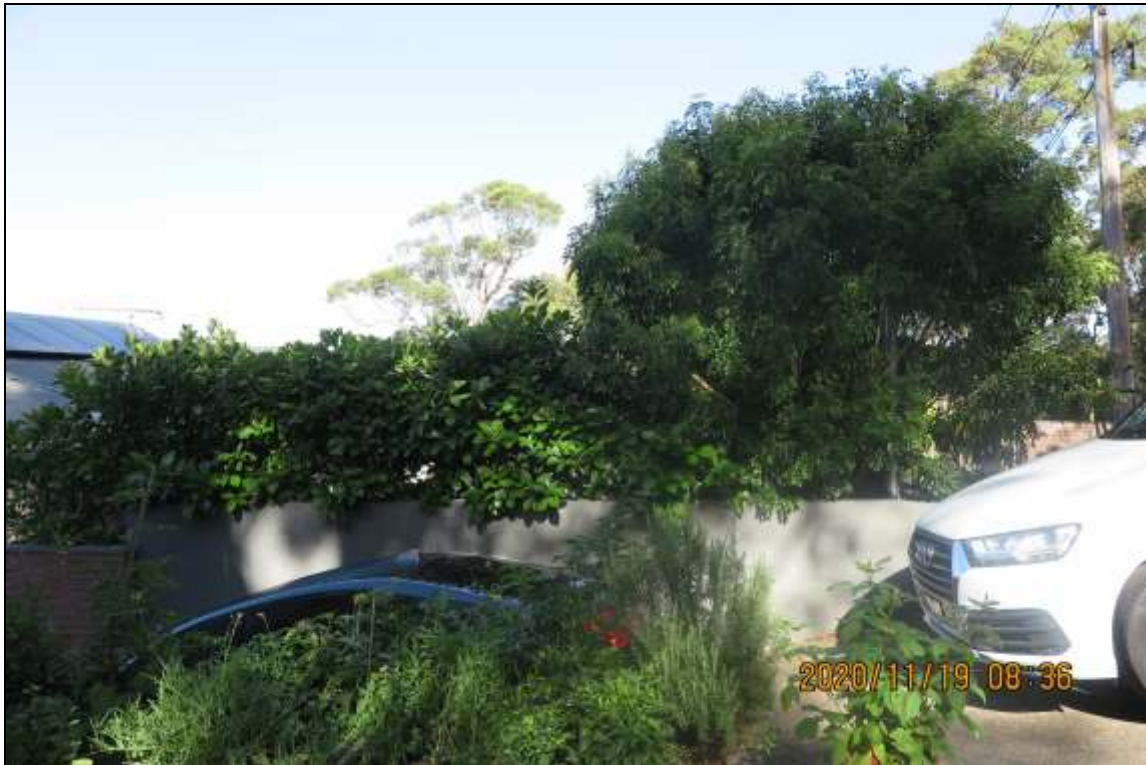
Figure 7: Illustrates adjoining property trees/shrubs. Note: existing damage to common boundary masonry retaining wall/subject site concrete driveway.

Tree/Shrubs located within the adjoining 2 Yachtview Avenue property are confirmed to be totally separated/isolated from the subject site as proposed works by the existing common boundary masonry retaining wall. As such, no management specification or further discussion is required.
