Report Title: Geotechnical Report 13 Minkara Road, Bayview

Report Date: 3/6/19

GEOTECHNICAL INVESTIGATION:

New Shed, Tennis Court, Carport, and Awning at **13 Minkara Road, Bayview**

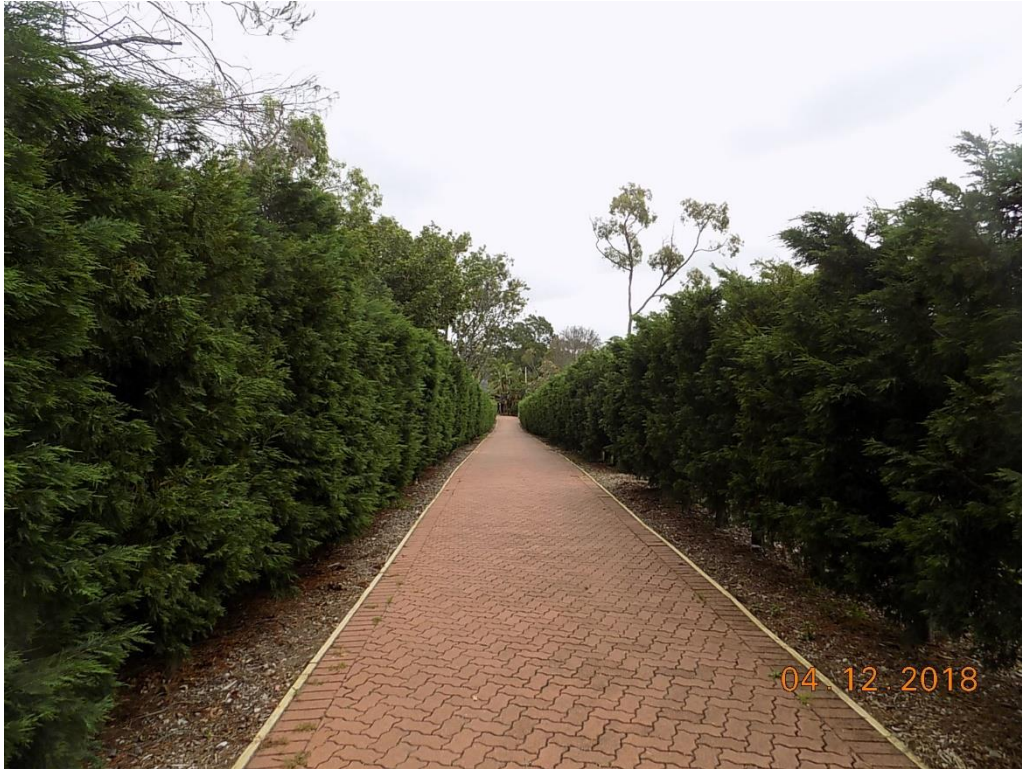
Photo 1

- 2.3** At the road frontage, a long brick driveway runs across the slope to the property (Photo 1). The driveway runs to a parking area on the E side of the site, garages on the E side of the office (Photo 2), and to a carport and parking area on the uphill side of the house (Photo 3). A dam has been constructed in the SE corner of the

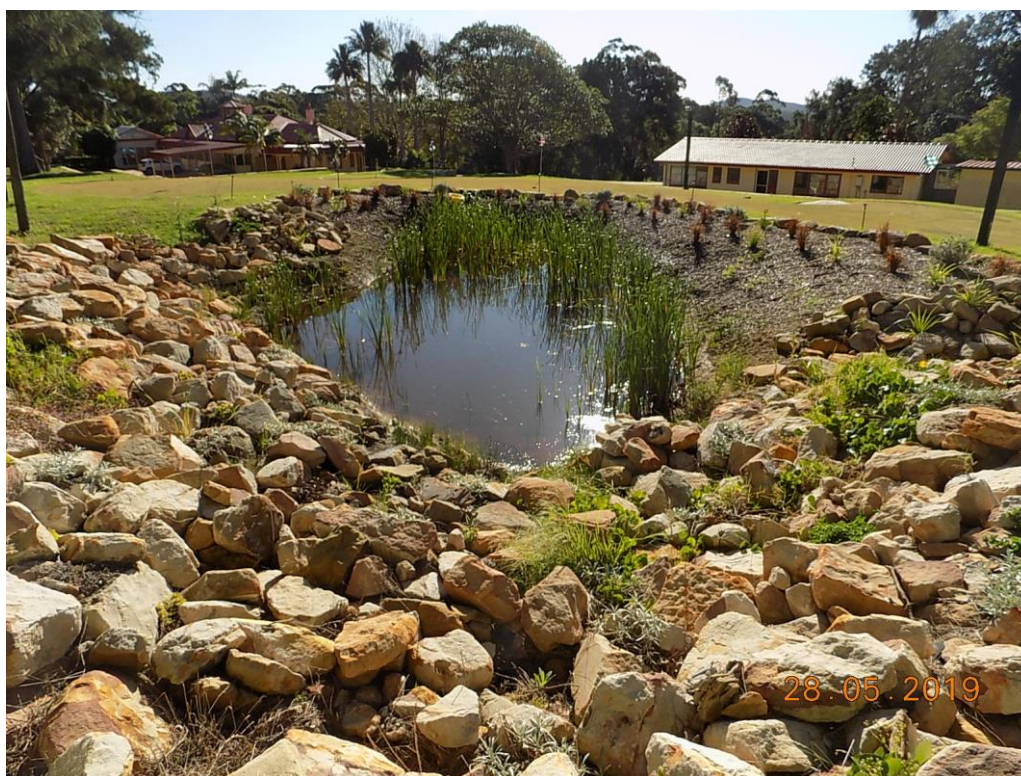
Photo 4

property (Photo 4). The dam recently went through the council approval process that involved this firm and it is currently considered stable. An excavation has been made in the slope for the house and office buildings. The cut is supported by a stable ~1.5m high sandstone block retaining wall (Photo 5). A pool has been cut into the slope to the W of the house (Photo 6). The water level of the pool indicates no ground movement has occurred in the shell of the pool since its construction. A creek runs down and under the W side of the property (Photo 7). A stable timber outbuilding has been constructed in the SW corner of the property (Photo 8). A large lawn area encompasses the majority of the downhill side of the property (Photo 9). Another dam has been constructed near the entrance to the property that will be removed as part of the proposed works (Photo 10). Competent Medium Strength Sandstone outcrops above this dam (Photo 11). The earthworks for the proposed tennis court (including a cut and fill) had already been completed prior to our first inspection (Photo 12). The earthworks were subject to a separate approval process and are currently considered stable.

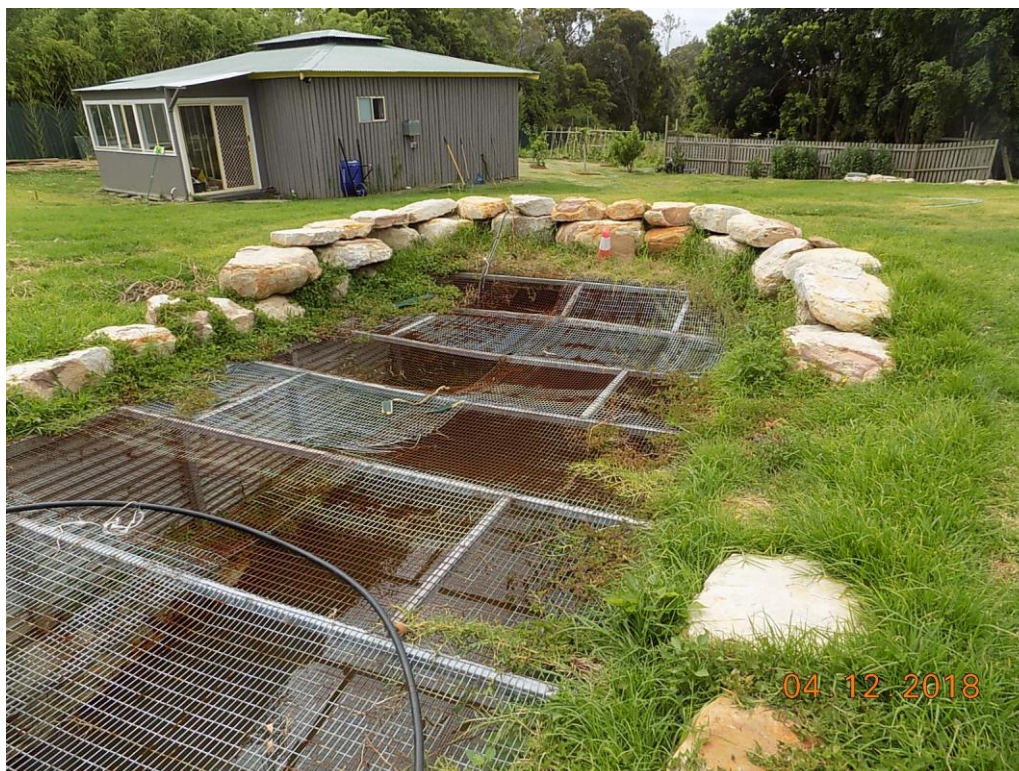
Photo 7

Ground water seepage is expected to move over the buried surface of the rock and through the cracks. As a creek flows down the W side of the block (Photo 7), we expect groundwater seepage to be slightly higher across the block as slope seepage will move toward the creek. Due to the slope and elevation of the block, the water table is expected to be many metres below the base of the proposed excavation.

Apart from the flowing creek down the W side of the site, no evidence of surface flows were observed on the property during the inspection. It is expected that normal sheet wash will move onto the site from above the property during heavy down pours.

There is fall to the creek that runs down the W side of the property (Photo 7). Roof water from the development is to be piped to the creek through any tanks that may be required by the regulating authorities. A diffuser is to be installed at the outlet of any new stormwater pipes that divert stormwater to the creek channel.

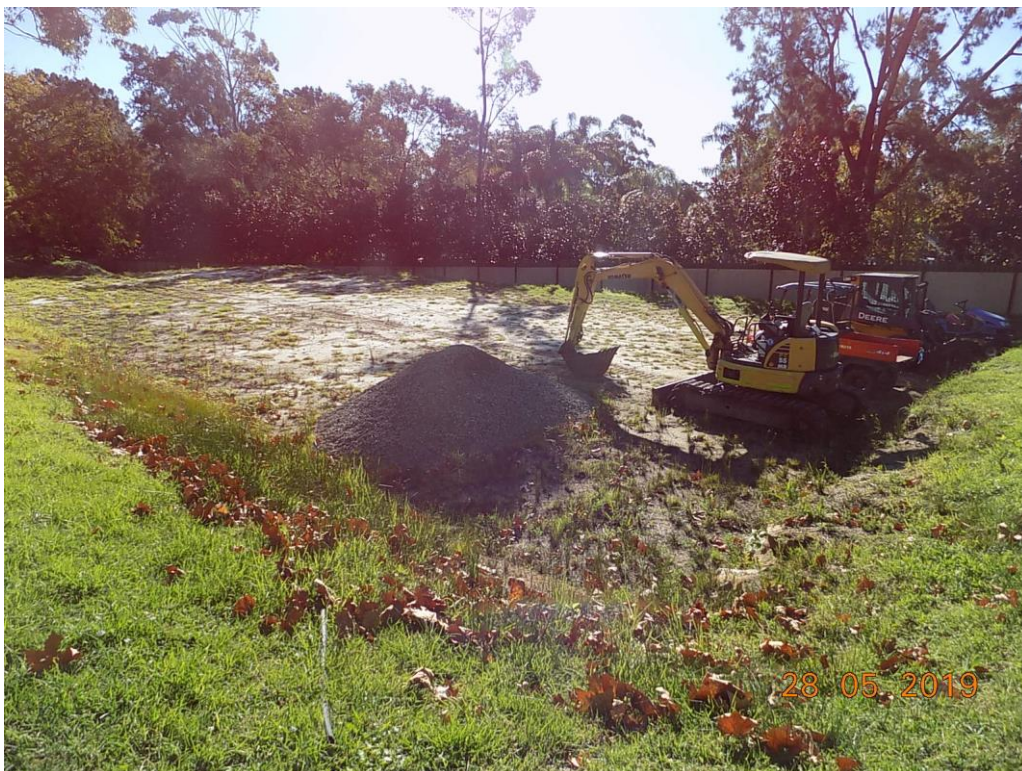
Photo 12

The earthworks for the proposed tennis court consist of a cut and fill (Photo 12). Competent Medium Strength Sandstone was observed to be outcropping through the low cut and DCPs 1 & 2 confirm that the sandstone underlies the surface at shallow depths across the uphill

side. The ground tests confirm that the fill placed across the downhill side has been adequately compacted to a consistency of hard clay/weathered rock. The fill overlies the natural surface at a maximum depth of ~1.2m. Medium Strength Sandstone was then encountered at a maximum depth of ~2.4m below the current surface.

The density testing that was carried out on the earthworks for the proposed tennis court confirmed the fill has been adequately compacted for a maximum allowable bearing pressure of 100kPa.

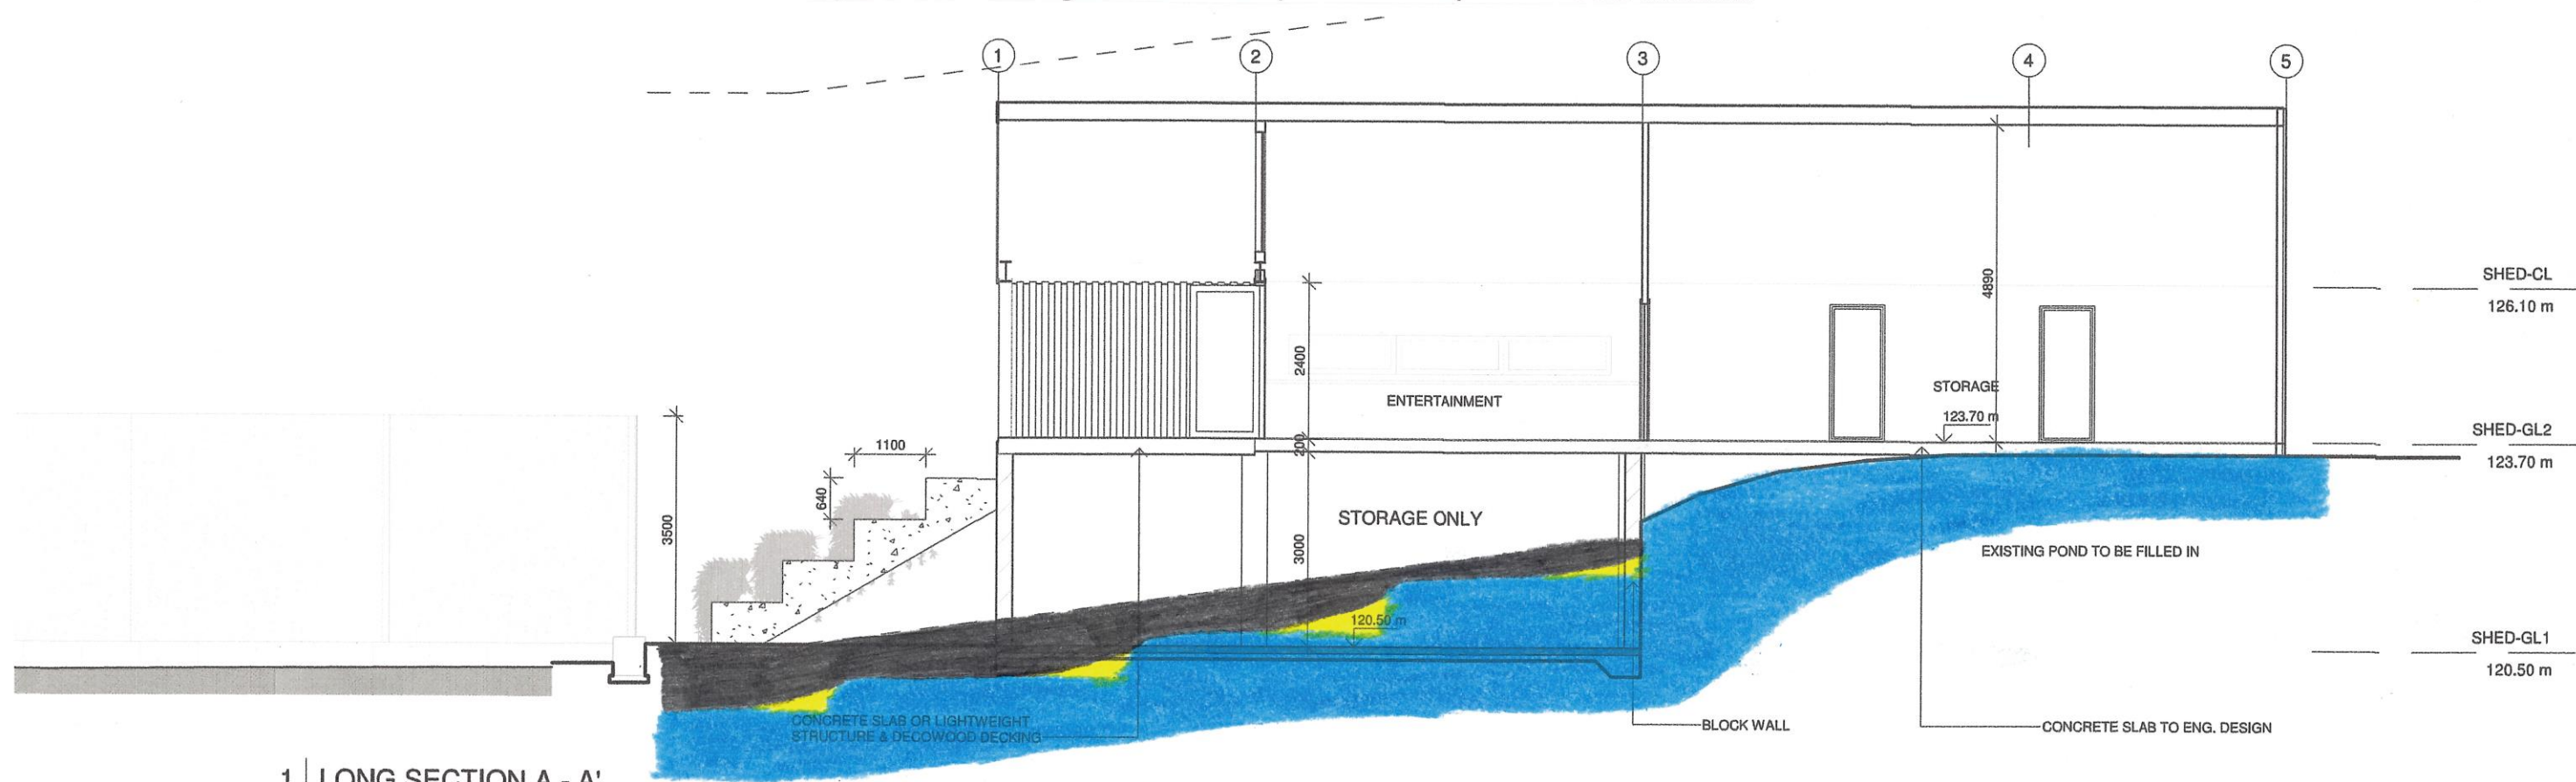
TYPE SECTION – Diagrammatical Interpretation of expected Ground Materials

The surface features of the block are controlled by the outcropping and underlying sandstone bedrock that steps down the property forming sub-horizontal benches between the steps. Where the grade is steeper, the steps are larger, and the benches narrower. Where the slope eases, the opposite is true. Where the rock is not exposed, it is overlain by natural sandy soils and firm to stiff sandy clays that fill the bench step formation. In DCPs 5 to 12, where it was not exposed, rock was encountered at depths of between 0.1 to 0.9m below the current surface, being slightly deeper due to the stepped nature of the underlying rock. The exposed sandstone across the site is estimated to be Medium Strength and a similar strength rock is expected to underly the entire site. See Type Section attached for a diagrammatical representation of the expected ground materials.
