## CLEARANCE CERTIFICATE

Project: 4 Cross Street, Brookvale  
Job Number: 47537

**PROJECT: 4 Cross Street, Brookvale**
**JOB NO: 47537**
**CLIENT DETAILS**

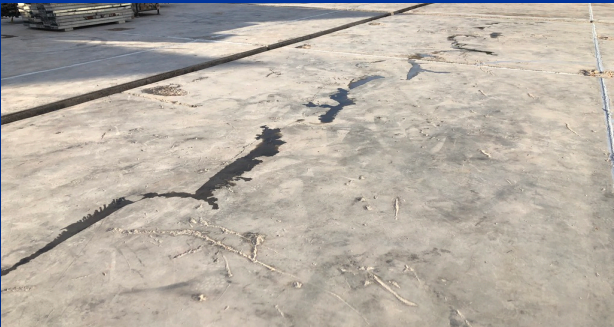
**Photo 1**

Surface of slab following removal of building

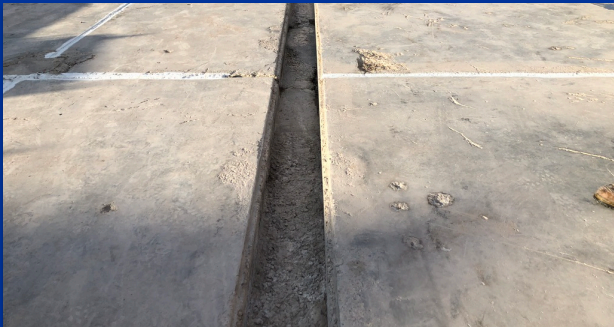
**Photo 2**

Surface of slab following removal of building

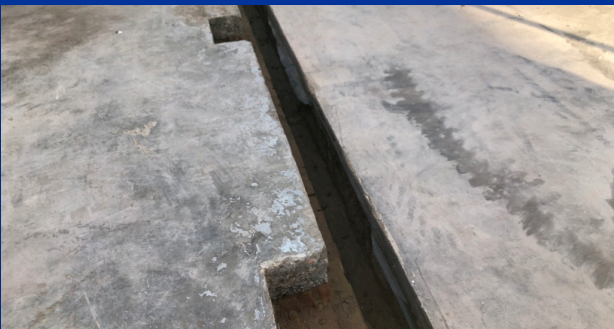
**Photo 3**

Surface of slab following removal of building

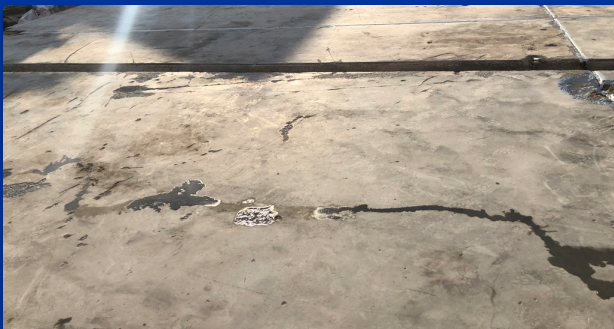
**Photo 4**

Surface of slab following removal of building

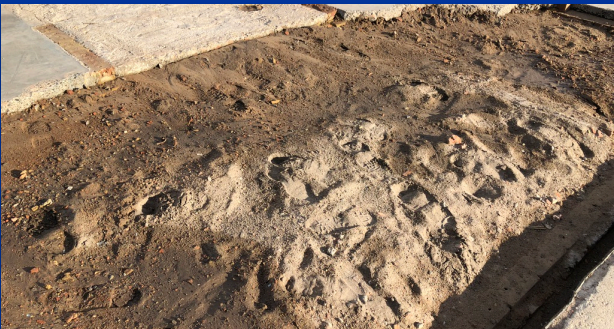
**Photo 5**

Heavily damaged sections of the slab have been removed

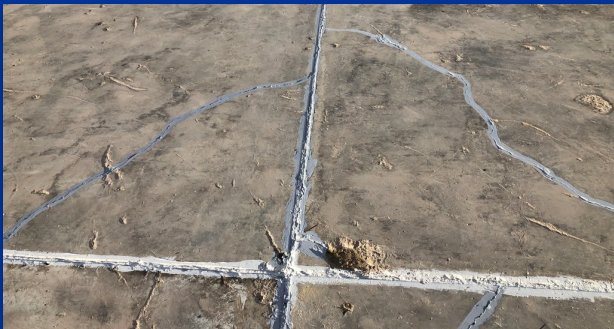
**Photo 6**

Porous bituminous membrane expansion joints remain in situ within the slab. This material has been encapsulated with ermaclad paint. This material is outside the scope of works and is not covered by this clearance certificate.

Expansion joints have been encapsulated
