## **63 Marine Parade, Avalon**

### Geotechnical Comments for Section 4.55

## **GEOTECHNICAL INVESTIGATION:**

### **Alterations & Additions at 63 Marine Parade, Avalon**

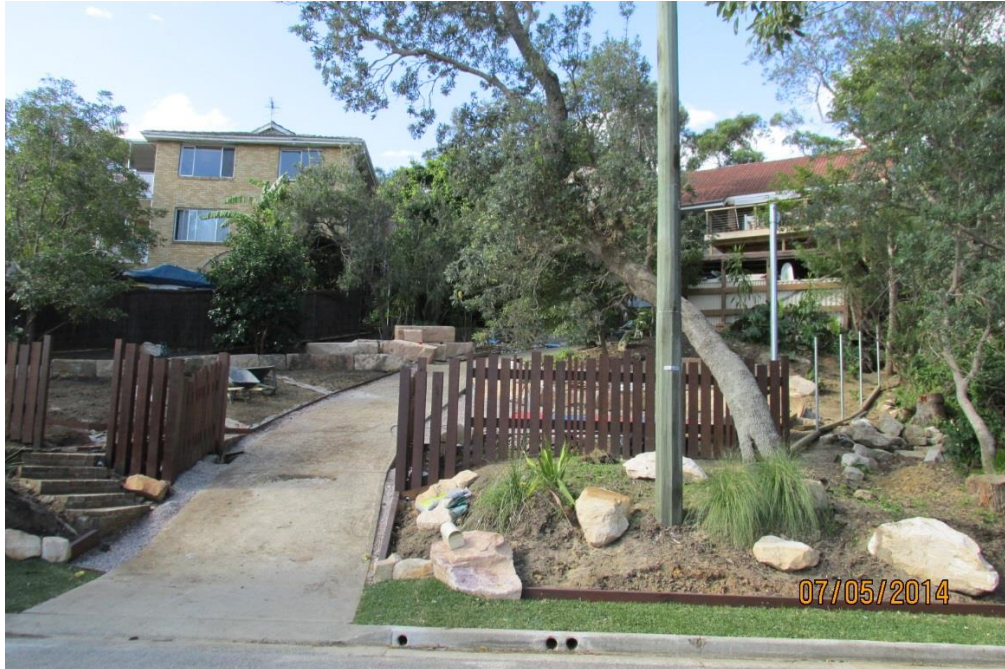
Photo 1

- 2.3 At the road frontage a concrete paved driveway climbs the slope to a brick carport below the house (Photo 1 & 2). The carport is constructed over a cut and fill in the slope. The cut is supported by a brick wall. The fill merges into the natural slope. The house is a two storey brick structure and has also been supported on a cut and fill. At the higher northern side sandstone bedrock is exposed in the cut. At the southern downhill corner some settlement is evident in the exterior supporting wall, where it is likely supported on the fill (Photo 3). On the uphill side of the house a cut has been made in the slope to provide a lawn area. The cut is supported by a brick wall that has cracked and tilted (Photo 4). This wall will be replaced as part of the works. Above the wall sandstone bedrock that caps the cliff outcrops and rises to the crest of the slope. At the crest the surface is level for ~10m before the cliff drops to the ocean (Photo 5). The top half of the face is horizontally bedded sandstone with shale beds forming the lower half (Photo 6). Some minor undercutting was observed through the upper sandstone beds but the majority of the face within the property contained no undercutting and is considered stable. The base of the cliff is protected from the erosive forces of wave action by the rock platform and boulders that have accumulated at the base of the cliff as part of the normal weathering process.

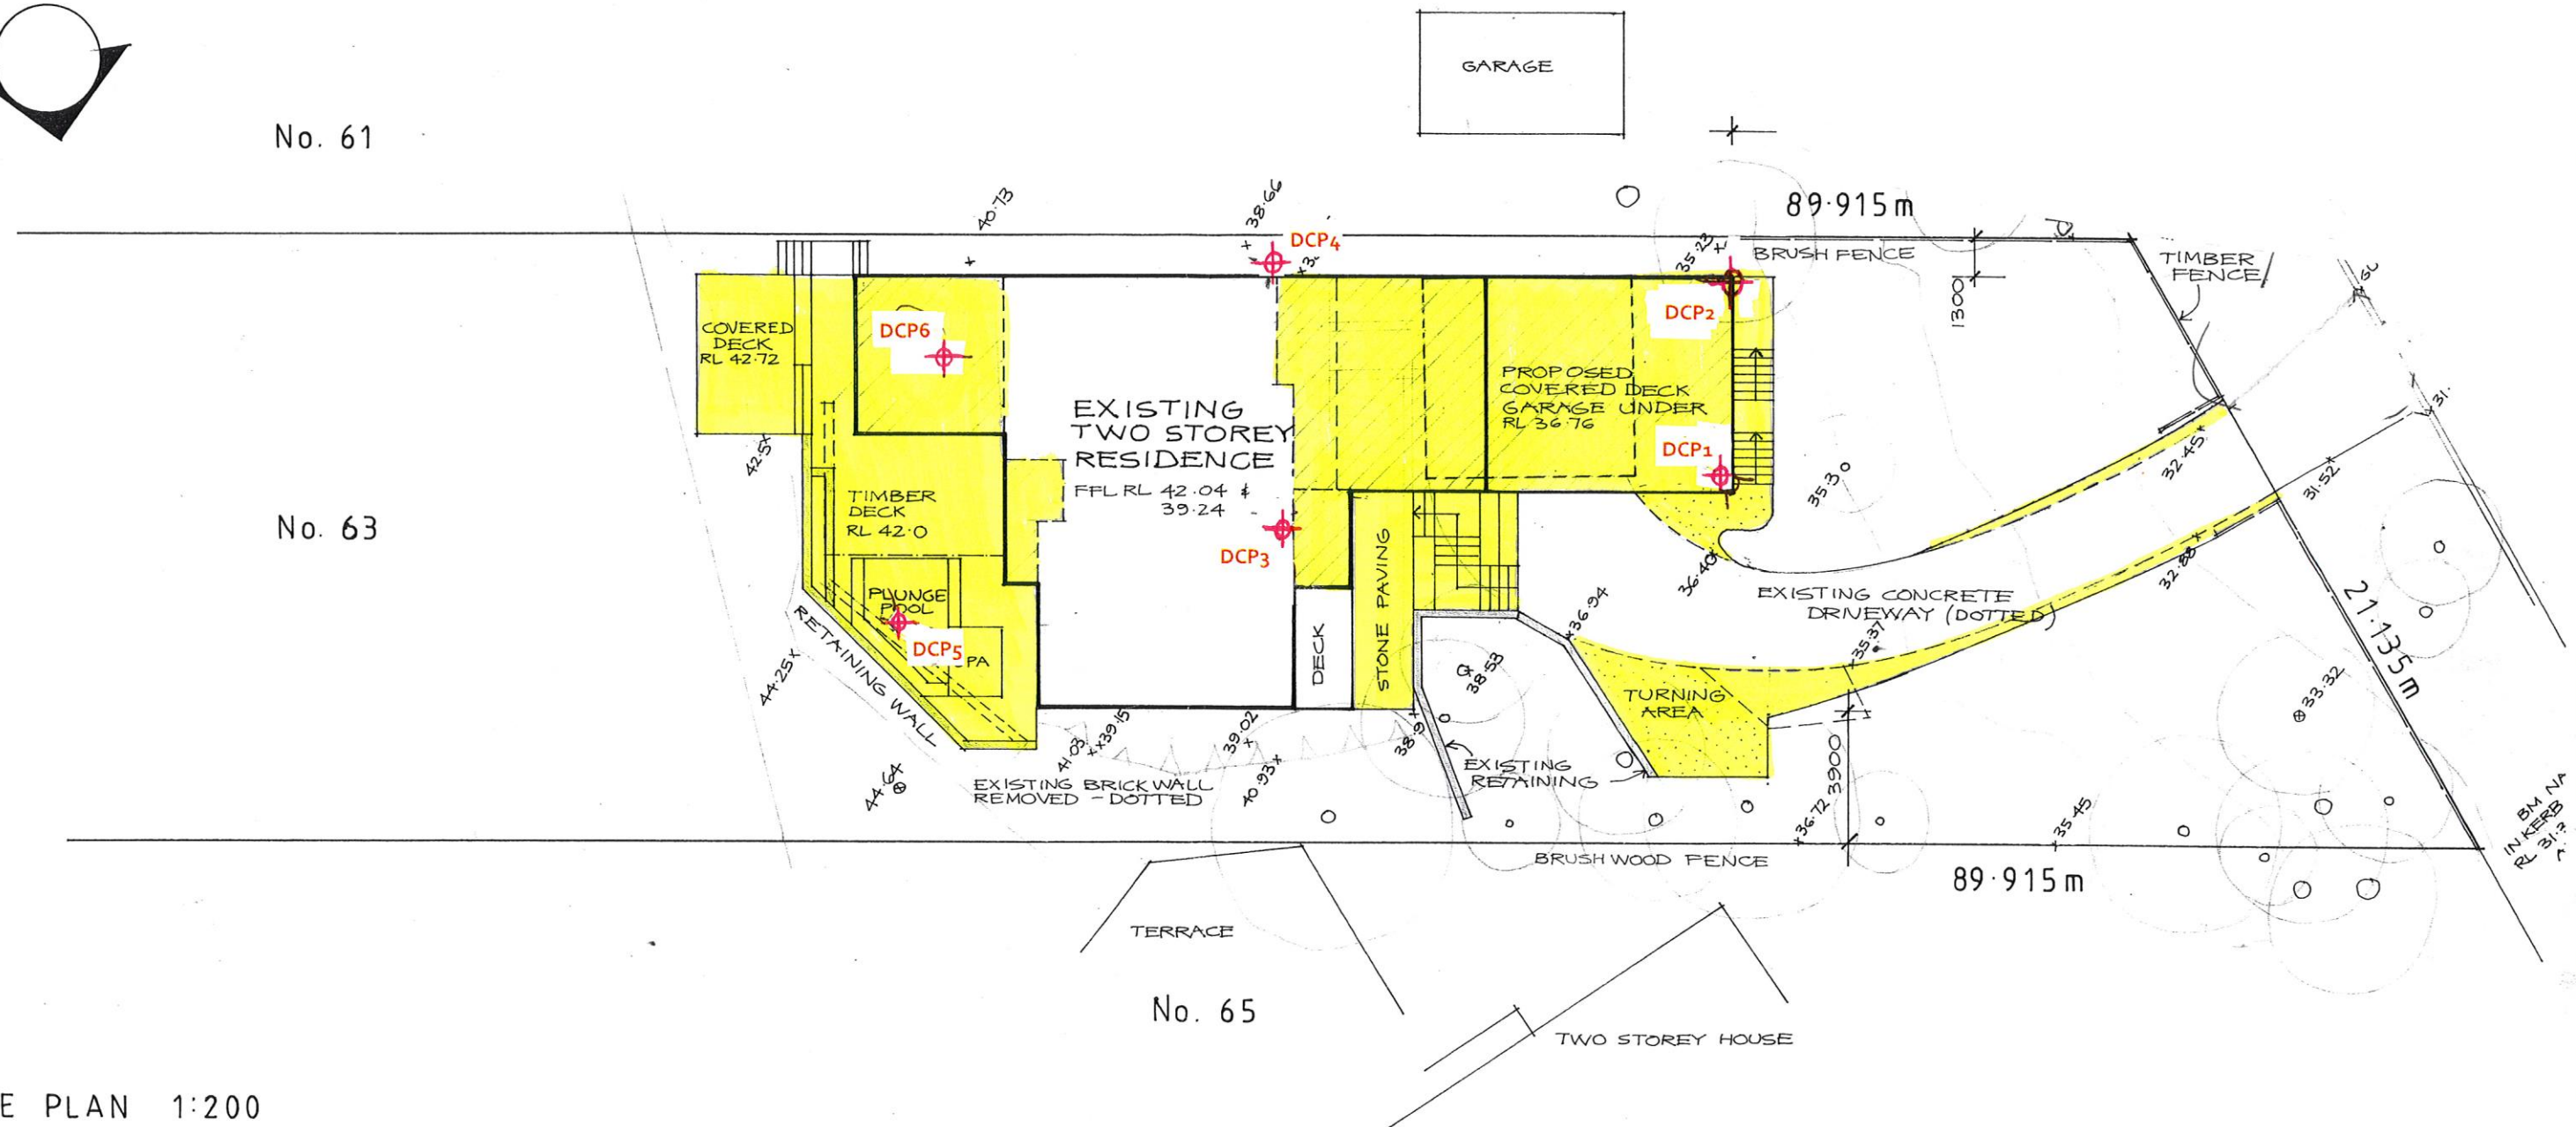
# SITE PLAN – showing test locations

Five DCP (Dynamic Cone Penetrometer) tests were put down to determine the relative density of the overlying soil and the depth to bedrock. The location of the tests are shown on the site plan and the results are as follows:

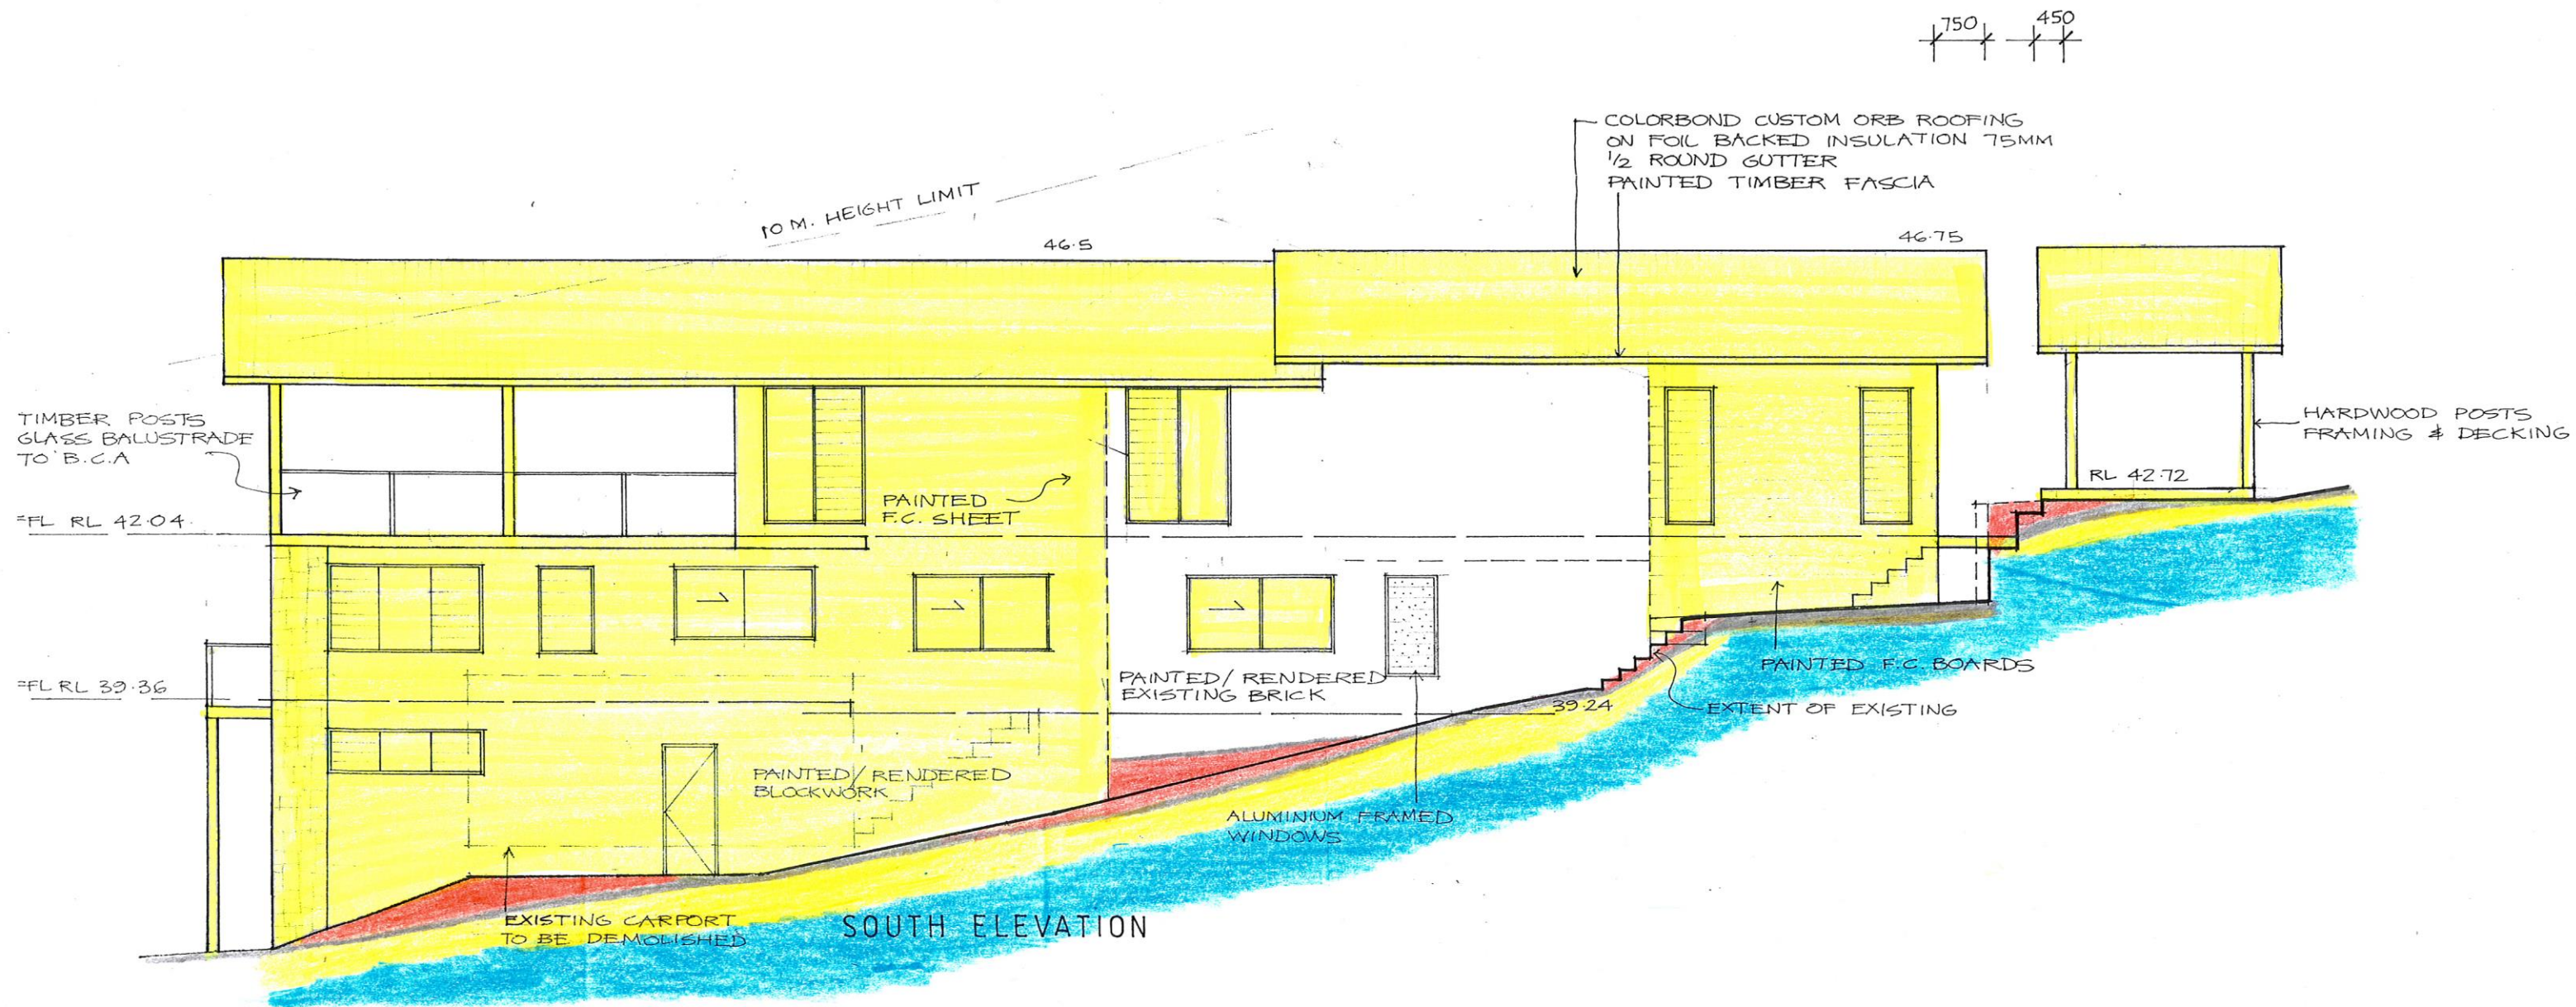
# TYPE SECTION

- Fill
- Topsoil
- Sandy Clay
- Narrabeen Group Rocks – sandstone beds expected above the house, shale beds expected below - on encounter after excavation can resemble a stiff to hard clay
