GROUND TESTING:

Remedial Works at 53 Londonderry Drive, Killarney Heights

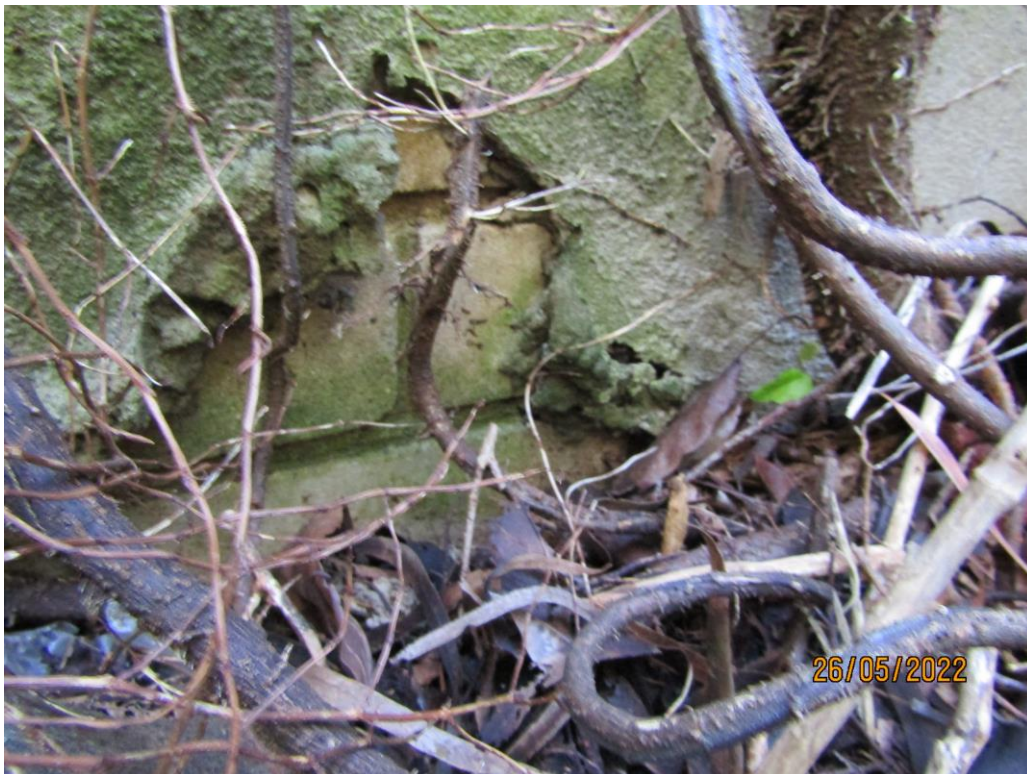
Photo 1

The E portion of the retaining wall was determined to be brick by observation through a small gap in the external render at the base of the wall (Photo 1).
