J3526A. 8th February, 2023. Page 1.

GEOTECHNICAL INVESTIGATION:

Subdivision and Two New Houses at 50 Condover Street, North Balgowlah

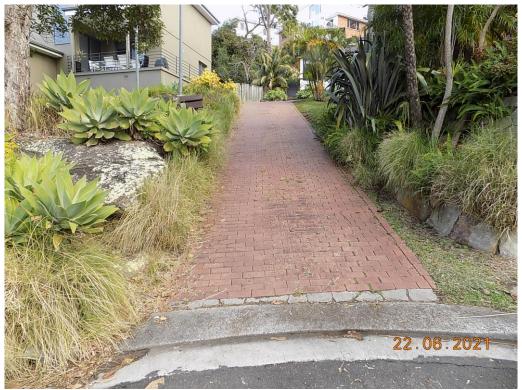
Photo 1

- 2.3 At the road frontage, a brick-paved driveway runs up the slope to a carport on the downhill side of the property (Photo 1). The driveway and carport will both be demolished as part of the proposed works. Competent Medium Strength Sandstone outcrops at the road frontage and on the downhill side of the carport (Photo 2). The single-storey brick house was observed to be supported directly off outcropping sandstone and will also be demolished as part of the proposed works (Photo 3). The cut for the uphill side of the house is supported by a stable stack rock retaining wall ~1.0m high (Photo 4). Medium Strength Sandstone bedrock outcrops and steps up the

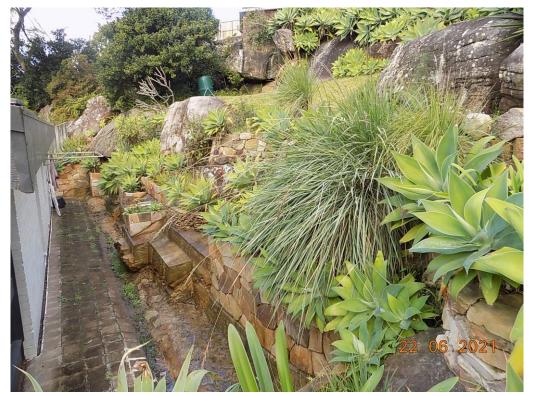
Photo 5

slope above the cut (Photo 5). The outcropping rock is slightly undercut but has been

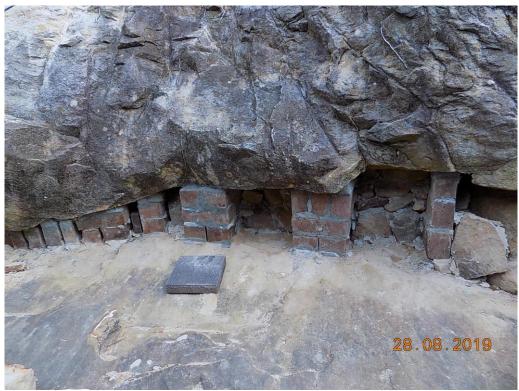
Photo 6

underpinned in the past by the owner using concrete block and brick blade walls and

piers mortared with non-shrink grout (Photo 6). A gentle to moderately sloping lawn

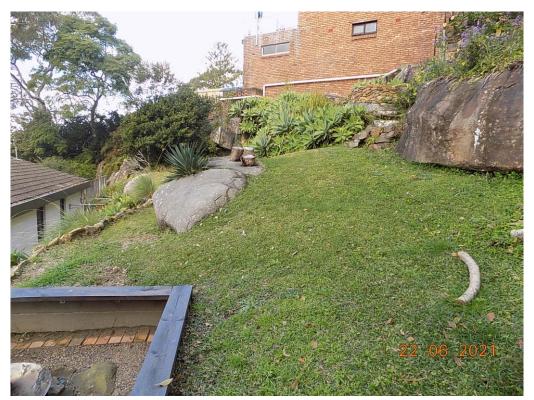
Photo 7

rises above the outcrop to the road frontage with Kimo Street (Photo 7). Medium

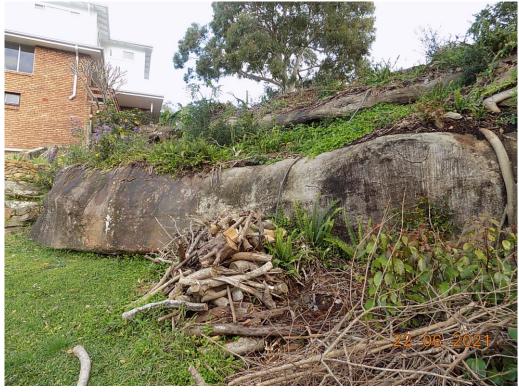
Photo 8

Strength Sandstone outcrops and steps up the slope through this lawn (Photo 8). No

significant geological defects were observed in the outcrop and it is considered stable.
