Report on  
Geotechnical Investigation

Proposed Alterations and Additions  
60 Hudson Parade, Clareville

Project 215034.00  
August 2022

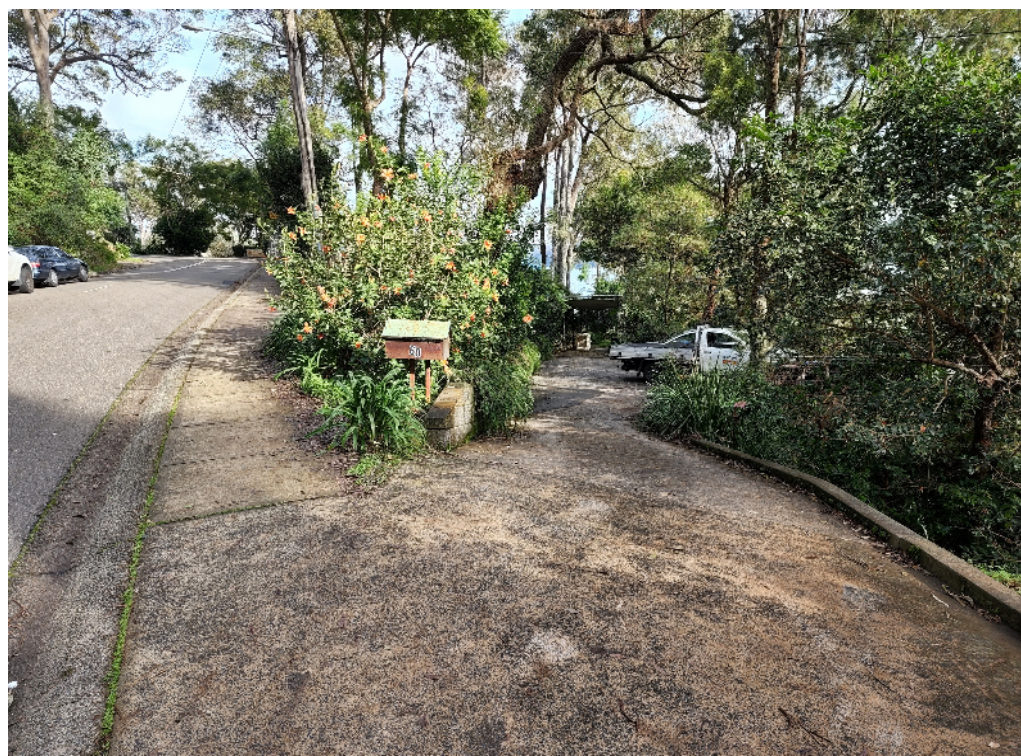
- The existing concrete driveway has been constructed by excavating into the original slope. The excavation face is supported by keystone and stacked rock retaining walls which appear stable (see Photo 1);

Photo 1: Driveway to 60 Hudson Parade

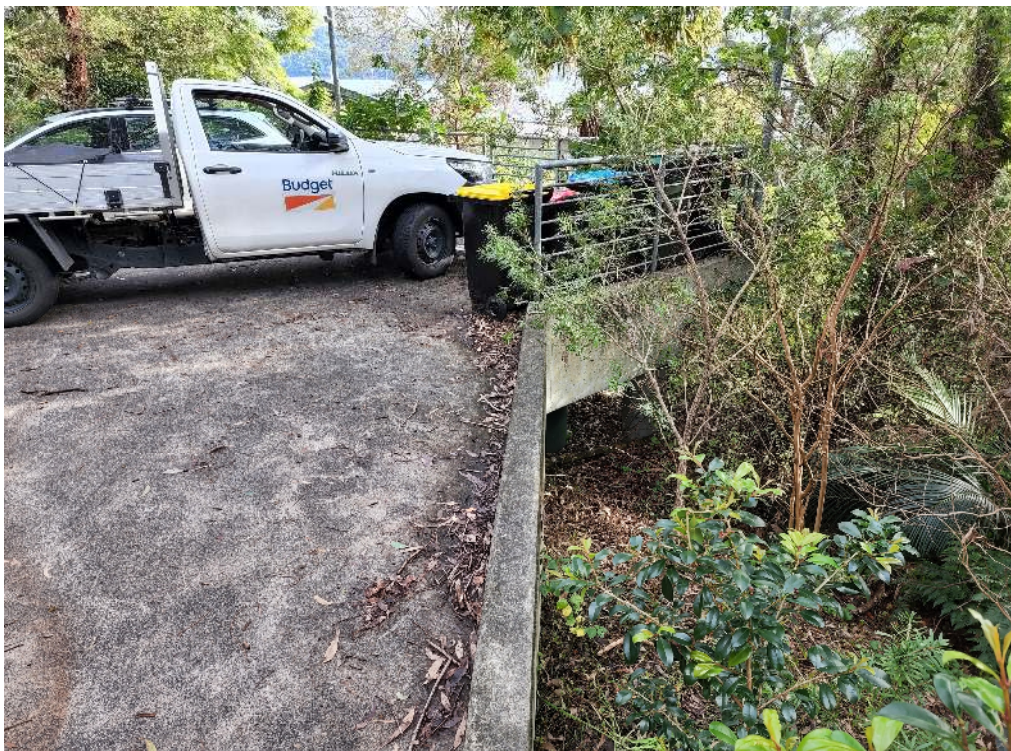
- The driveway leads to a suspended concrete parking area which is supported on columns and likely piles. The visible supporting columns are vertical with no signs of tilting (see Photos 2 and 3);

Photo 2: Suspended concrete platform

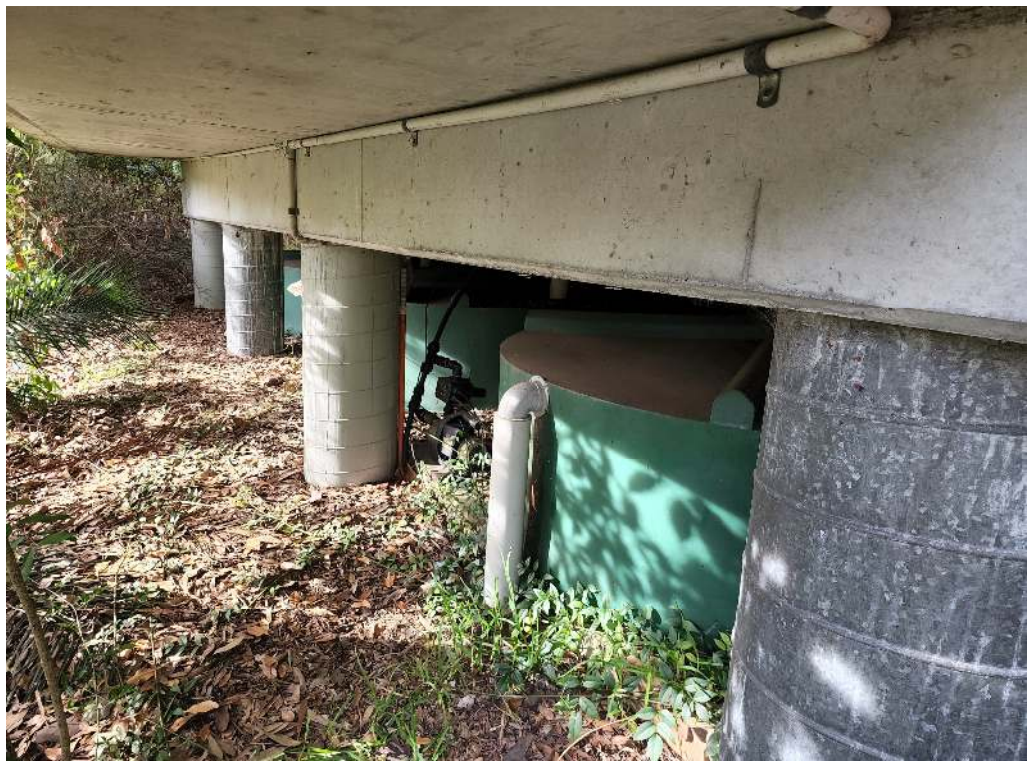
Photo 3: Columns supporting the concrete platform

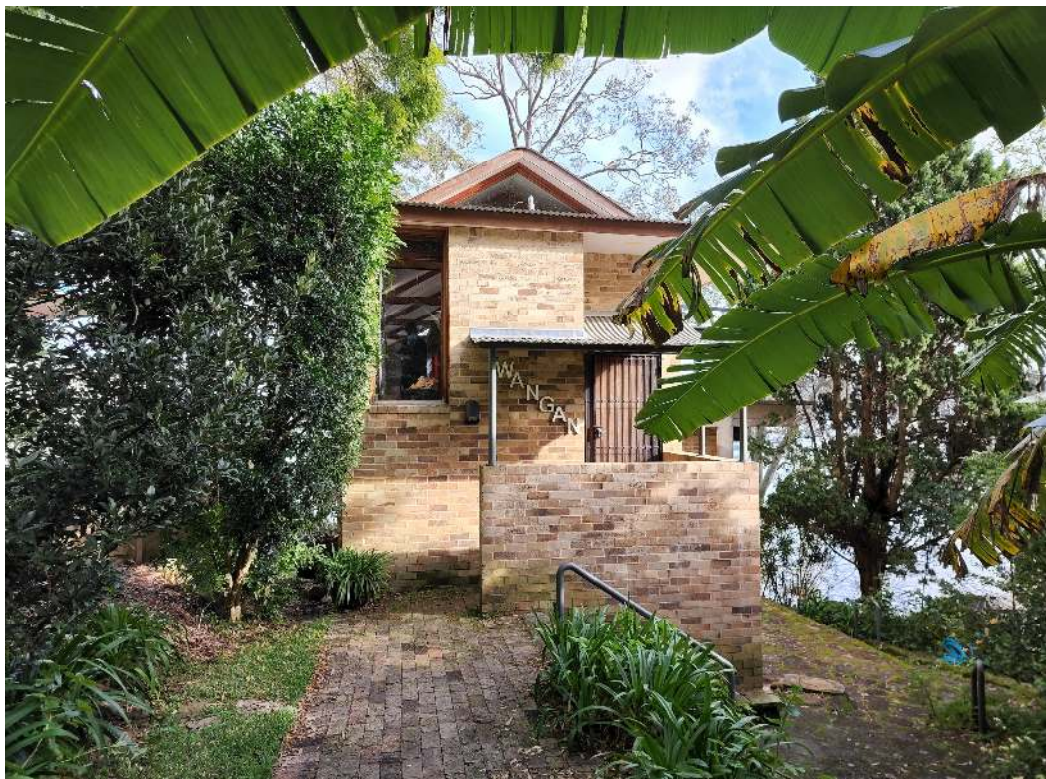
- The two and three level brick house steps down the slope. The external walls of the house display no significant cracking or signs of movement (see Photo 4);

- The house does not have guttering or downpipes to collect stormwater from the roof (see Photo 4). Stormwater discharges around the perimeter of the house. A large concrete dish drain collects water along the southern side of the house and is piped underground to an unknown location (see Photo 5);

Photo 4: Existing two and three level brick house

It is recommended that gutters and downpipes be installed on the house and proposed development to collect stormwater and pipe it to Pittwater.

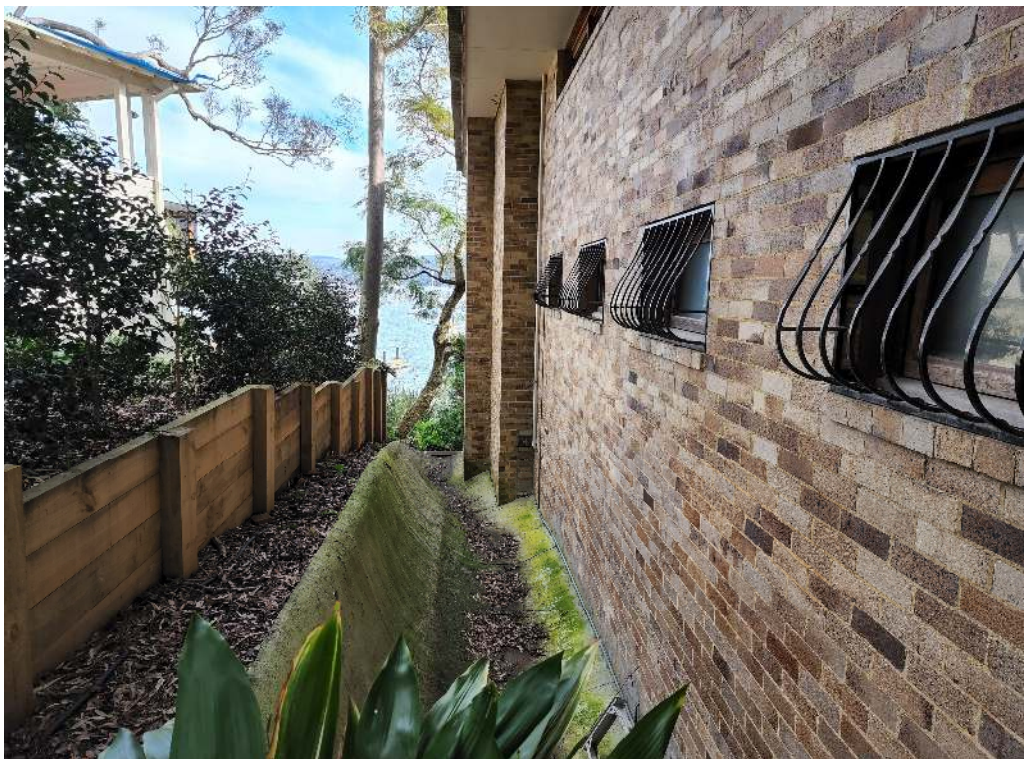
Photo 5: Concrete dish drain along the southern side of house

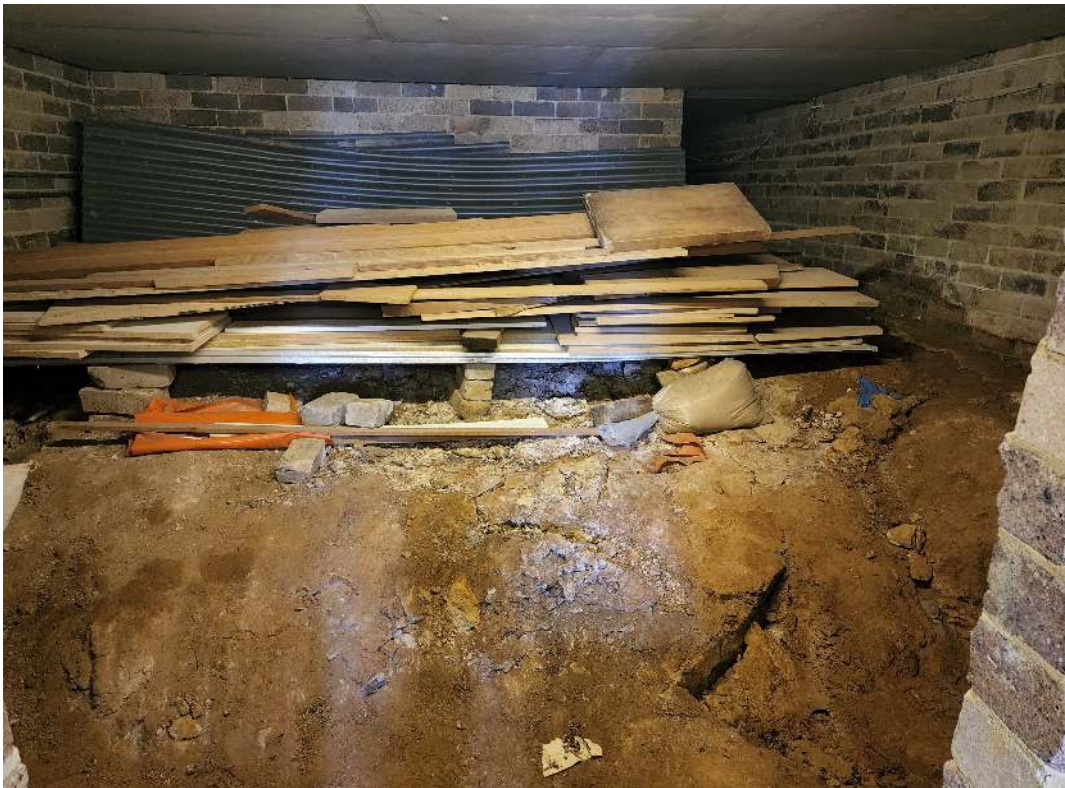
- The lower sub-floor of the house was accessed (see Photo 6). There appears to be minor seepage, likely along the top of rock. Given the significant rainfall in the week before the inspection, the area was relatively dry and seepage volumes are estimated to be low;

Photo 6: The subfloor of the existing house

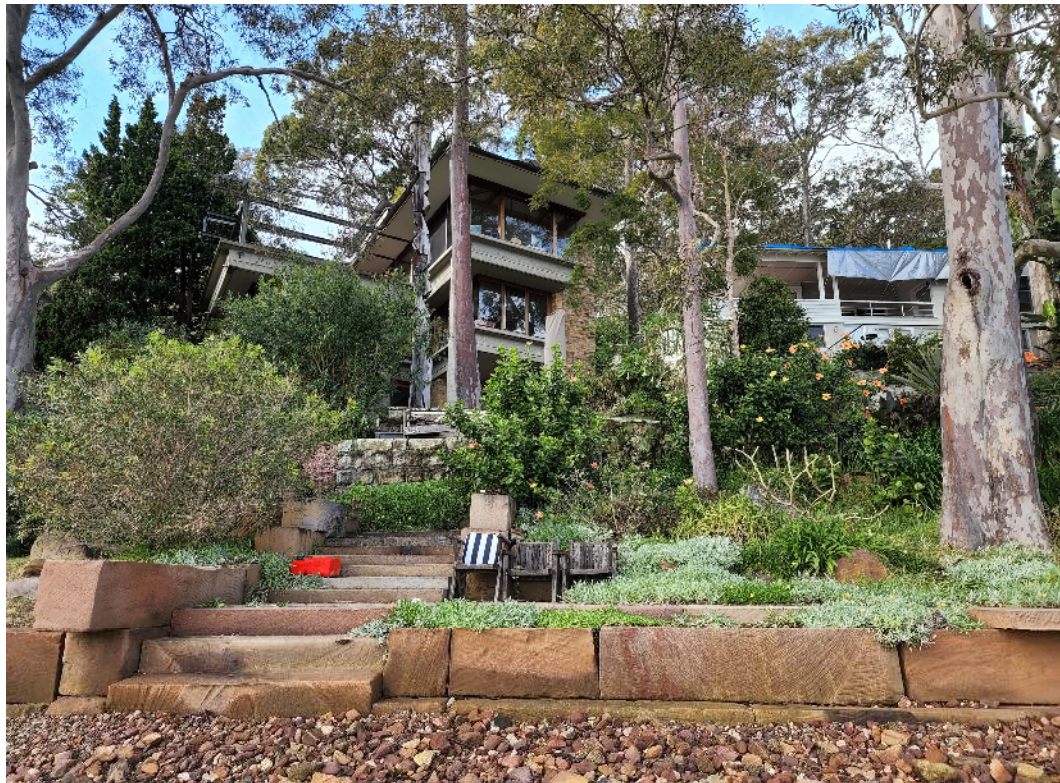
- The area surrounding the house has been terraced in areas with a series of small stacked rock retaining walls (see Photo 7). Some of the walls are slightly tilting and bulging. The movement appears to be due to the wall construction rather than slope instability;

Photo 7: Downhill side of the house

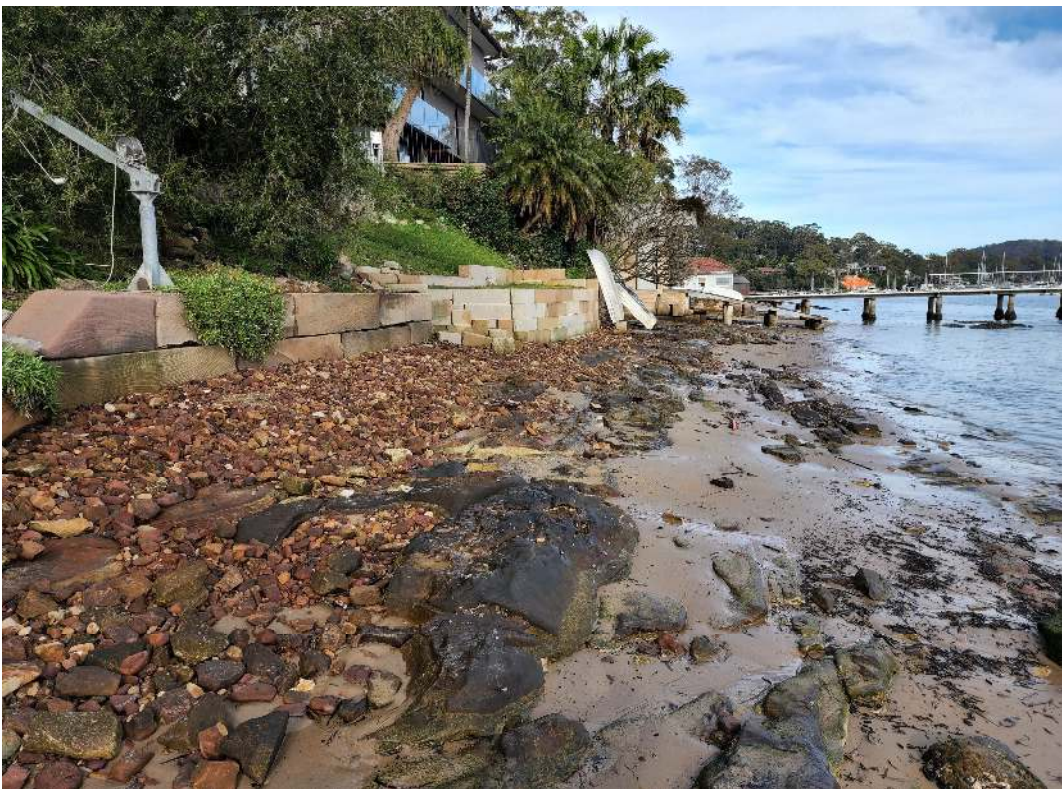
- Some large sandstone boulders (or ‘floaters’) were observed on the property, probably fallen from cliffs upslope thousands of years previously; and
- Medium to high strength, fine grained sandstone bedrock was exposed along the Pittwater foreshore (see Photo 8).

Photo 8: Sandstone bedrock exposed along the Pittwater foreshore
