Report Title: Geotechnical Report <u>34 Narrabeen Park Parade, Warriewood</u>
Report Date: <u>19/5/22</u>
Author: <u>BEN WHITE</u>
Author's Company/Organisation: <u>WHITE GEOTECHNICAL GROUP PTY LTD</u>

GEOTECHNICAL INVESTIGATION:

Alts. & Adds., New Pool, and Carport at **34 Narrabeen Park Parade, Warriewood**

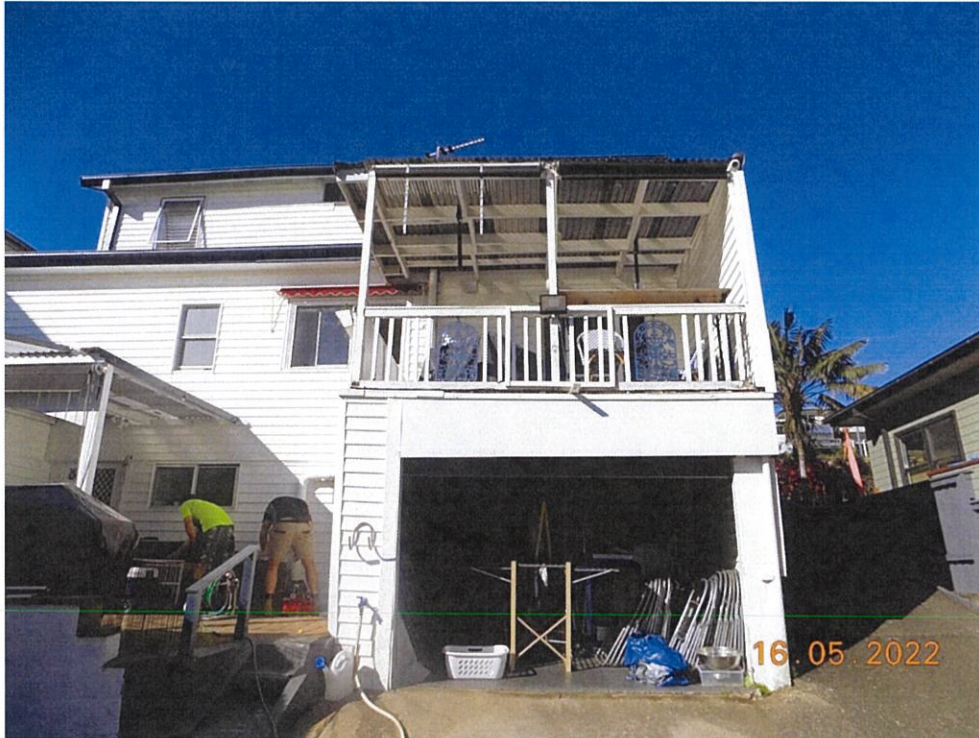
Photo 1

- 2.1** The site was inspected on the 16th May, 2022.
- 2.2** This residential property is on the low side of the road and has a W aspect. It is located on the moderate to steeply graded upper reaches of a hillslope. The natural slope falls across the property at an average angle of ~14°. The slope above the property eases to the crest of the slope, and the slope below the property continues at similar angles.
- 2.3** At the road frontage, a concrete driveway runs past the house to a carport and garage underneath the downhill side of the house (Photo 1). The concrete blocks supporting the driveway displays minor stepped cracking through the mortar (Photo 2). A ~1.3m high stack rock retaining wall supports a fill for the road reserve and a cut

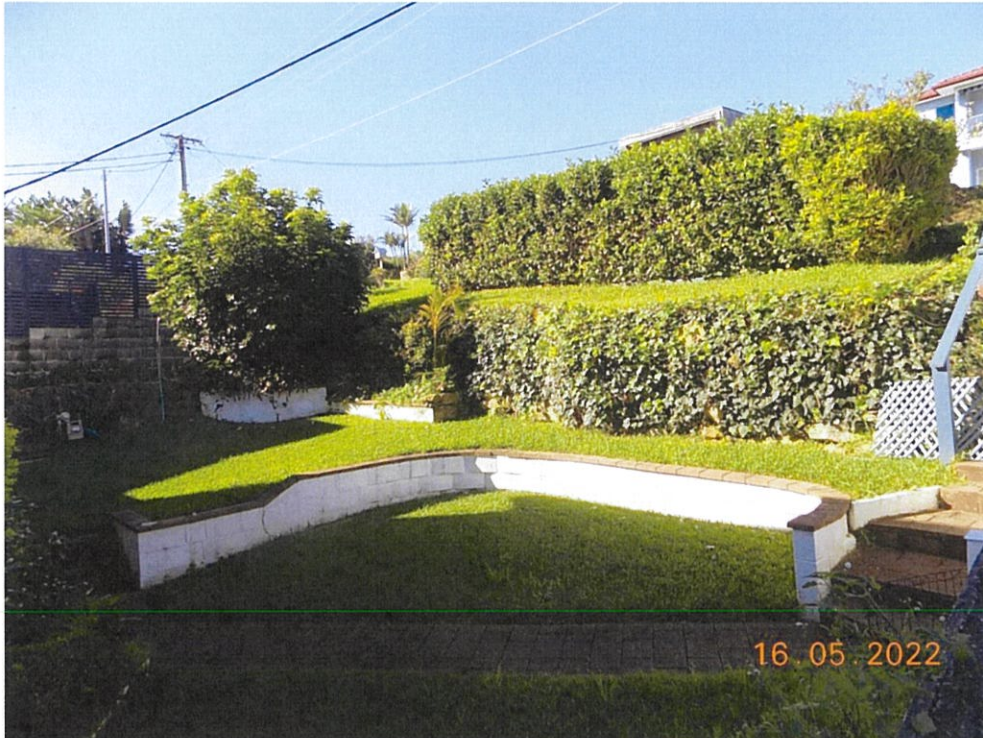
Photo 3

for a gently sloping lawn area in between the road frontage and the house (Photo 3). The stack rock wall is covered in dense vegetation and could not be assessed in terms of stability. The two-storey timber framed and clad house is supported on brick piers (Photo 4). The brick piers appear to stand vertical. A stable ~0.6m high concrete block retaining wall supports a fill for a pathway and cut for a level platform for the carport (Photo 5). An above ground steel pool with a liner has been partially cut into the slope on the downhill side of the property (Photo 6). This pool is to be removed as part of the proposed works. A gently sloping lawn extends from the pool area to the lower common boundary (Photo 7).

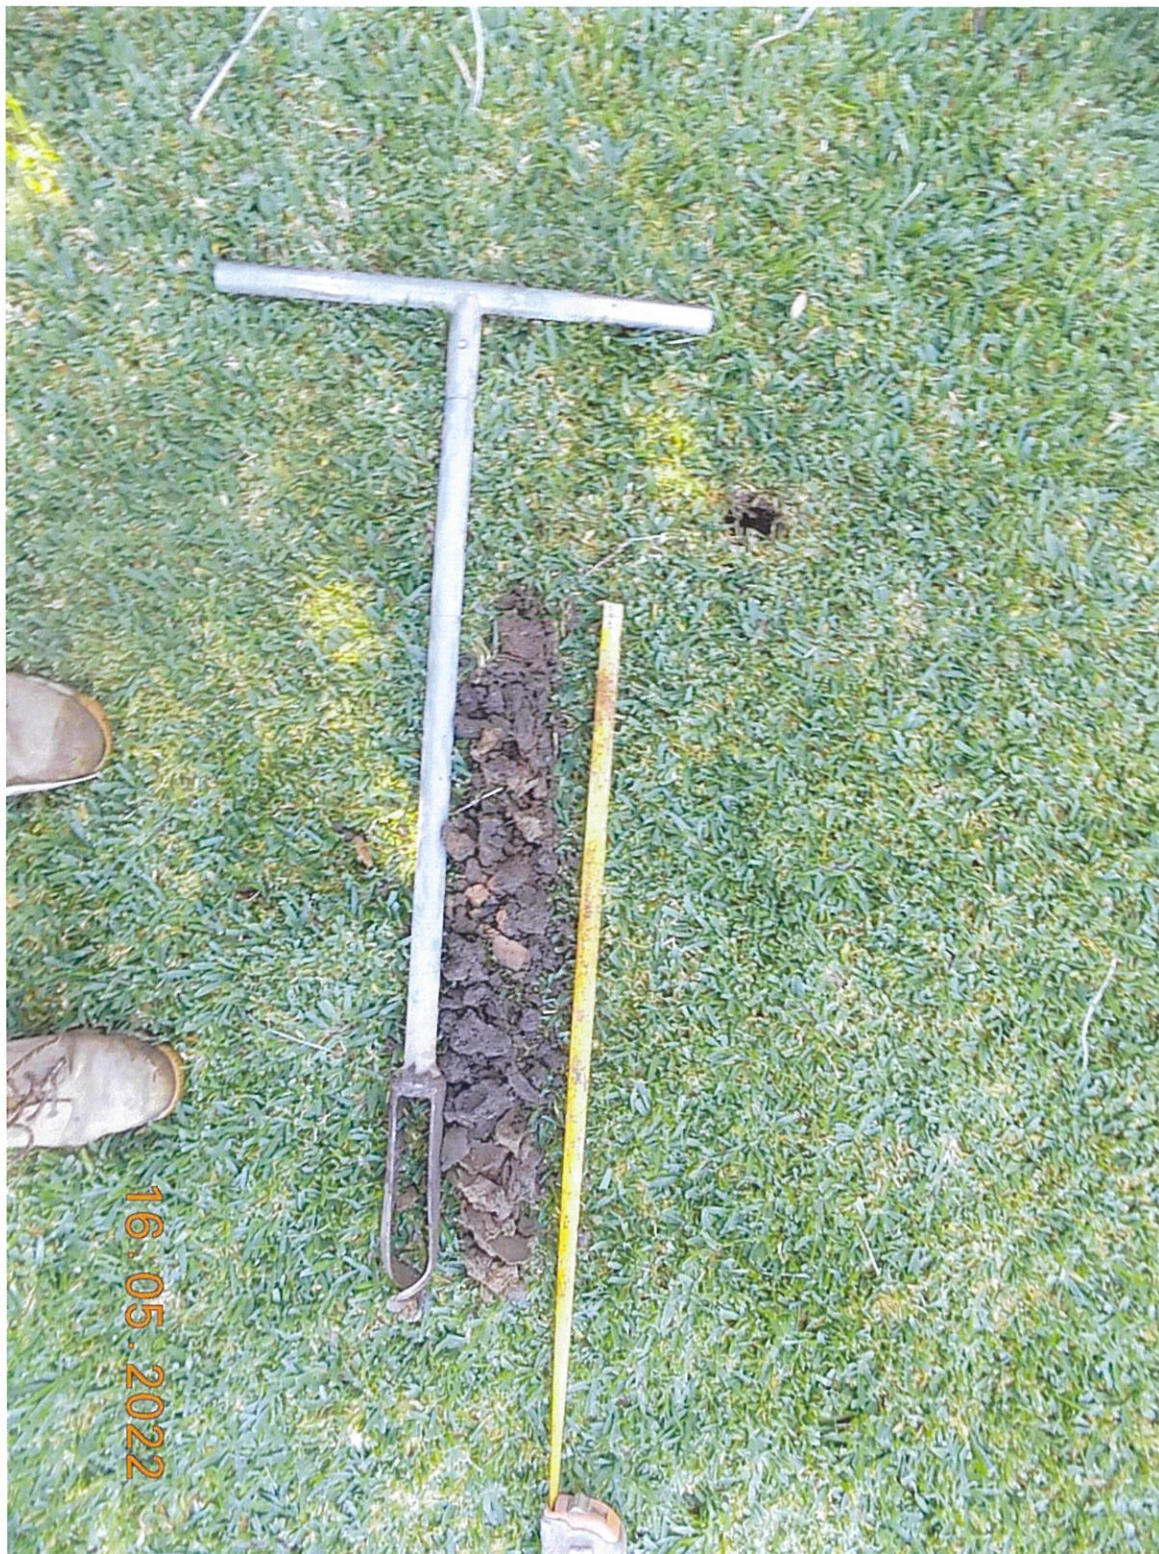
Photo 8

AUGER HOLE 1 (~RL20.6) – AH1 (Photo 8)

Depth (m)	Material Encountered
0.0 to 0.4	TOPSOIL , dark brown clayey soil, medium grained, loose, fine trace of organic matter, dry.
0.4 to 0.8	CLAY , brown, fine grained, firm to stiff, dry.

End of test @ 0.8m. No water table encountered.
