Project name 2A WEST ST, BALGOWLAH	Project Number:	Responsible:	Date: 7/08/2019
--	-----------------	--------------	---------------------------

WSA assessment

Date: 7/08/2019	Asset owner's job ref.: 202379'2781	Asset Owner:	Operator : CRAIG PICKUP	Section number: 1	Pipe Asset Id: SW 1
Time of inspection: 12:27:00	Cleaning: not cleaned	Standard: WSA 05-2008 2.2	LRP Inside Face of the Wall	Conduit Unit Length	Method of Inspection Television Camera

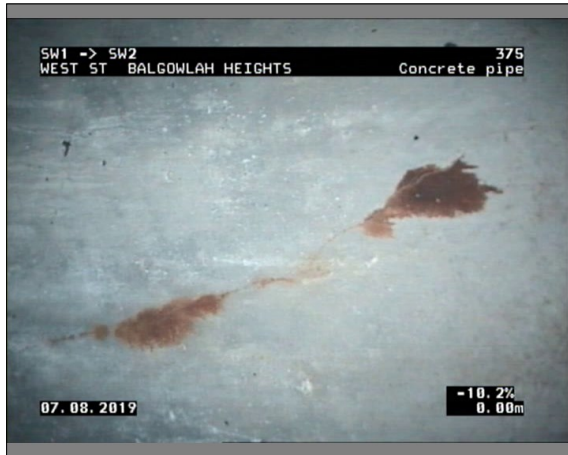
Photo: 1_1_4_A.JPG
0m, Circumferential fracture , width 0.5mm , from 1 to 5 o'clock

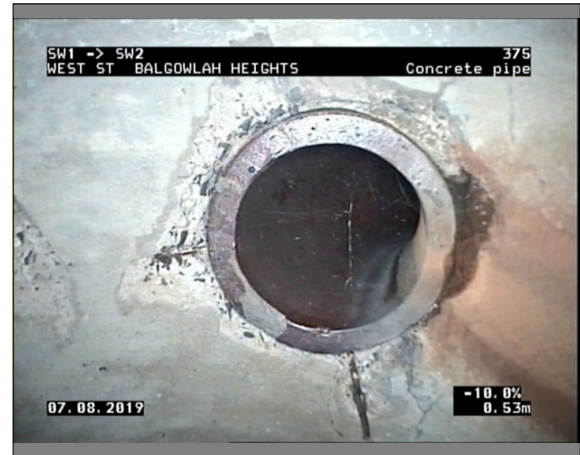
Photo: 1_1_5_A.JPG
0.53m, Connection, poor workmanship, connection appears to be open , diameter 150mm

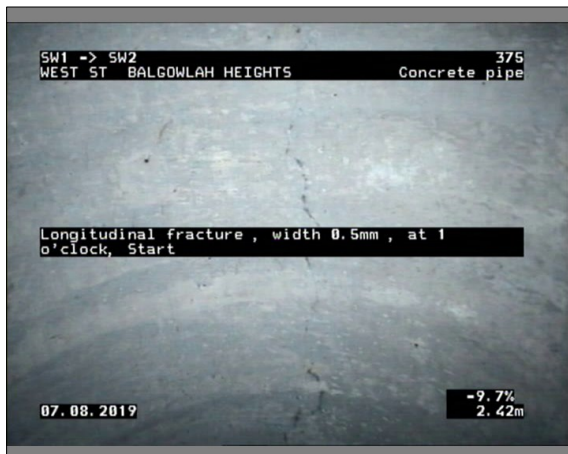
Photo: 1_1_6_A.JPG
2.42m, Longitudinal fracture , width 0.5mm , at 1 o'clock, Start

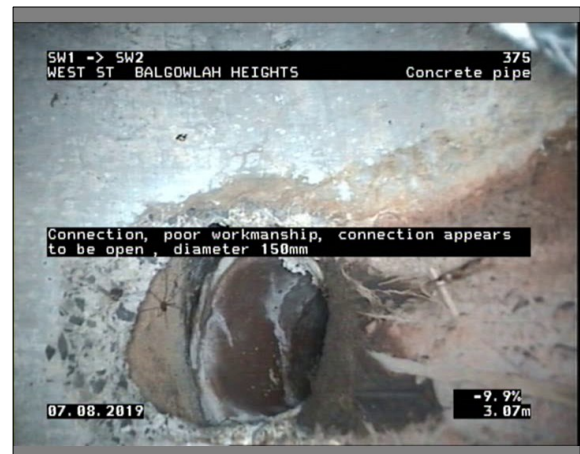
Photo: 1_1_8_A.JPG
3.07m, Connection, poor workmanship, connection appears to be open , diameter 150mm

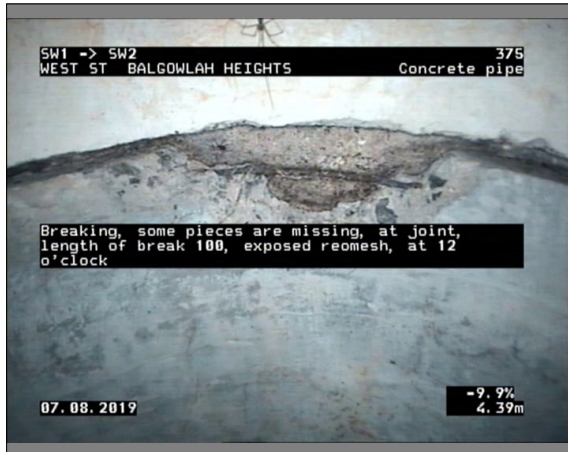
Photo: 1_1_9_A.JPG
4.39m, Breaking, some pieces are missing, at joint, length of
break 100, exposed reomesh, at 12 o'clock
