Geotechnical Assessment

Project: New Dwelling
139-141 Riverview Road, Avalon Beach NSW

Prepared for:
MMIG Developments Pty Ltd

Ref: AG 24222
11 December 2024

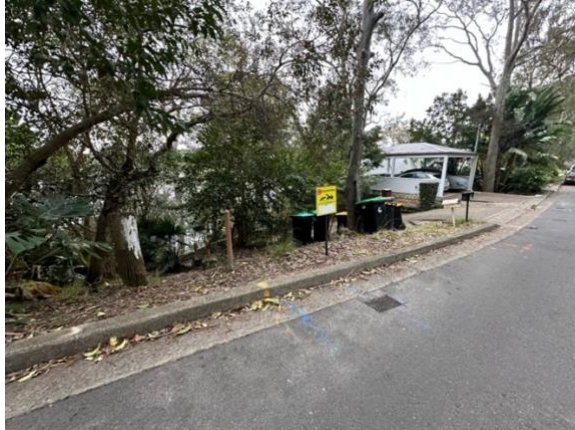
Photo 1: Site frontage at Riverview Road

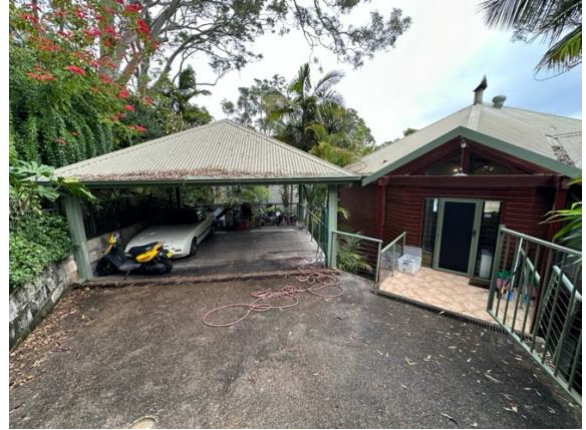
Photo 2: Residence frontage and carport

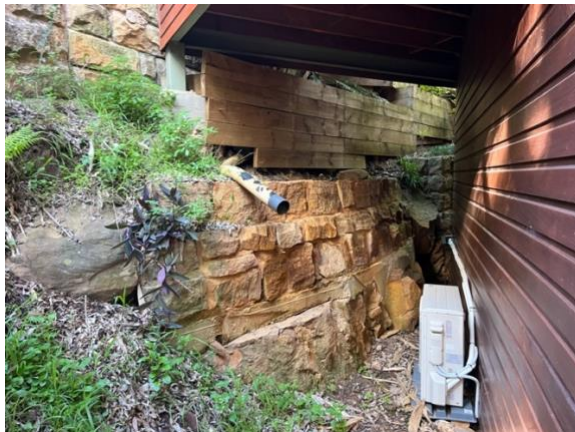
Photo 3: Wall structures at residence frontage and outcropping sandstone bedrock

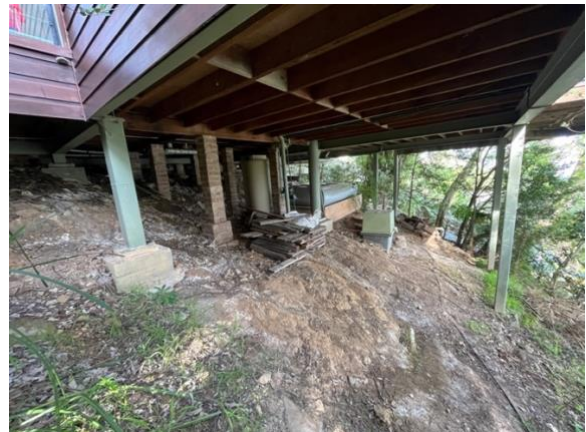
Photo 4: Slope under residence rear

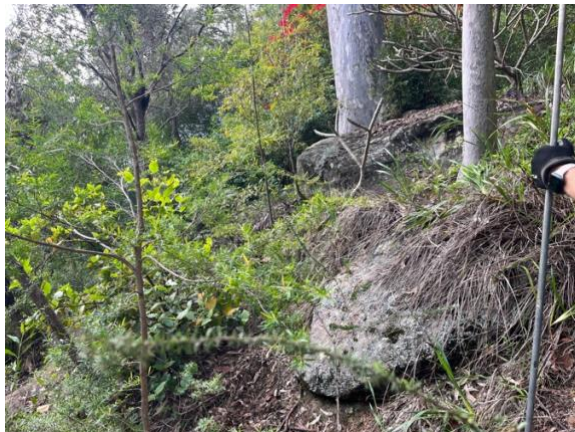
- **Hazard One:** The potential mobilisation of detached sandstone boulders on site.
- **Hazard Two:** Landslip / failure of fill / soils from proposed excavation works
- **Hazard Three:** Rock topple / rock slide from defects, joints or weak rock from proposed excavation works.

Photo 3: Example of sandstone boulders on the slope, to the west of the existing residence

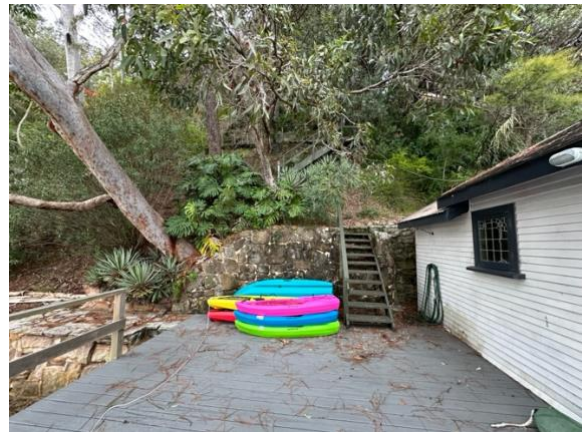
Photo 4: Looking east at the subject site from the jetty and boatshed at the western boundary

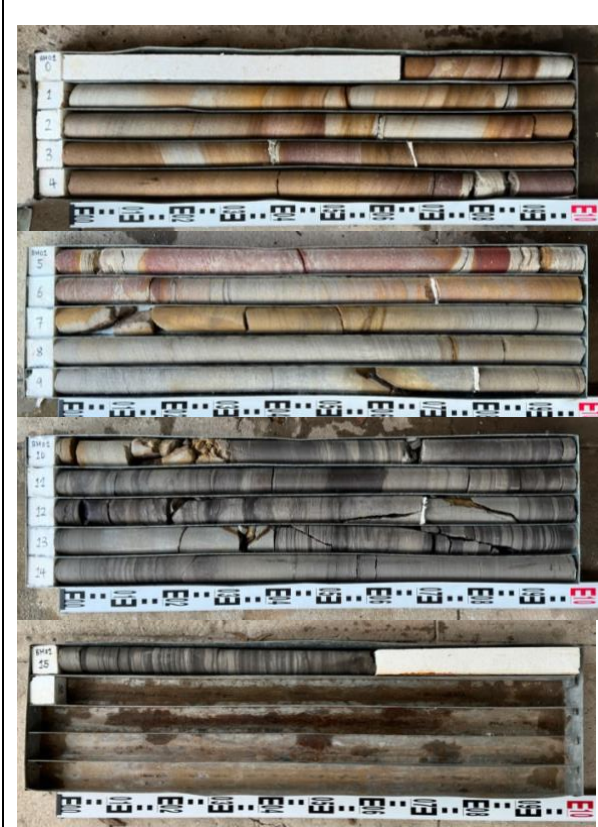
Photo 1: Bore Hole 1 core sample

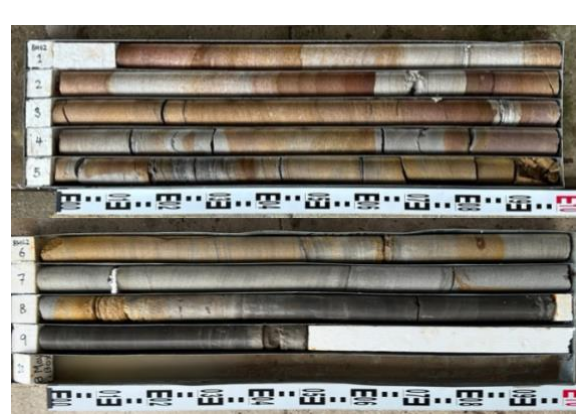
Photo 2: Bore Hole 2 core sample
