MT 31547
20th August, 2018
Page 1

GEOTECHNICAL ASSESSMENT REPORT FOR PROPOSED NEW RESIDENCE & POOL AT 10 POULTON PARADE FRENCHS FOREST

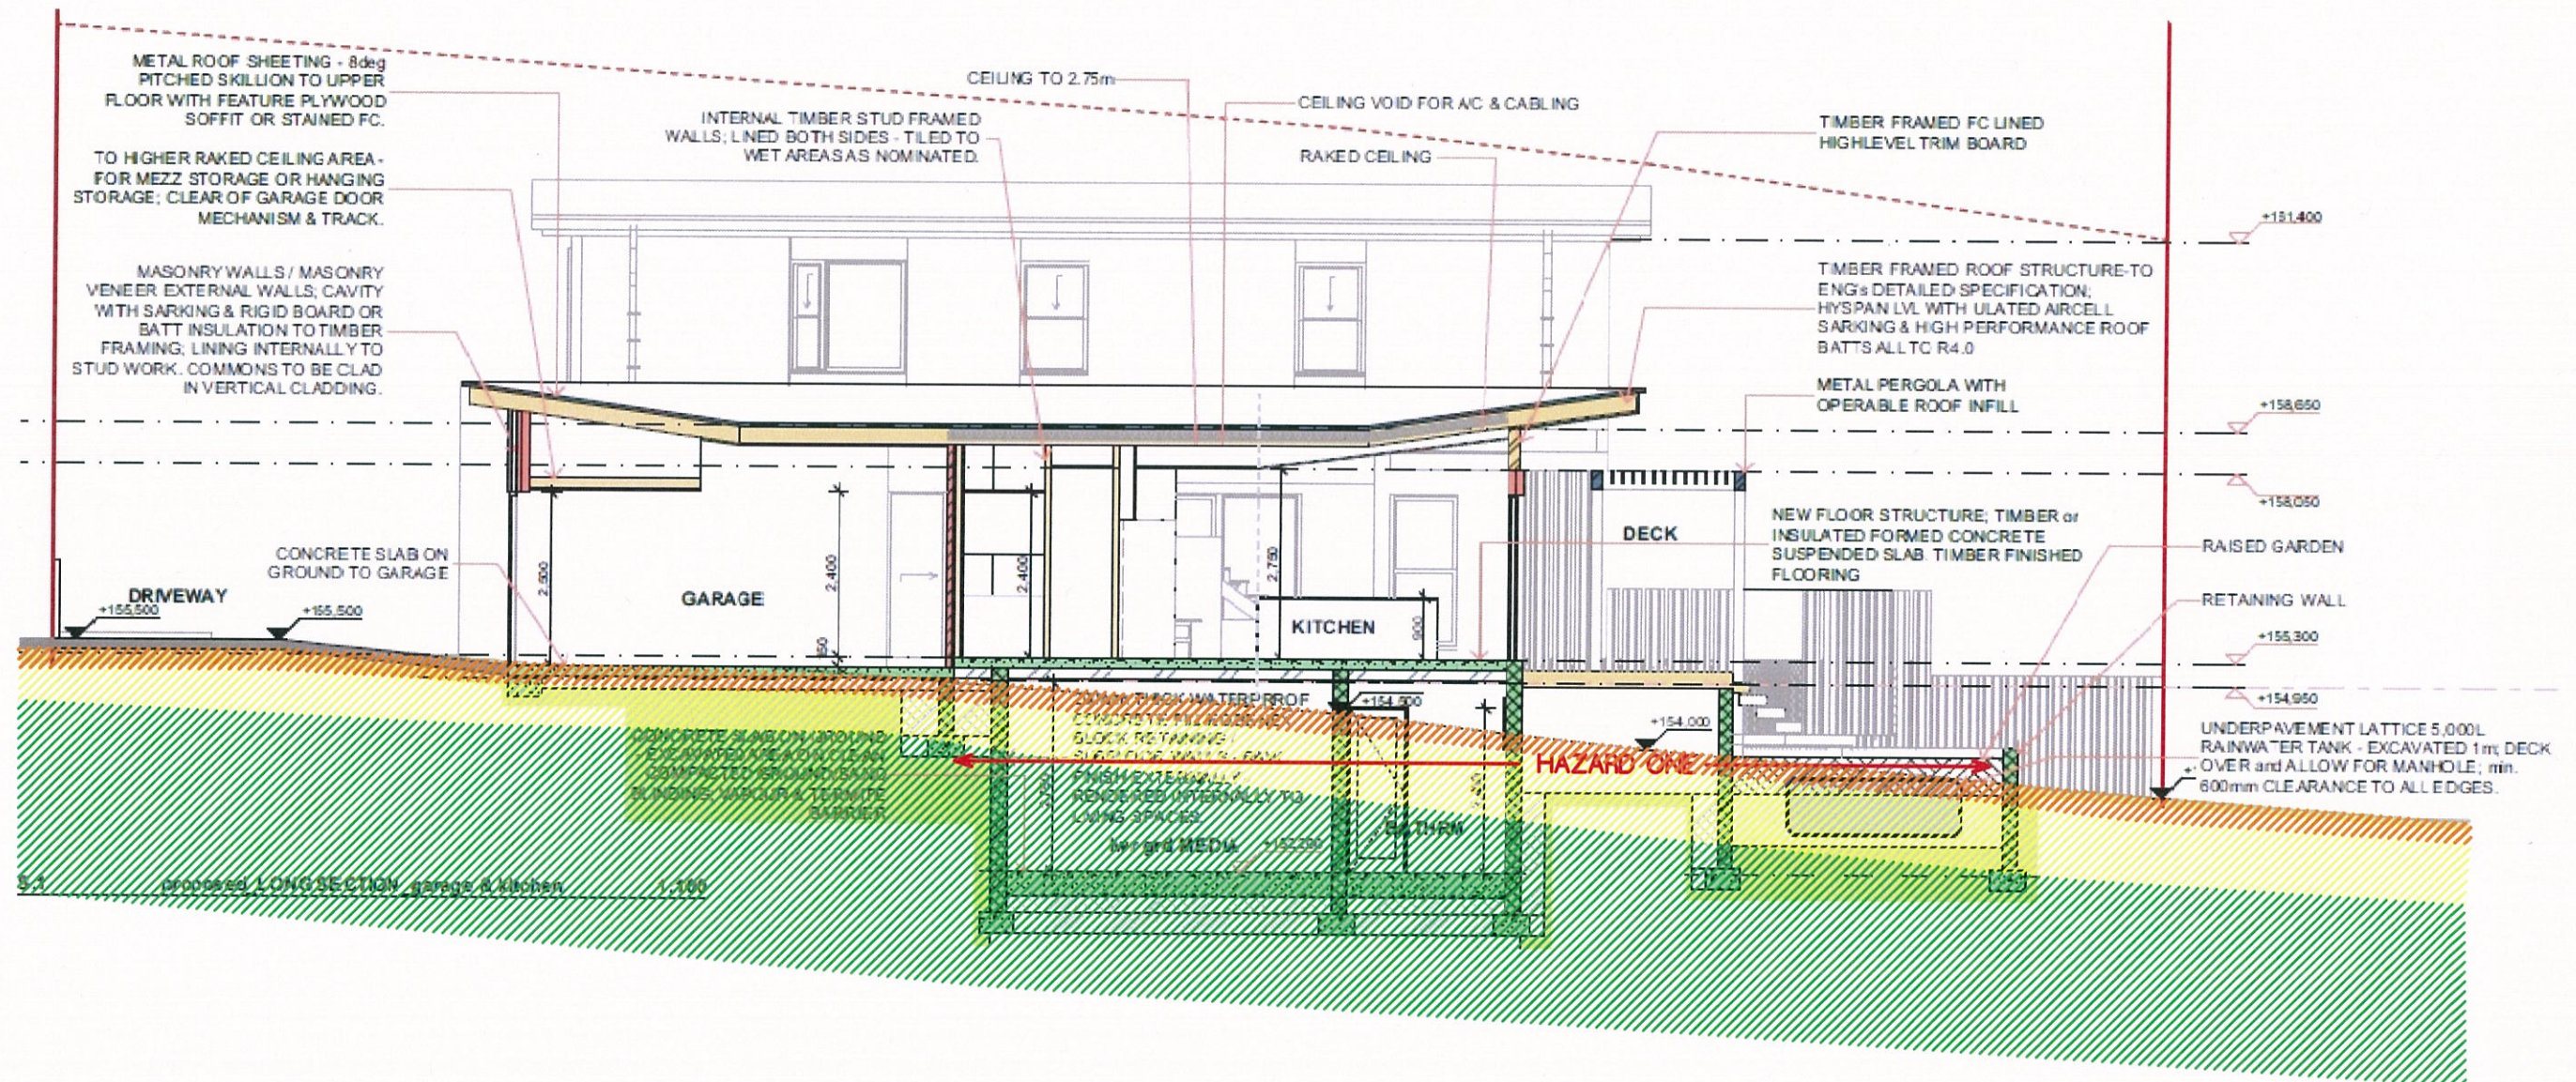
TYPE SECTION

NOTE
INTERPRETED SUB SURFACE SECTION ONLY.
ACTUAL GROUND CONDITIONS MAY VARY.

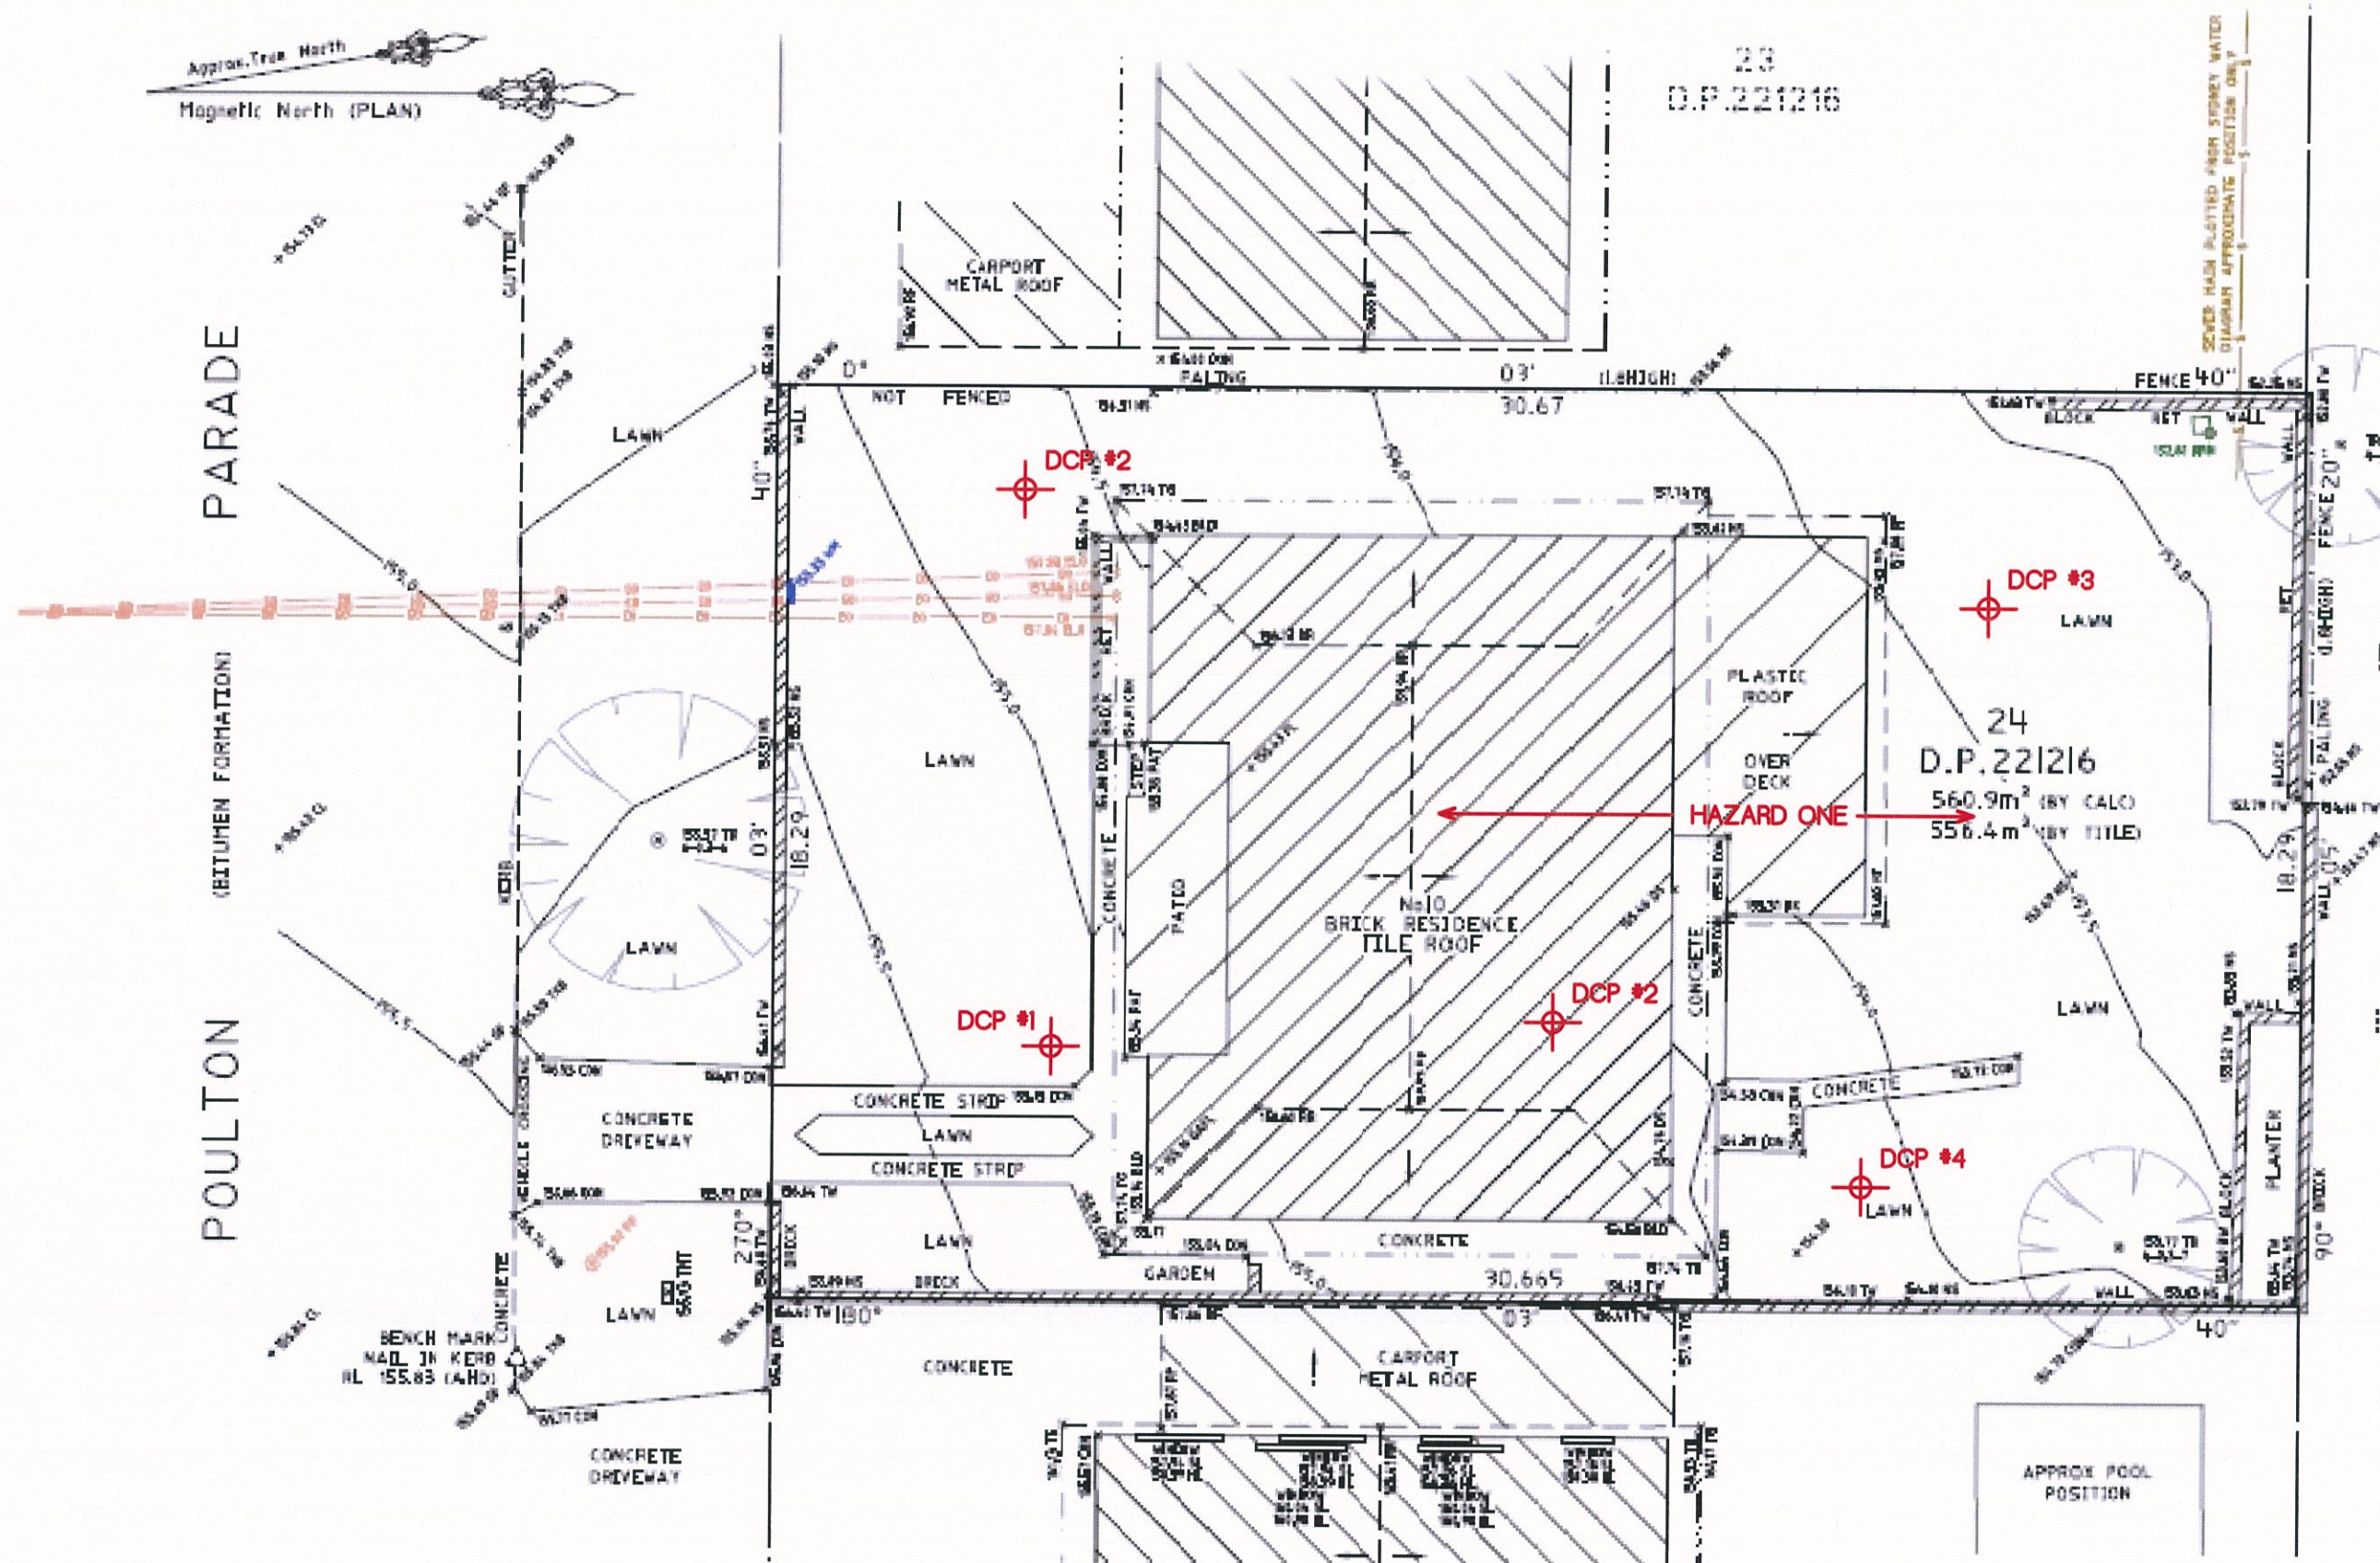
SITE PLAN - HAZARD ONE & DCP LOCATIONS

The excavation for the proposed residence and swimming pool is identified as a potential hazard (**HAZARD ONE**).
