## **GEOTECHNICAL INVESTIGATION:**

### **New House and Pool at 35A Queens Avenue, Avalon Beach**

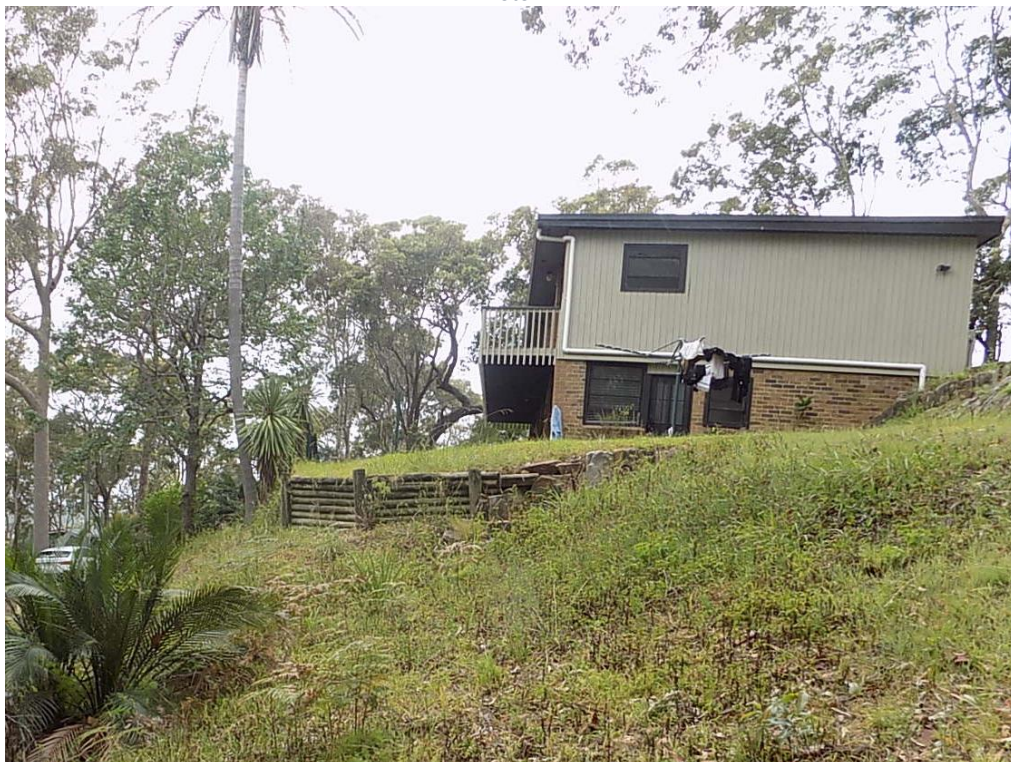
Photo 3

- 2.1** The site was inspected on the 6<sup>th</sup> February, 2024.
- 2.2** This vacant residential property is accessed by a Right of Carriageway (ROW) off the uphill side of Queens Avenue and has a N aspect. It is located on the steeply graded middle reaches of a hillslope. The natural slope rises across the property at an average angle of ~22°. The slopes above and below the property continue at similar steep angles.
- 2.3** At the road frontage, a concrete ROW runs up and across the to a parking area at the E corner of the property (Photo 1). The steeply graded lawn (Photo 2) which extends across the entire property is terraced in timber and mortared dimensioned sandstone retaining walls reaching up to ~1.5m. Some of these walls have been constructed with a tilt back into the slope. One of the timber retaining walls which

continues onto the SE neighbouring property (Photo 3) was observed to be tilting downslope. This wall will be partially demolished as part of the proposed works

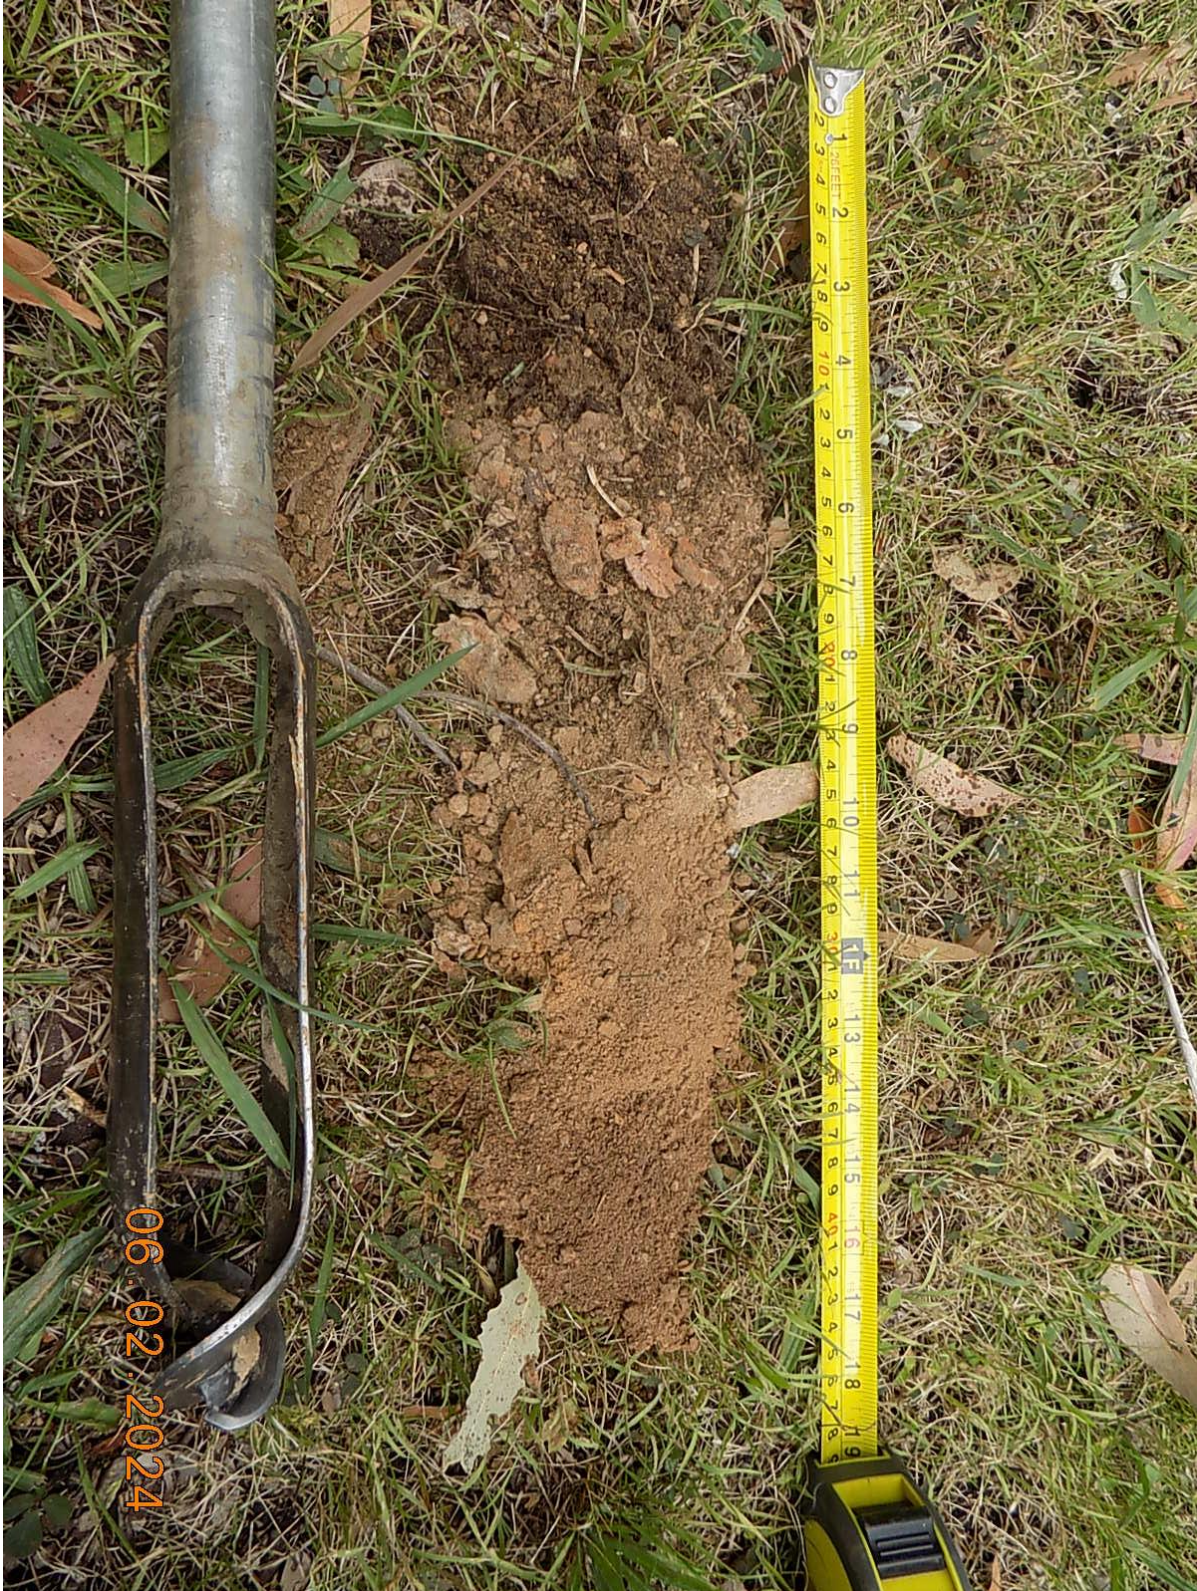
Photo 4 – AH1 - (downhole is Top to bottom)

#### AUGER HOLE 1 (~RL54.5) – AH1 (Photo 4)

Depth (m)	Material Encountered
0.0 to 0.1	<b>FILL</b> , brown, dense, dry, fine to medium grained.
0.1 to 0.2	<b>CLAYEY FILL</b> , light brown, stiff, dry, fine to medium grained.
0.2 to 0.4	<b>SANDY CLAY</b> , brown, hard, dry, fine to medium grained.

End of hole @ 0.4m. No water table encountered.

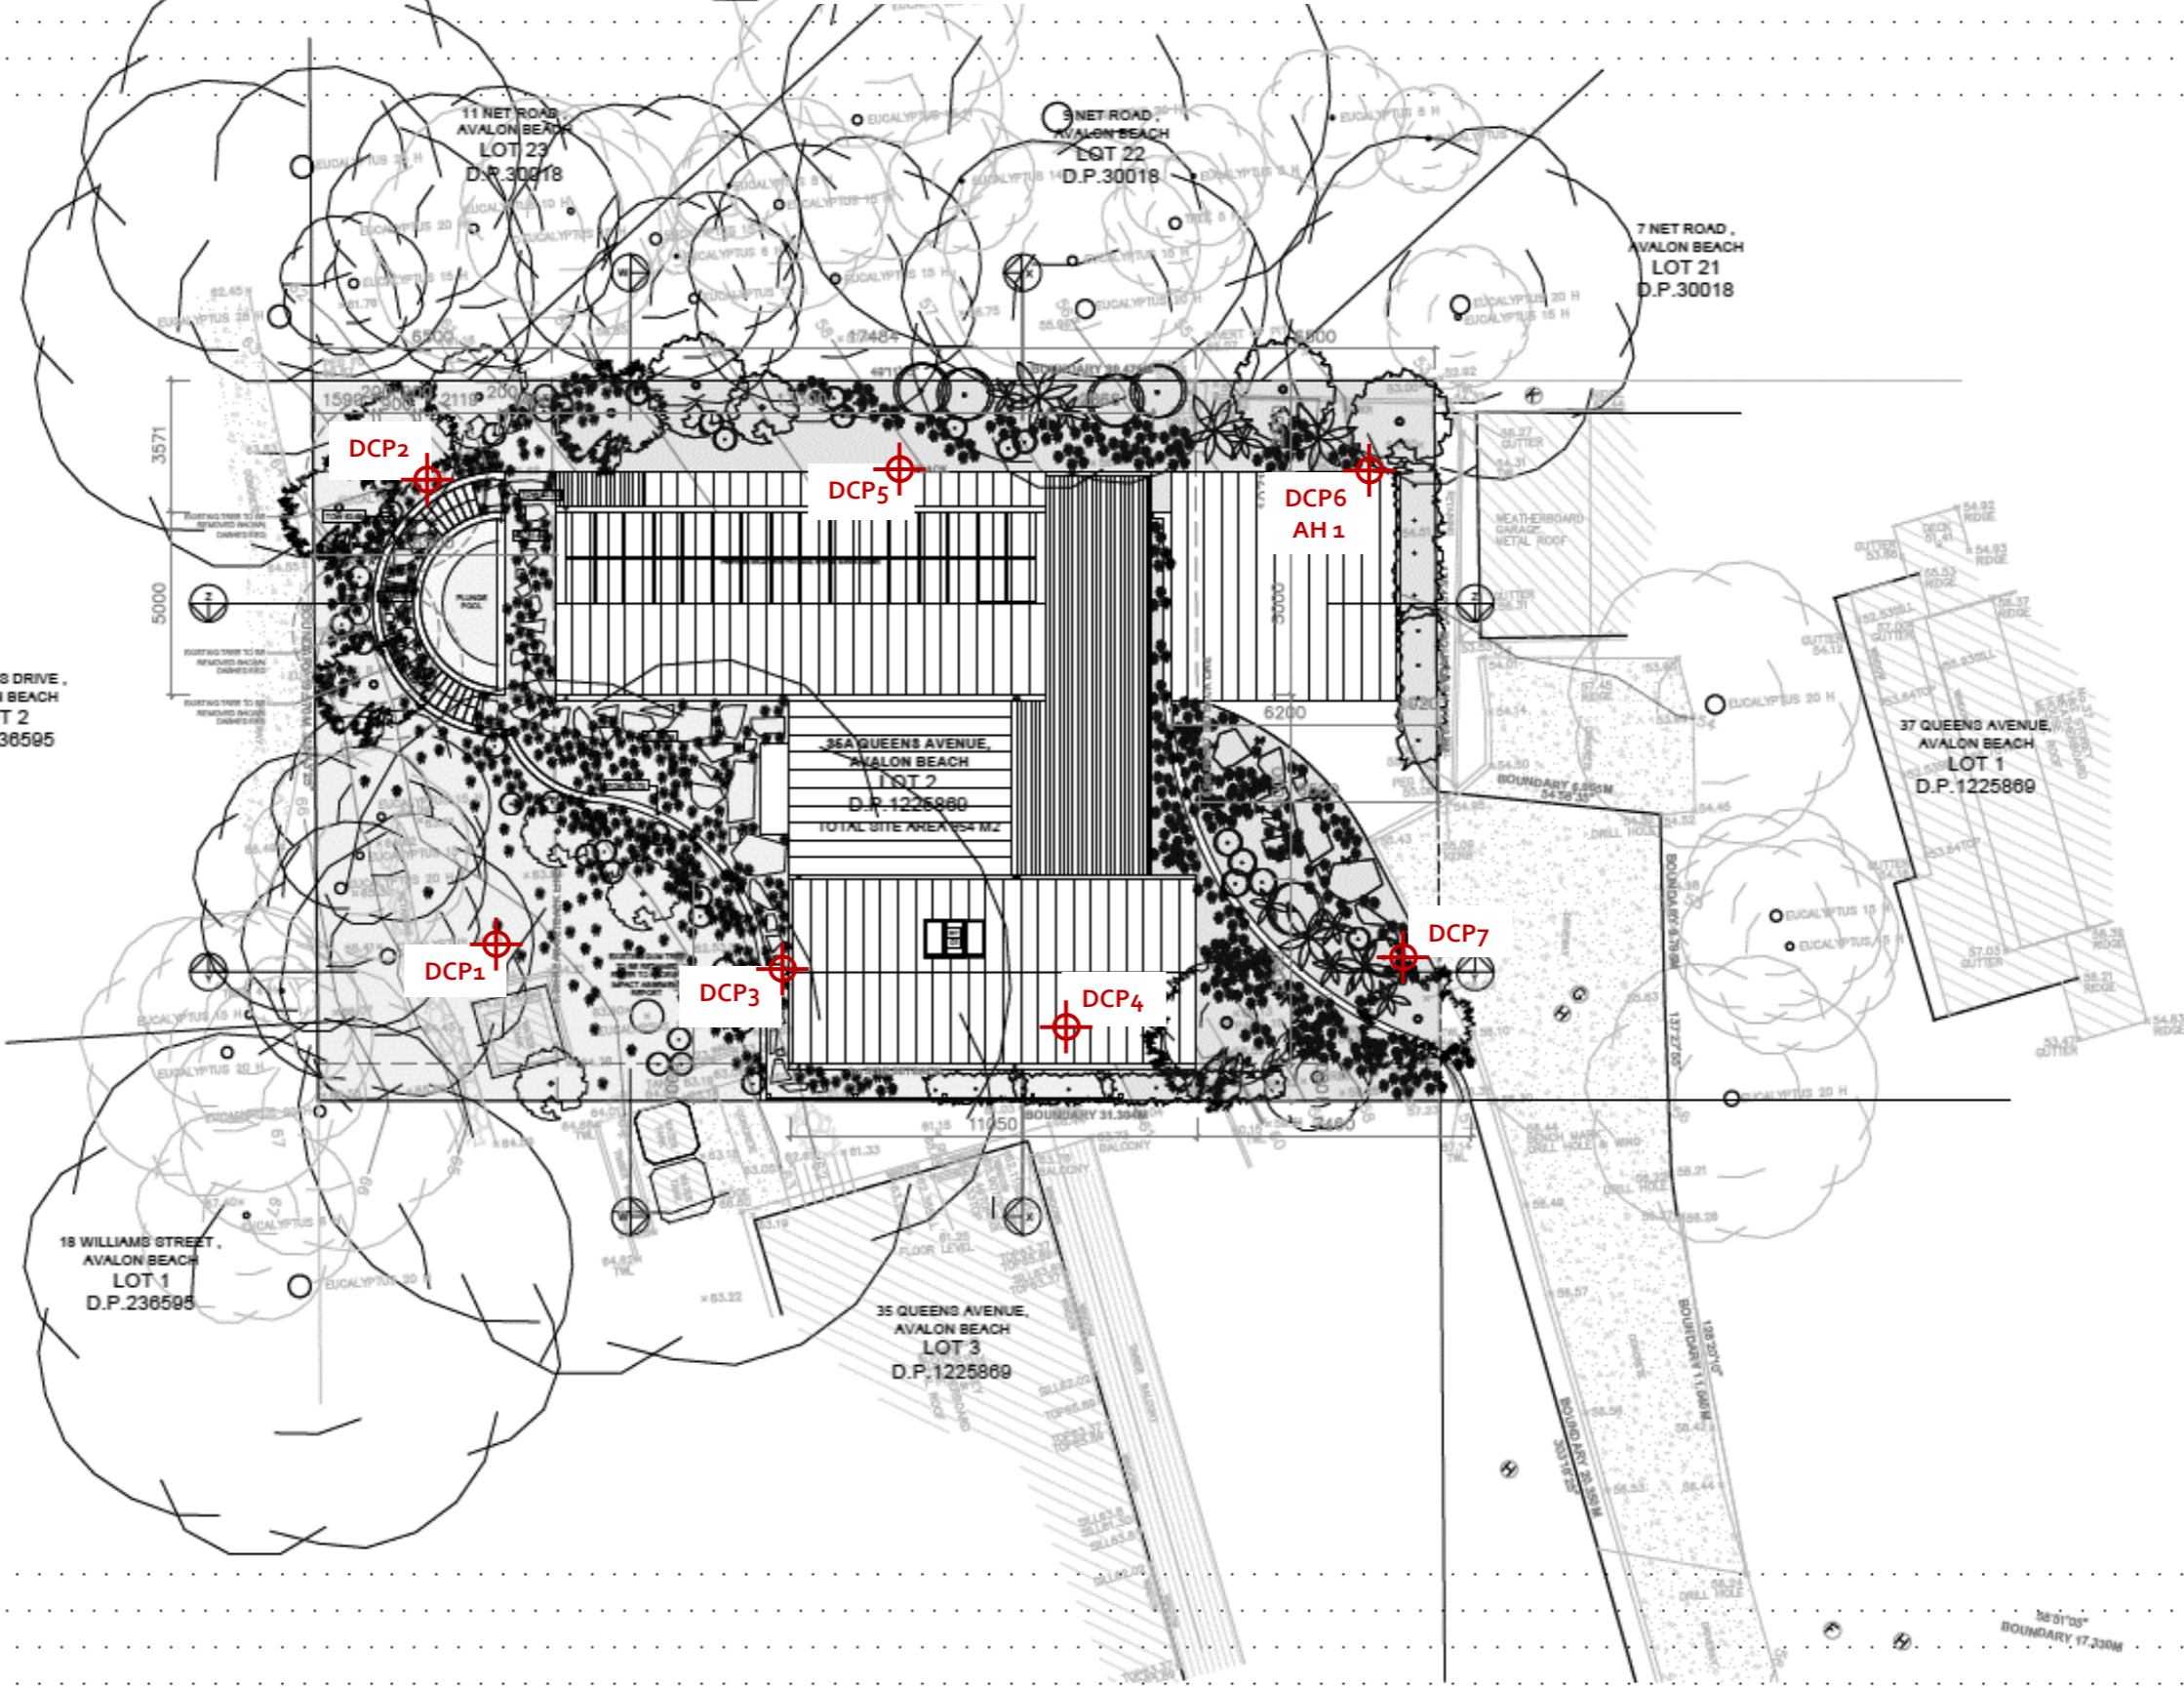
**SITE PLAN – showing test locations**

One hand Auger Hole (AH) was put down to identify the soil materials. Seven Dynamic Cone Penetrometer (DCP) tests were put down to determine the relative density of the overlying soil and the depth to bedrock. The locations of the tests are shown on the site plan attached. It should be noted that a level of caution should be applied when interpreting DCP test results. The test will not pass through hard buried objects so in some instances it can be difficult to determine whether refusal has occurred on an obstruction in the profile or on the natural rock surface. This is not expected to have been an issue for this site. But due to the possibility that the actual ground conditions vary from our interpretation there should be allowances in the excavation and foundation budget to account for this. We refer to the appended "Important Information about Your Report" to further clarify. The results are as follows:

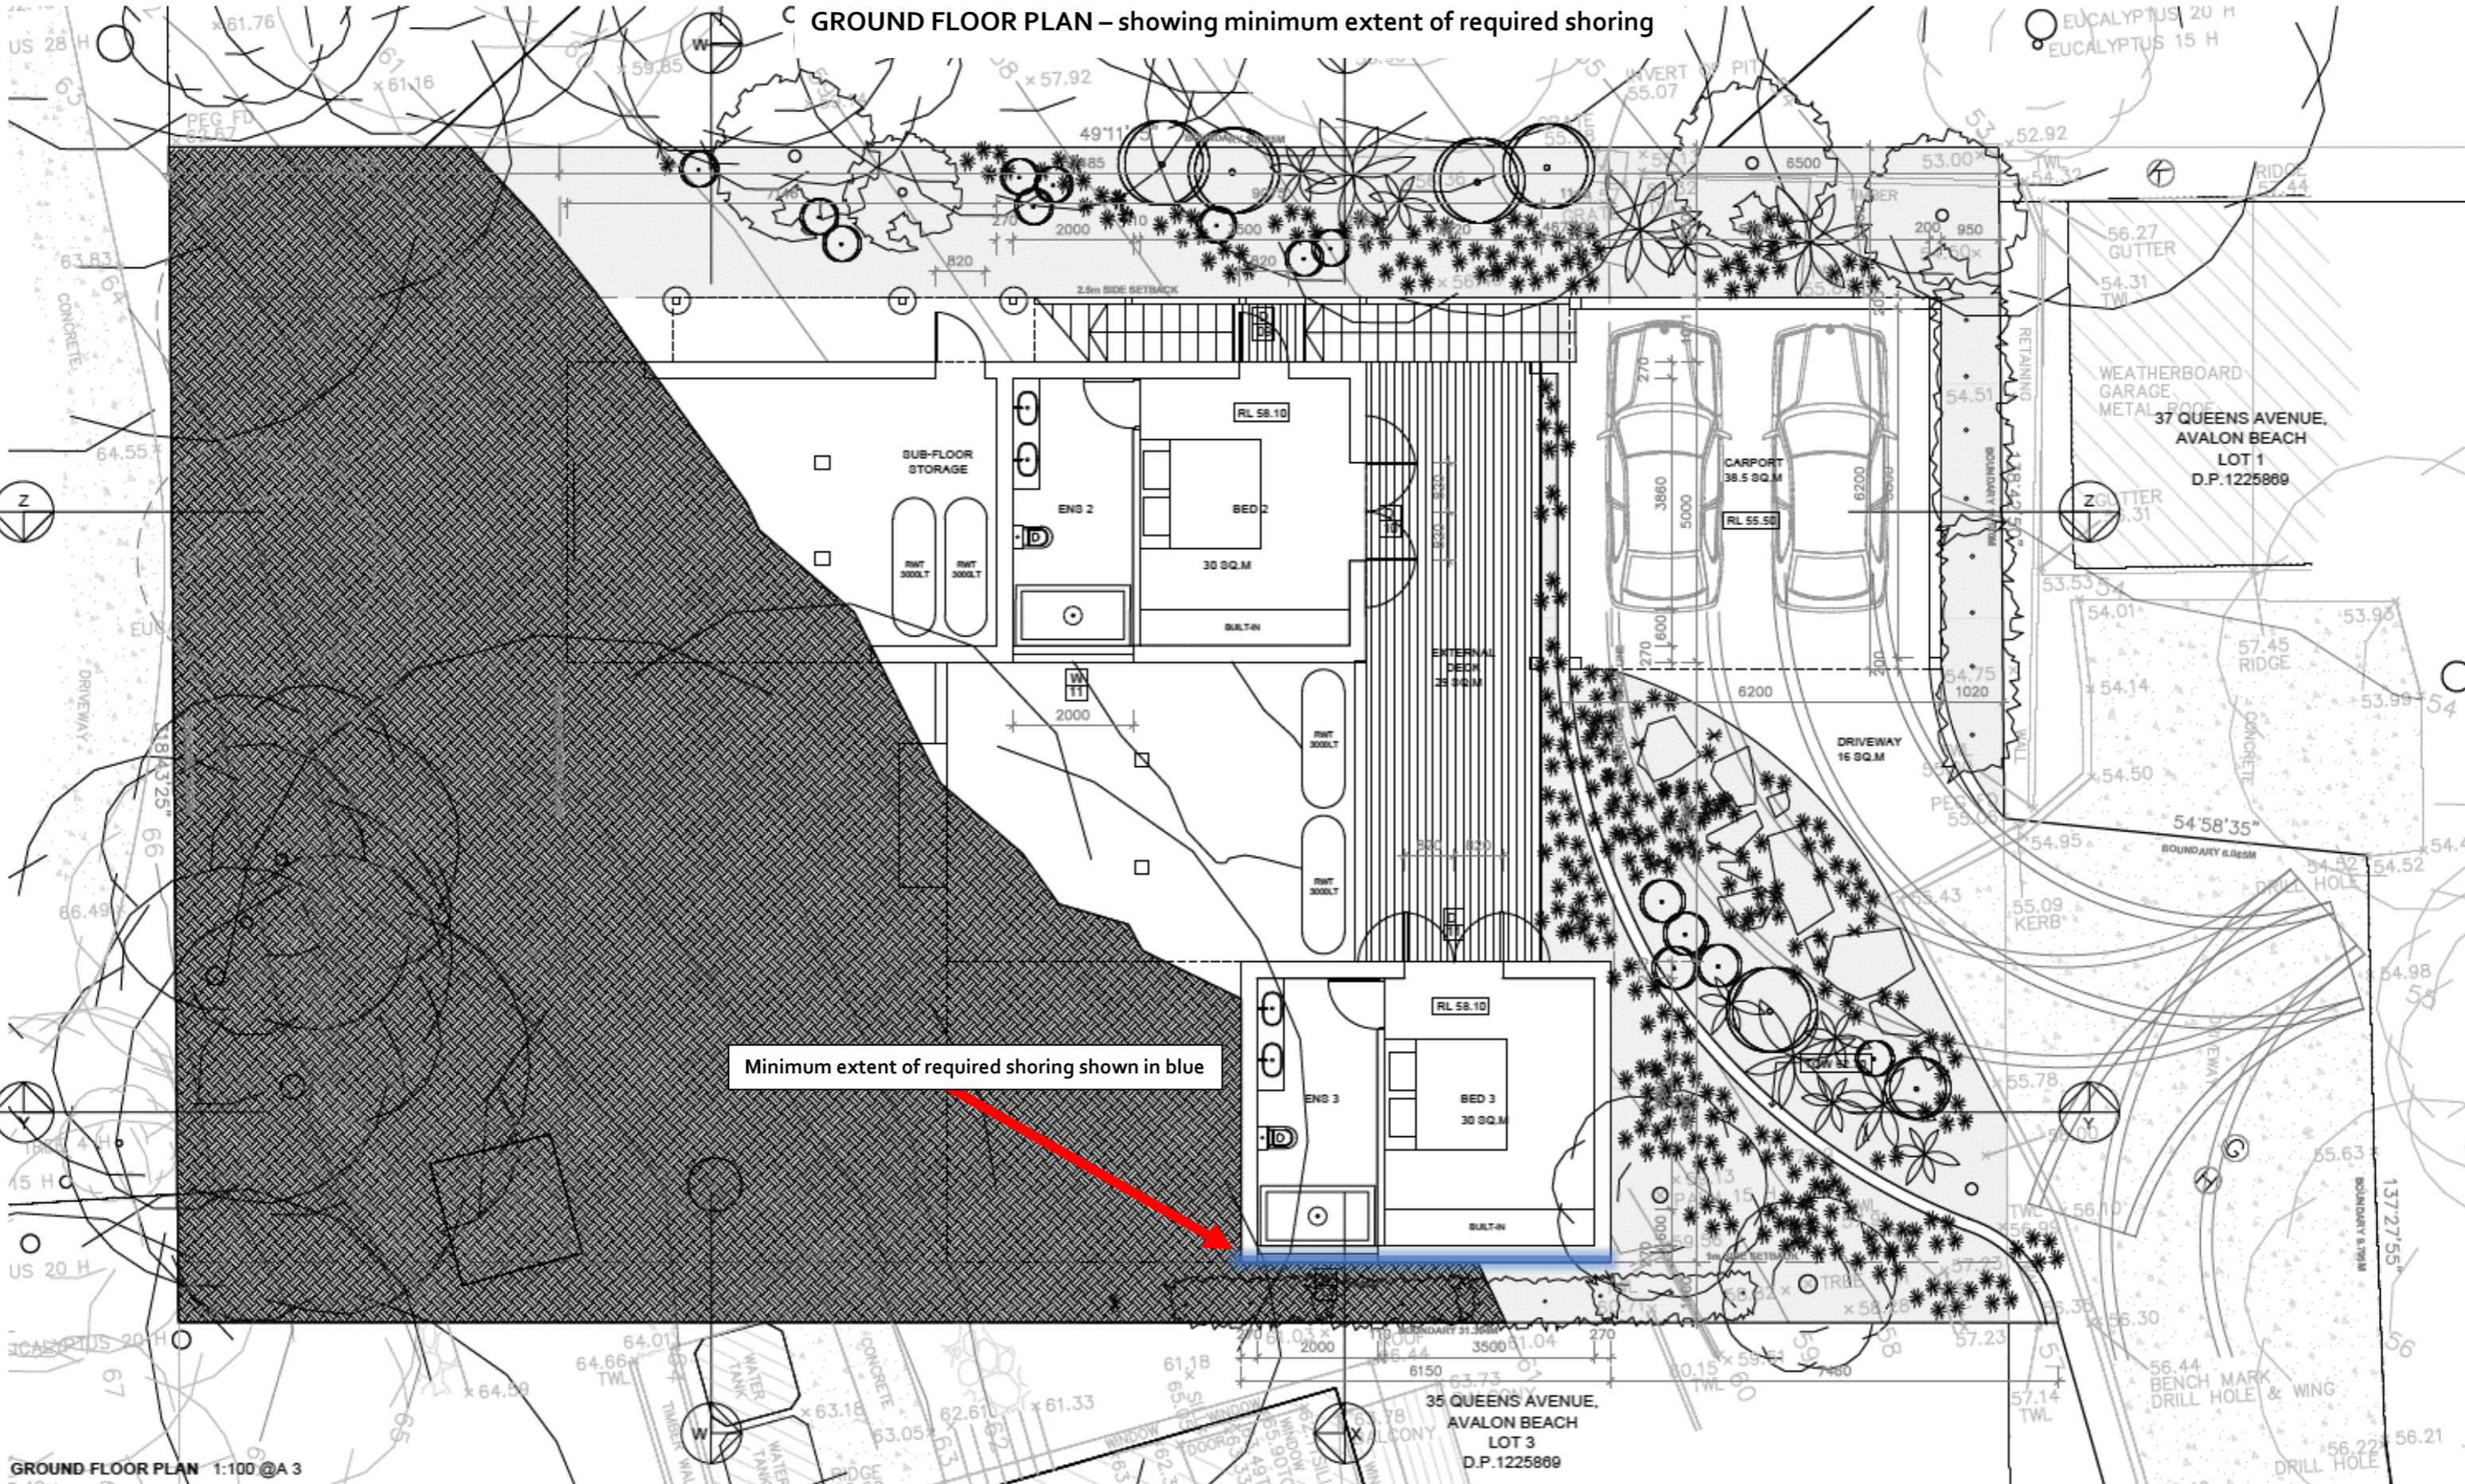
**GROUND FLOOR PLAN – showing minimum extent of required shoring**

Given that rock was found to a maximum depth of 1.4m, and the neighbouring house is set back 1.5m from the cut, assuming standard foundation depths, it is likely the SE neighbouring house is founded below the zone of influence of the proposed excavation. However, to ensure the integrity of the neighbouring property (land), we recommend that the SE side of the excavation through fill, sandy clay, and Very Low Strength Sandstone will need to be temporarily or permanently supported prior to the commencement of the excavation through rock, or during the excavation process in a staged manner, so cut batters are not left unsupported. The support will need to be designed by the structural engineer. See the site plan attached for the minimum extent of the required shoring shown in blue.

Minimum extent of required shoring shown in blue
