PRELIMINARY ASSESSMENT: Acid Sulfate

For Proposed Aged Care Centre at **23-25 Bassett Street, Mona Vale**

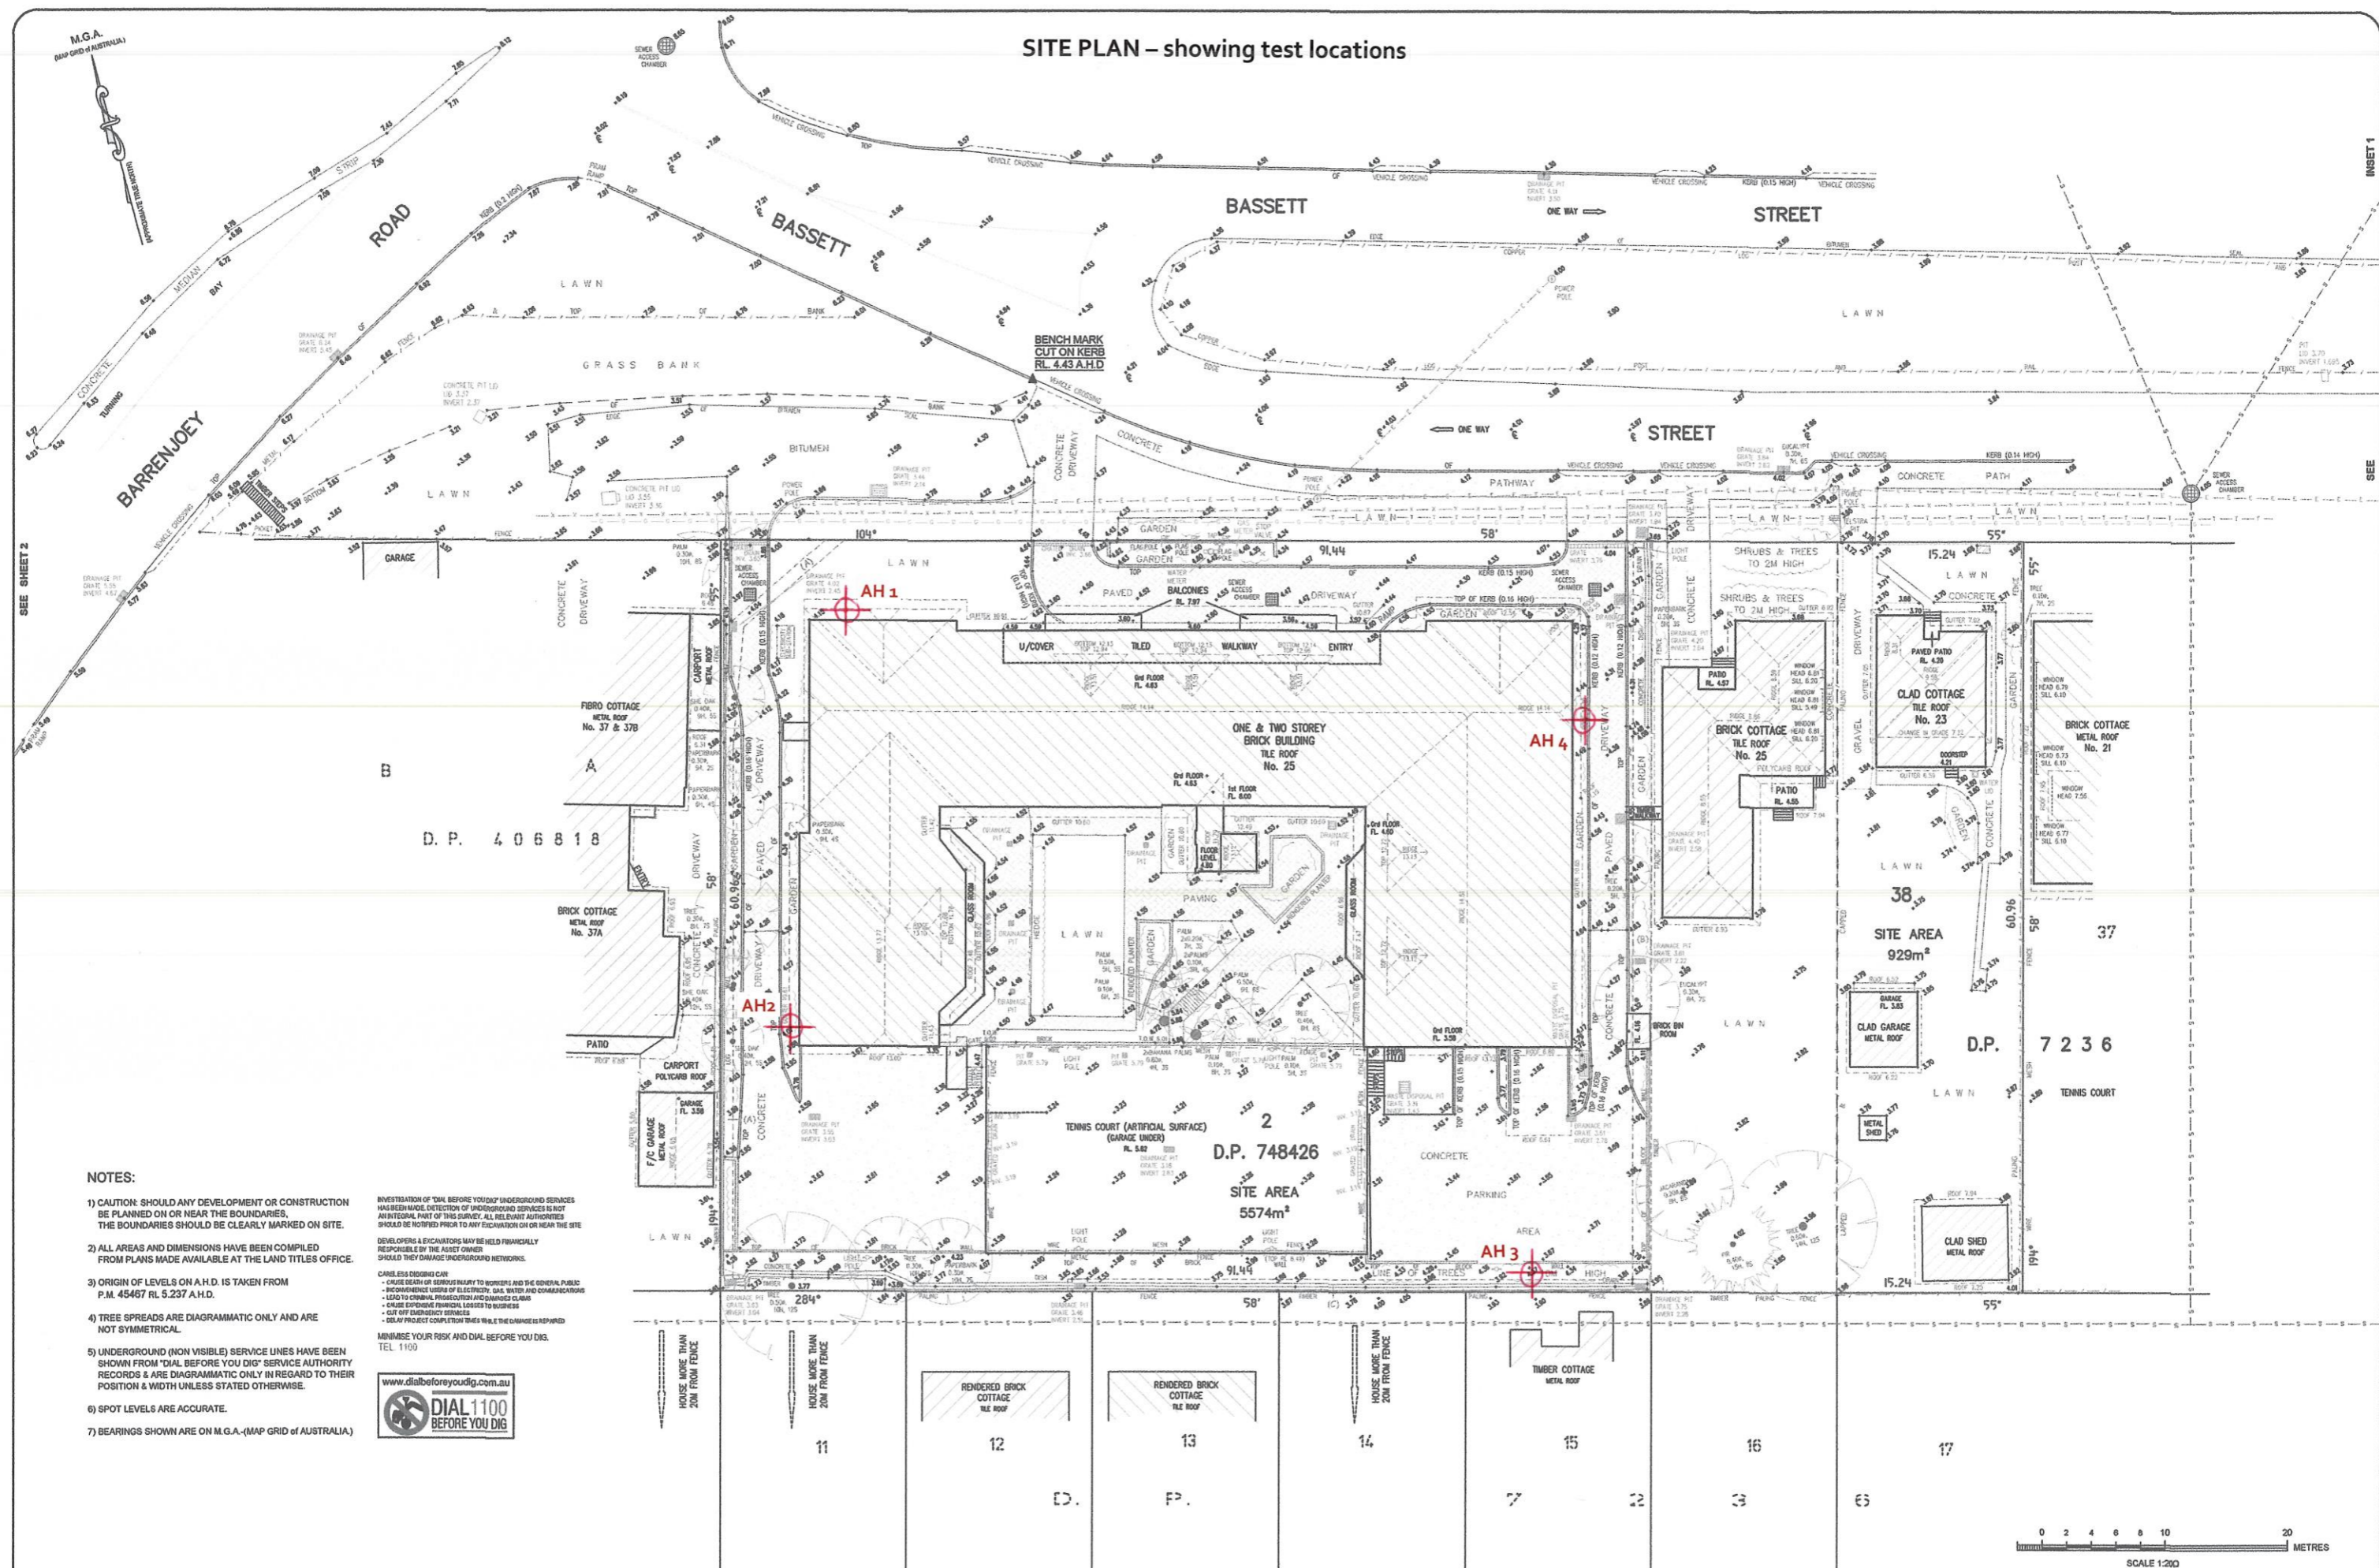
SITE PLAN – showing test locations

Four hand auger holes were put down in the locations shown on the site plan attached. Field pH and peroxide testing was carried out on samples taken from the auger holes at regular intervals. The logs of the auger holes and the test results are as follows.
