## ARBORICULTURAL IMPACT ASSESSMENT REPORT BELROSE MANOR: 181 FOREST WAY, BELROSE

### HUNTINGDON NURSING HOME

STURT NOBLE ARBORICULTURE  
**CONSULTING ARBORISTS**

30<sup>th</sup> August 2018 DA ISSUE Rev. B  
PROJECT: 1630

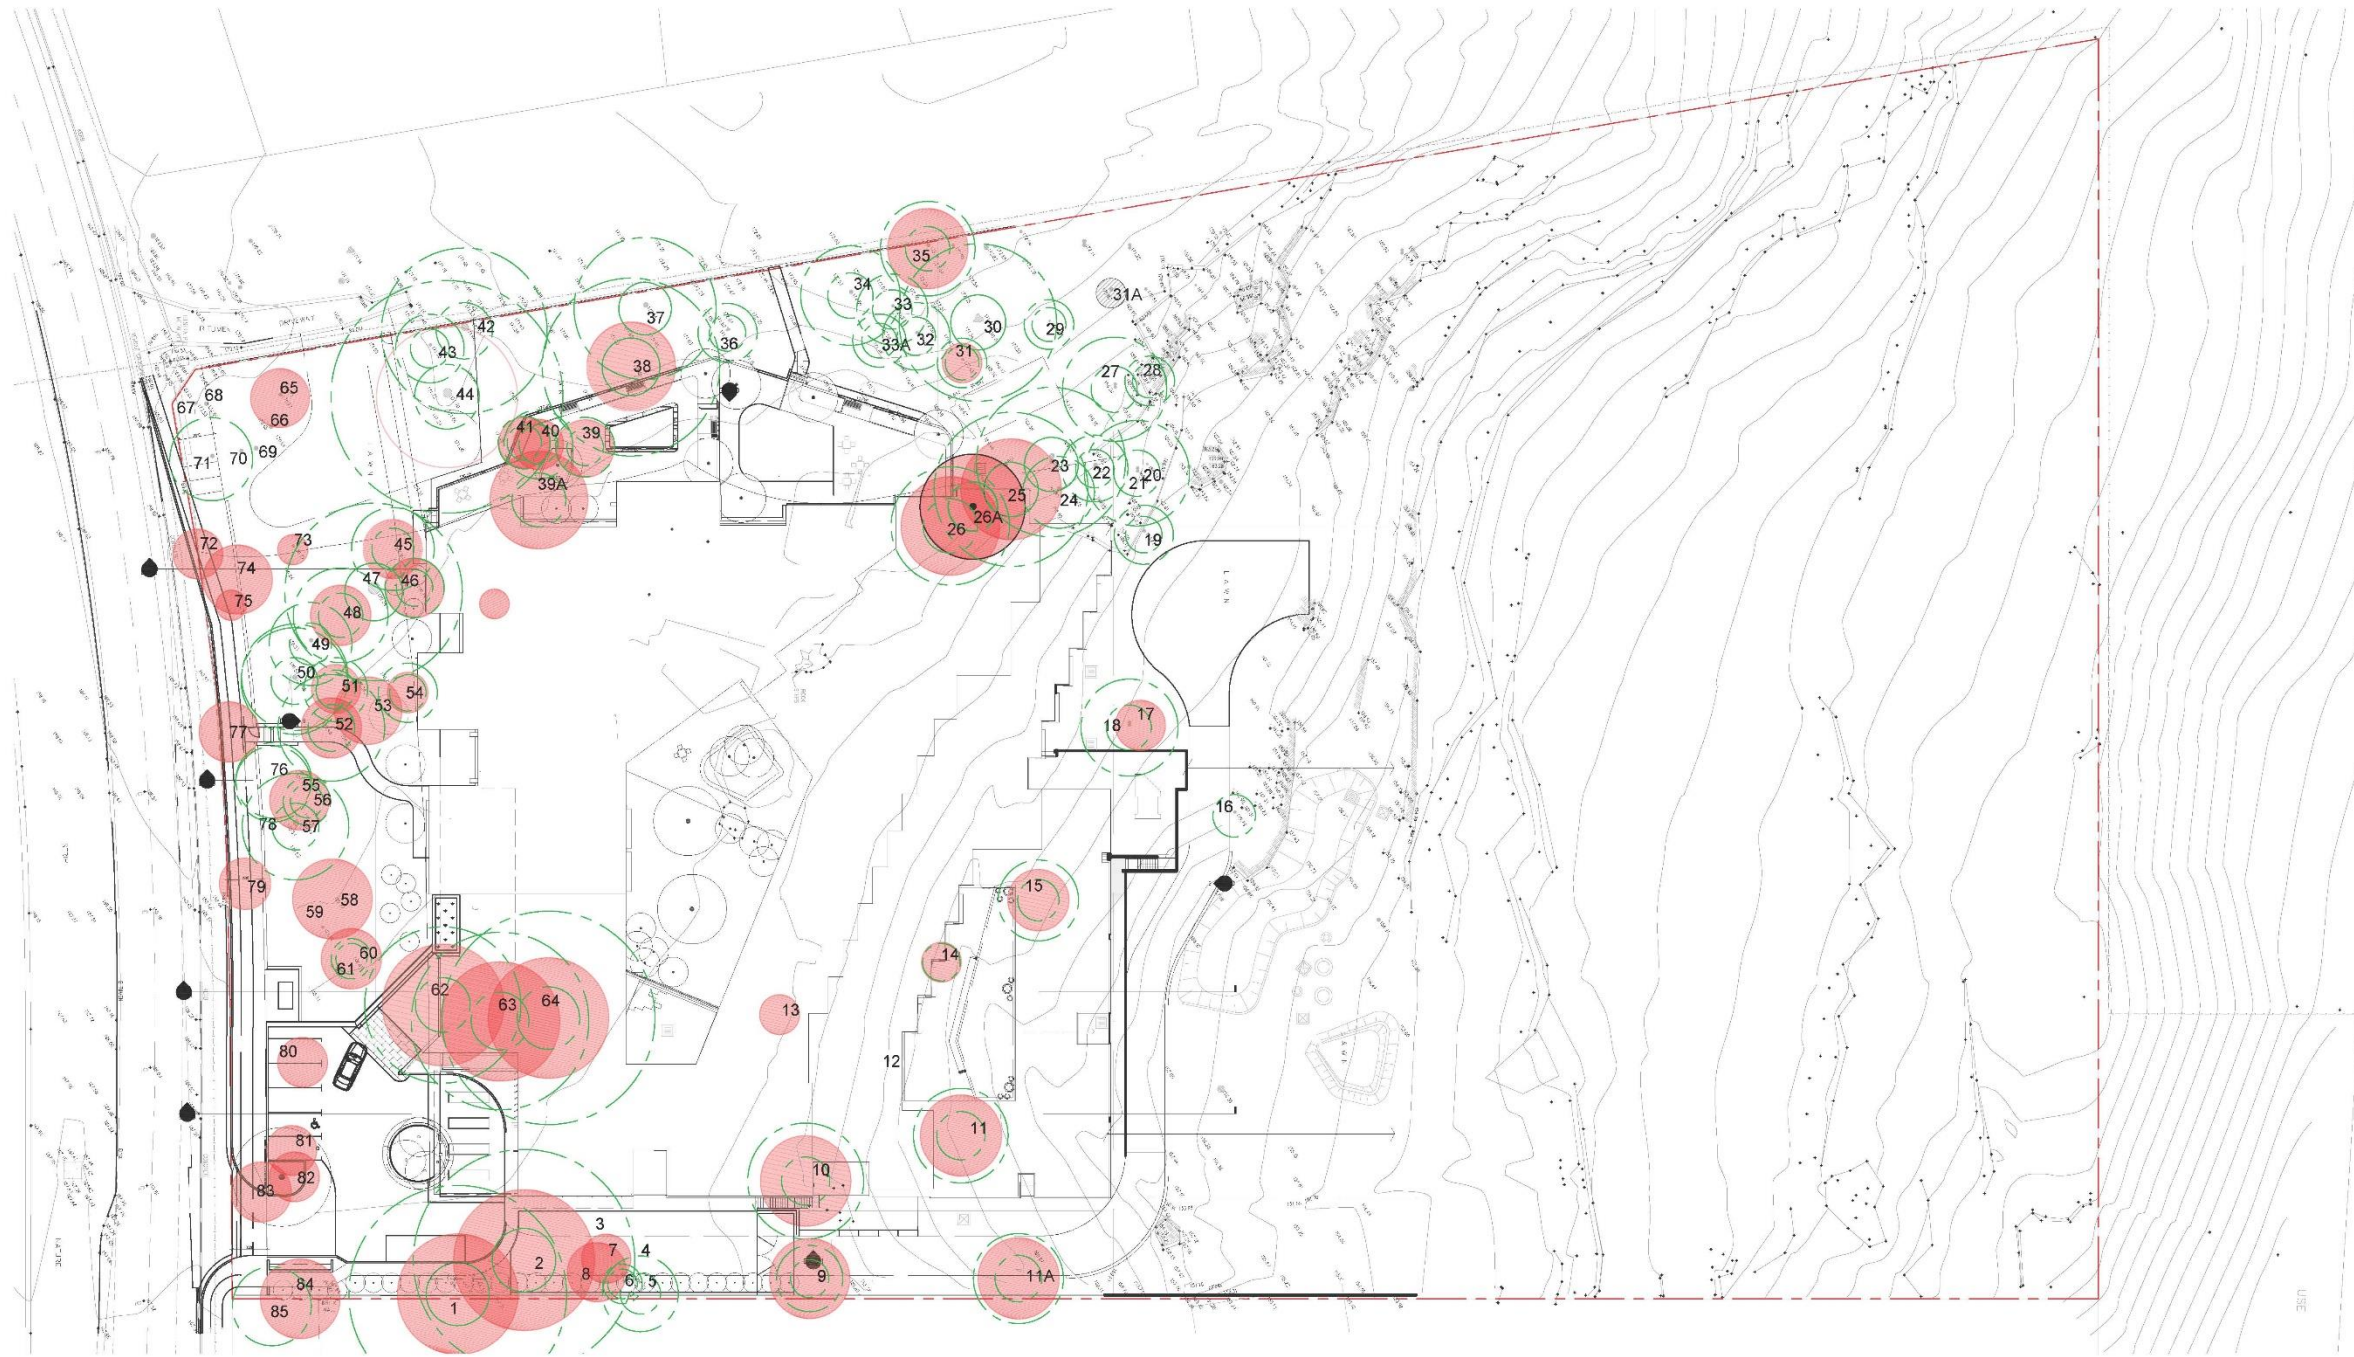
Figure 4: Impact assessment

2 trees (No. 44,47) have encroachments of greater than 10% on their TPZ. Both have encroached by approximately 12% which in our opinion is acceptable subject to the tree protection measures in this report being followed.

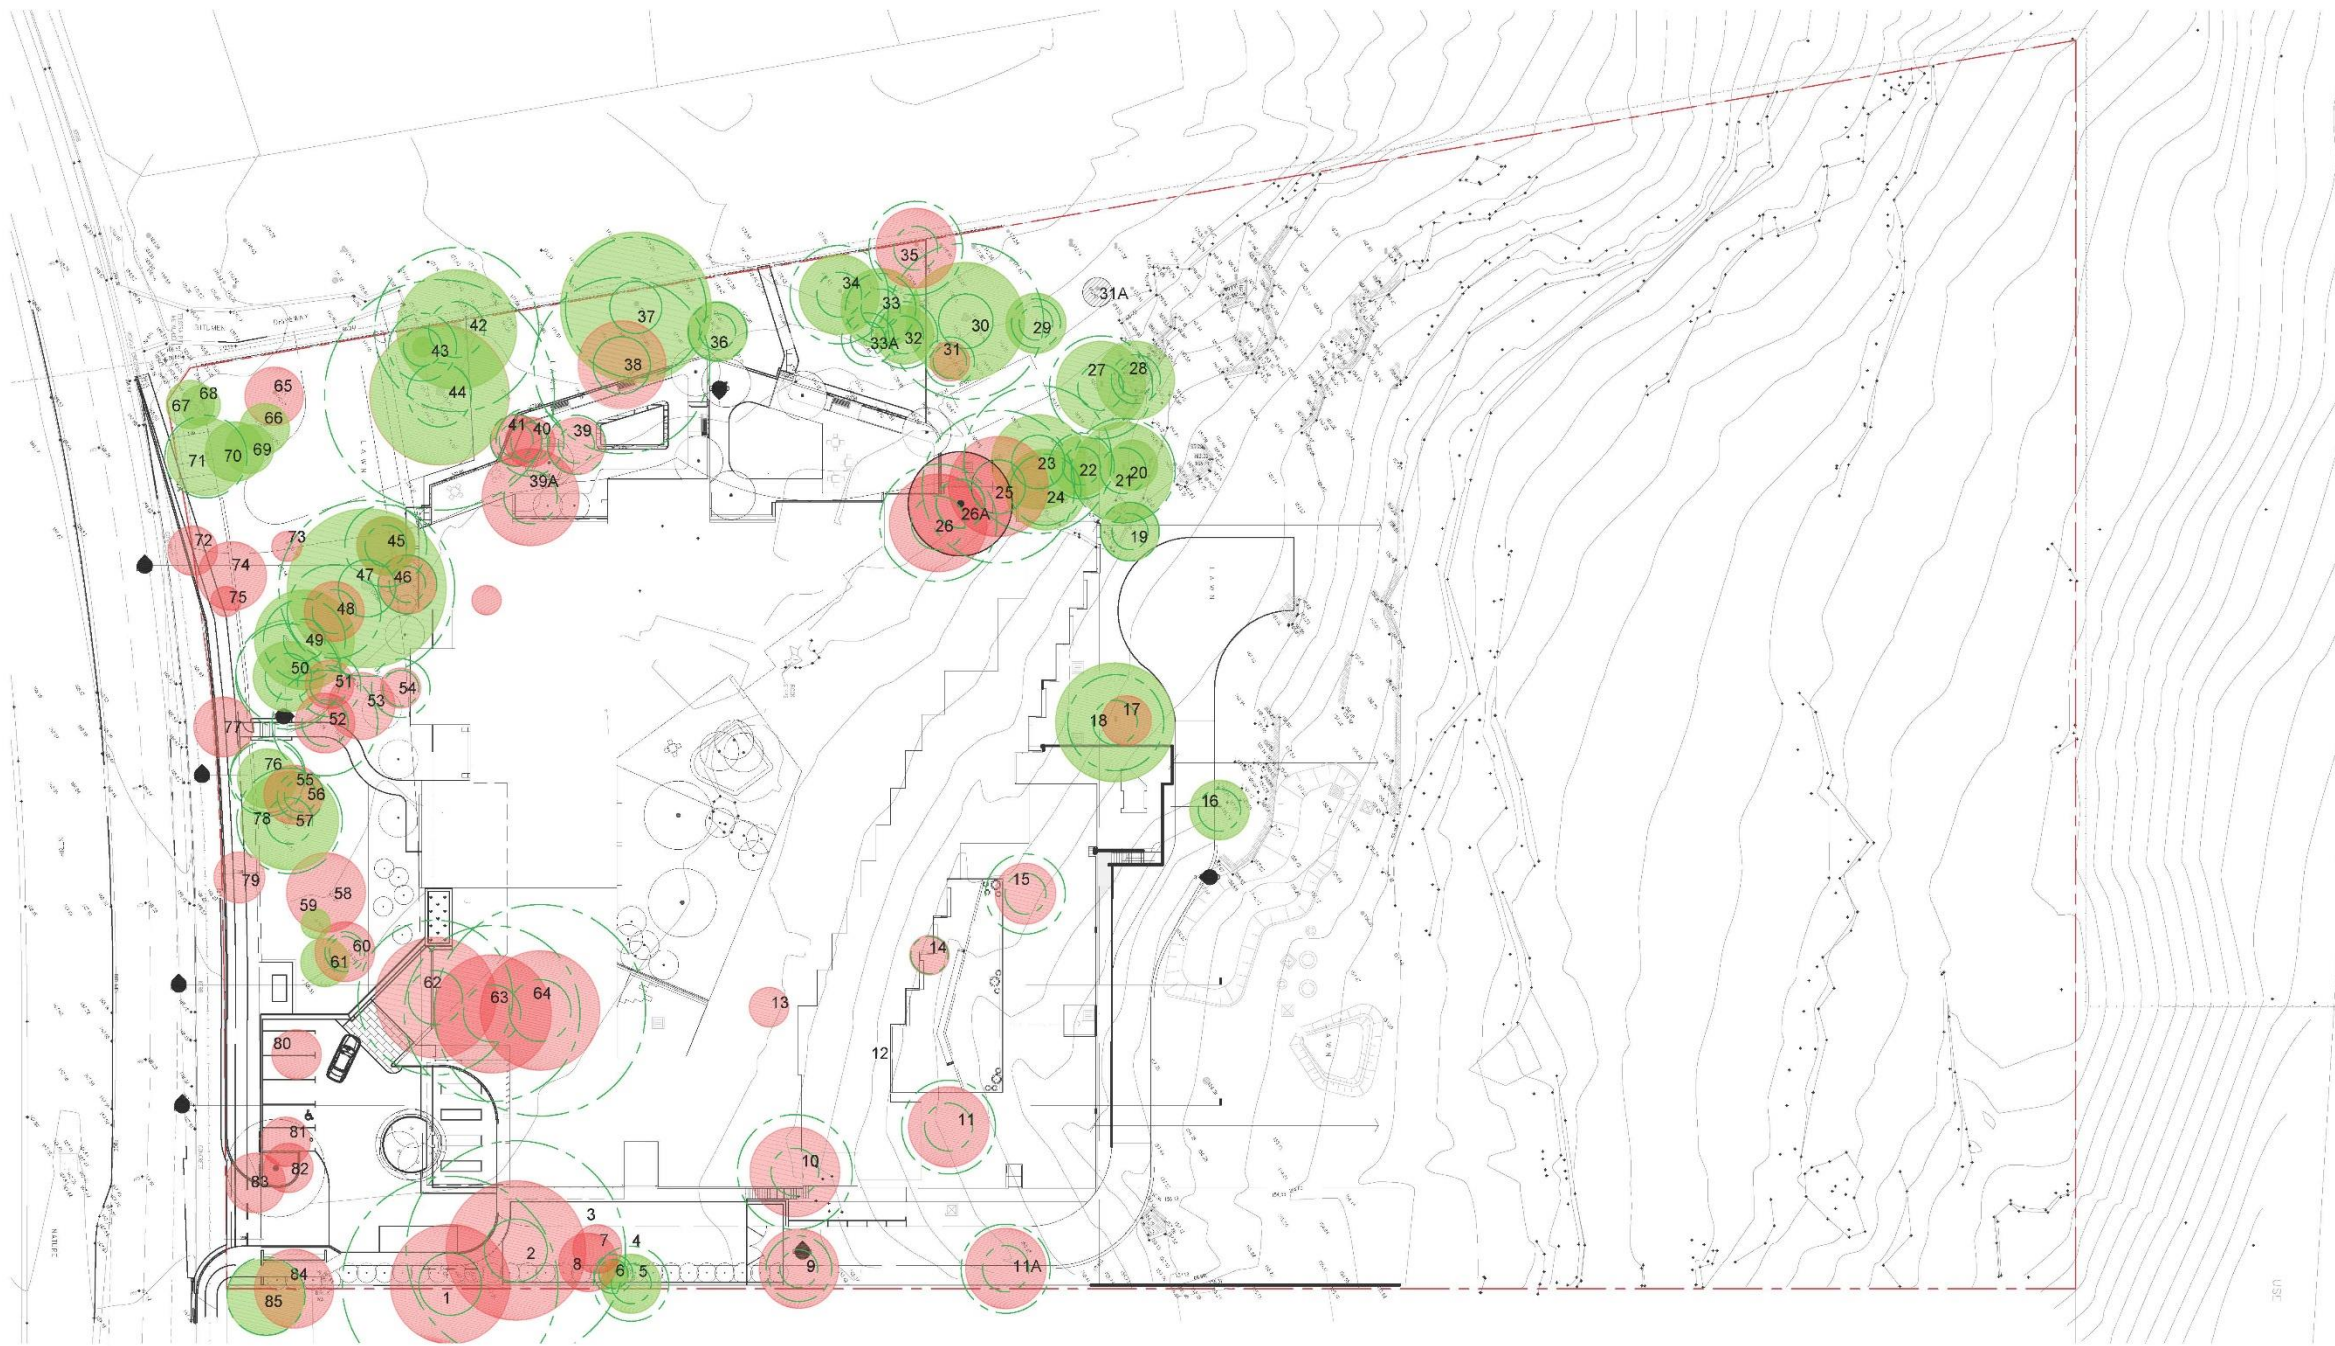
Figure 5: Tree Retention Plan

We have also noted Tree Number 31A as a habitat tree and this should be retained and protected as per guidelines by Cumberland Ecology. Refer Cumberland Ecology Report.
