J2412. 4th December, 2019. Page 1.

GEOTECHNICAL INVESTIGATION:

New Pool at 325 Whale Beach Road, Palm Beach

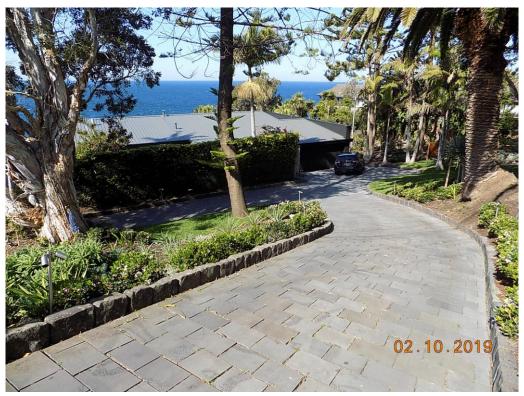
Photo 1

- 2.3 At the road frontage, a tile-paved driveway runs down and across the slope to a parking area on the uphill side of the property and to a garage attached to the uphill side of the house (Photo 1). The slope between the road frontage and the house is garden and lawn-covered (Photo 2). The single-storey rendered brick house is supported on brick walls and brick piers (Photo 3). No significant signs of movement were observed in the supporting brick walls and the supporting brick piers stand vertical. A moderately sloping lawn extends off the downhill side of the house to a

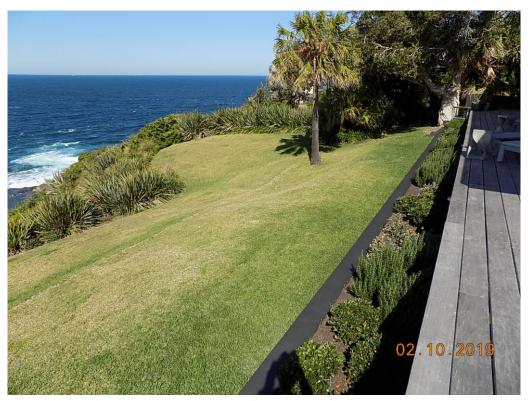
Photo 4

well-vegetated garden at the cliff-top (Photos 4 & 5). A ~15m high sea cliff falls from near the lower boundary to a rock platform below (Photo 6). It consists of competent Medium Strength Sandstone. The cliff face displays no significant undercutting or serious geological defects that could affect its stability. The rock platform has a covering of dislodged sandstone boulders at the cliff base. Some of the boulders were observed to be greater than 3m in diameter and effectively armour the cliff base from the erosional forces of storm surf.

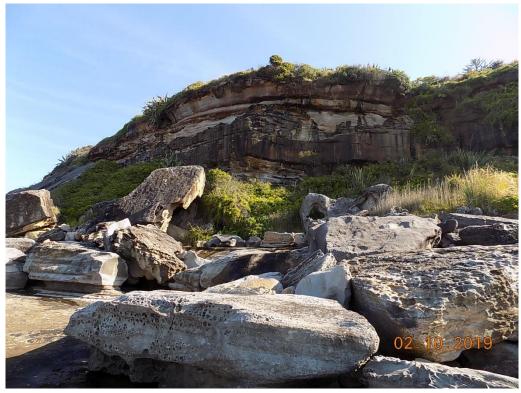
Photo 6

No geotechnical hazards were observed beside the property. The moderately graded slope that falls across the property and continues above is a potential hazard (**Hazard One**). The sea cliff that falls below the lower boundary is a potential hazard (**Hazard Two**).
