## 29 Wandeen Road, Clareville

### Comments on Updates to Plans

## **GEOTECHNICAL INVESTIGATION:**

### **Alterations and Additions at 29 Wandeen Road, Clareville**

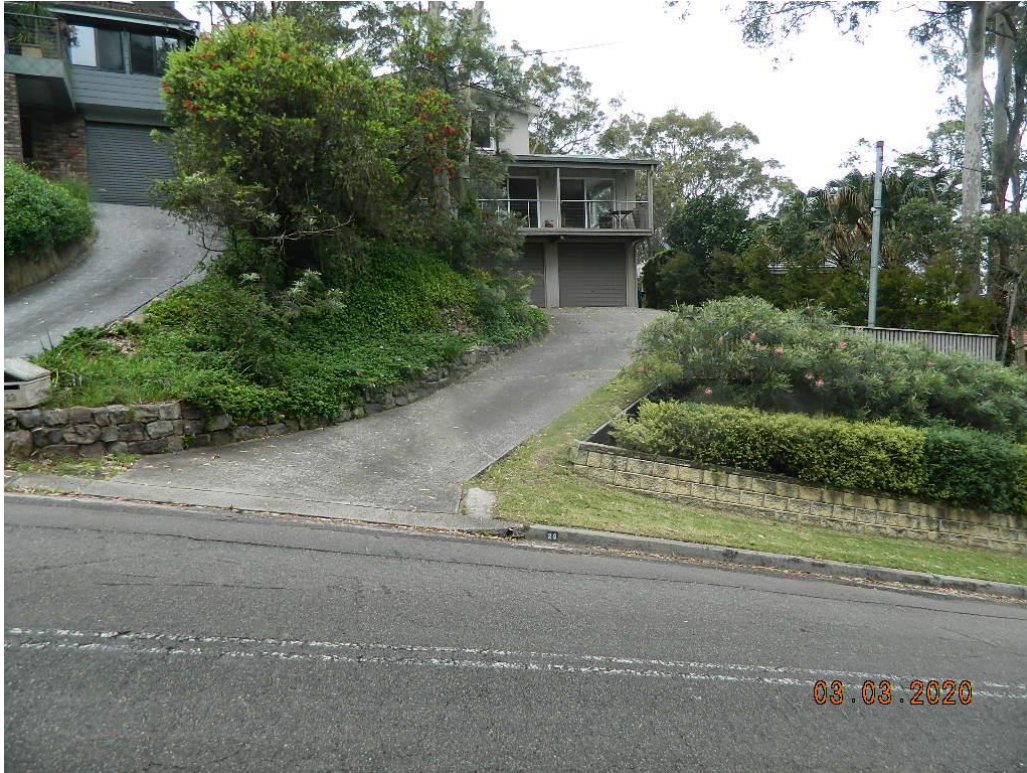
Photo 1

**2.3** At the road frontage a concrete driveway cuts across the slope and leads to a double garage under the house. Low stable sandstone stack rock and keystone retaining walls line the slope either side of the driveway (Photo 1). The part three storey rendered masonry house is supported by masonry walls and a concrete slab (Photos 2 & 3). The external supporting walls are in good condition and show no significant signs of movement.

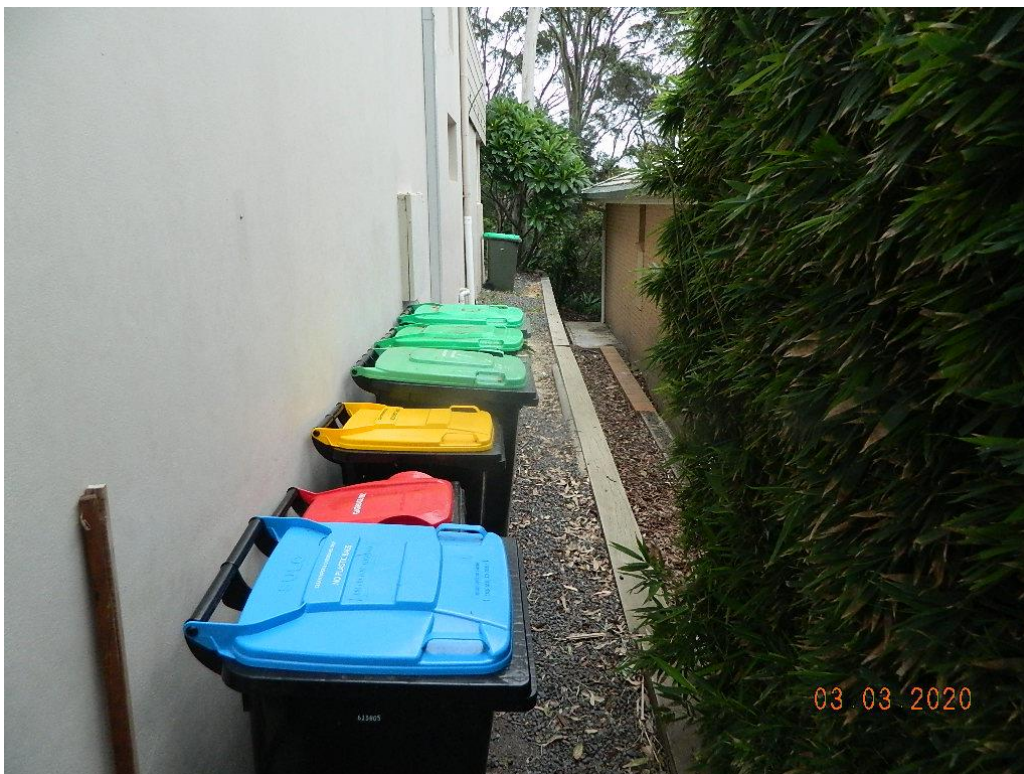
Photo 4

A  $\sim 0.6\text{m}$  high timber retaining wall supports a cut for the downhill property to the W along part of the W common boundary (Photo 4). A  $\sim 1.6\text{m}$  high timber retaining wall supports a cut in the slope next to the house along part of the E common boundary. Where the wall changes direction and extends onto the neighbouring property the supporting soldier post is tilting (Photos 5 & 6) some  $10^\circ$  from vertical. Due to its location the wall poses no significant threat to life or property. See '**Section 16** Ongoing maintenance.

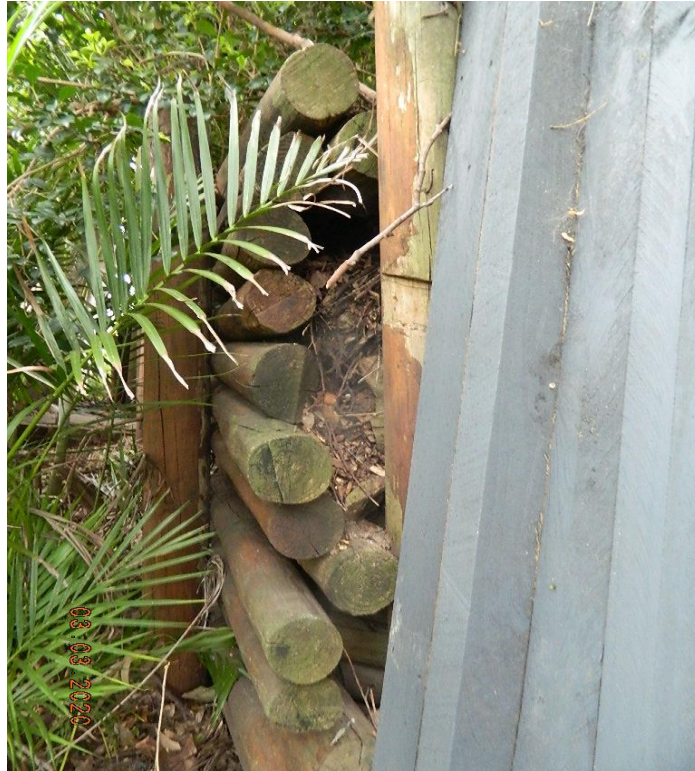
Photo 5

- The lift portion of the excavation comes underneath the first floor of the house and comes flush with the E perimeter masonry wall supporting the house.
- The storage room portion of the excavation comes underneath the first floor of the house and is setback ~1.1m from the E perimeter masonry wall supporting the house.
- The undercroft (connected to the proposed pool pump and water tank room) portion of the excavation is outside the footprint of the house. It comes flush with the S masonry house wall and is set back ~0.2m from a timber retaining wall near the E common boundary (Photo 5) and ~0.6m from the E common boundary.

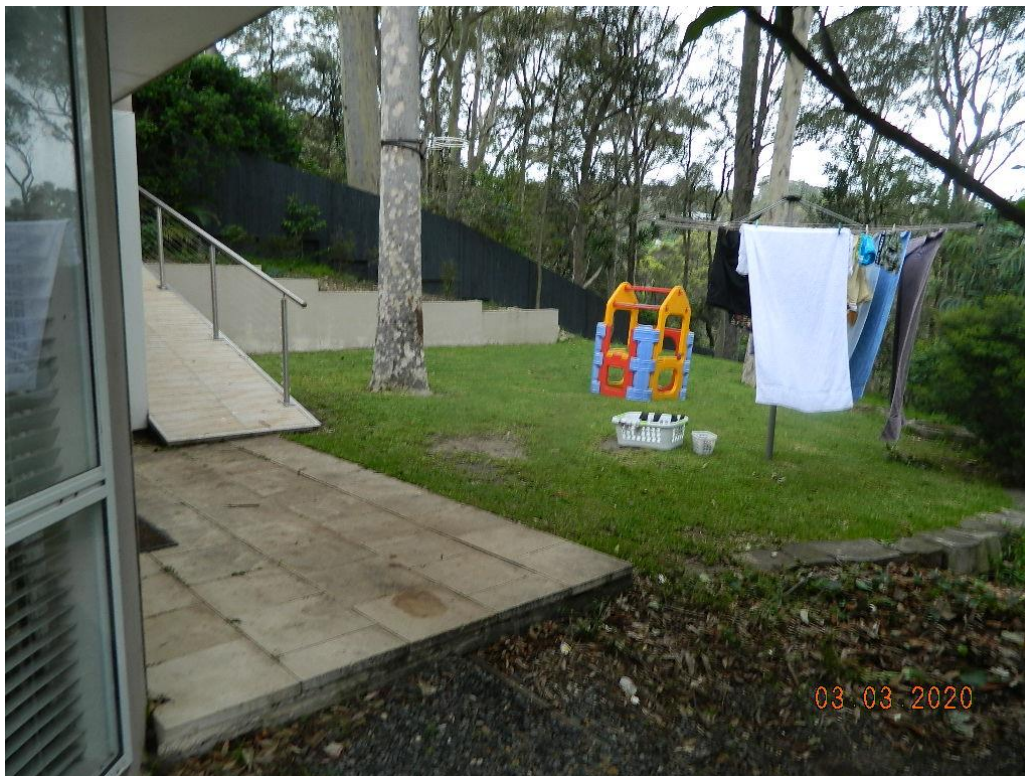
Photo 7

A cut and fill in the slope provides a near level lawn which extends from the S side of the house (Photo 7). Above the lawn a stable masonry retaining wall up to  $\sim 1.4\text{m}$  high supports the cut (Photo 8). The lawn drops away to the S where the fill batter merges into the natural slope (Photos 9 & 10).

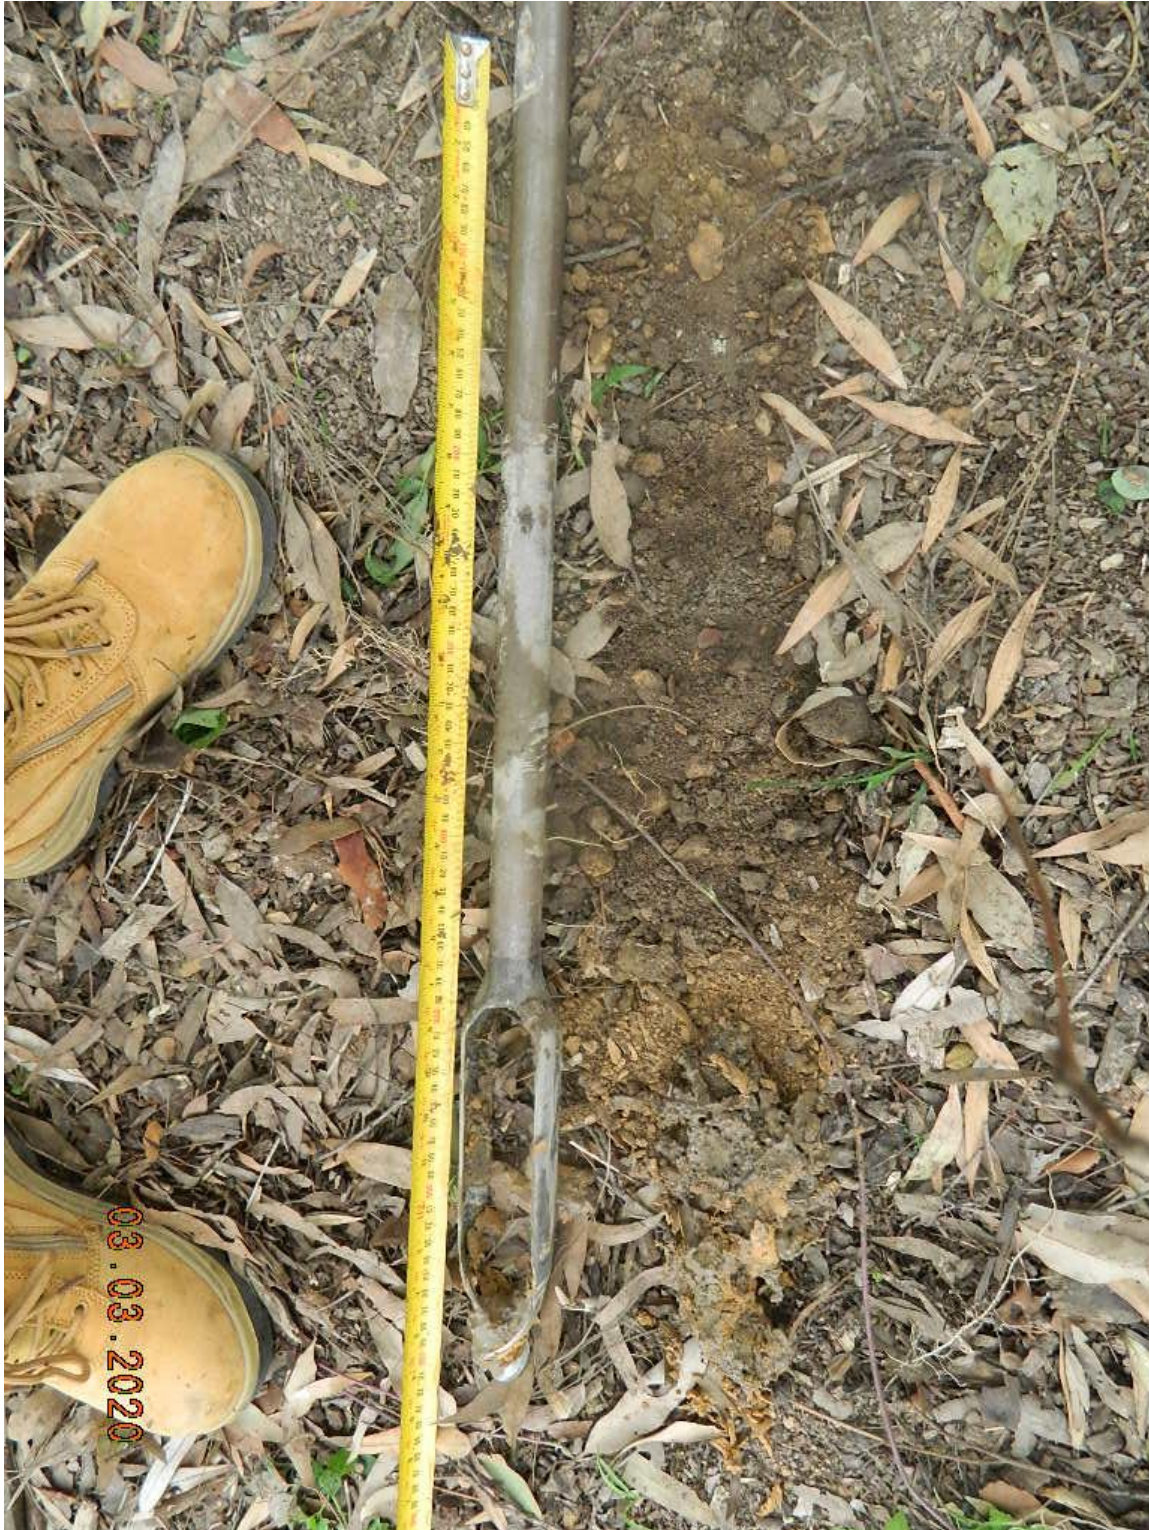
Photo 11: AH1 – Downhole is from top to bottom

##### AUGER HOLE 1 (~RL58.4) – AH1 (photo 11)

Depth (m)	Material Encountered
0.0 to 0.5	<b>CLAYEY SOIL</b> , brown and orange, dry.
0.5 to 0.7	<b>CLAY</b> , orange, firm to stiff, dry.

End of Hole @ 0.7m in Clay. No watertable encountered.

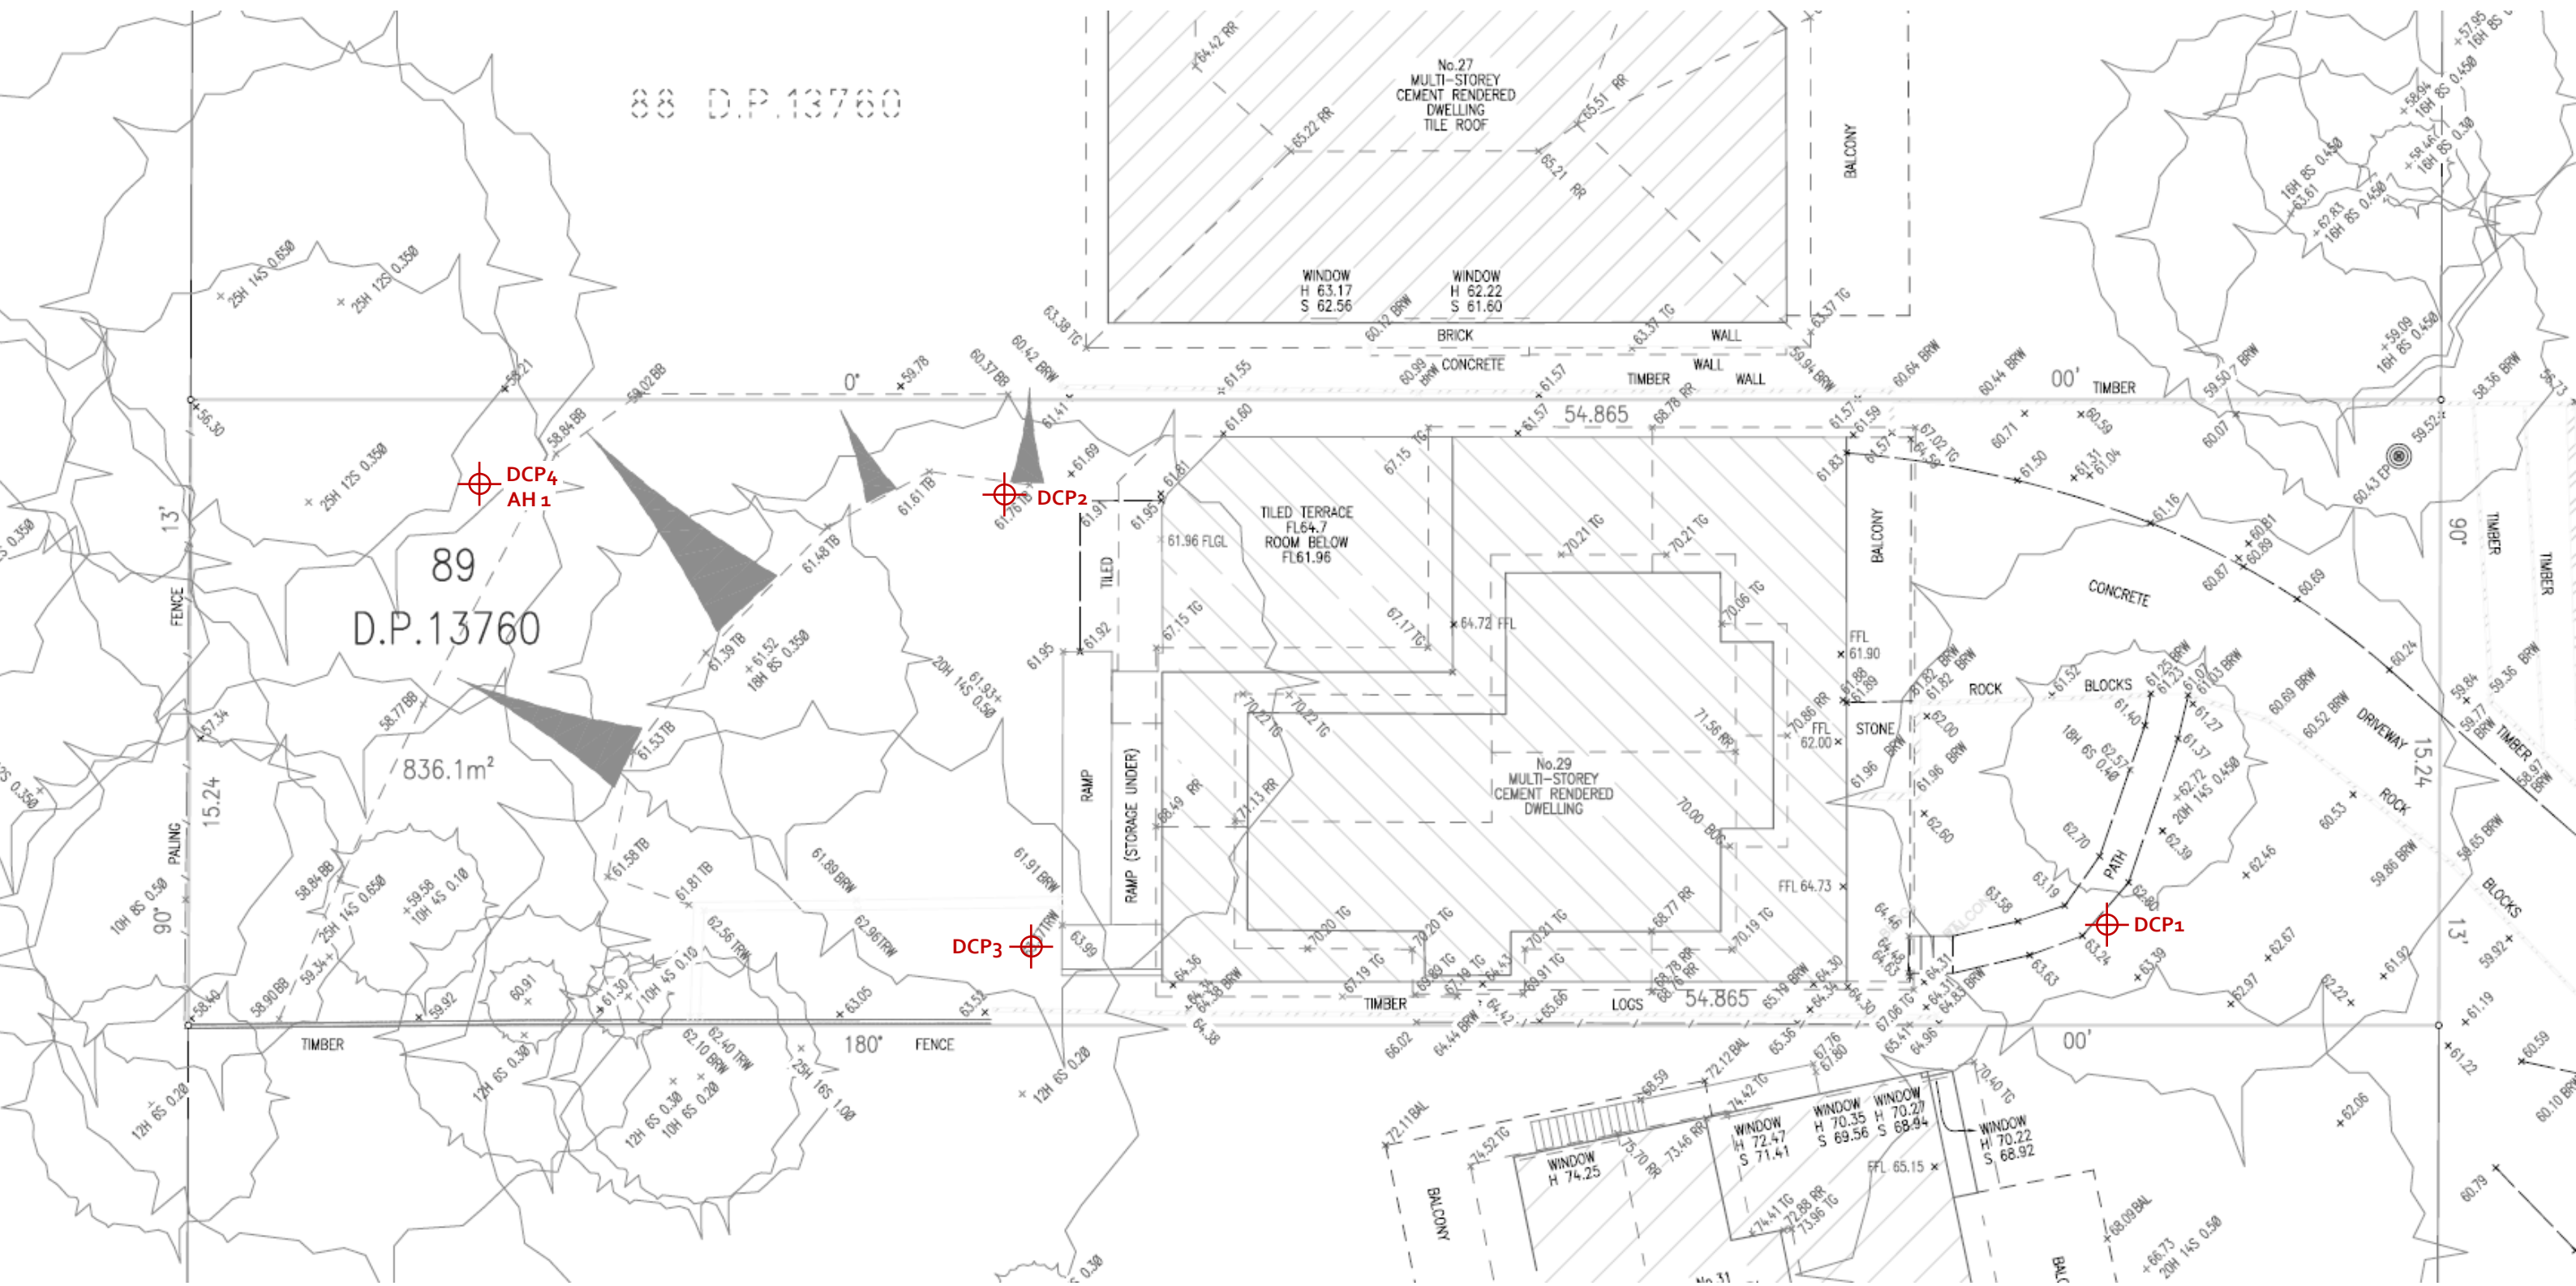
SURVEY – showing test locations

One hand auger hole (AH) was put down to identify the soil materials. Four Dynamic Cone Penetrometer (DCP) tests were put down to determine the relative density of the overlying soil and the depth to weathered rock. The locations of the tests are shown on the site plan. It should be noted that a level of caution should be applied when interpreting DCP test results. The test will not pass through hard buried objects so in some instances it can be difficult to determine whether refusal has occurred on an obstruction in the profile or on the natural rock surface. This is not expected to have been an issue for this site. But due to the possibility that the actual ground conditions vary from our interpretation there should be allowances in the excavation and foundation budget to account for this. We refer to the appended "Important Information about Your Report" to further clarify. The results are as follows:

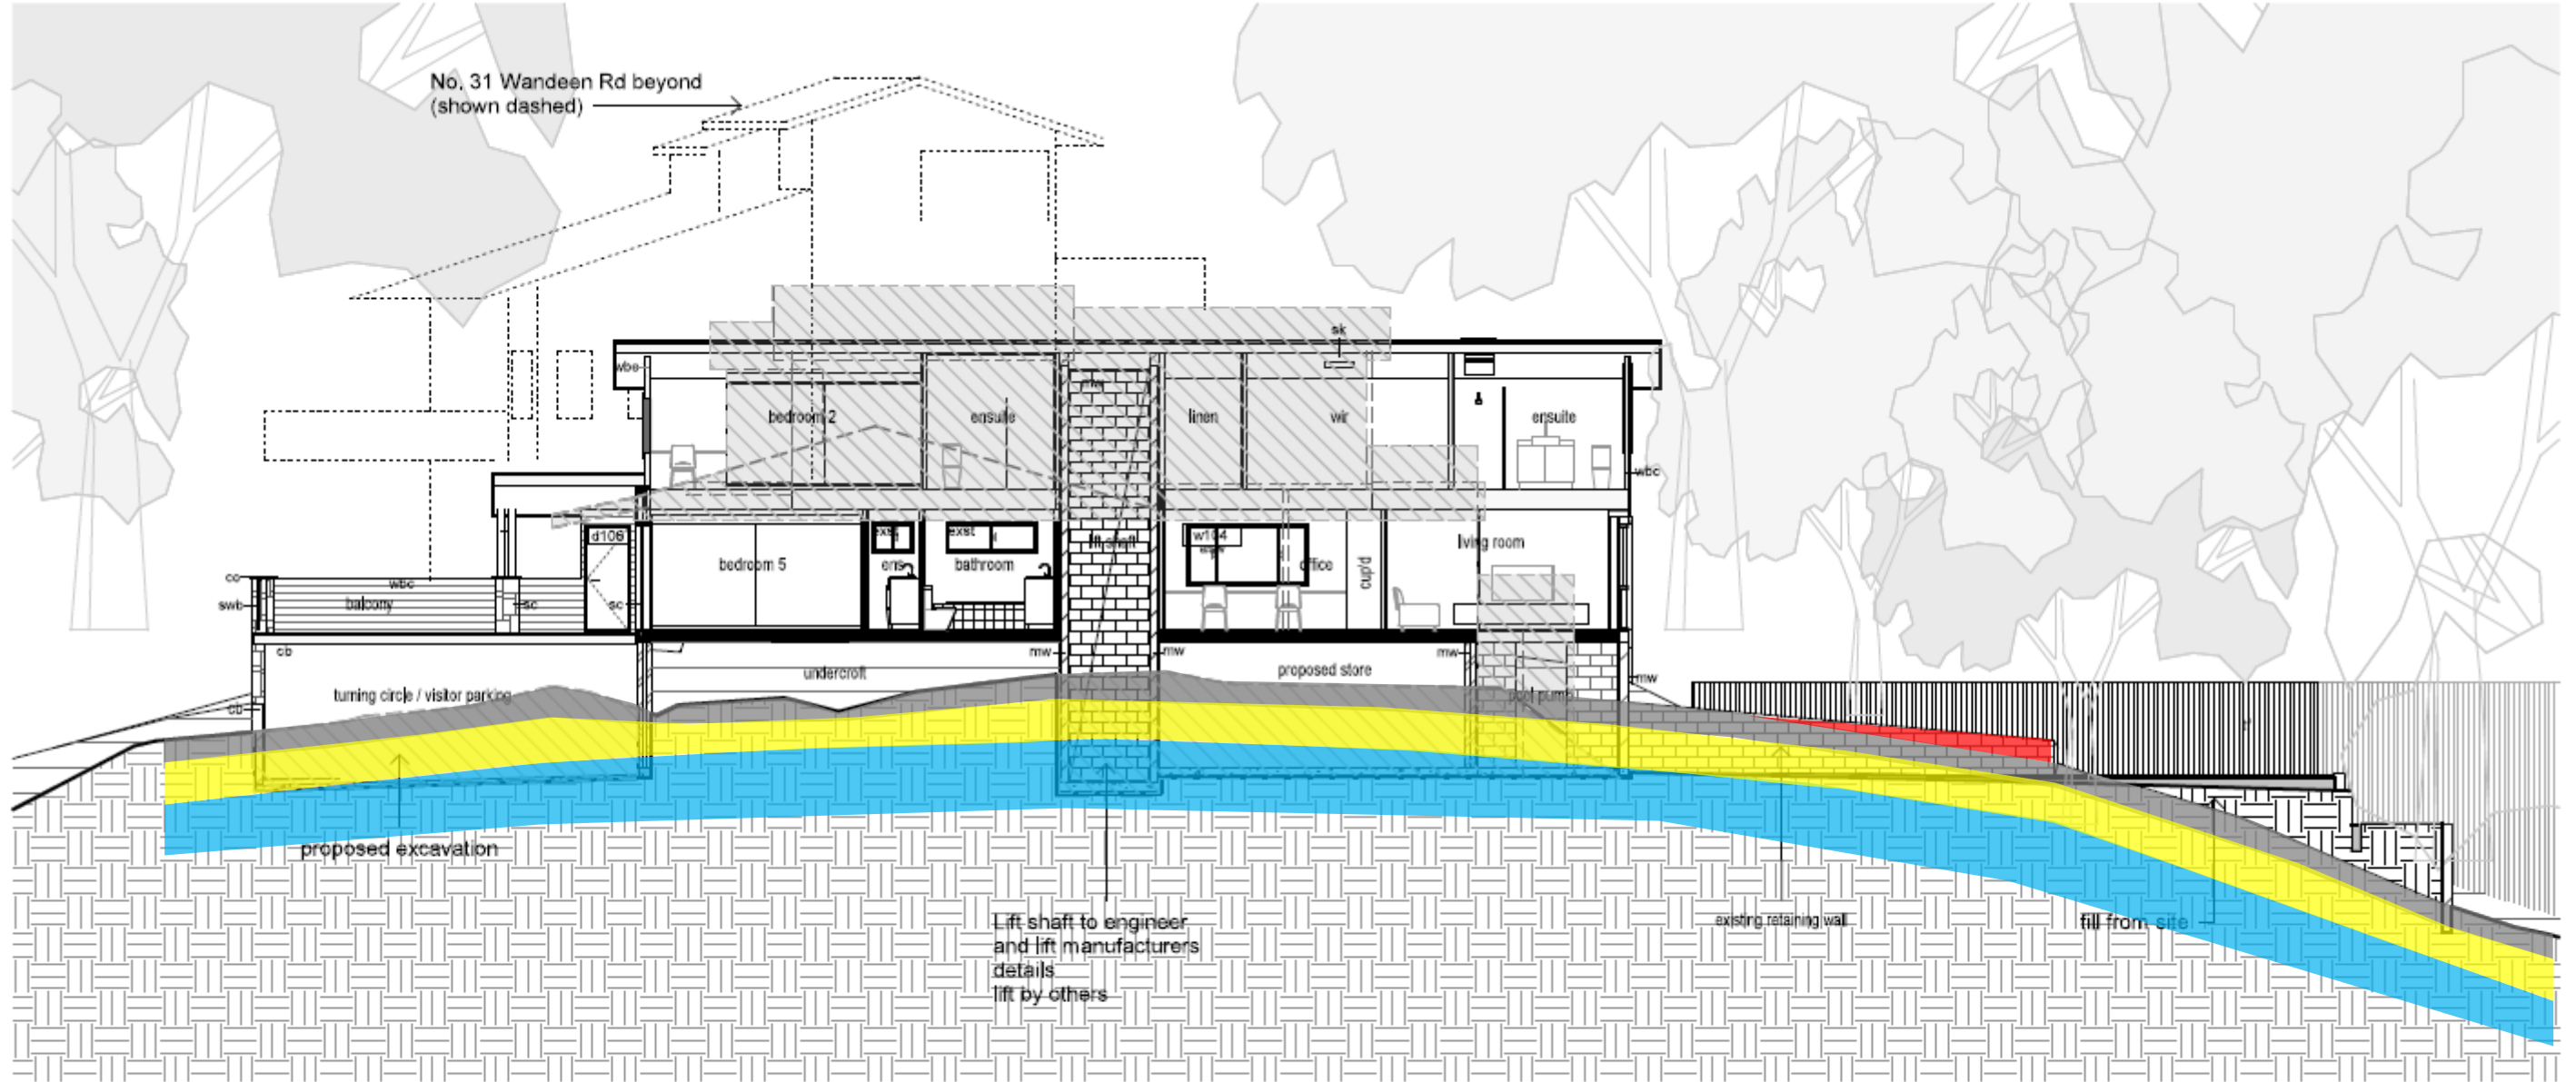
TYPE SECTION – Diagrammatical Interpretation of expected Ground Materials

The slope materials are colluvial at the near surface and residual at depth. In the test locations, the ground materials consist of Clayey Soil up to 0.5m deep over Firm to Very Stiff Clay. The clays merge into the weathered zone of the underlying rocks at depths of between 0.1m to 1.5m below the current surface, being shallower at the downhill side of an existing retaining wall supporting a cut (DCP3). The weathered zone of the underlying rock is interpreted as Very Low to Low Strength Rock. See Type Section attached for a diagrammatical representation of the expected ground materials.
