Report Title: Geotechnical Report 7 Cooleena Road, Elanora Heights

Report Date: 10/12/24

## **GEOTECHNICAL INVESTIGATION:**

Subdivision and Driveway at **7 Cooleena Road, Elanora Heights**

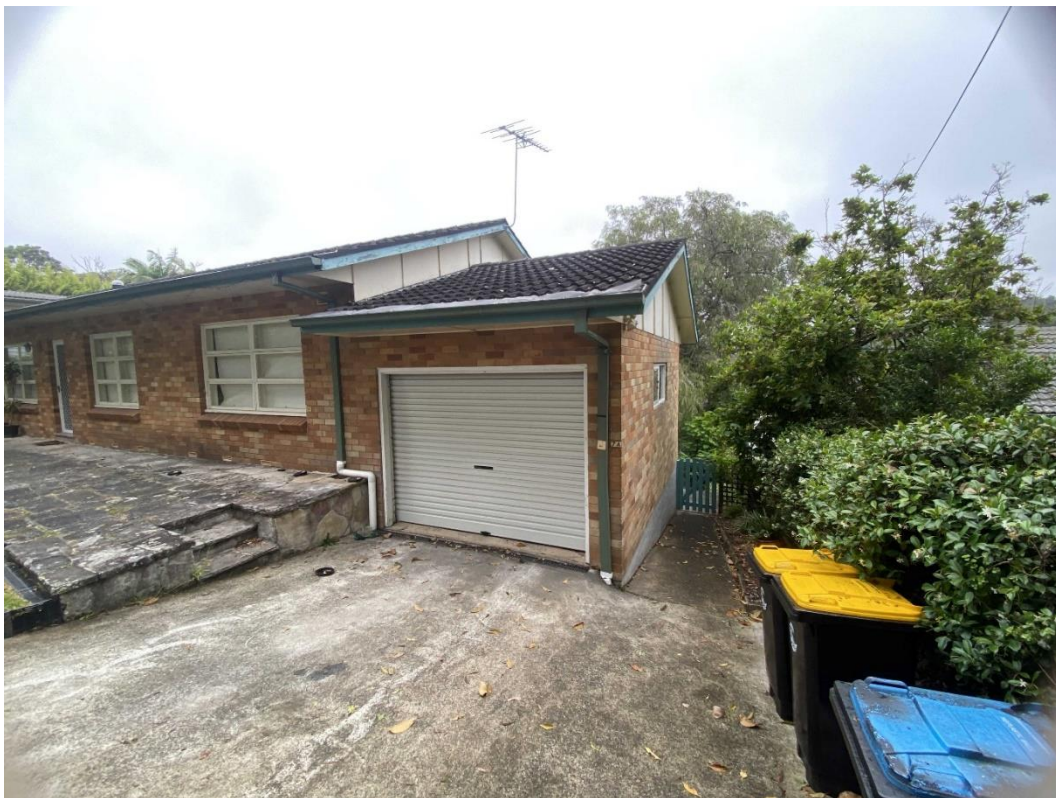
Photo 1

- 2.3** At the road frontage, a concrete driveway runs down the slope to a garage attached to the W side of the house (Photo 1). The garage will be demolished as part of the proposed works. Between the road frontage and the house is a gentle to moderately sloping lawn area (Photo 2). The part two-storey house is supported on brick walls and sandstone block walls (Photo 3). The visible external walls show no significant signs of movement. Access to the foundation space was not available at the time of this inspection. A level lawn area that extends off the downhill side of the house is supported by a low retaining wall. This wall was covered in dense vegetation

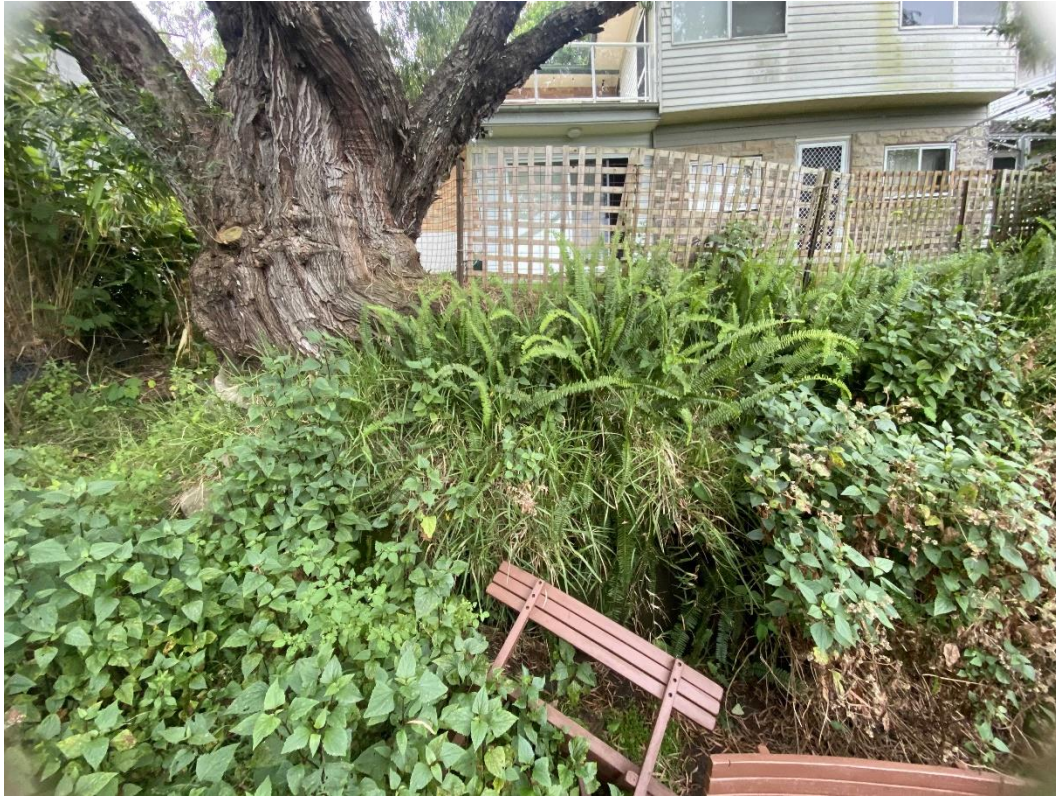
Photo 4

and could not be assessed. However, it was observed to be directly supported on outcropping Medium Strength Sandstone (Photo 4). A second ~2.5m high Medium Strength Sandstone rockface outcrops and steps down the property below this wall (Photo 5). This outcropping rock is undercut to 1.0m and extends onto the neighbouring property. Given the thickness of the cantilever arm with no visible defects, it is considered stable. A moderately sloping overgrown lawn area extends to the lower common boundary (Photo 6). Several floaters are embedded in this slope in stable positions (Photo 7).

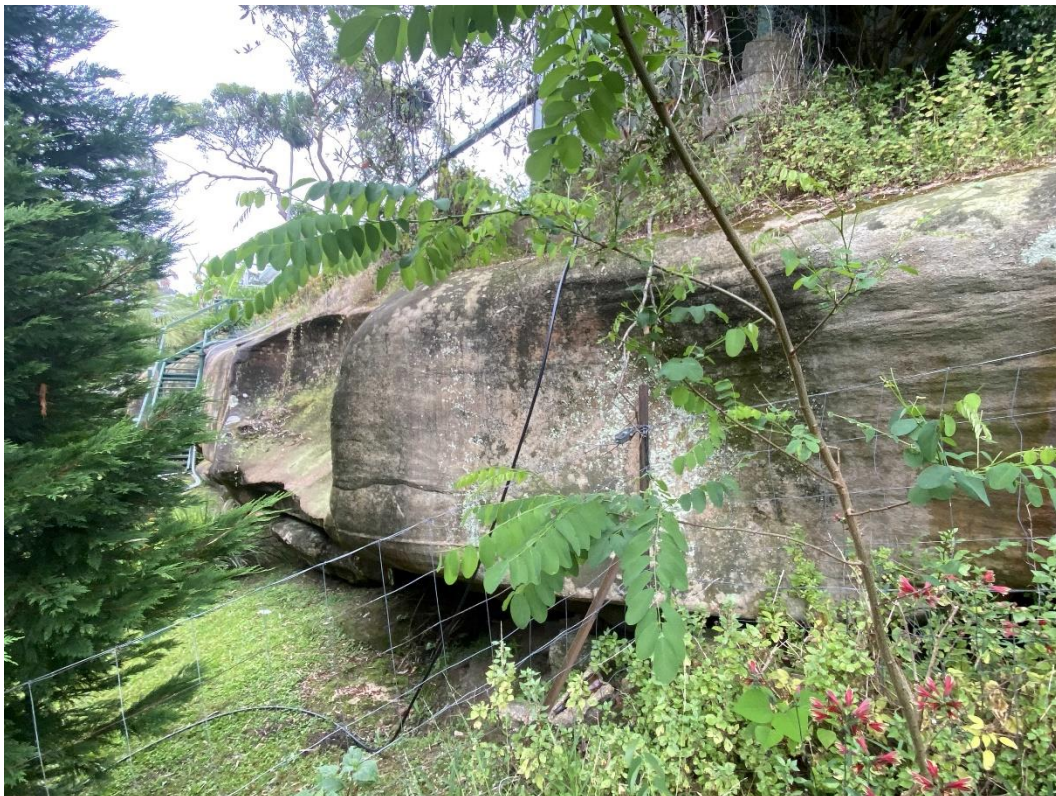
Photo 5

No geotechnical hazards were observed beside the property. The moderately graded slope that falls across the property and continues above and below is a potential hazard (**Hazard One**). The undercut rock face (Photo 5) failing and toppling onto the slope below is a potential hazard (**Hazard Two**). The vibrations from the proposed excavation are a potential hazard (**Hazard Three**). The proposed excavation is a potential hazard until retaining walls are

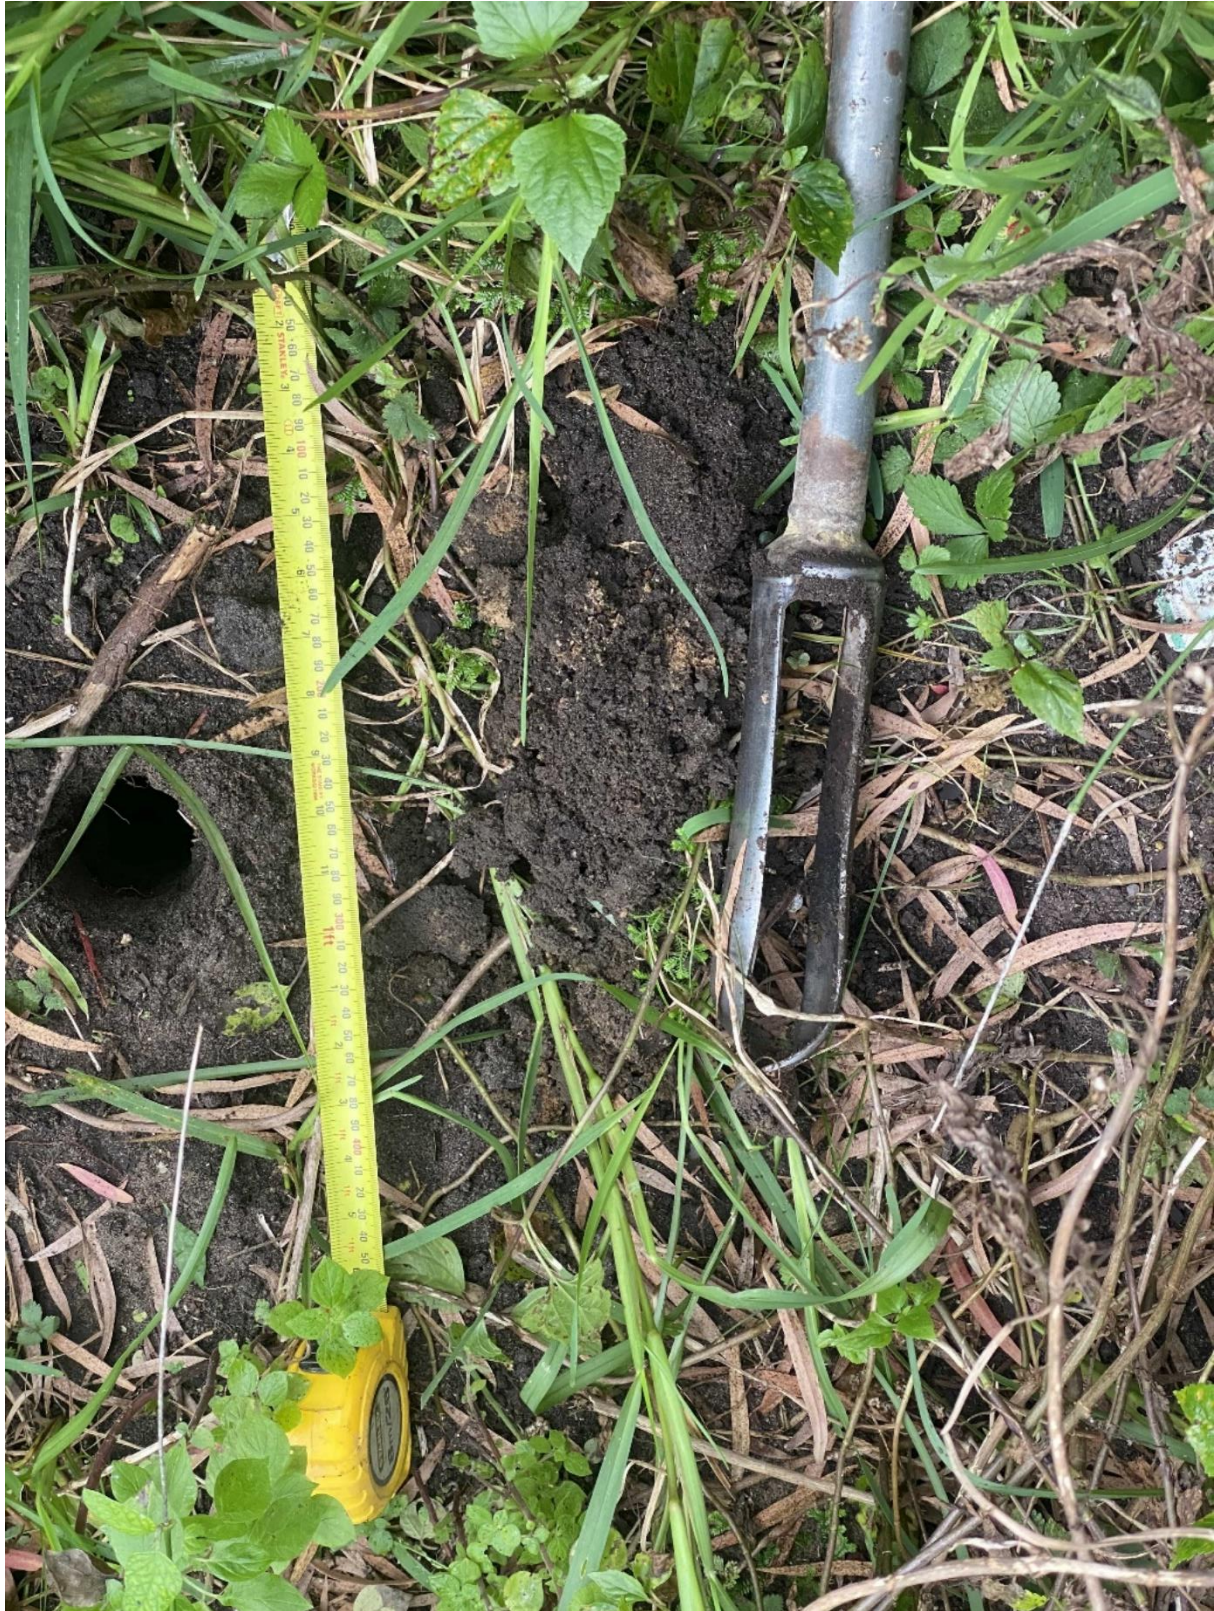
Photo 8 (Top to bottom)

## AUGER HOLE 1 (~RL43.5) – AH1 (Photo 8)

0.0 to 0.3      **TOPSOIL**, dark brown, medium grained, loose to medium dense, dry.

Refusal @ 0.3m on rock. Auger grinding. No water table encountered.

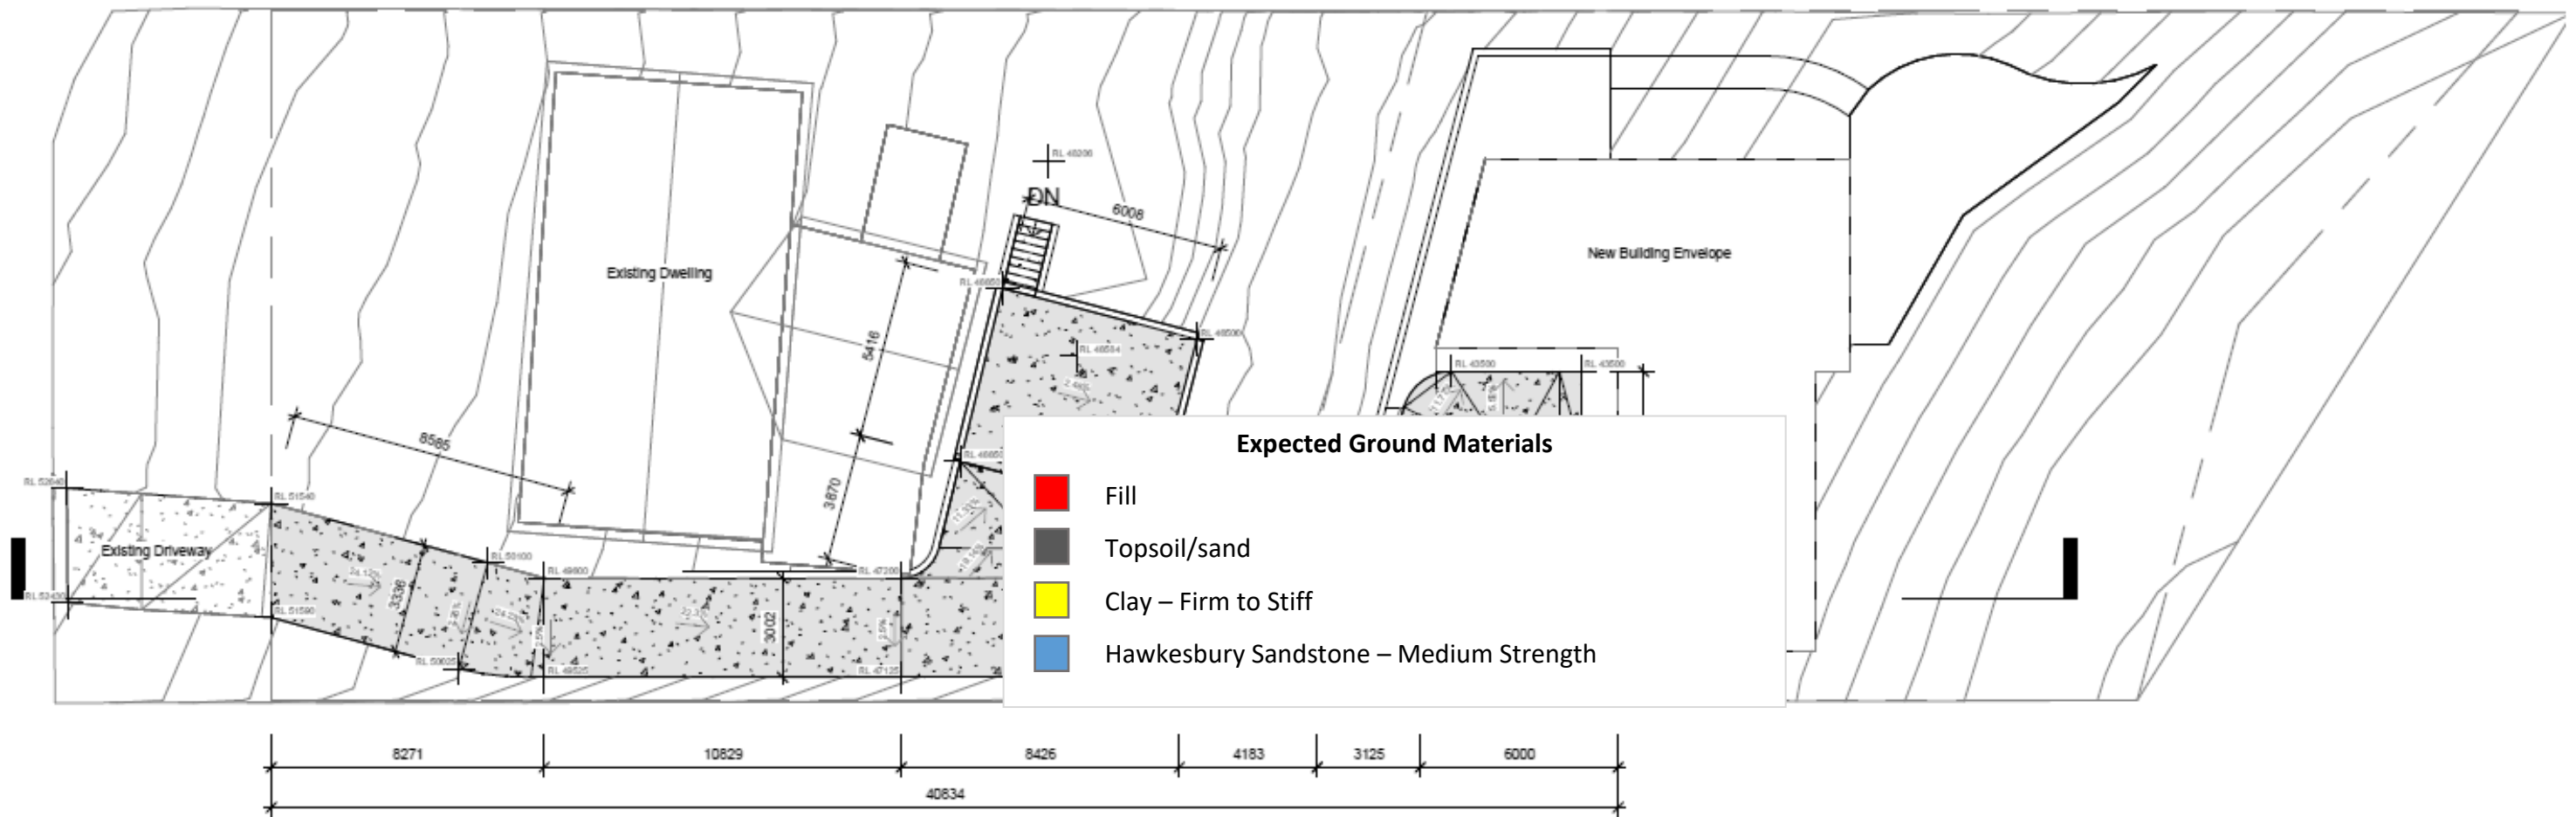
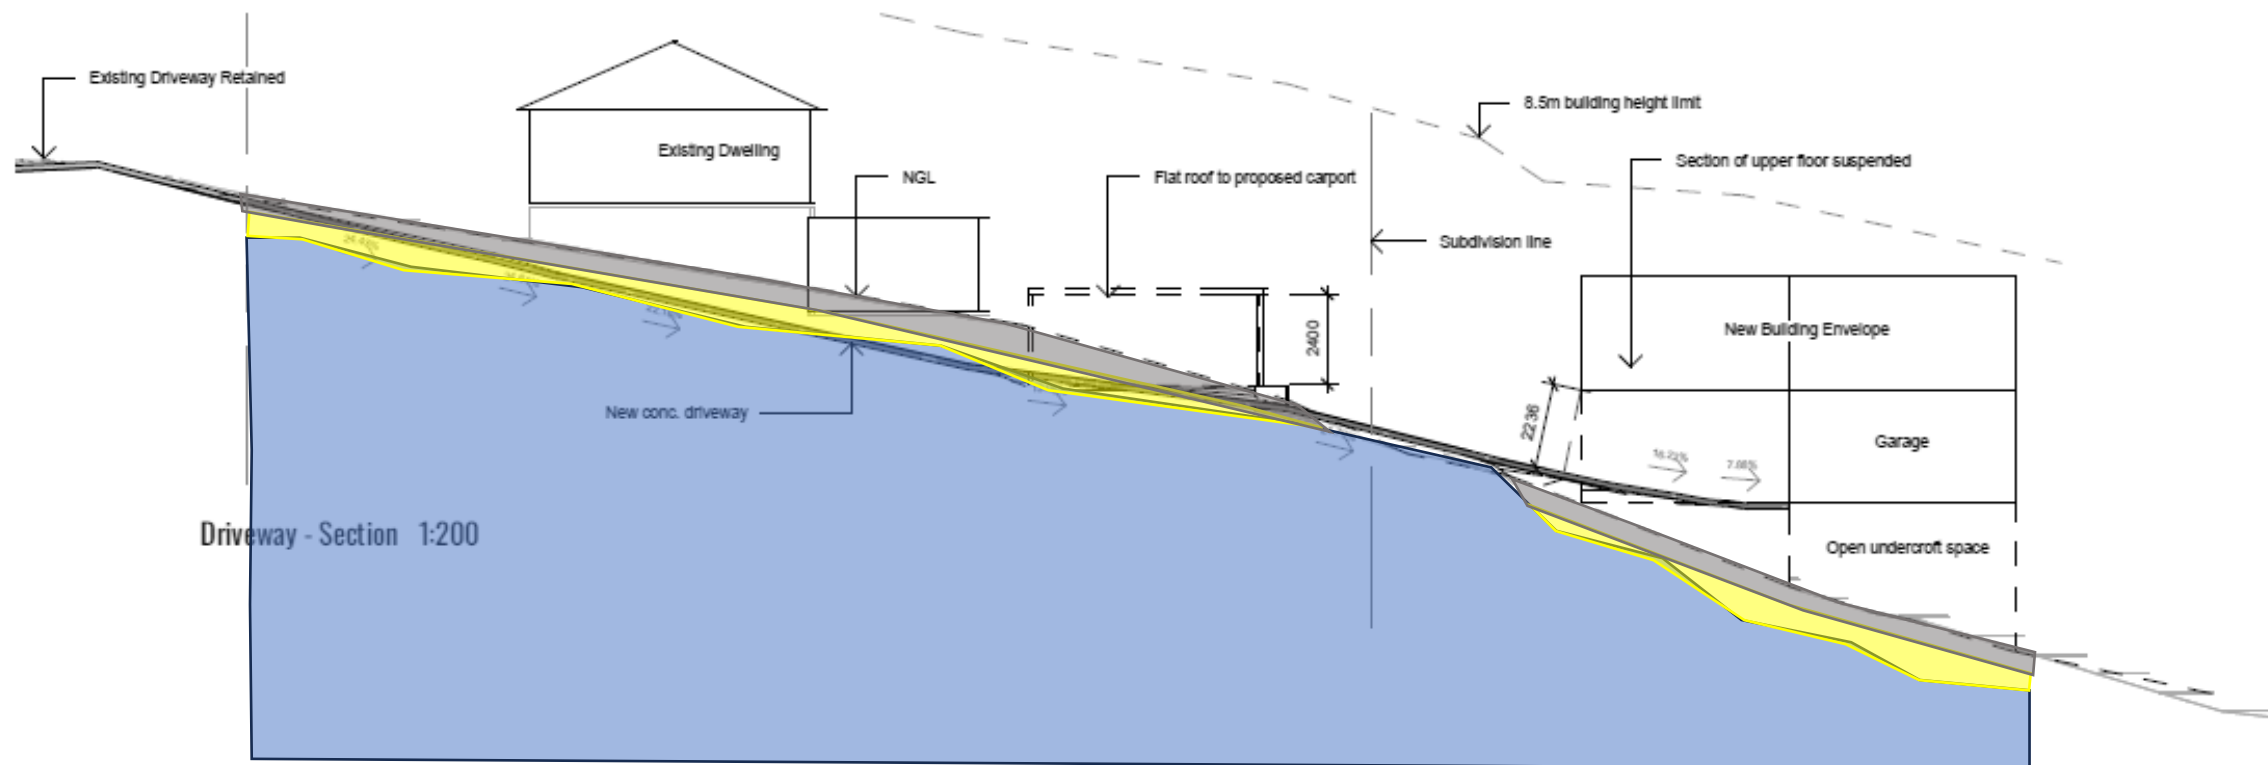
# TYPE SECTION – Diagrammatical Interpretation of expected Ground Materials

The surface features of the block are controlled by the outcropping and underlying sandstone bedrock that steps down the property forming sub-horizontal benches between the steps. Where the grade is steeper, the steps are larger and the benches narrower. Where the slope eases, the opposite is true. Where the rock is not exposed, it is overlain by fill and shallow soils over sand and clays that fill the bench step formation. Filling has been placed below the house for landscaping. In the test locations, where the rock is not exposed, it was encountered at depths of between 0.4m to 1.6m below the current surface, being slightly deeper due to the stepped nature of the underlying bedrock. The outcropping sandstone on the property is estimated to be Medium Strength or better and similar strength rock is expected to underlie the entire site as all the DCP tests bounced at refusal. See Type Section attached for a diagrammatical representation of the expected ground materials.
