Project 203454.00  
28 June 2021  
DEM:pc

## **Geotechnical Assessment, Proposed New Residence 521 Barrenjoey Road, Bilgola Beach**

PROJECT No: 203454.00
	DRAWING No: 1
	REVISION: 0

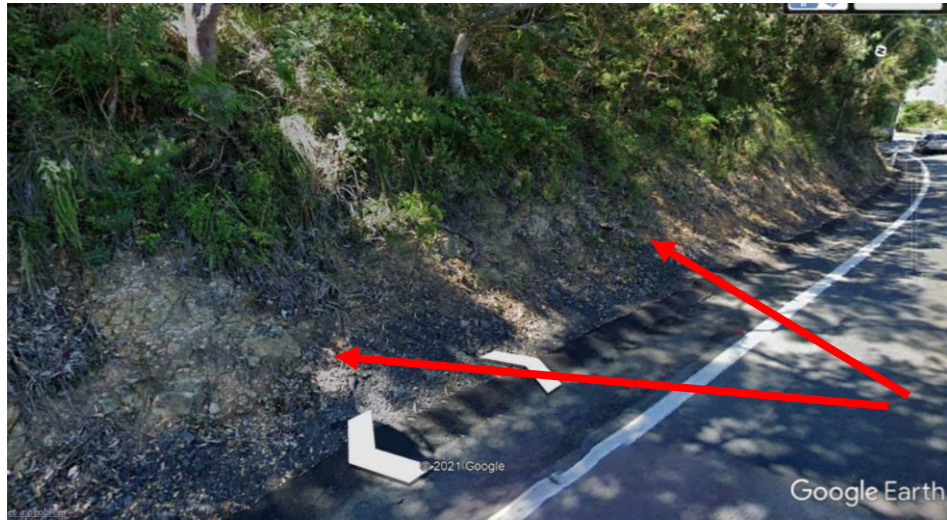
Photo 1: Bedrock exposed in excavated batter alongside Barrenjoey Road. (Google Streetview March 2020)

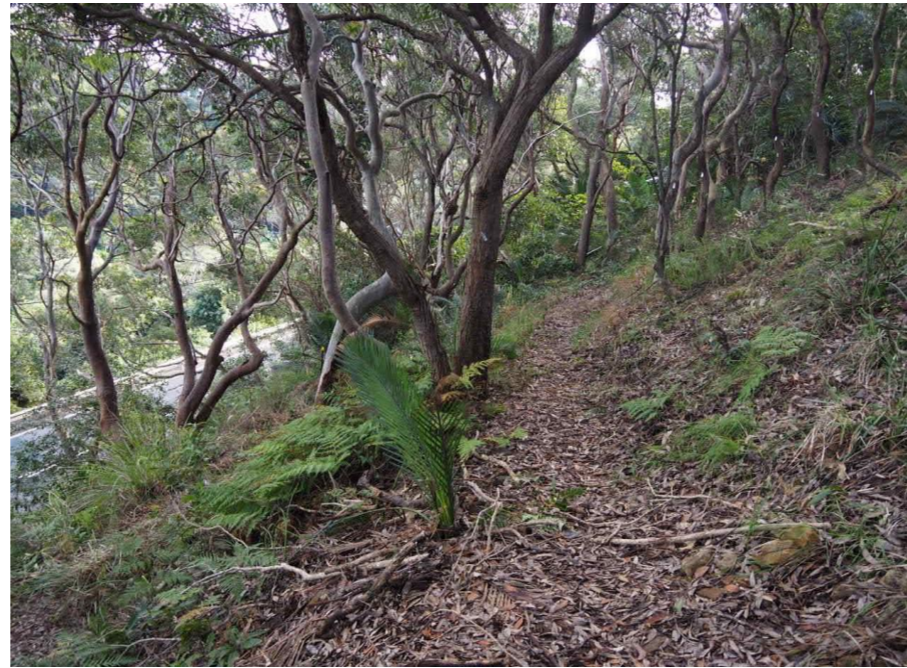
The site typically slopes to the south at about 25° and has a moderate cover of coastal eucalypts, shrubs and grasses (refer to Photos 2, 4 and 5).

Photo 2: Typical slope conditions across lower (southern) end of site

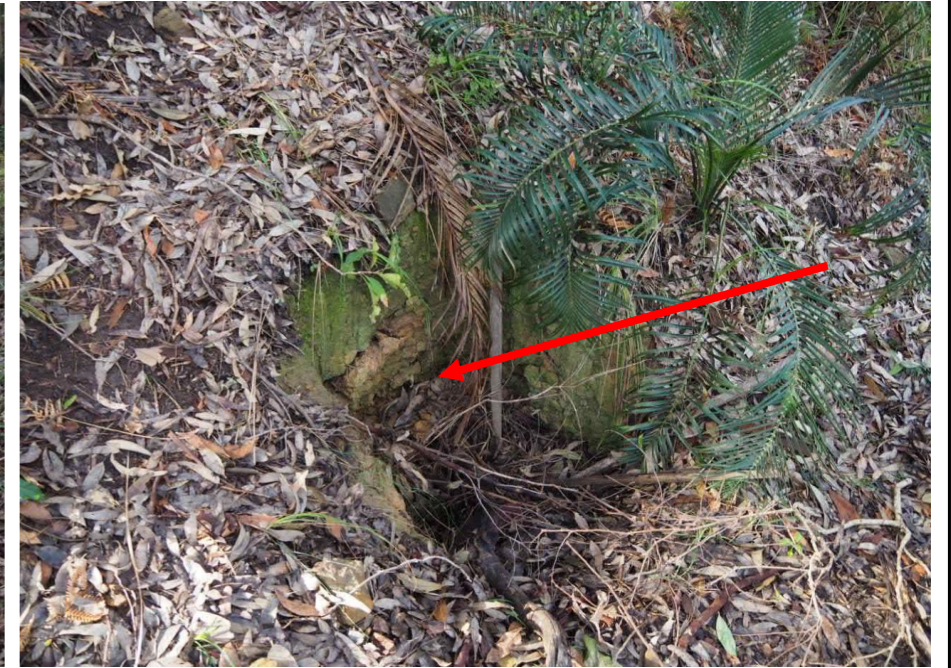
- there was no evidence of previous significant instability having occurred within the excavated road batter below the site,
- a similar sub-surface profile to that noted with the road batter was observed within the two small, open (partly backfilled?) excavations on the site (refer to Photo 3),

Photo 3: Bedrock exposed within pit located towards lower end of site

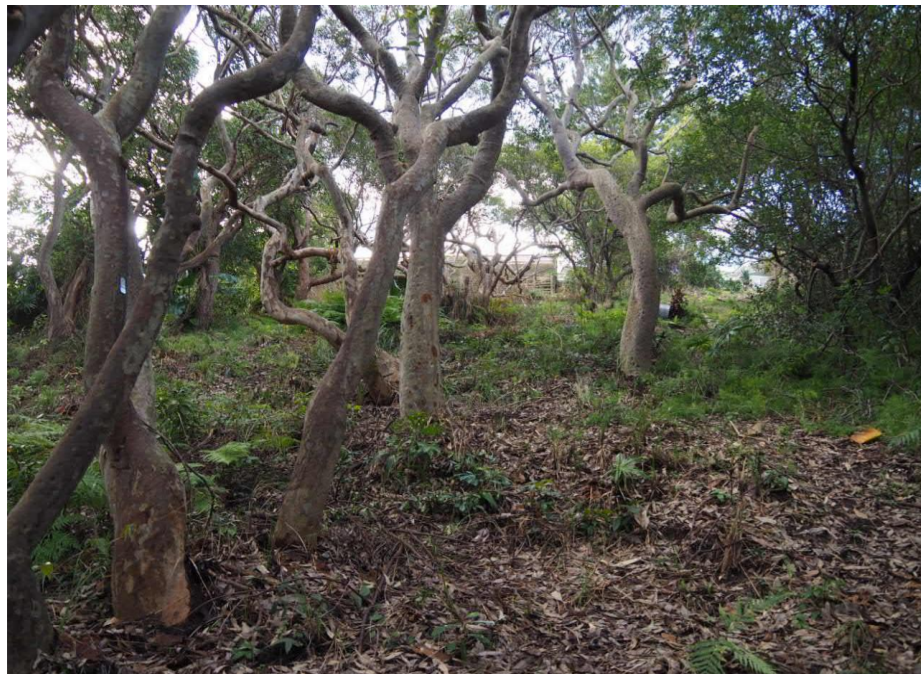
Photo 4: Typical conditions looking upslope along eastern site boundary

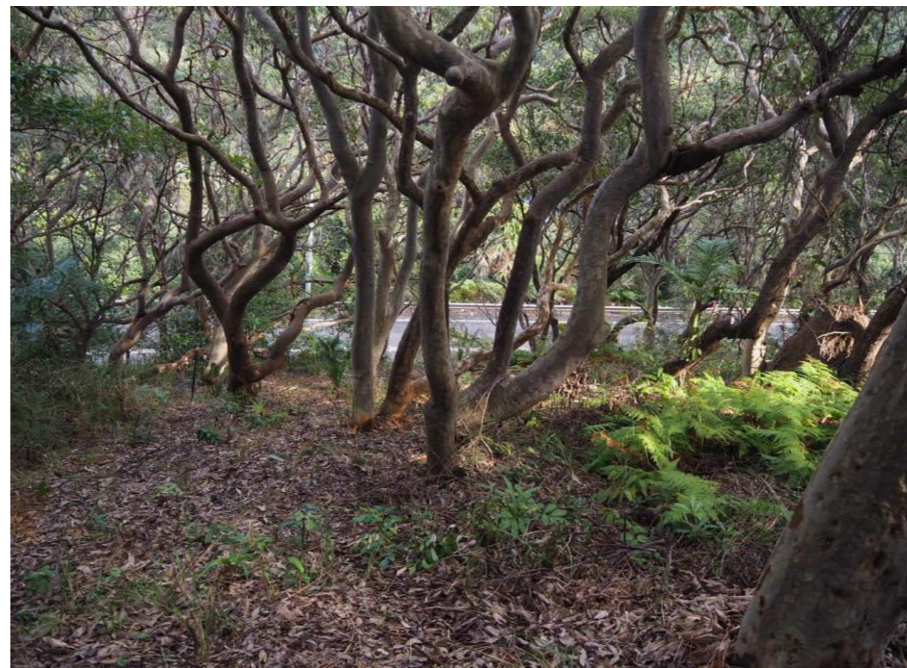
Photo 5: Typical conditions looking upslope along eastern site boundary

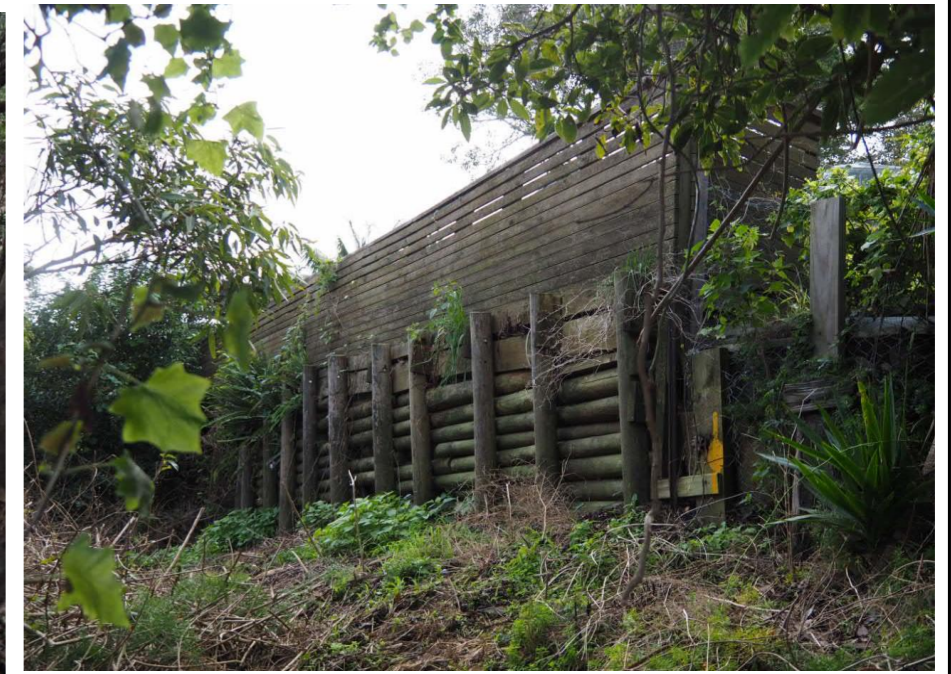
- a timber log retaining wall at the northern site boundary, supporting an upslope property, appears to be in a satisfactory condition (refer to Photo 6).

Photo 6: Timber log wall at northern boundary supporting upslope property

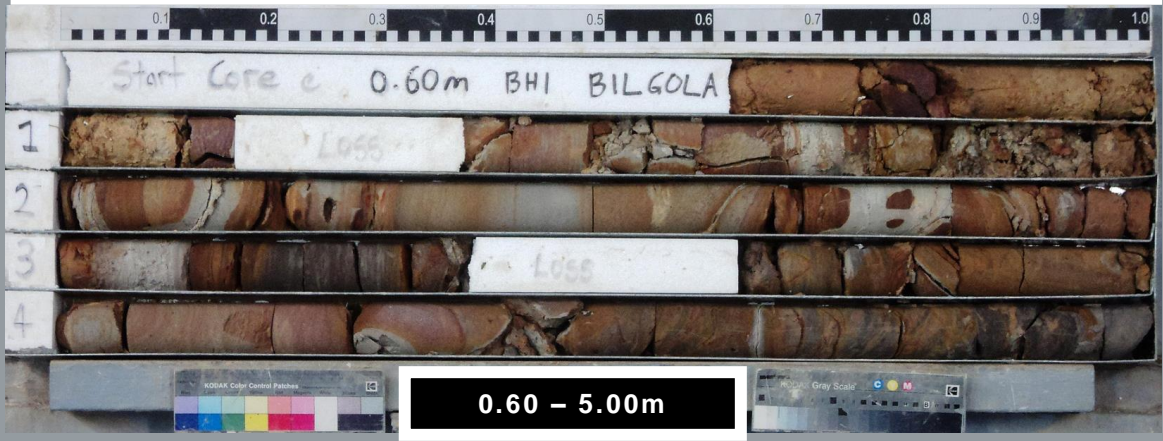
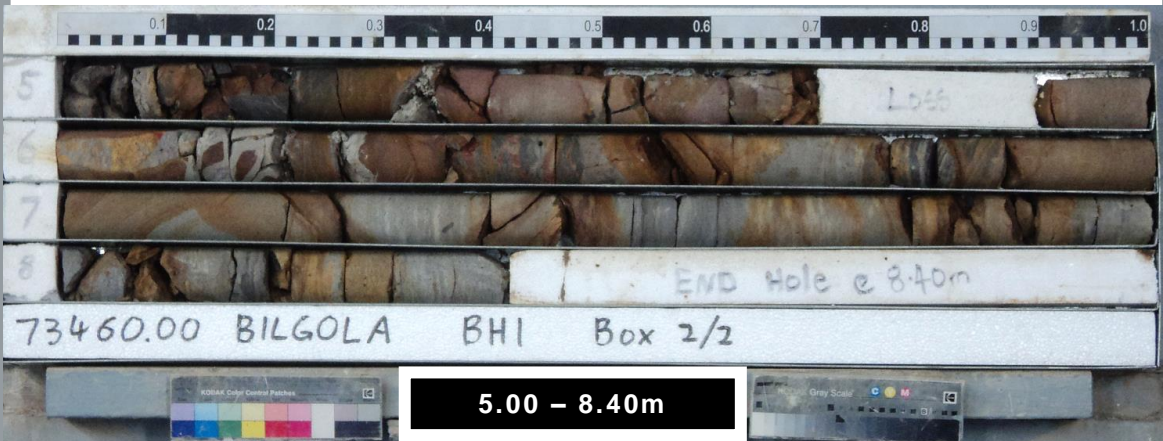
DOUGLAS PARTNERS PTY LTD  
MR PETER MADEW  
PROPOSED NEW RESIDENCE - BILGOLA BEACH  
BORE 1 PROJECT 203454.00 MAY 2013

The full details of the subsurface profile encountered by Bore 1 are provided on the attached Bore Hole Log Sheet along with colour photographs of the core samples. In summary, Bore 1 encountered, very low strength, highly weathered and highly fractured sandstone bedrock below 0.6 m depth, extending to 2 m depth, underlain by medium to high strength, fractured sandstone and siltstone bedrock which extended to the termination of the bore at 8.4 m depth.

For the most part, the defects within the recovered bedrock core comprised bedding partings or joints with clayey or iron-coated surfaces. Their dips typically ranged from sub-horizontal to 50° from horizontal. Some steeper dipping joints were also noted.
