## **GEOTECHNICAL INVESTIGATION for CC:**

New House at **Lot 2 in Master Subdivision Site Plan for 12-14 Gladys Avenue, Frenchs Forest**

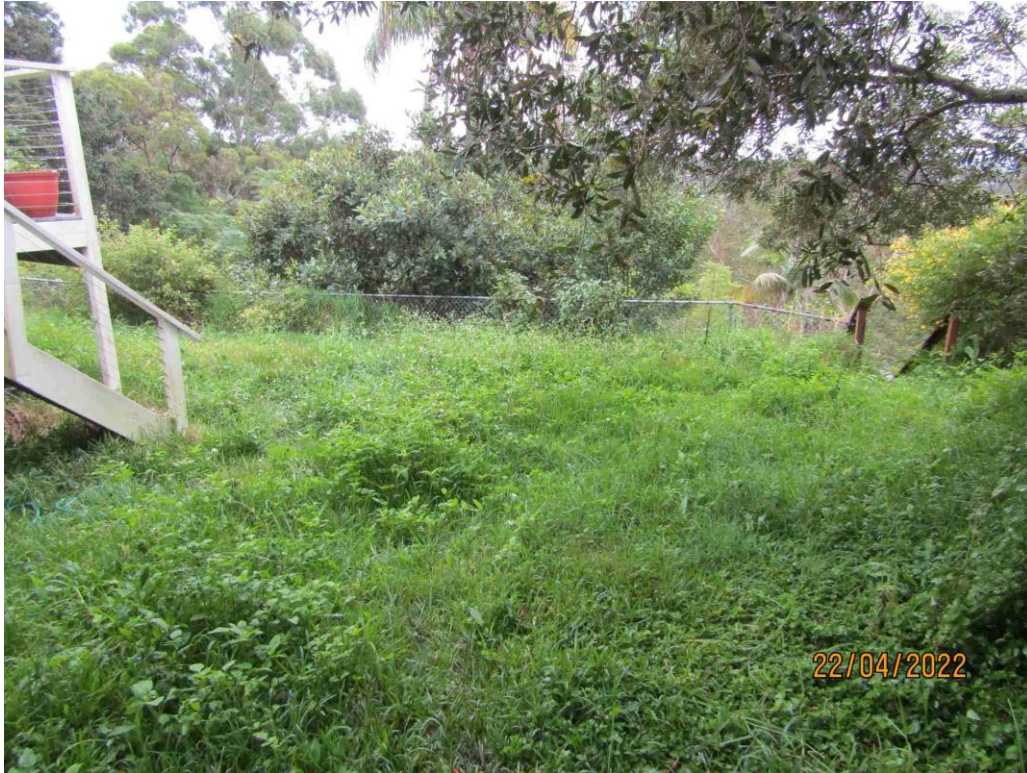
Photo 1

- 2.3** A near level lawn area is located near the uphill boundary of Lot 2 and at the downhill side of the existing house at Lot 1 (Photo 1). Sandstone bedrock steps down the slope on downhill side of the lawn (Photo 2). The outcropping rock is estimated to be up to ~4m high. The upper portion of the rock is obscured by vegetation. The rock face is undercut at the base slightly, but has a thick cantilever arm in relation to its overhang length and is currently considered to be stable. A pool that shows no

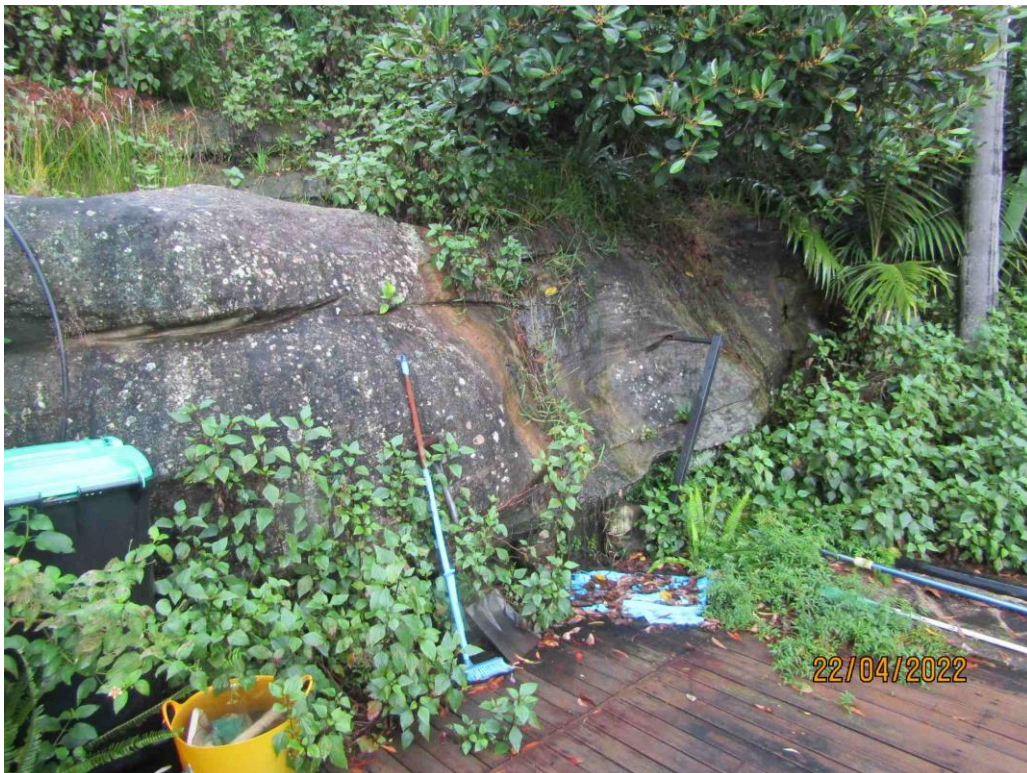
Photo 2

Evidence of recent surface flows were observed on the outcropping sandstone bedrock on the uphill side of the proposed new house (Photo 2). It is recommended that drainage measures be installed on the uphill side of the house to capture and divert any surface water that flows over the rock face.

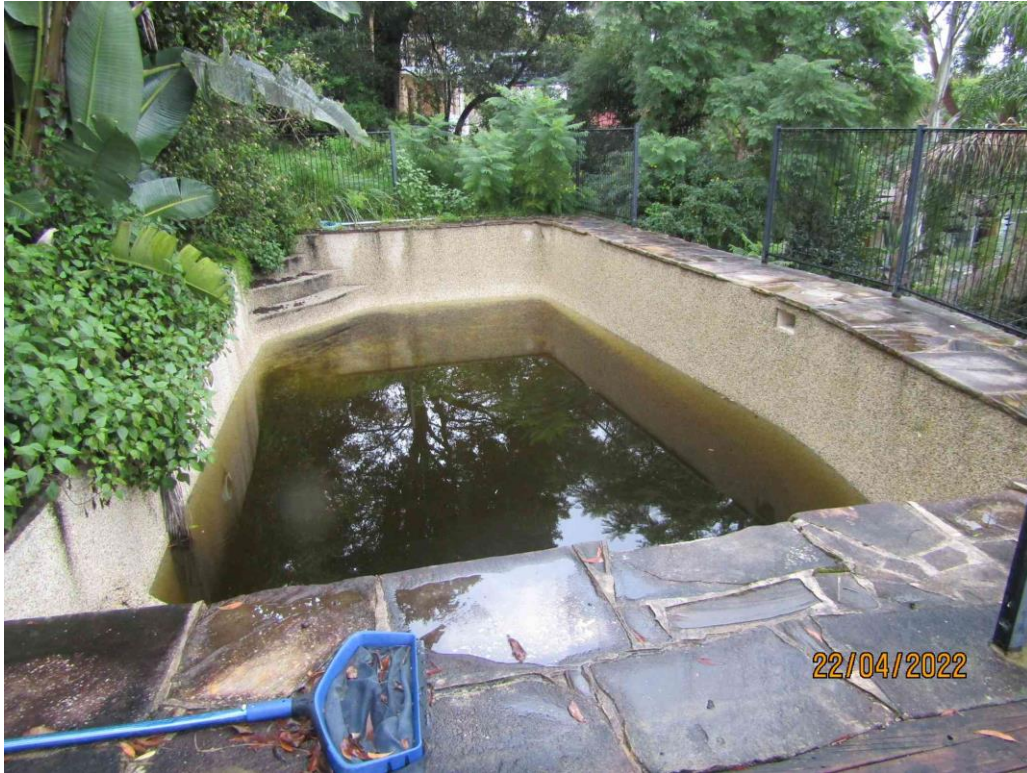
Photo 3

significant signs of movement is located on the downhill side of the rock face (Photo 3). The pool was partially empty at the time of inspection. The slope below the pool is thickly vegetated (Photo 4). Sandstone bedrock outcrops in places on the slope. Sandstone joint blocks are embedded in stable positions in the slope. No signs of slope instability were observed on the property that could have occurred since the property was developed. The adjoining neighbouring properties were observed to be in good order as seen from the street and subject property.

Part of the house will be constructed over the footprint of the existing pool. If the pool shell is to remain in place, the portion of the proposed house that will be over the footprint of the pool is to be supported on piers drilled through the base of the pool shell and taken to the rock below the base of the pool. Drainage holes are to be core drilled through the side of the pool near the base on the downhill side.

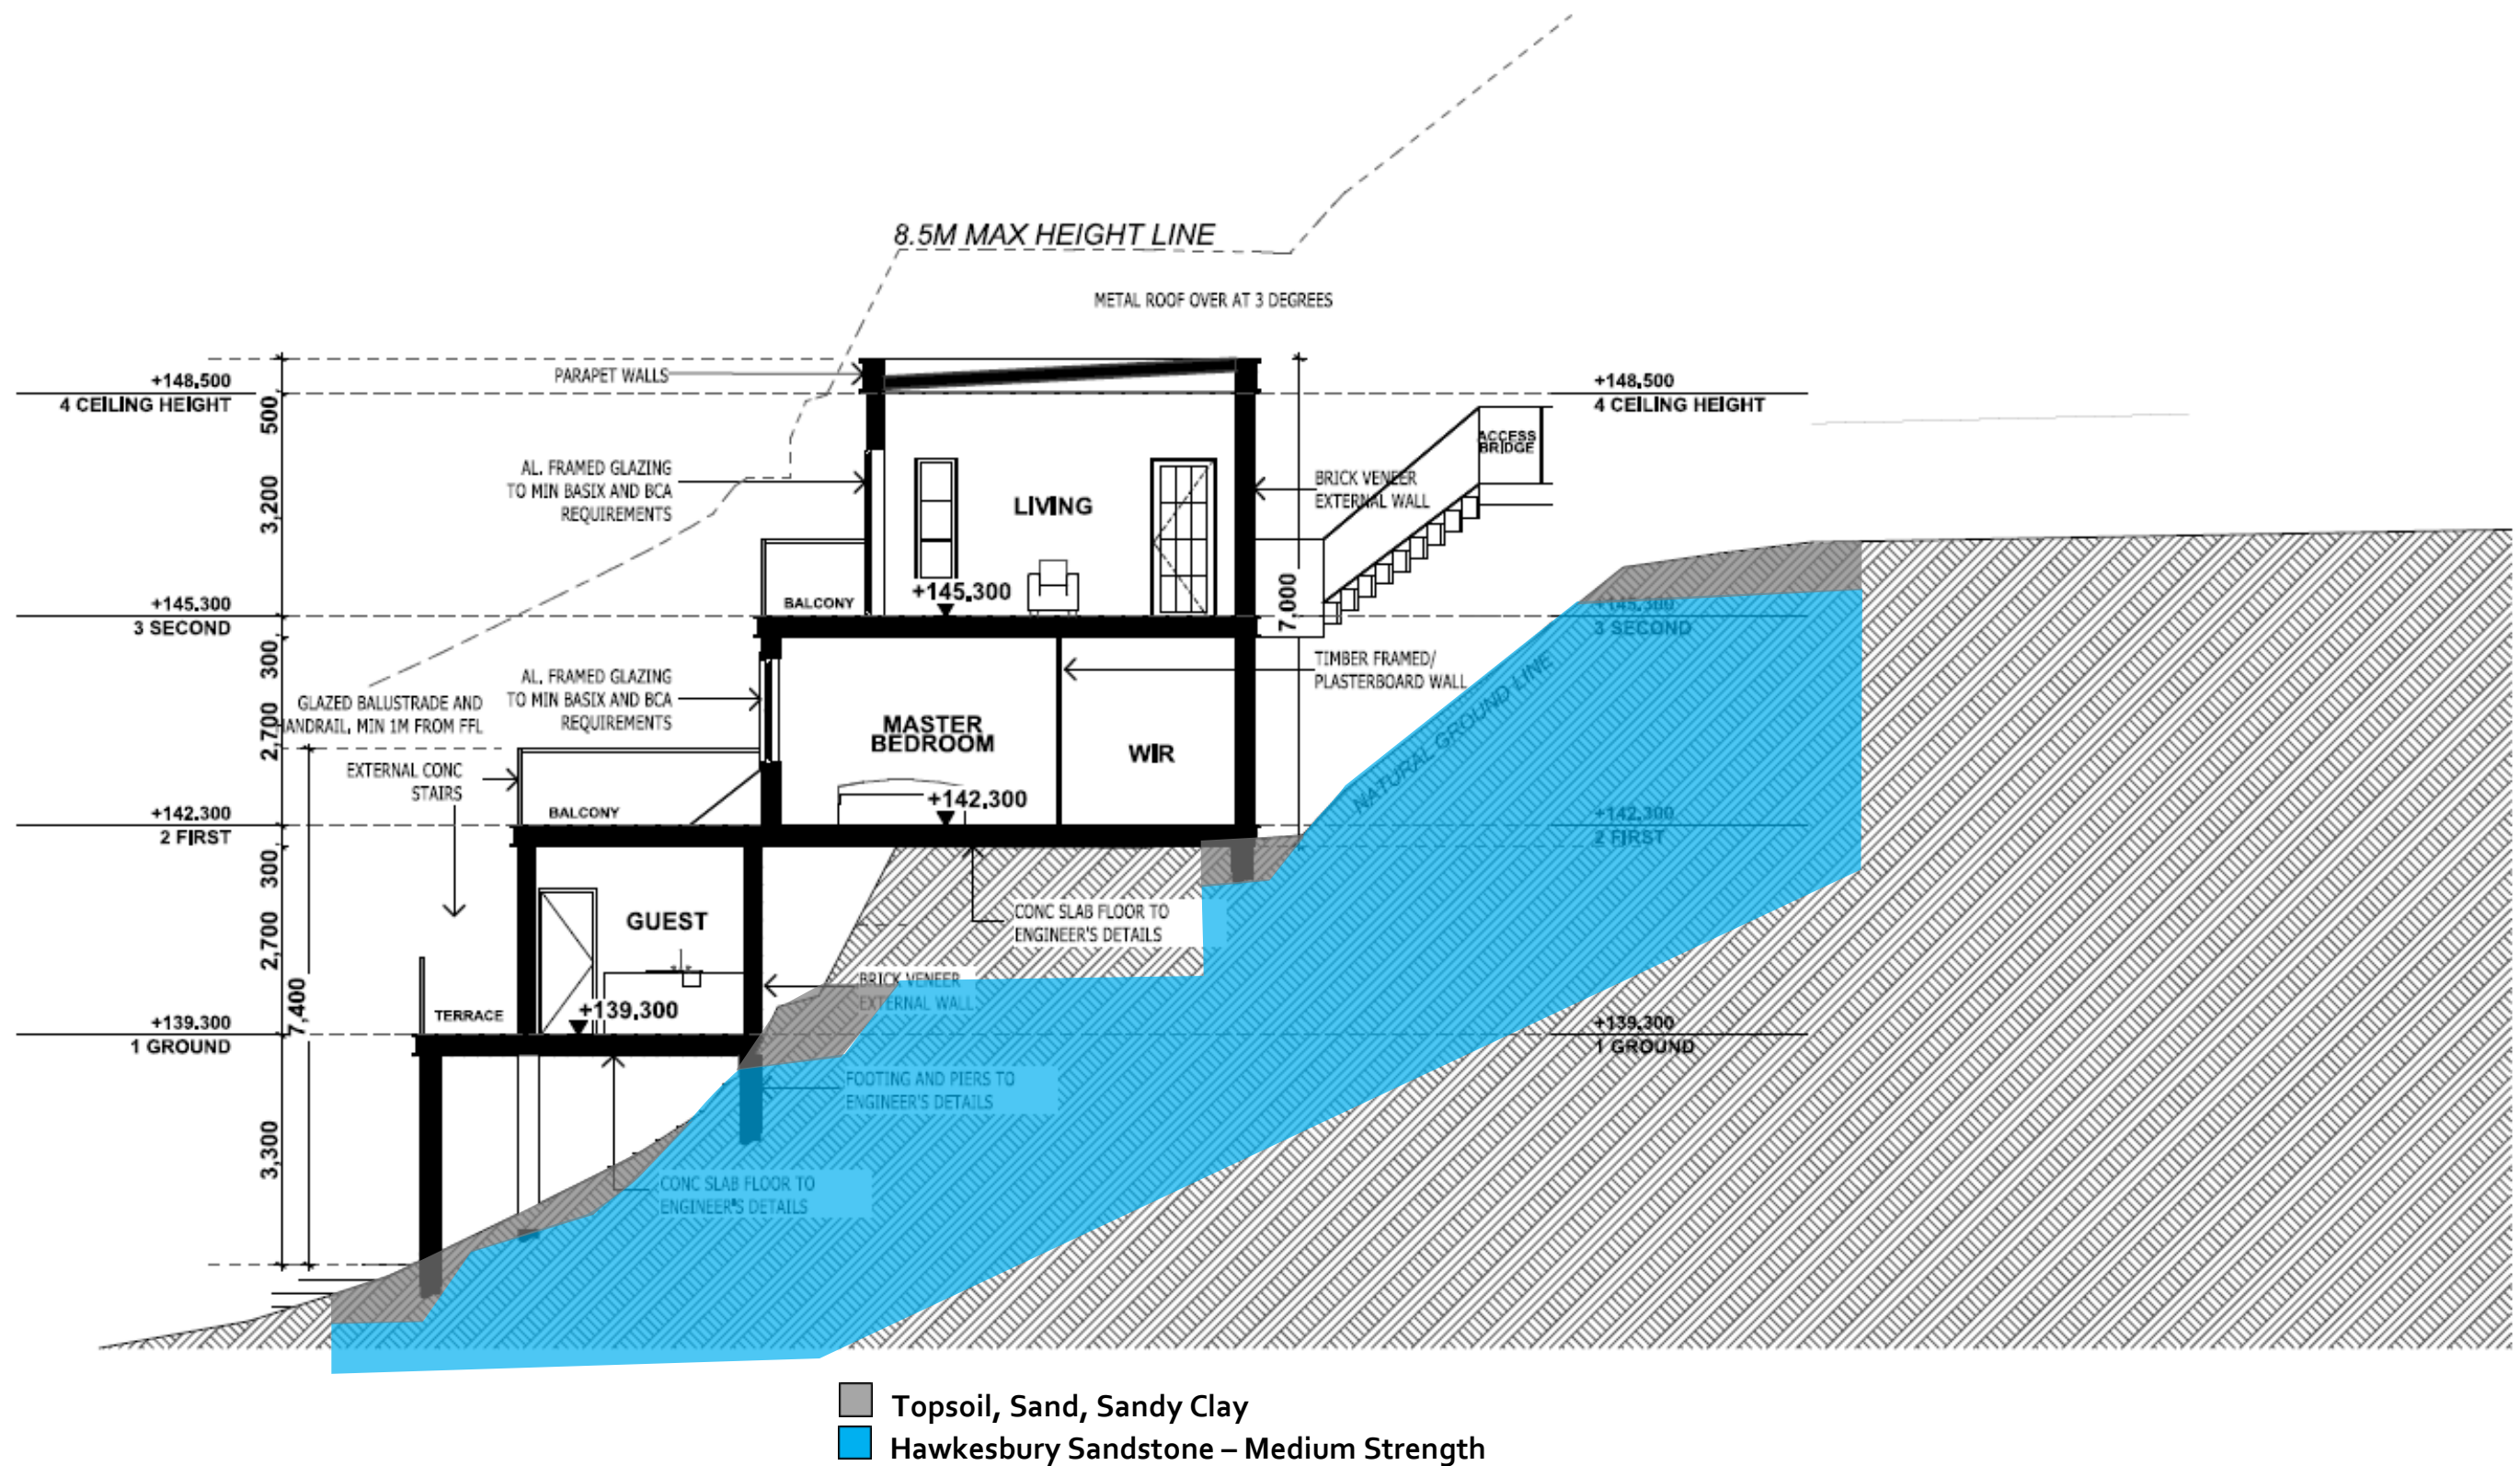
# TYPE SECTION – Diagrammatical Interpretation of expected Ground Materials

The surface features of the block are controlled by the underlying sandstone bedrock that steps down the property forming sub-horizontal benches between the steps. Where the grade is steeper, the steps are larger and the benches narrower. Where the slope eases, the opposite is true. The rock is overlain by a thin sandy topsoil, sand and sandy clay that fills the bench step formation. Rock is exposed at the surface at the downhill side of the proposed garage and above and below the proposed new house. In the test locations, the depth to rock ranged from ~0.7m to ~0.8m below the current surface. A geotechnical report completed by another firm on the property indicates that the depth to rock at the location of the proposed house reaches a maximum depth of ~1.4m on the downhill edge of the existing pool and a maximum depth of ~0.6m at the location of the proposed garage. The sandstone underlying

the property is estimated to be Medium Strength or better. See Type Section attached for a diagrammatical representation of the expected ground materials.
