GEOTECHNICAL INVESTIGATION:

New House at **45 Oxford Falls Road, Beacon Hill**

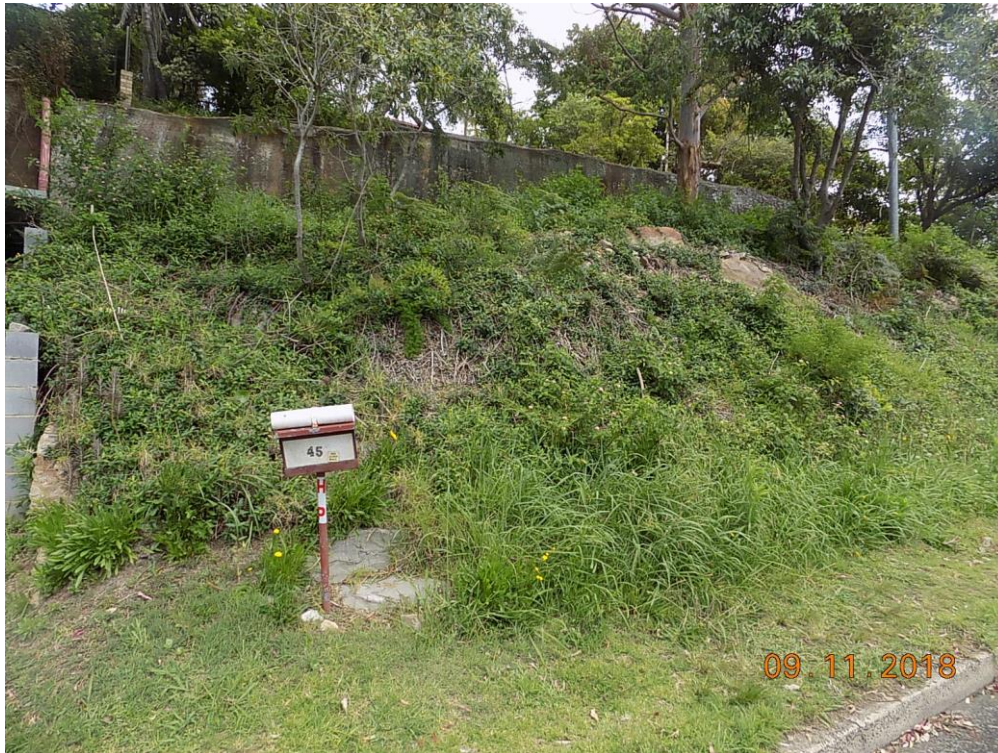
Photo 1

No geotechnical hazards were observed beside the property. The sandstone cliff face that rises just beyond the street frontage is a potential hazard (**Hazard One**). The vibrations from the proposed excavations are a potential hazard (**Hazard Two**). The proposed excavations are a potential hazard until retaining walls are in place (**Hazard Three**).

HAZARDS	Hazard One	Hazard Two	Hazard Three
TYPE	The sandstone cliff face above the carport failing and impacting on the proposed works (Photo 1).	The vibrations produced during the proposed excavations impacting on the cliff and supporting walls of the neighbouring carport.	The proposed excavations collapsing onto the work site before retaining walls are in place.
LIKELIHOOD	'Rare' (10^{-5})	'Possible' (10^{-3})	'Possible' (10^{-3})
CONSEQUENCES TO PROPERTY	'Major' (40%)	'Medium' (15%)	'Medium' (15%)
RISK TO PROPERTY	'Low' (6×10^{-5})	'Moderate' (2×10^{-4})	'Moderate' (2×10^{-4})
RISK TO LIFE	9.96×10^{-6} /annum	5.3×10^{-7} /annum	8.9×10^{-6} /annum
COMMENTS	This level of risk is 'ACCEPTABLE'.	This level of risk to property is 'UNACCEPTABLE'. To move risk to 'ACCEPTABLE' levels the recommendations in Section 12 are to be followed.	This level of risk to life and property is 'UNACCEPTABLE'. To move the risk to 'ACCEPTABLE' levels the recommendations in Section 13 are to be followed.

Excavations through Medium Strength Sandstone or better should be carried out to minimise the potential to cause vibration damage to the rock face immediately above and the neighbouring carport. The supporting walls of the neighbouring carport to the E will be as close as ~0.9m from the edges of the proposed excavations. Close controls by the contractor over rock excavation are recommended so excessive vibrations are not generated.

Excavation methods are to be used that limit peak particle velocity to 10mm/sec at the common boundaries. Vibration monitoring will be required to verify this is achieved.

If a milling head is used to grind the rock, vibration monitoring will not be required. Alternatively, if rock sawing is carried out around the perimeter of the excavation boundaries in not less than 1.0m lifts, a rock hammer up to 300kg could be used to break the rock without vibration monitoring. Peak particle velocity will be less than 10mm/sec at the common boundaries using this method provided the saw cuts are kept well below the rock to broken.

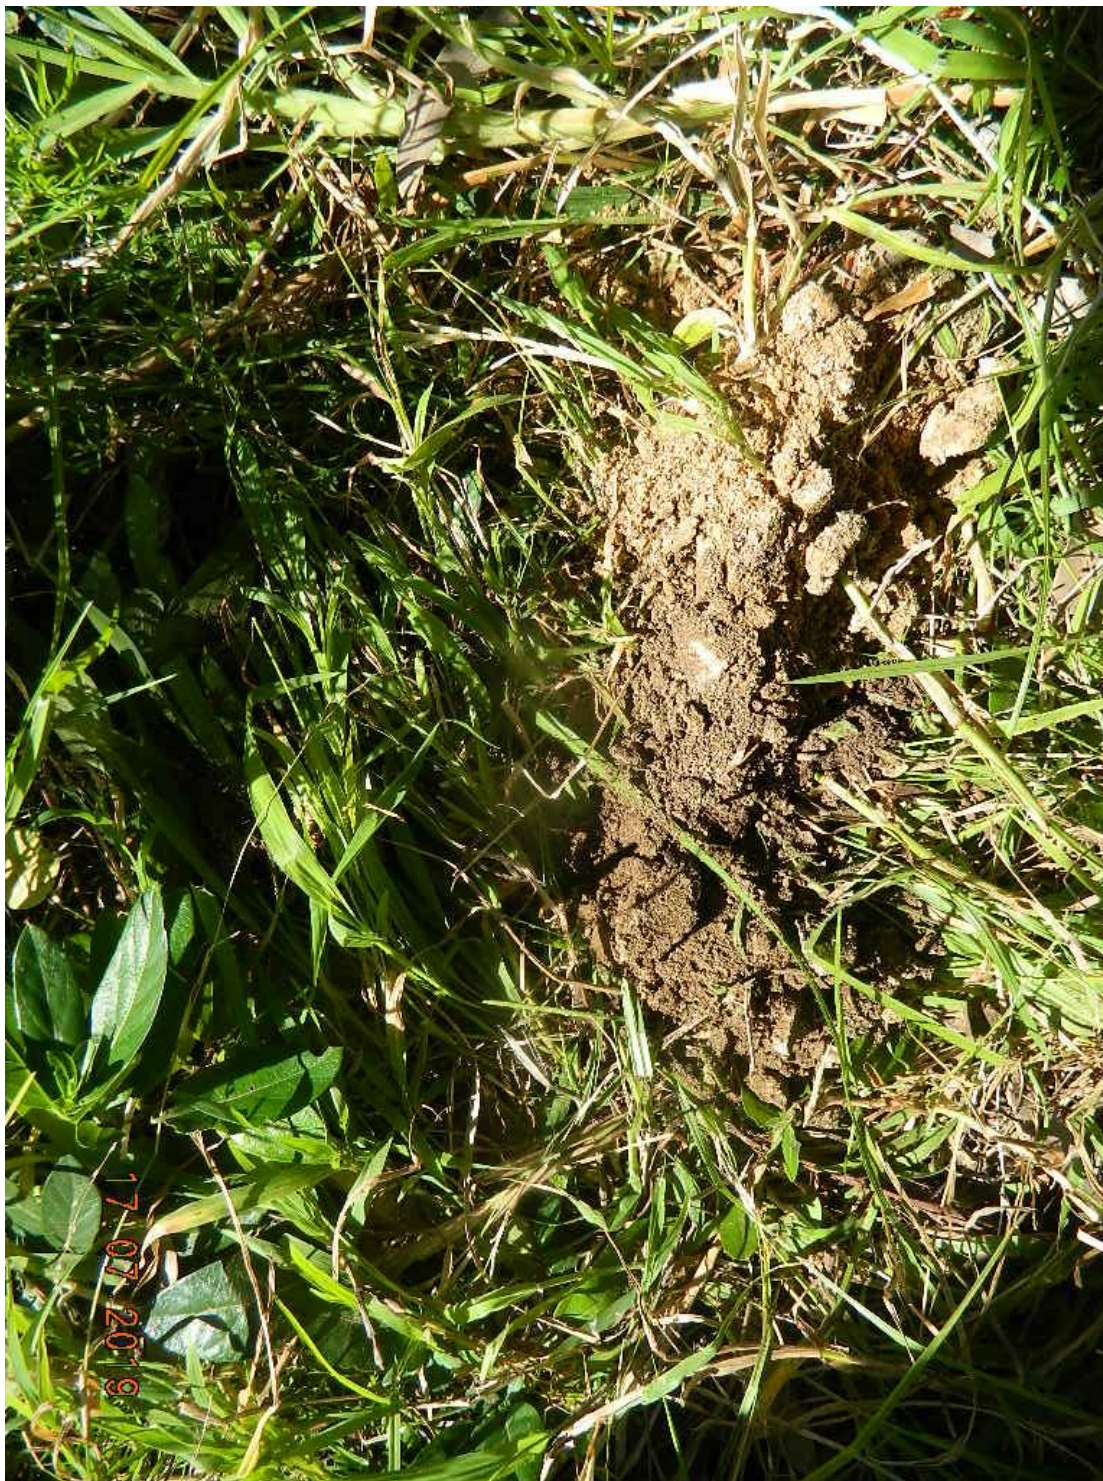
Photo 5-AH1

AUGER HOLE 1 (~RL26.75) – AH1 (Photo 5)

Depth (m)	Material Encountered
0.0 to 0.15	TOPSOIL , sandy soil, brown, medium grained with fine trace organic matter.
0.15 to 0.3	SANDY SOIL , light brown medium grained with clumps of white clay.

End of hole @ 0.3m grinding on rock surface. No watertable encountered.

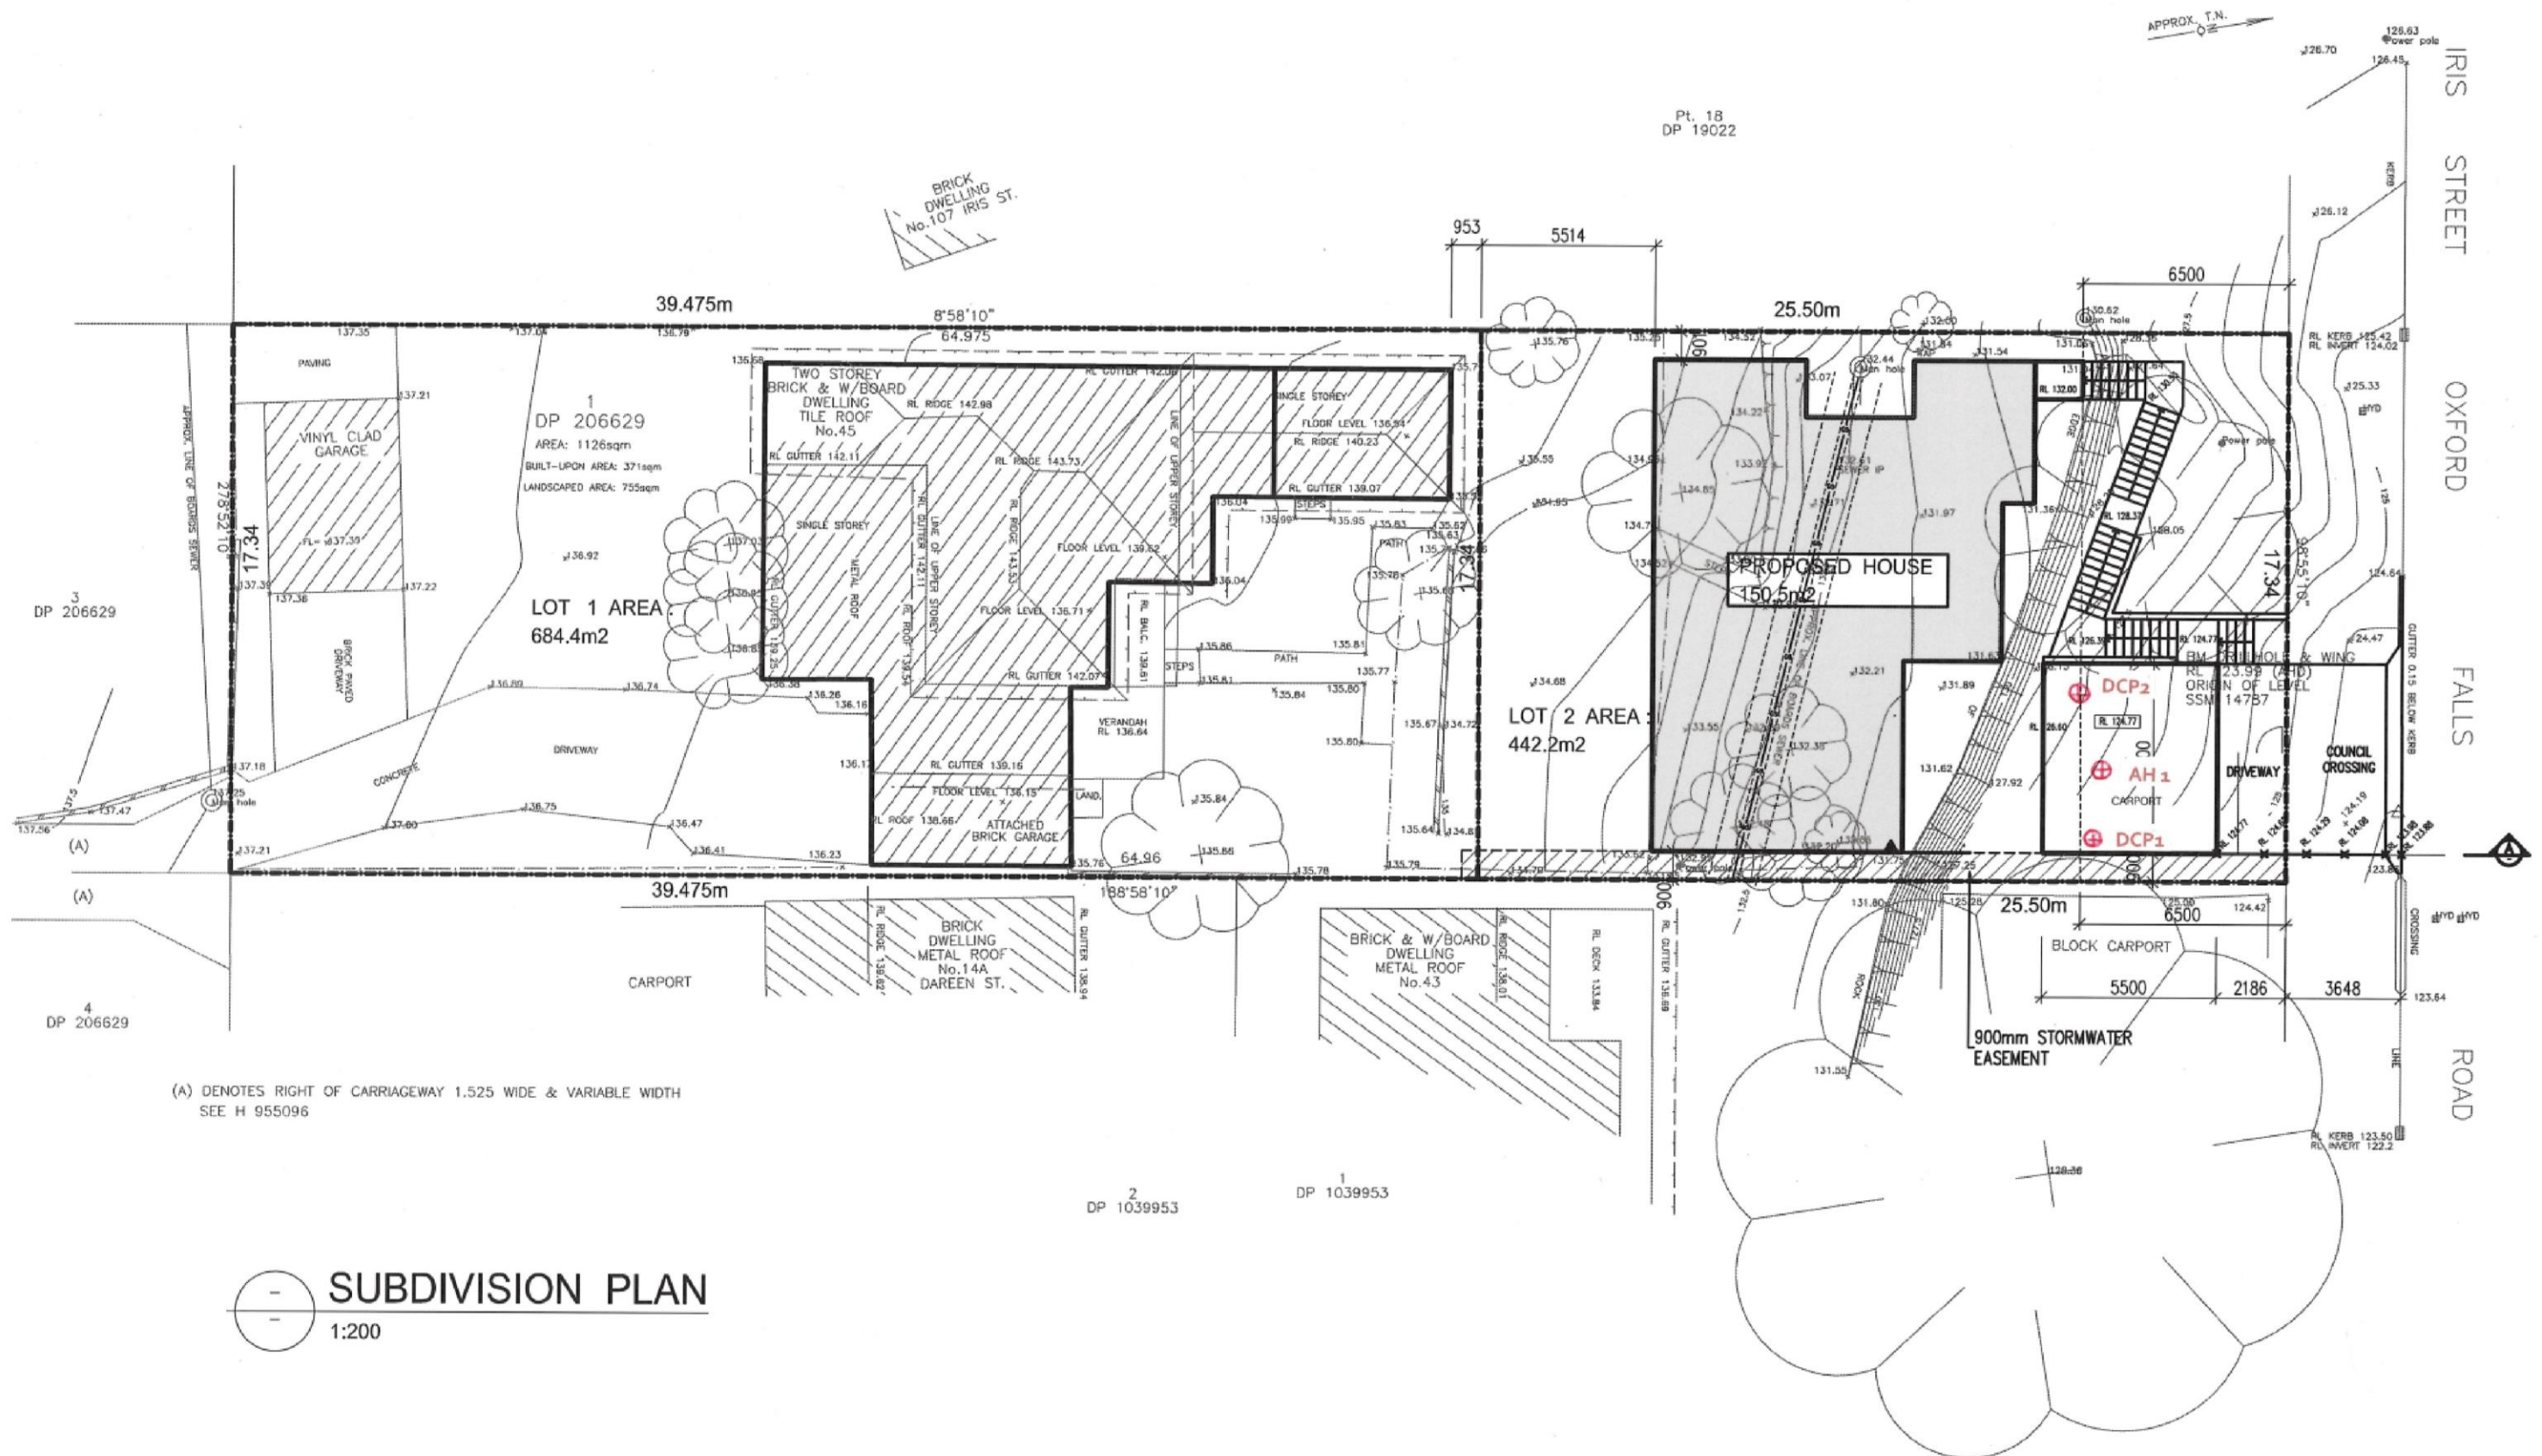
SITE PLAN – showing test locations

One auger hole was put down to identify the soil materials. Two Dynamic Cone Penetrometer (DCP) tests were put down to determine the relative density of the overlying soil and the depth to bedrock. The locations of the tests are shown on the site plan. It should be noted that a level of caution should be applied when interpreting DCP test results. The test will not pass through hard buried objects so in some instances it can be difficult to determine whether refusal has occurred on an obstruction in the profile or on the natural rock surface. This is not expected to be an issue for the testing on this site and the results are as follows:

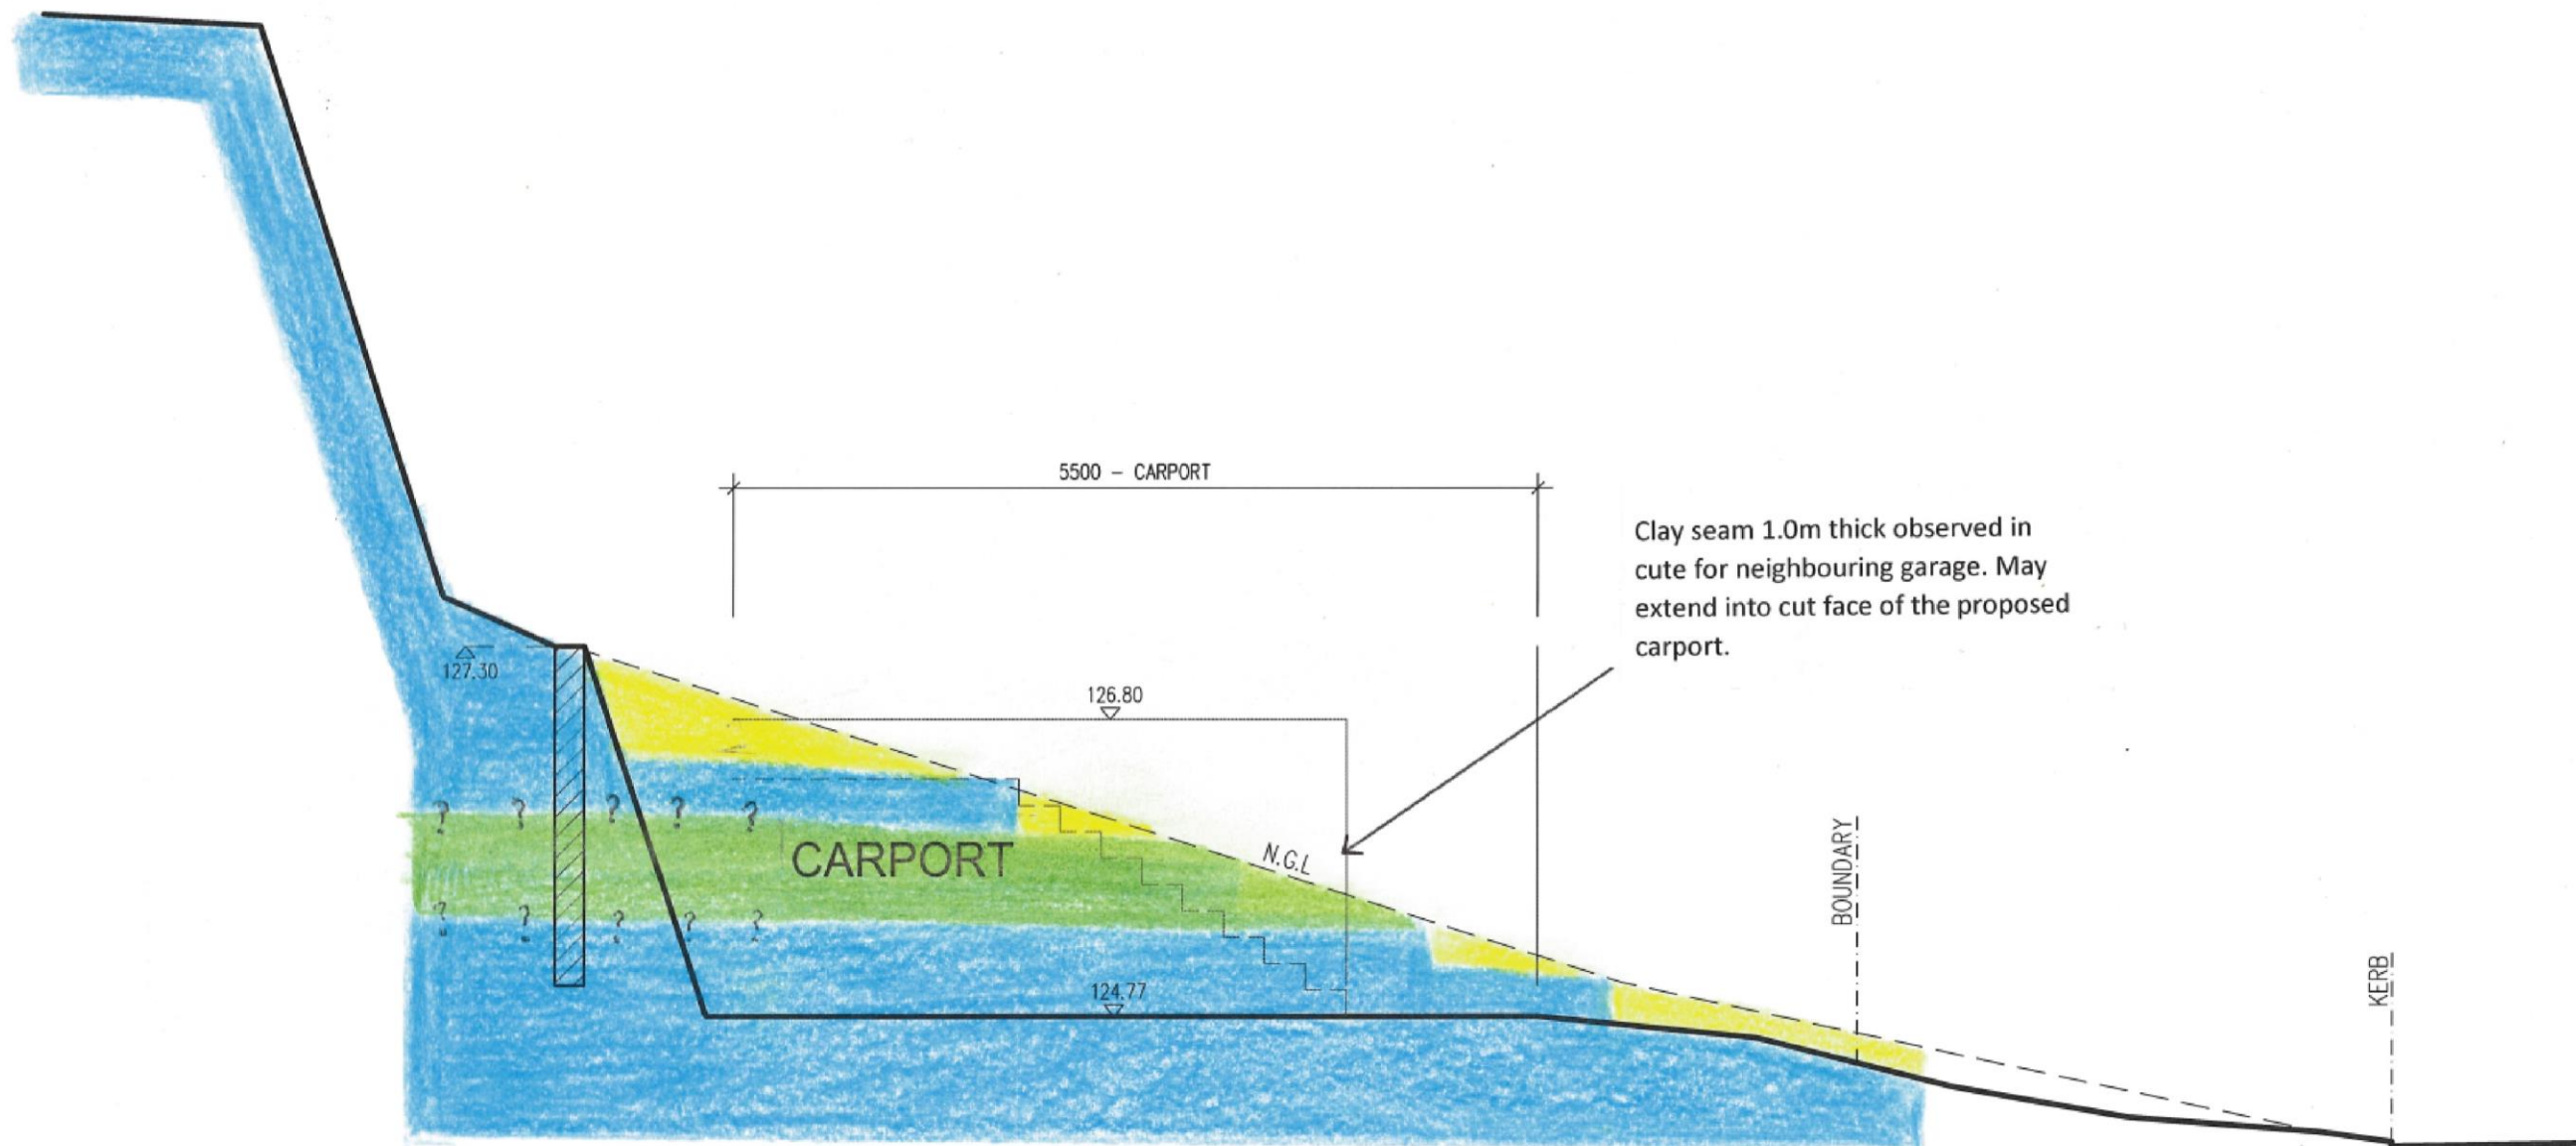
TYPE SECTION – Diagrammatical Interpretation of expected Ground Materials

The surface features of the block are controlled by the outcropping and underlying sandstone bedrock that steps down the property forming sub-horizontal benches between the steps. Where the grade is steeper, the steps are larger, and the benches narrower. Where the slope eases, the opposite is true. Where the rock is not exposed, it is overlain by natural sandy soils that fill the bench step formation. In the test locations where it was not exposed, rock was encountered at depths of between 0.3 to 0.5m below the current surface. The neighbour's excavated carport is positioned 0.9m E of the proposed development (Photo 3) and exposed sandstone bedrock at 0.2m below the surface (Photo 4). The exposed rock across the site is estimated to be Medium Strength and a similar strength rock is expected to underly the entire site. See Type Section attached for a diagrammatical representation of the expected ground materials.

It should be noted that clay seam some meter thick was observed in the existing cut for the neighbouring garage. If this seam is continuous we would expect it towards the base of the proposed cut. See type section. If the seam is present we do not expect it to be a major stability issue. To prevent the clay portion of the seam reeling back it may require support with drained sprayed concrete and mesh. The geotechnical consultant is to inspect the cut face as it is lowered in intervals of ~1.5m and can make the call on the stability of the clay seam when and if it is exposed.
