**GEOTECHNICAL RISK MANAGEMENT POLICY FOR PITTWATER
FORM NO. 1 – To be submitted with Development Application**

Development Application for _____	Name of Applicant
Address of site <u>163 McCarrs Creek Road, Church Point</u>

163 McCarrs Creek Road, Church Point

Minor Works Assessment

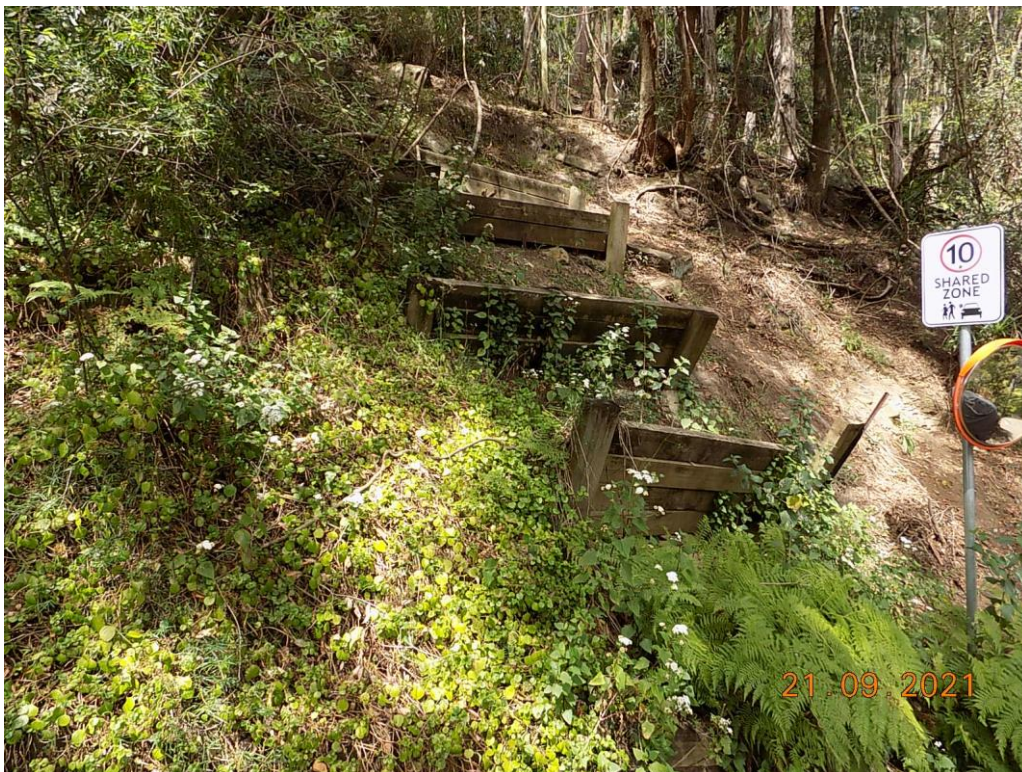
Photo 4

wall reaching ~1.4m high (Photo 3). A series of old timber retaining walls are in the slow process of collapse in the SW corner of the property (Photo 4). These walls do not retain any soil and are tilting at severe angles downslope (~33° from vertical). We recommend the walls be removed as part of the proposed works and this portion of the slope be planted out with low growing native shrubs. The slope above and below the property continues at steep angles and appears in good order as observed from the subject property. The likelihood of the land surface on, above, or below the property failing and impacting on the house is assessed as 'Unlikely' (10^{-4}). The consequences to property of such a failure are assessed as 'Medium' (15%). The risk to property is 'Low' (2×10^{-5}).
