# DILAPIDATION REPORT

**Warriewood Road, Warriewood**

**Prepared by: Rezoning Pty Ltd t/as Effective Building & Consultancy**

The inspection was carried out on 11 November 2024.

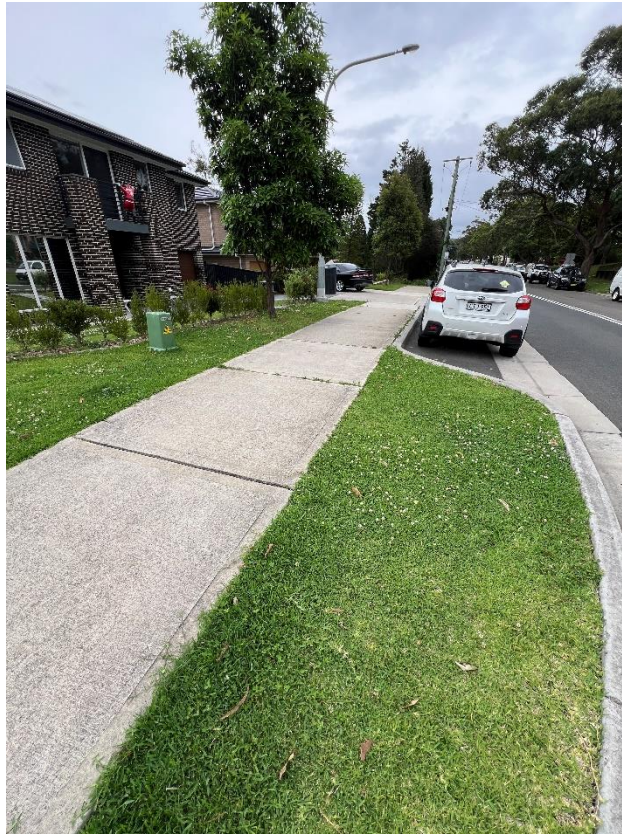
*Figure 1 – General condition of the nature strip/footpath.*

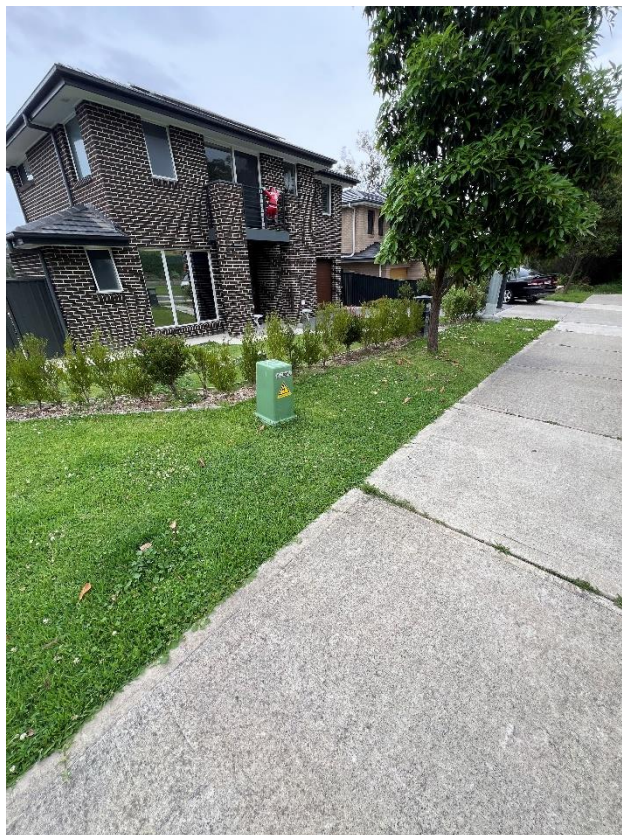
*Figure 2 – General condition of the nature strip/footpath.*

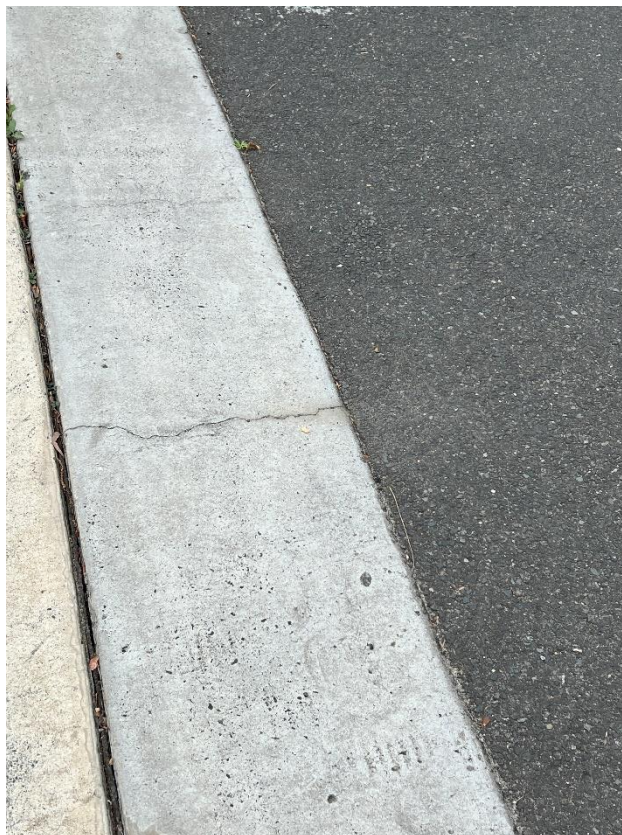
*Figure 10 – Crack is evident to the layback.*

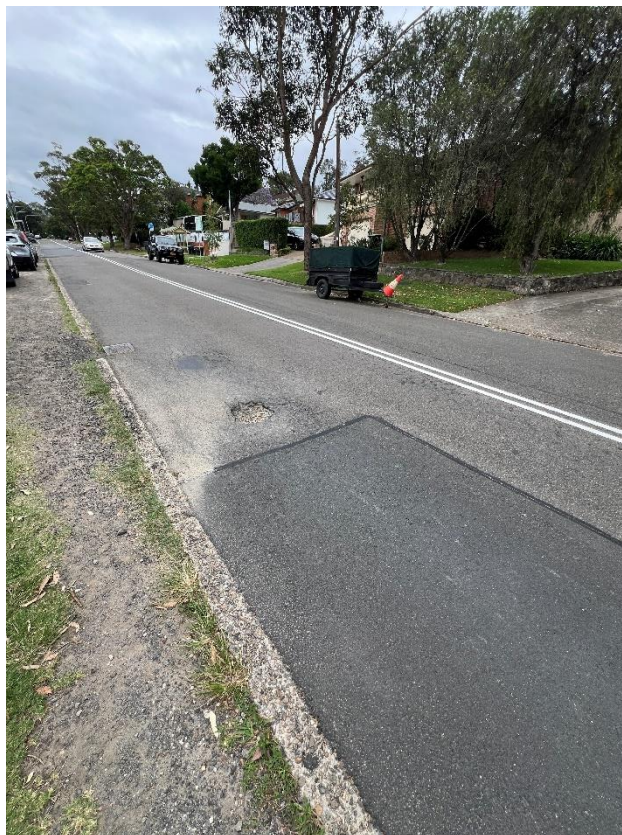
*Figure 28 – Pothole is evident to the road.*

The council assets were found to be in a fair condition with evidence of crack to the road, concrete to shed area, kerb, layback, pit, and driveway. Pothole is evident to the road.

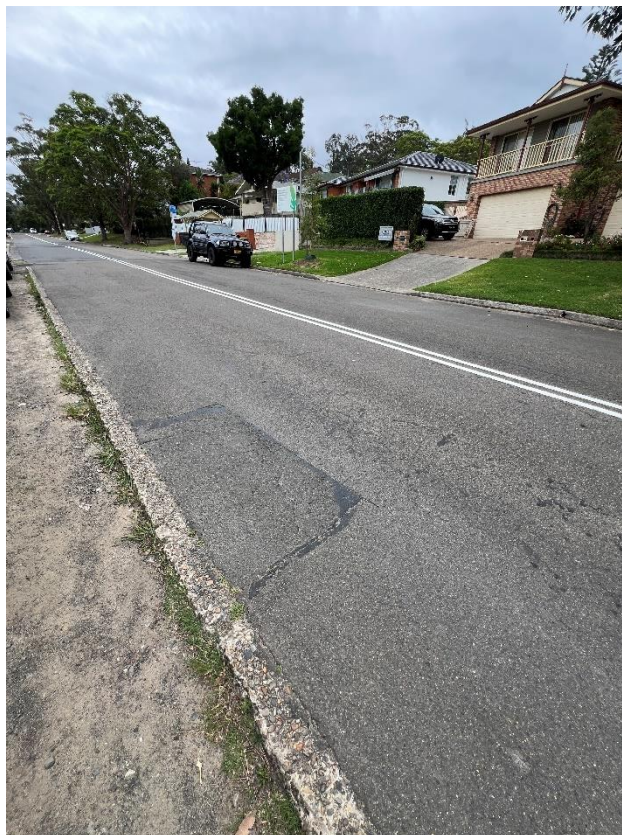
*Figure 32 – Crack is evident to the road.*

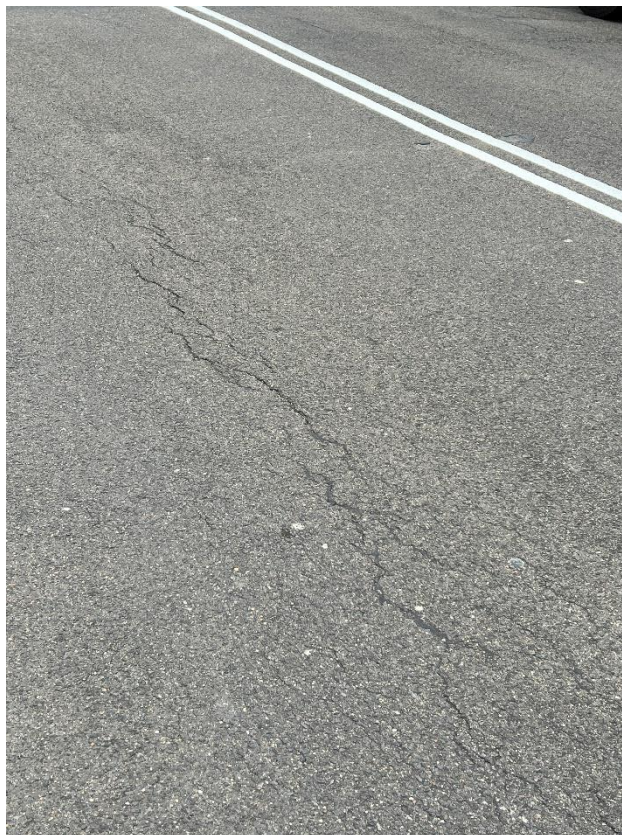
*Figure 34 – Crack is evident to the road.*

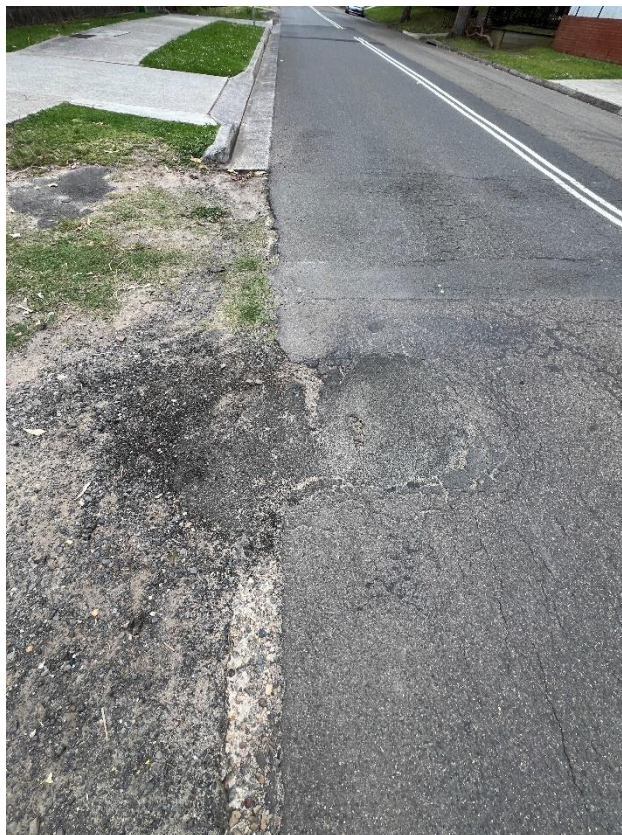
*Figure 36 – Crack is evident to the road.*

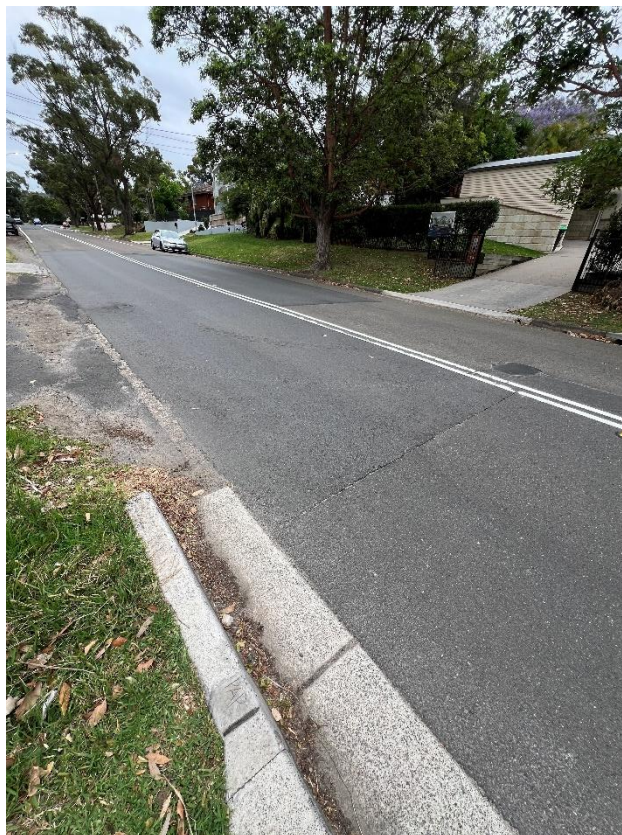
*Figure 48 – Crack is evident to the road.*

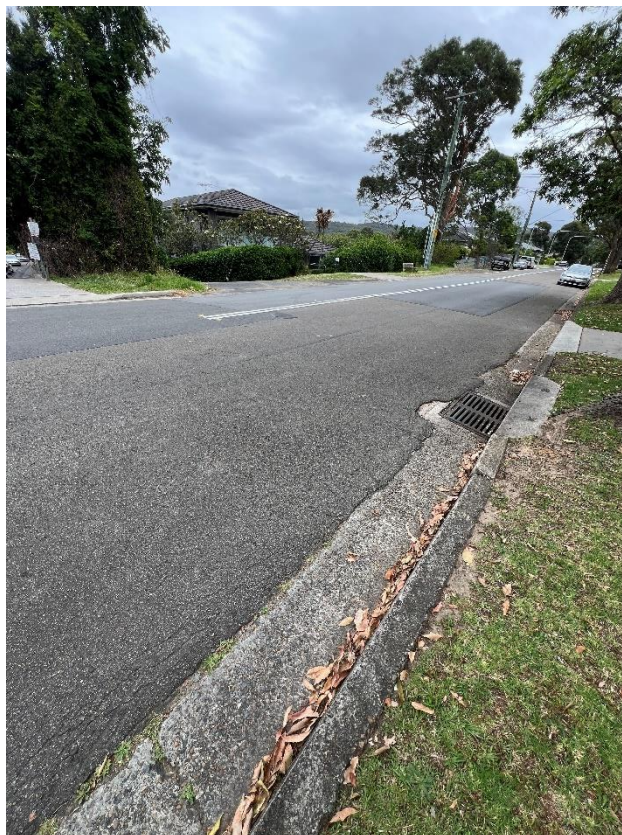
*Figure 56 – General condition of the kerb/road.*

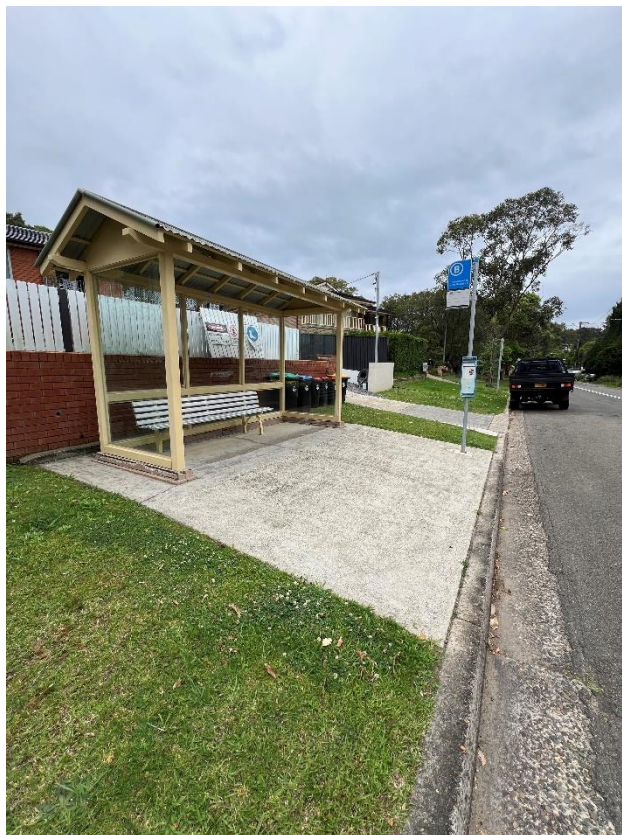
*Figure 58 – General condition of the shed area.*

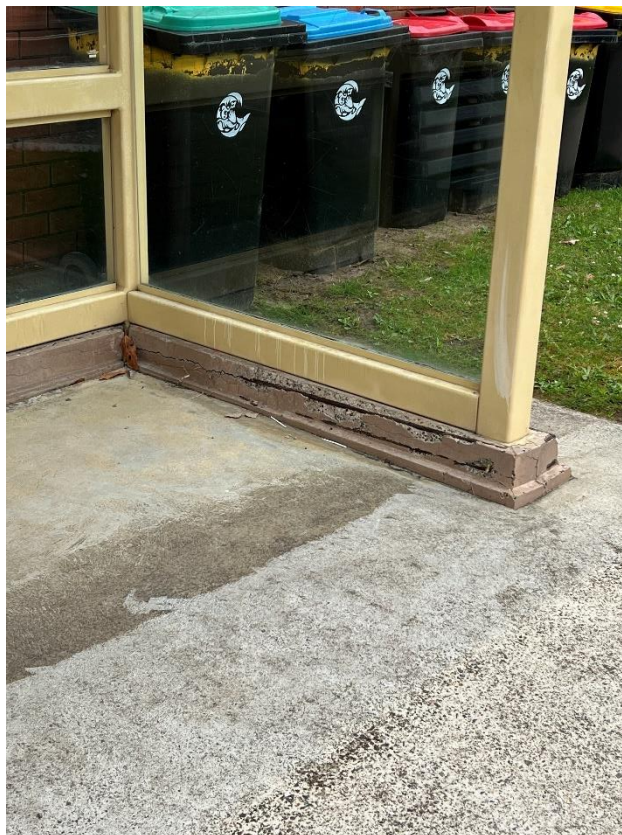
*Figure 60 - Crack is evident to the concrete at shed area.*

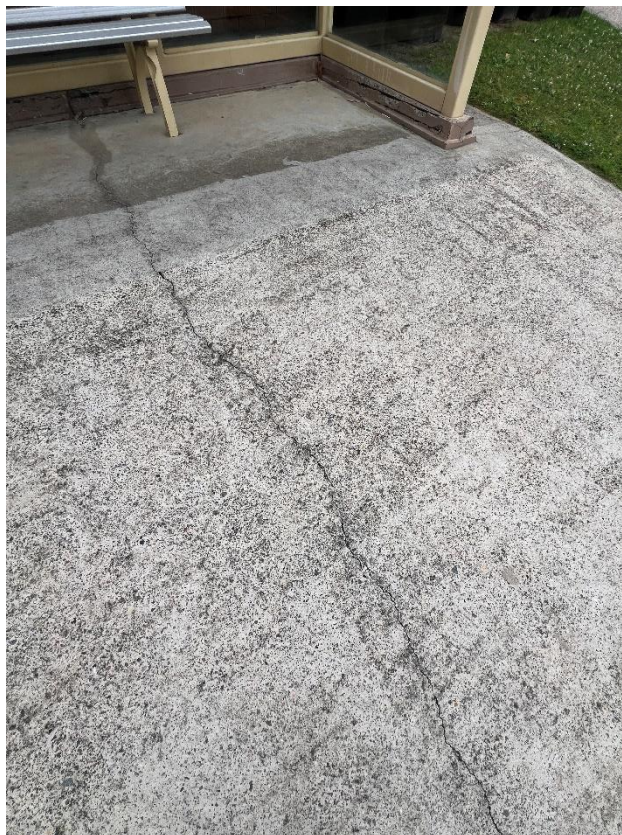
*Figure 62 – Crack is evident to the concrete at shed area.*

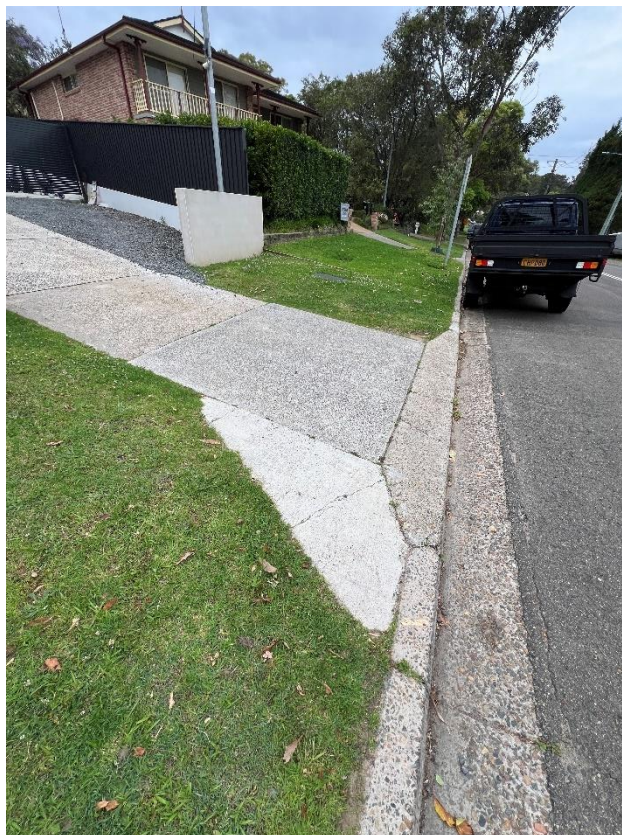
*Figure 64 – Crack is evident to the layback.*

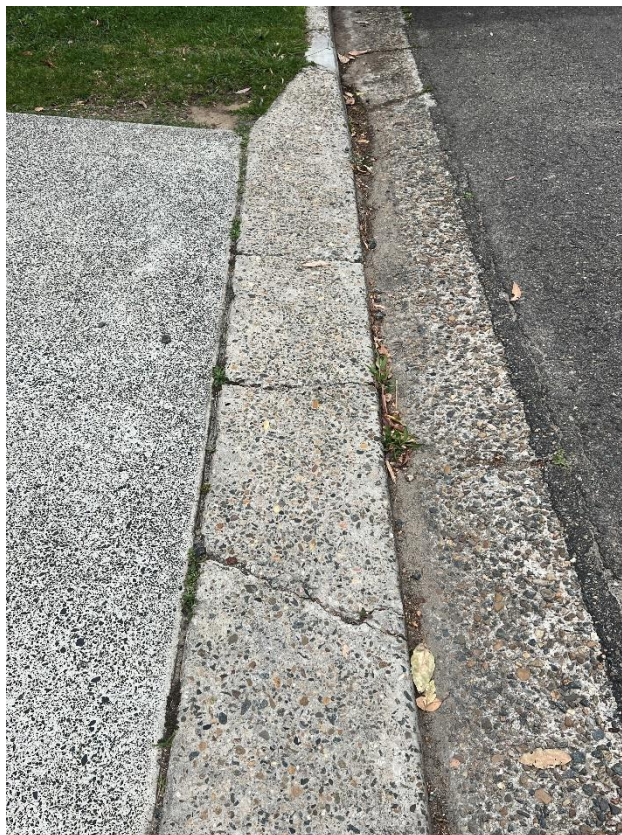
*Figure 66 – Crack is evident to the layback.*

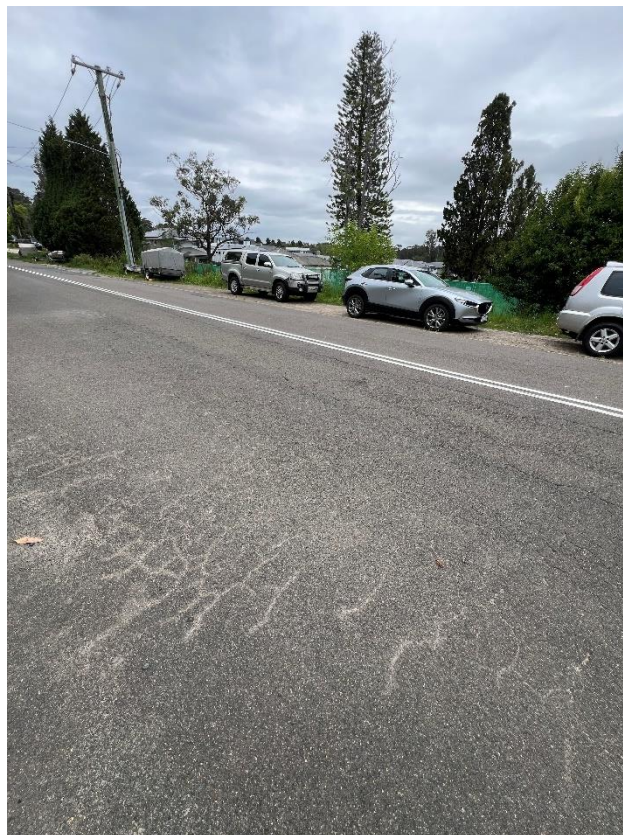
*Figure 72 – Crack is evident to the road.*

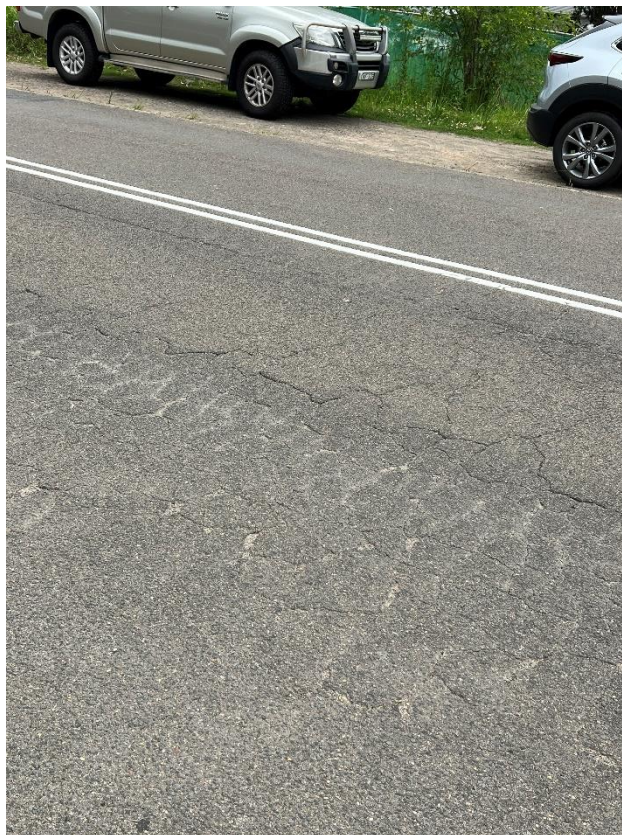
*Figure 74 – Crack is evident to the road.*

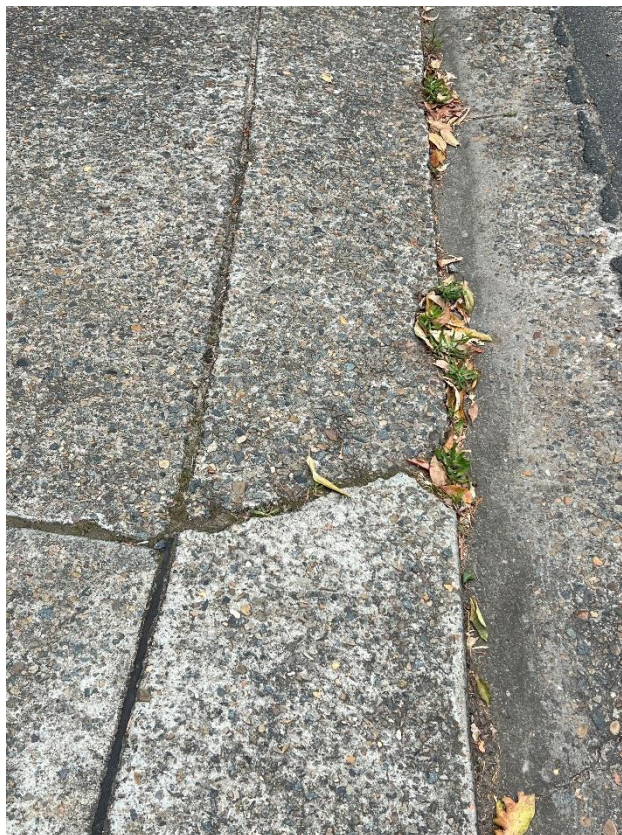
*Figure 86 – Crack is evident to the layback.*

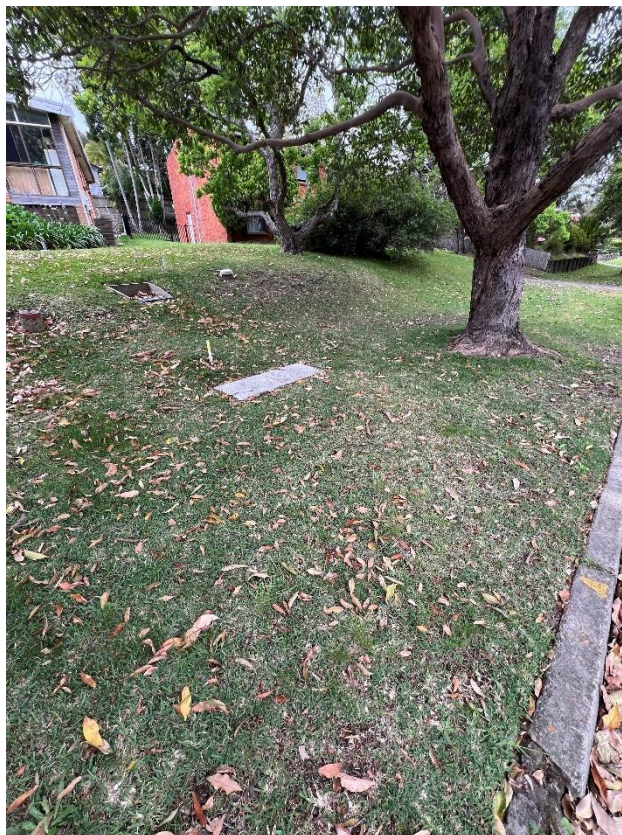
*Figure 92 – General condition of the nature strip.*

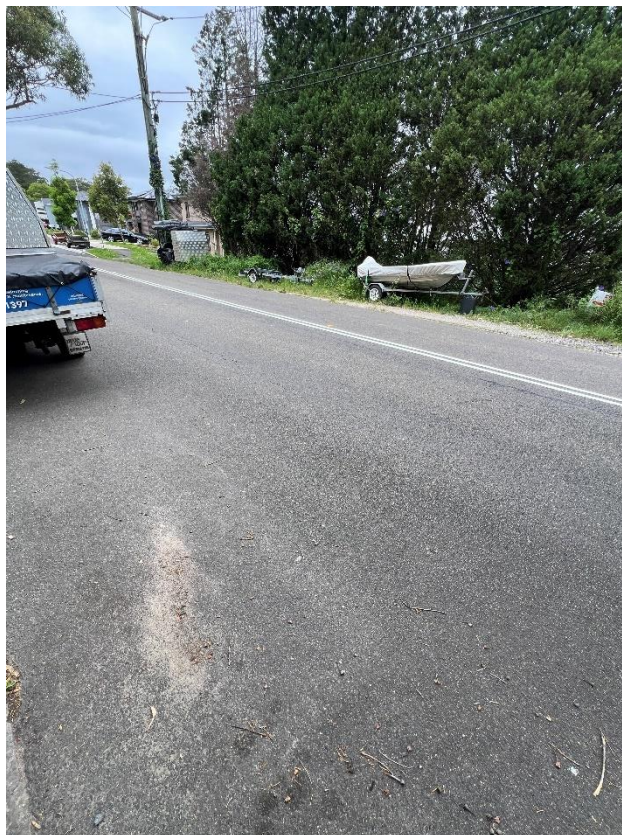
*Figure 98 – General condition of the road.*

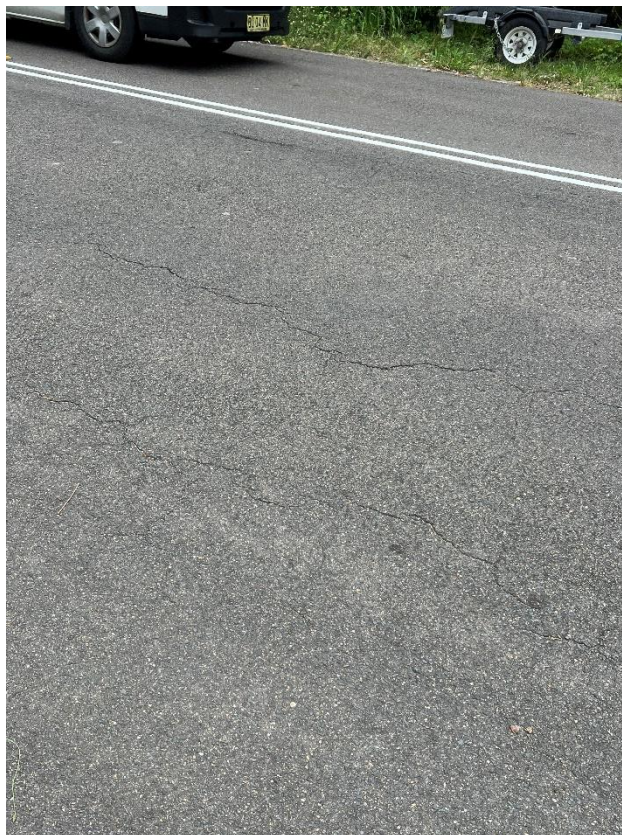
*Figure 102 – Crack is evident to the road.*

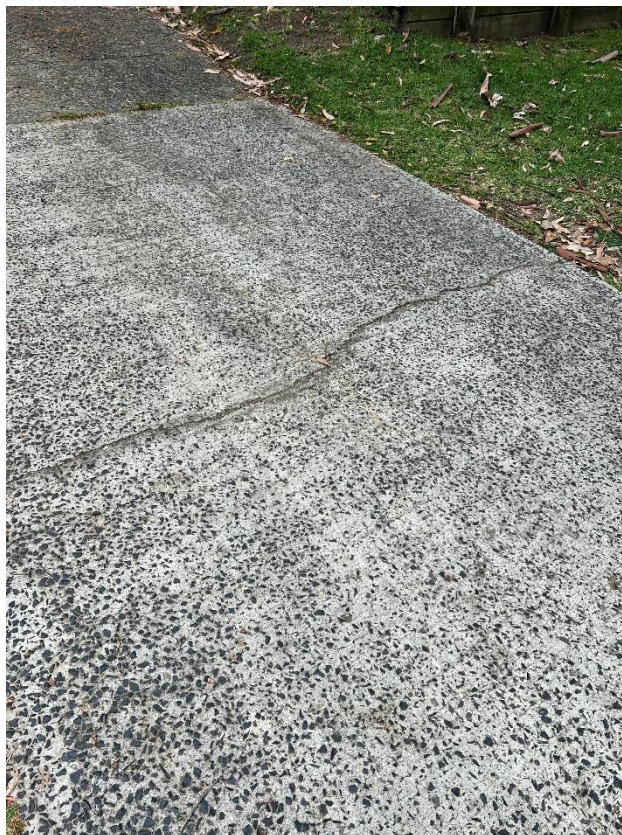
*Figure 104 – Crack is evident to the driveway.*

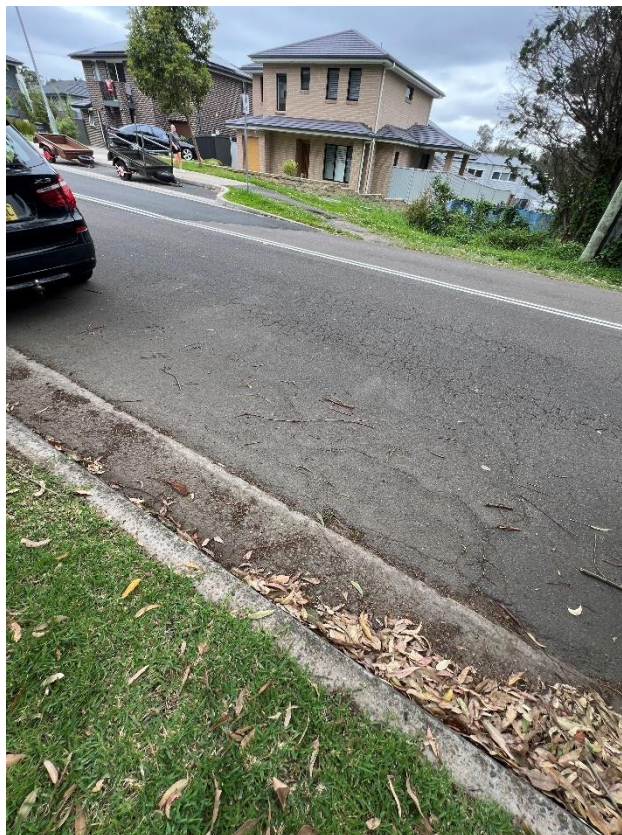
*Figure 112 – Crack is evident to the road.*

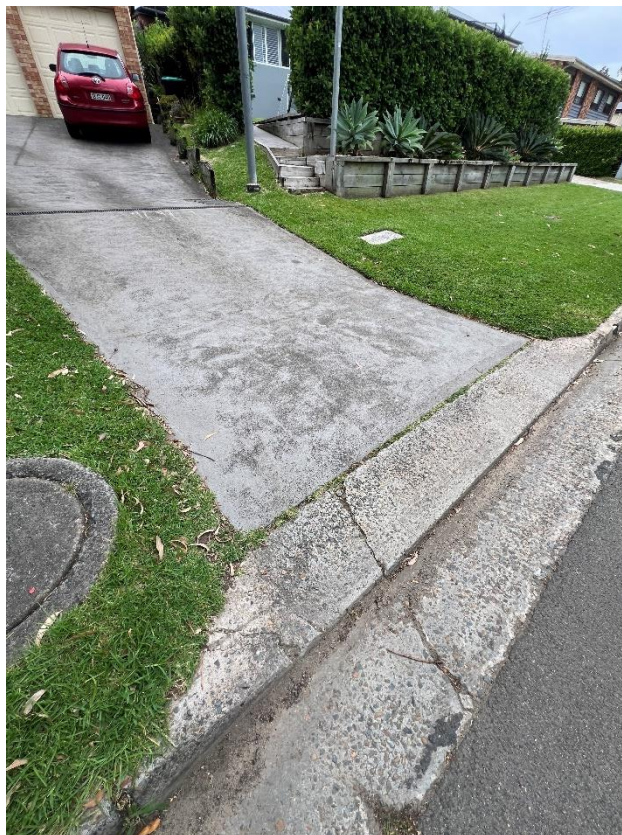
*Figure 118 – Crack is evident to the layback.*

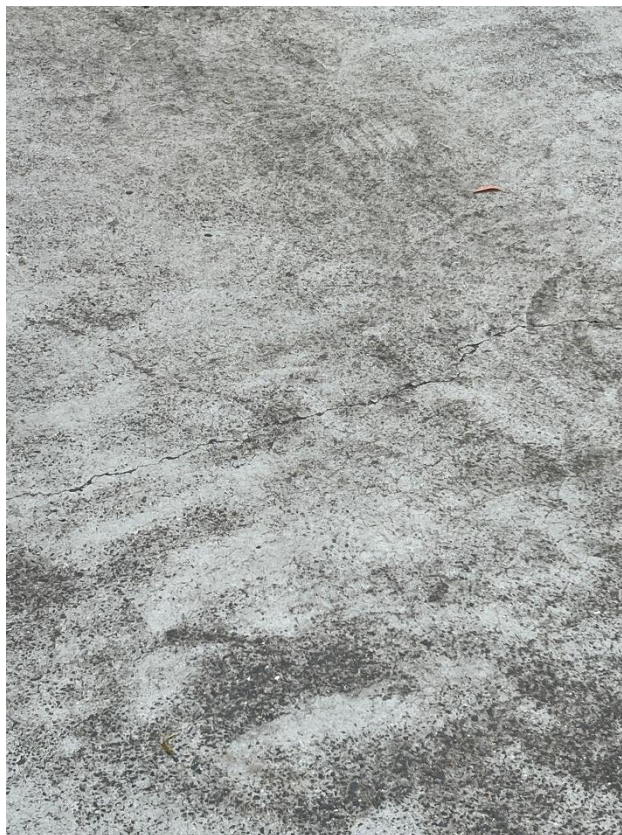
*Figure 120 – Crack is evident to the driveway.*

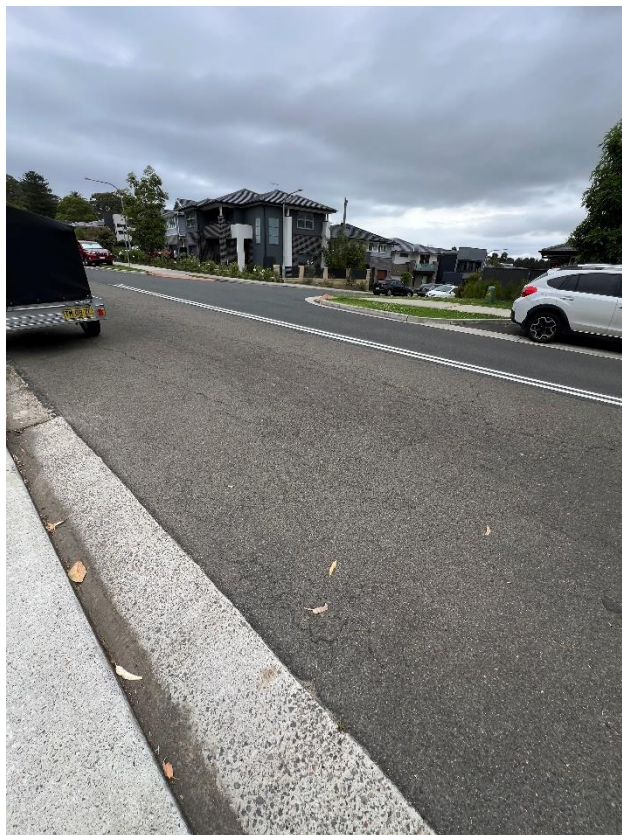
*Figure 128 – Crack is evident to the road.*

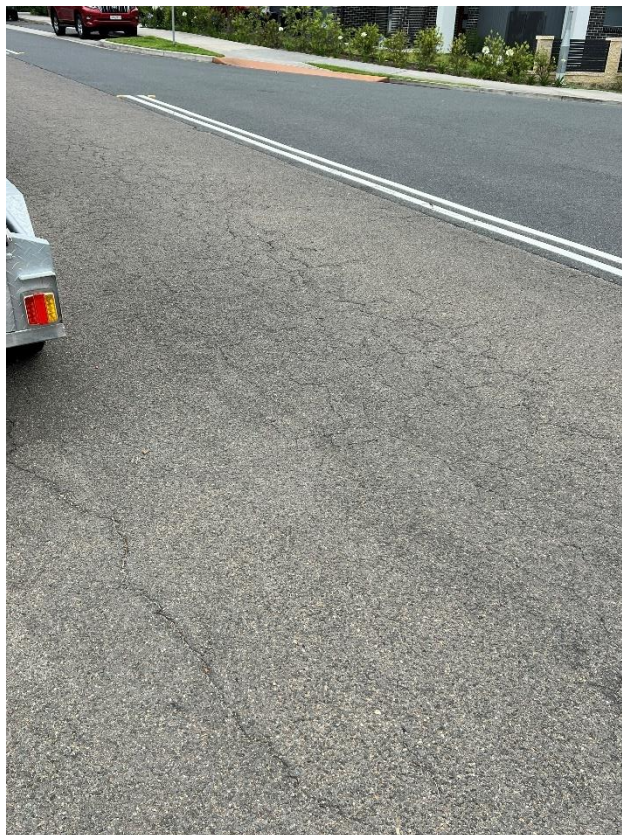
*Figure 130 – Crack is evident to the road.*

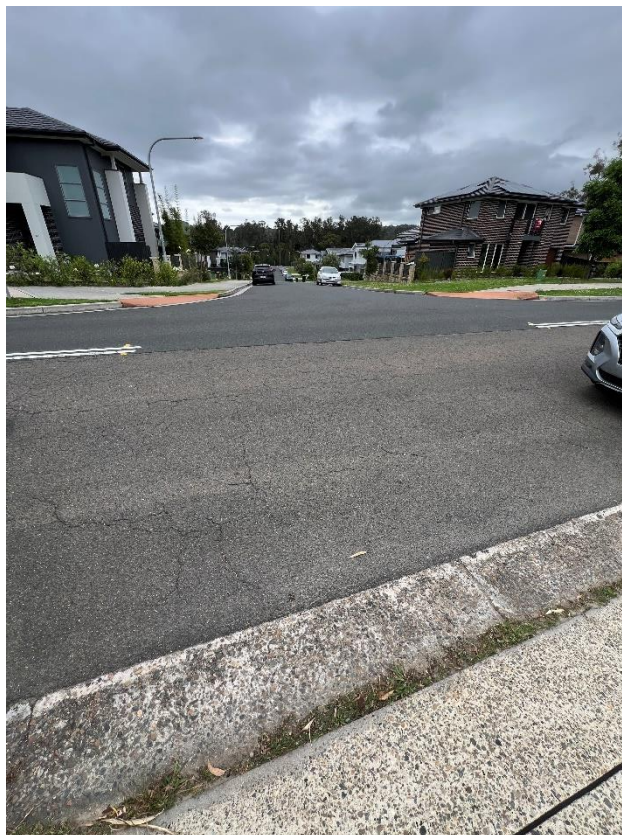
*Figure 136 – Crack is evident to the road.*
